# FOUNTAINBLEAU SOUTH GARAGE & BALLROOM

## 4360-4370 Collins Avenue

Re: 4441 Collins Avenue Miami Beach, FL

I visited the above-mentioned property on Sunday, March 15, 2020 to evaluate 72 trees, verify condition and measurements, take photographs and note any significant defects.

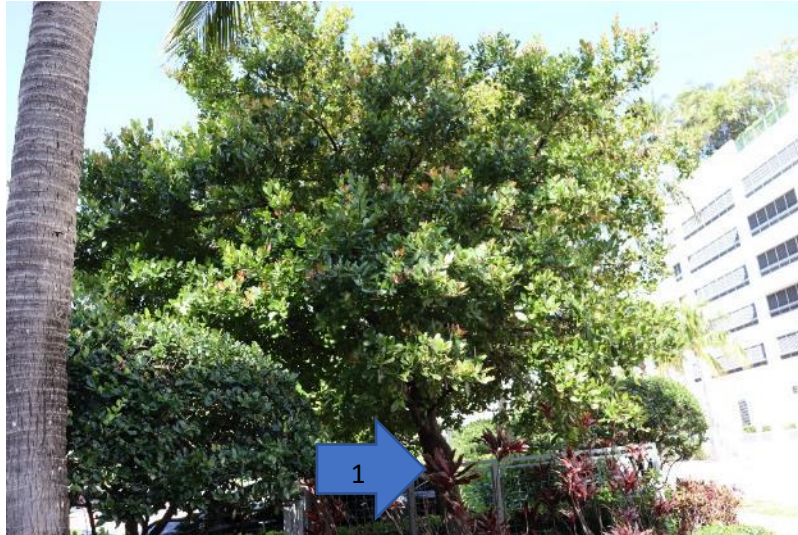
Tree One

Brazilian Beautyleaf (*Calophyllum brasiliense*), facing west.

Note trunk girdling (bracing straps) (red arrow), and trunk lean (south).

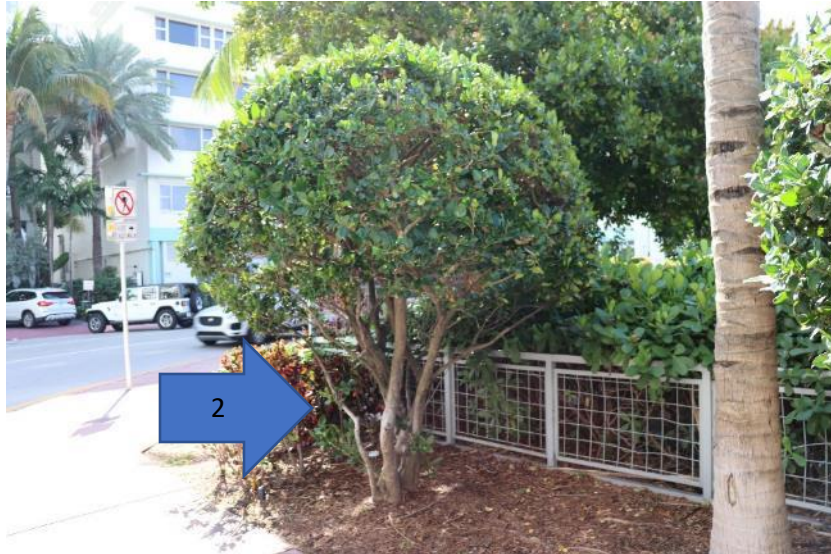
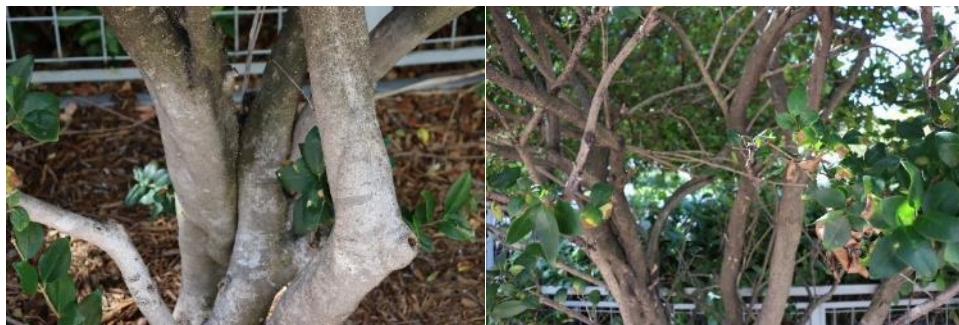
## Tree Two

Ligustrum (Ligustrum japonicum), facing east.

Note poor structure, shaping and deadwood.

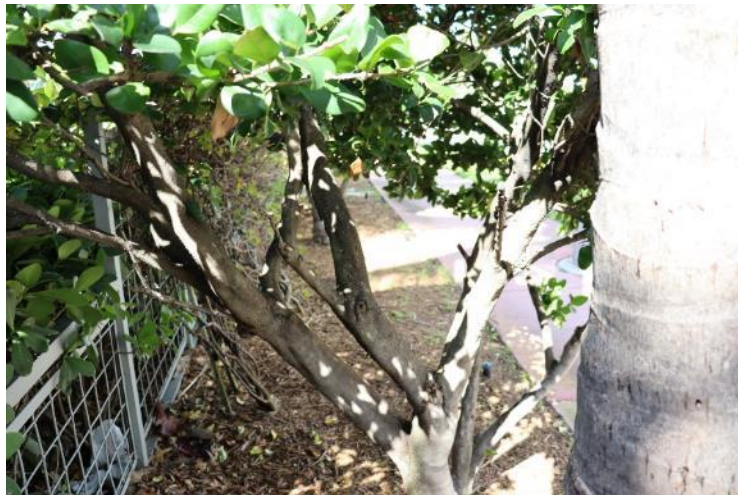
Tree Four

Ligustrum (*Ligustrum japonicum*), facing south.

Note poor structure, shaping and deadwood.

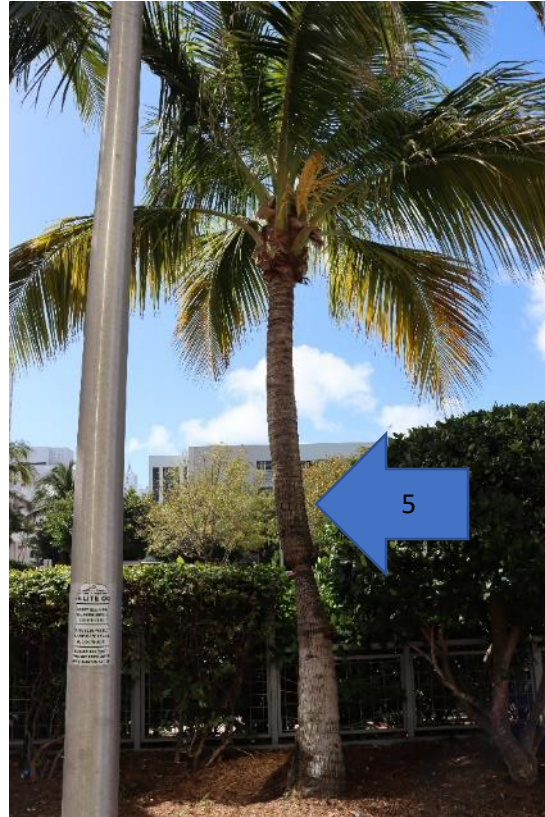
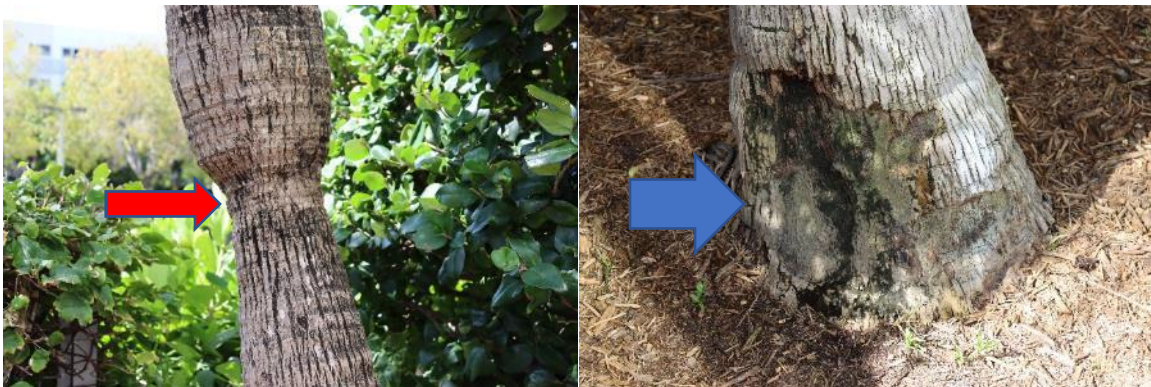
Tree Five

Coconut Palm (*Cocos nucifera*), facing south.

Note severe penciling (red arrow) and large trunk wound (blue arrow).

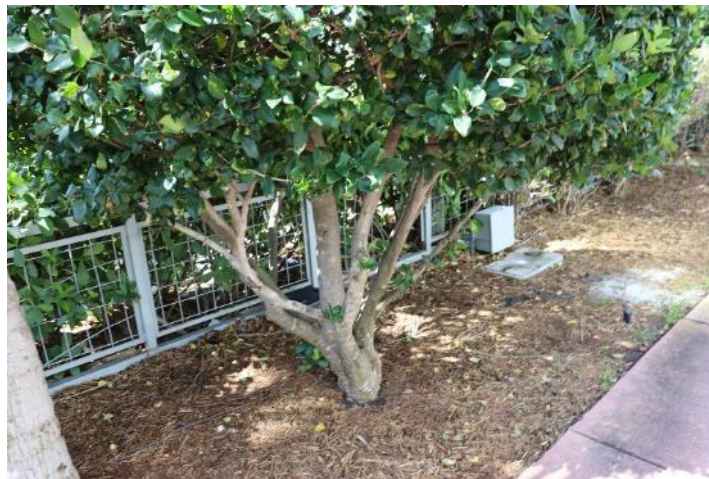
Tree Six

Ligustrum (*Ligustrum japonicum*), facing south.

Note poor structure and shaping.

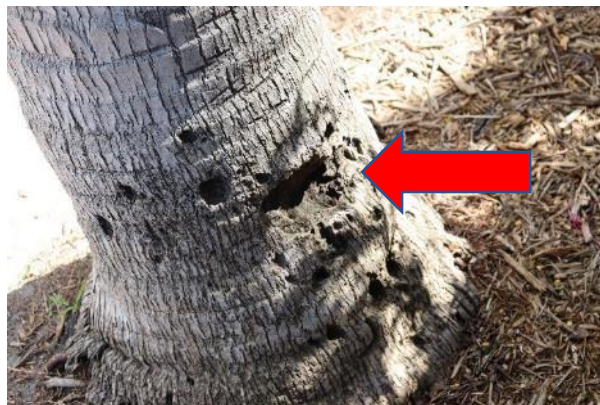
Tree Seven

Coconut Palm (*Cocos nucifera*), facing east.

Note trunk wounds (red arrow).

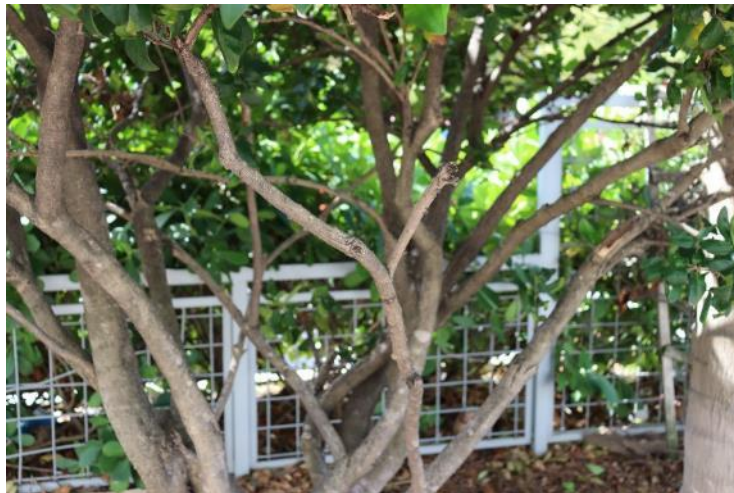
Tree Eight

Ligustrum (*Ligustrum japonicum*), facing south.

Note poor structure and shaping.

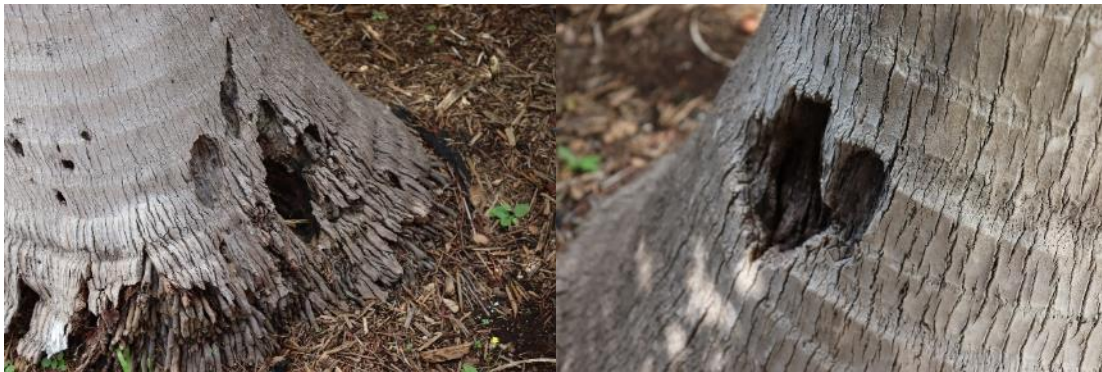
Tree Eleven

Coconut Palm (*Cocos nucifera*), facing east.

Note trunk wounds.

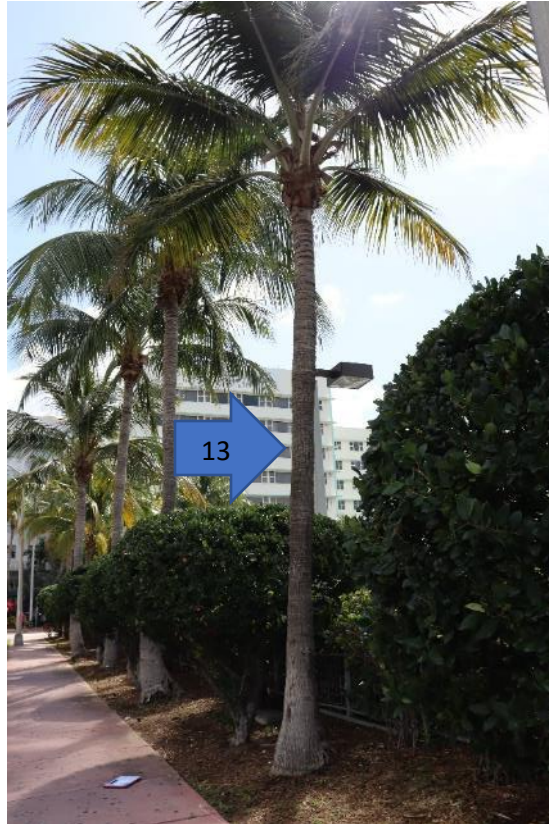
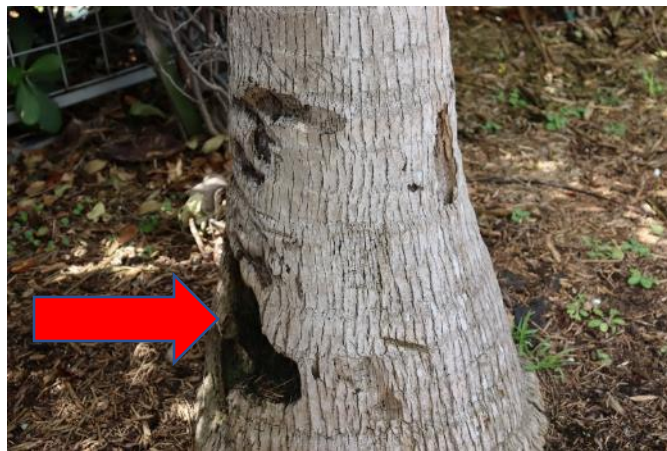
Tree Thirteen

Coconut Palm (*Cocos nucifera*), facing east.

Note large trunk wounds (red arrow).

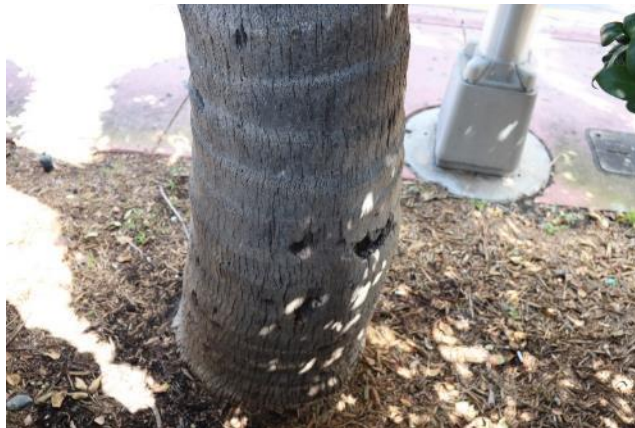
Tree Fifteen

Coconut Palm (*Cocos nucifera*), facing east.

Note trunk wounds.

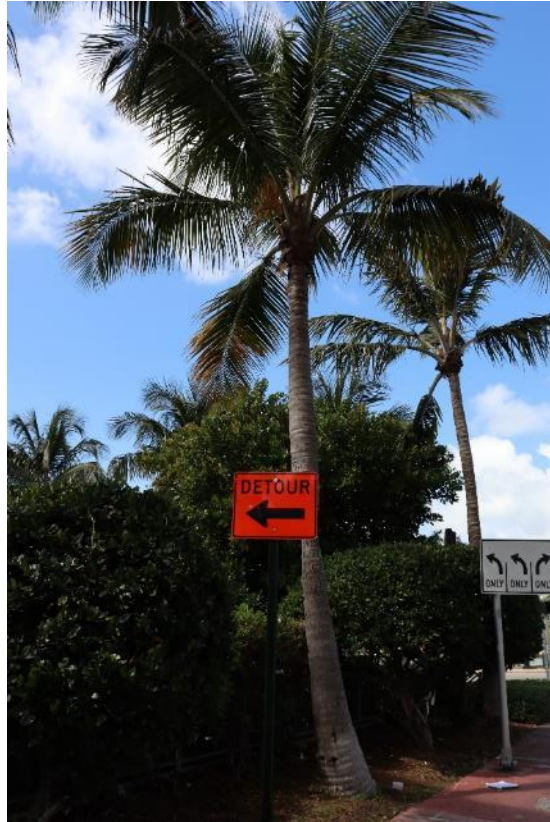
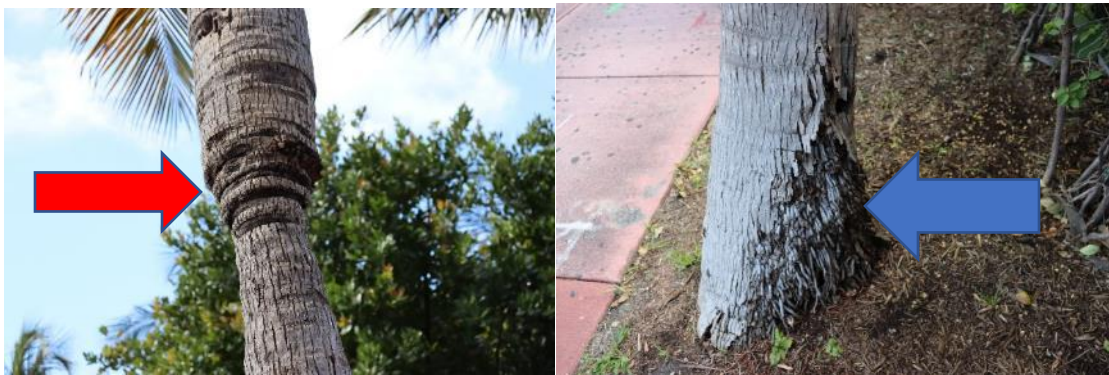
Tree Seventeen

Coconut Palm (*Cocos nucifera*), facing west.

Note severe pencilling (red arrow) and large trunk wound (blue arrow).

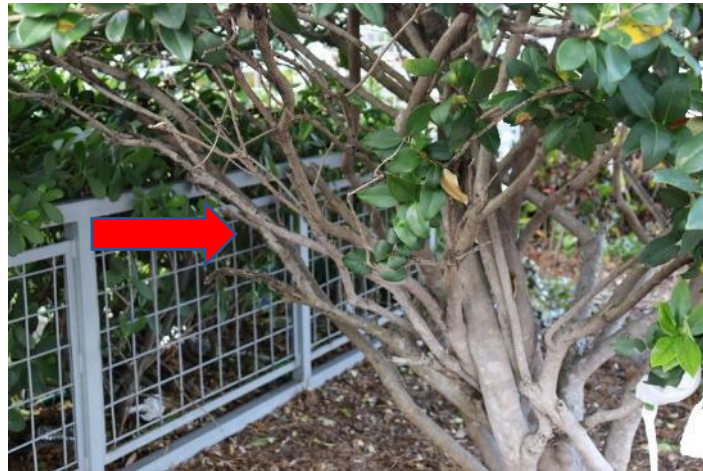
### Tree Eighteen

Ligustrum (*Ligustrum japonicum*), facing west.

Note poor structure, deadwood (red arrow) and shaping.

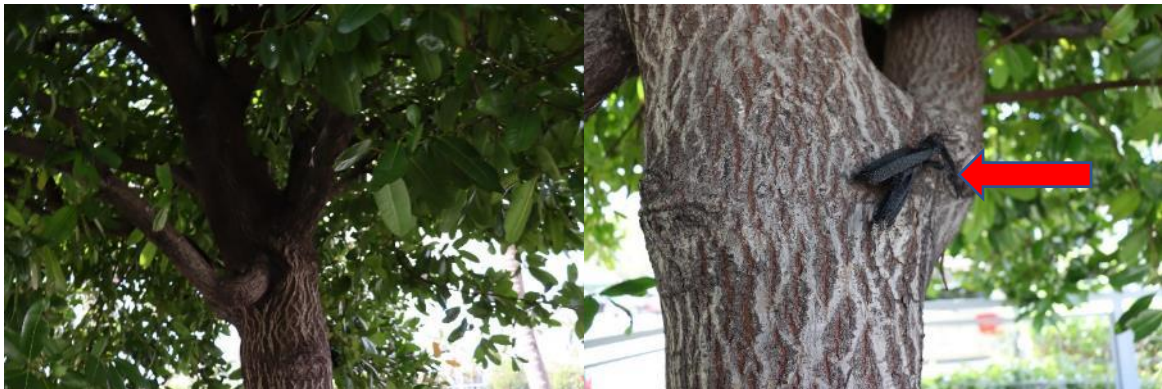
Tree Twenty

Brazilian Beautyleaf (*Calophyllum brasiliense*), facing east.

Note poor structure and trunk girdling (straps) (red arrow).

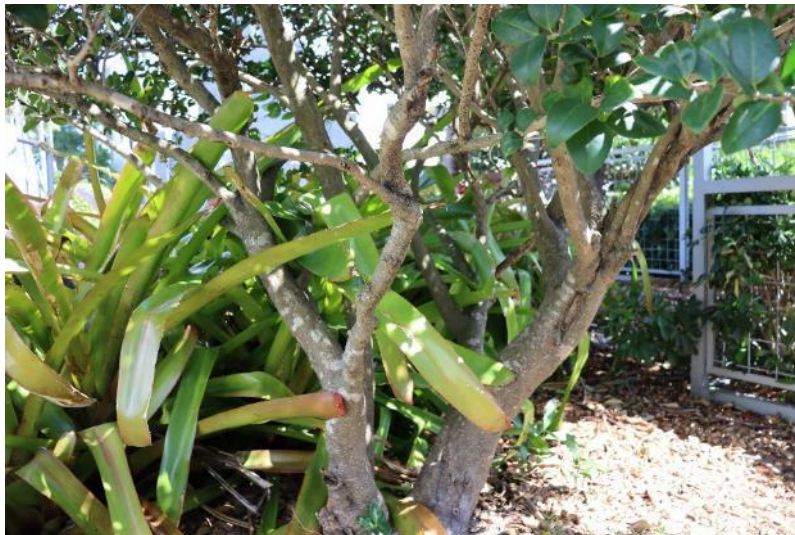
Tree Twenty-One

Ligustrum (*Ligustrum japonicum*), facing east.

Note shaping and poor structure.

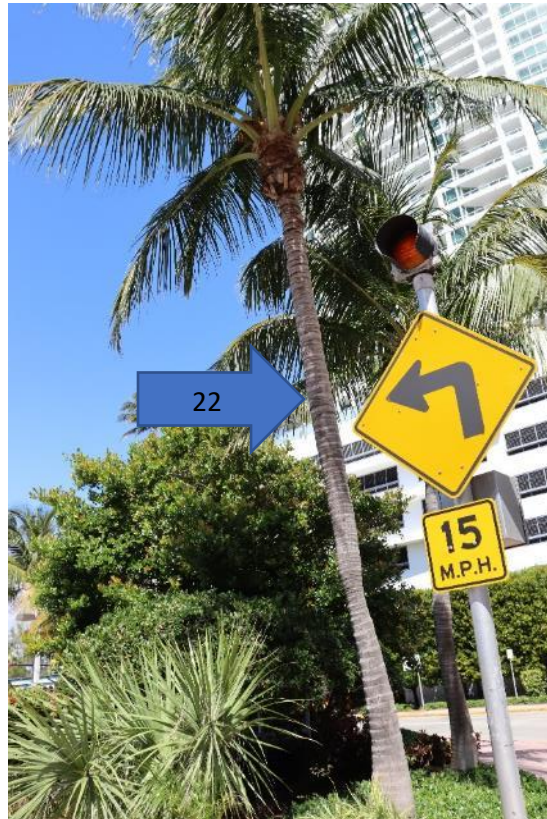
Tree Twenty-Two

Coconut Palm (*Cocos nucifera*), facing north.

Note significant pencilling (red arrow).

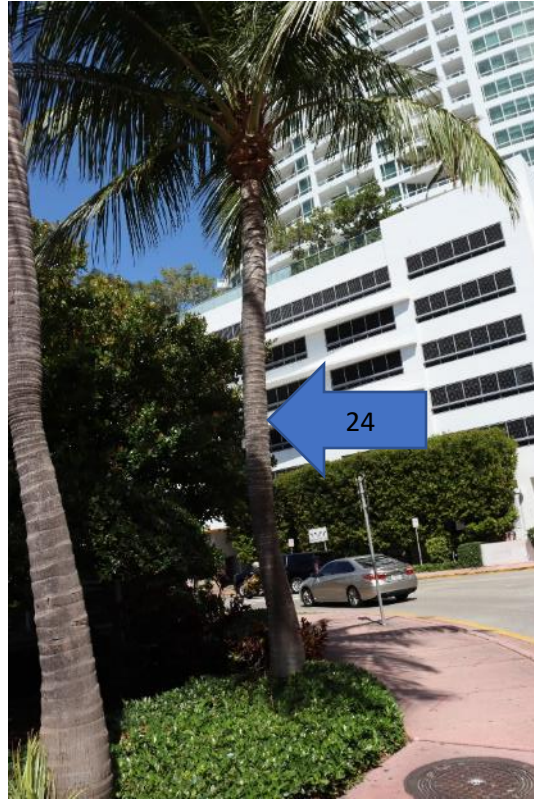
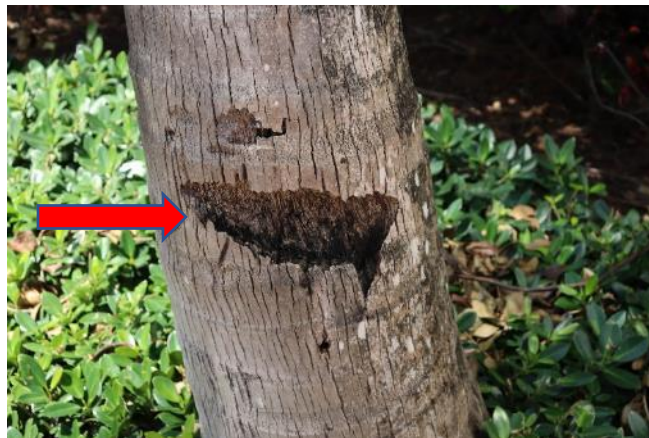
Tree Twenty-Four

Coconut Palm (*Cocos nucifera*), facing north.

Note large trunk wound (red arrow).

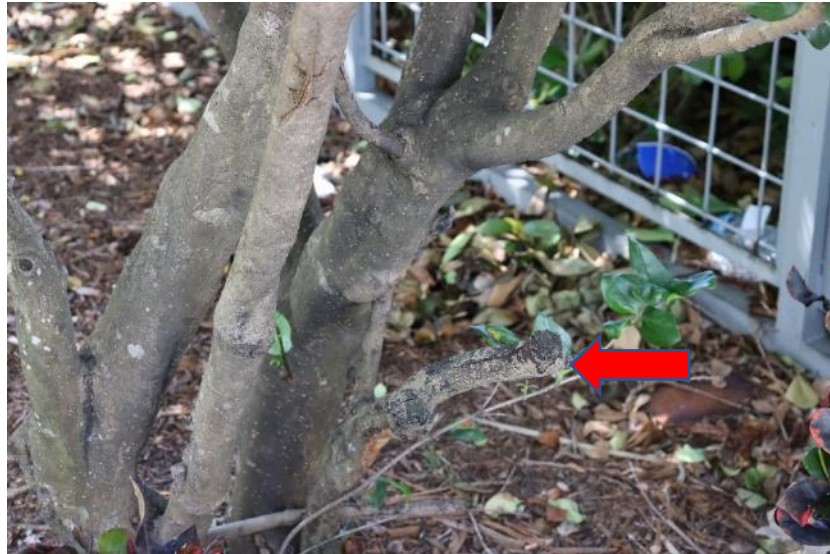
Tree Twenty-Five

Ligustrum (*Ligustrum japonicum*), facing south.

Note shaping, stub cuts (red arrow) and poor structure.

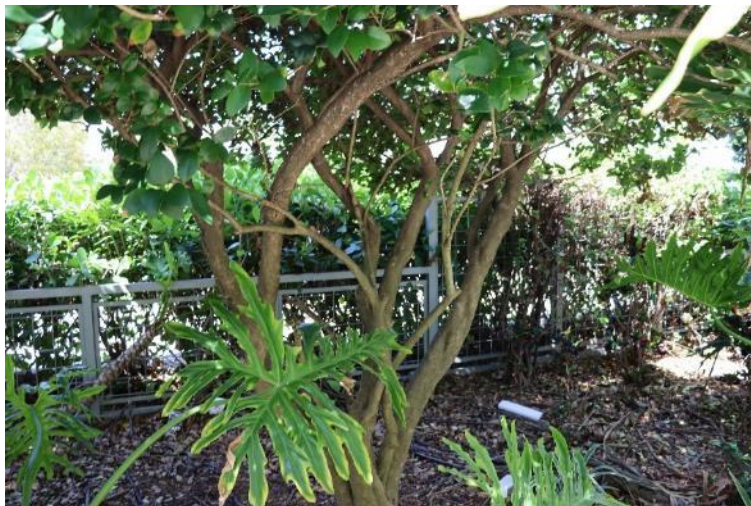
Tree Twenty-Six

Ligustrum (*Ligustrum japonicum*), facing west.

Note shaping, deadwood and poor structure.

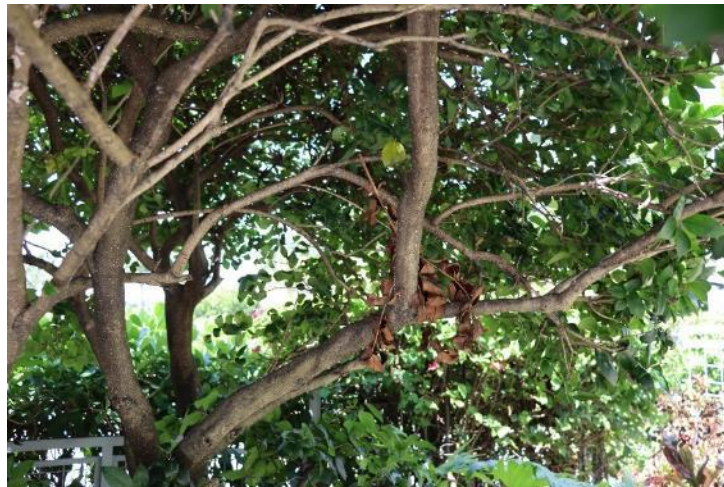
Tree Twenty-Eight

Ligustrum (*Ligustrum japonicum*), facing west.

Note shaping, deadwood and poor structure.

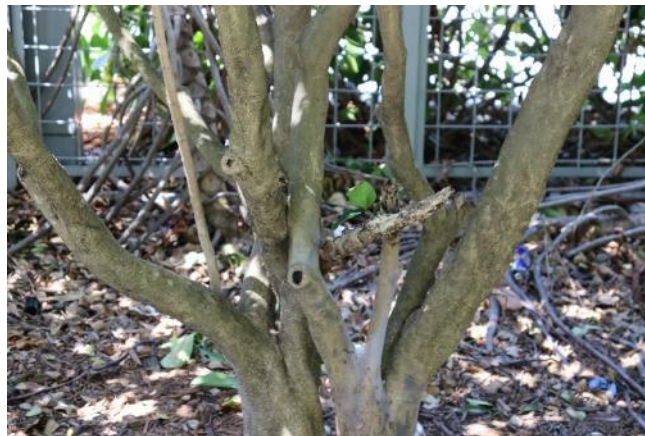
Tree Thirty

Ligustrum (*Ligustrum japonicum*), facing west.

Note shaping, deadwood and poor structure.

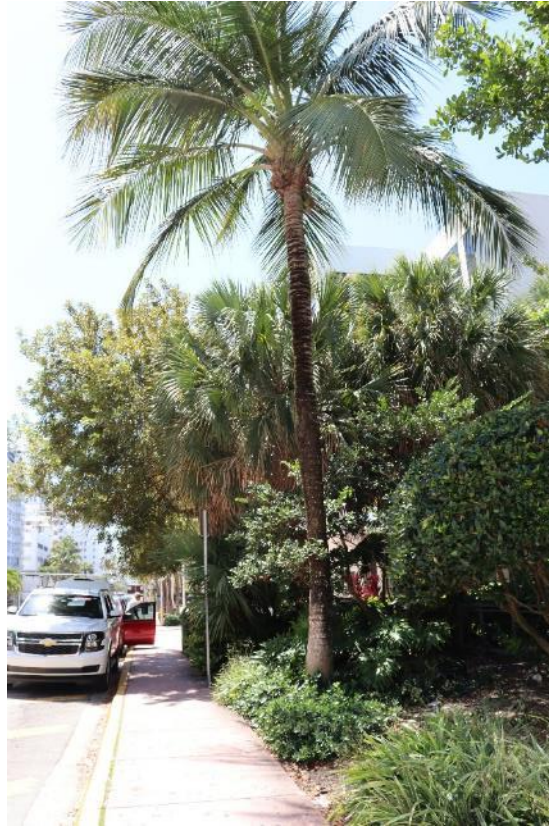
Tree Thirty-Four

Coconut Palm (*Cocos nucifera*), facing south.

Note nutrient deficiencies and large trunk wound (red arrow).

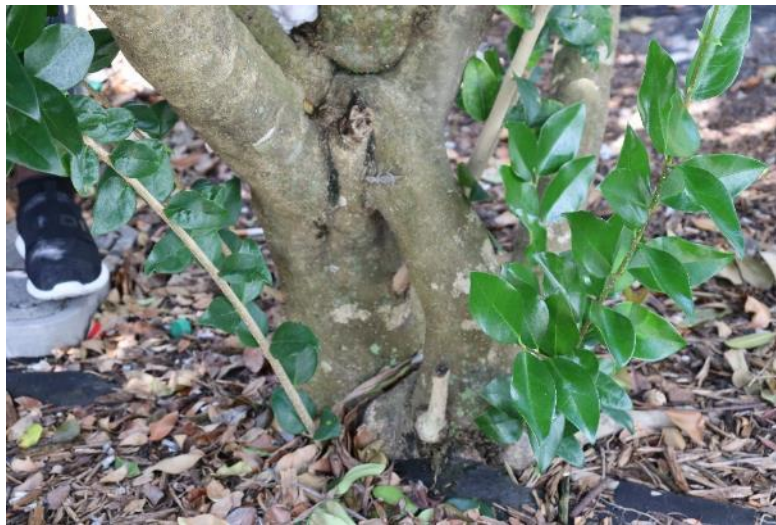
### Tree Thirty-Five

Ligustrum (*Ligustrum japonicum*), facing west.

Note shaping, deadwood and poor structure.

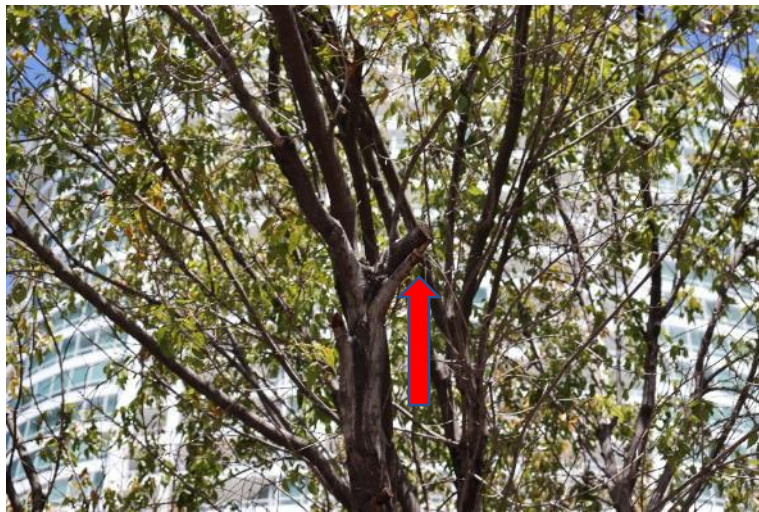
### Tree Thirty-Eight

Mahogany (*Swietenia mahagoni*), facing north.

Note poor structure, stub cuts (red arrow) and canopy over-lifting.

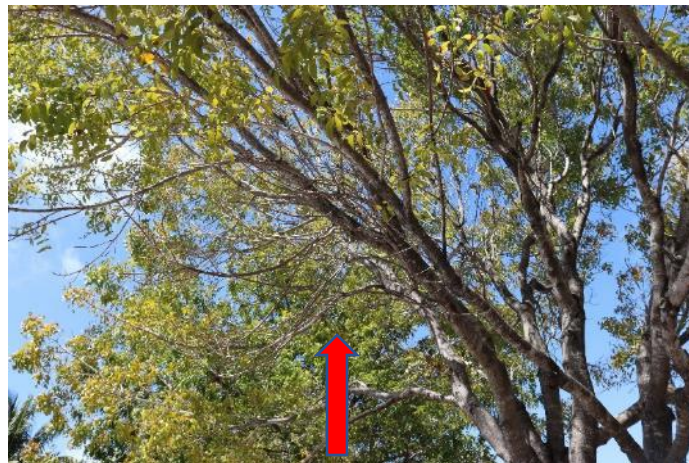
### Tree Forty

Note poor structure and canopy dieback (red arrow)

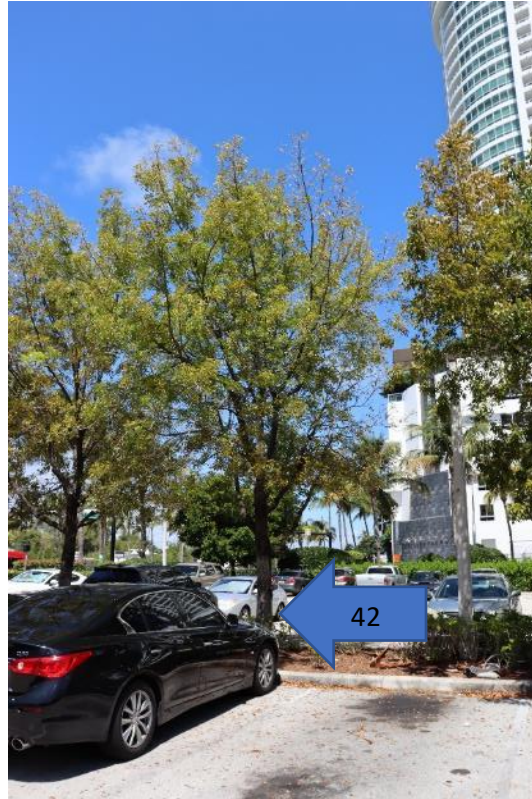
Tree Forty-Two

Mahogany (*Swietenia mahagoni*), facing north.

Note poor structure, stub and flush cuts.

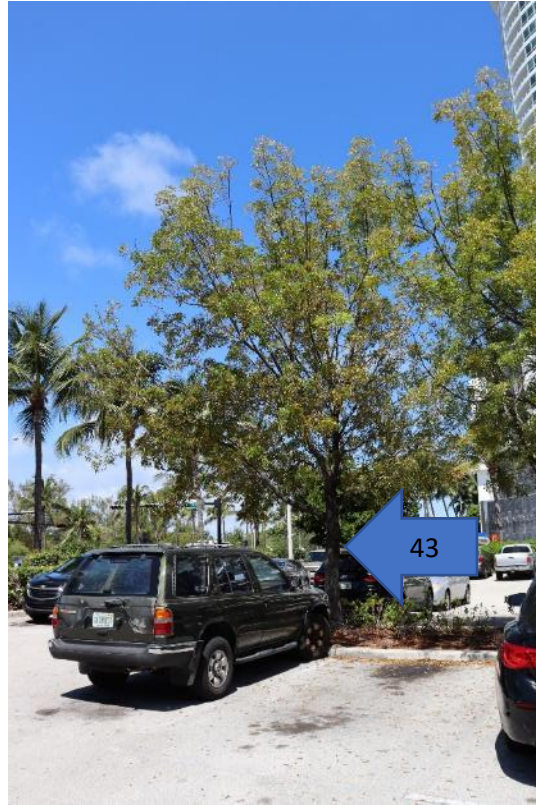
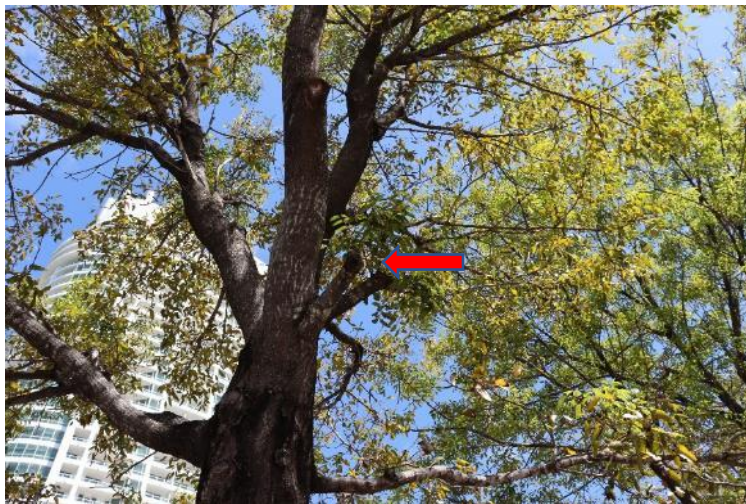
### Tree Forty-Three

Mahogany (*Swietenia mahagoni*), facing north.

Note poor structure, stub (red arrow) and flush cuts.

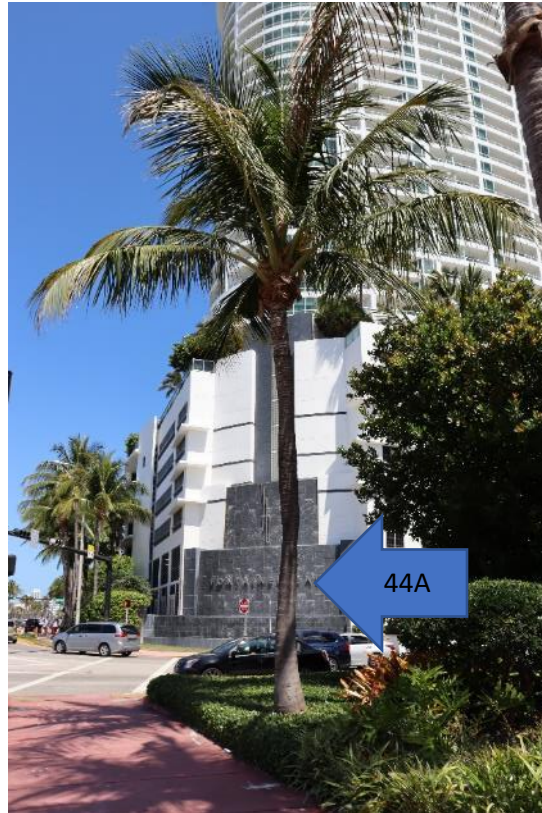
Tree Forty-Four A

Coconut Palm (*Cocos nucifera*), facing north.

Note nutrient deficiencies and pencilling.

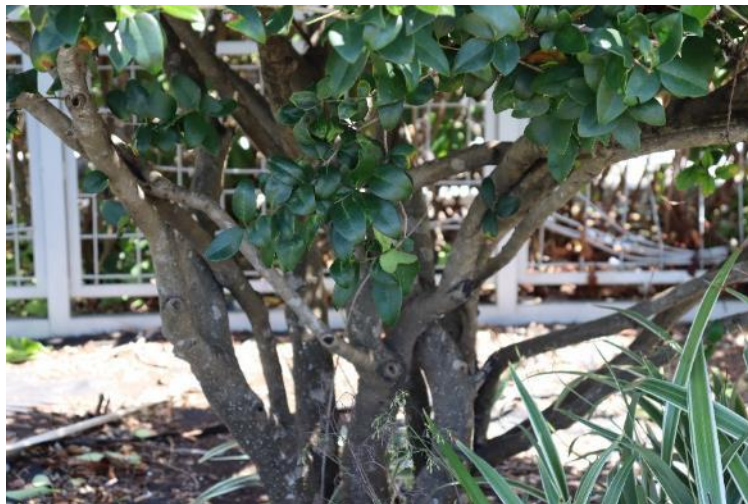
Tree Forty-Nine

Ligustrum (*Ligustrum japonicum*), facing east.

Note poor structure, deadwood and shaping.

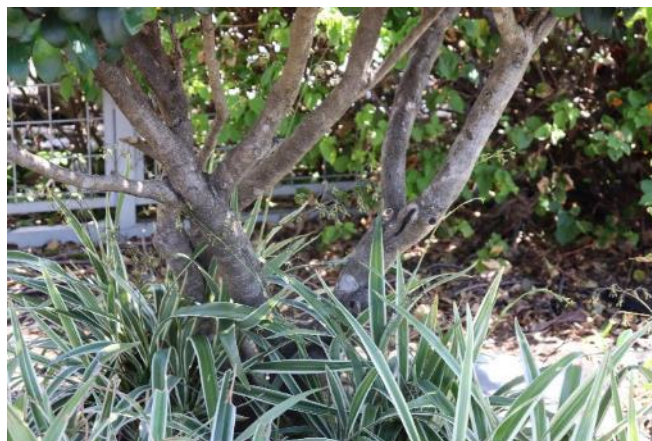
Tree Fifty

Ligustrum (*Ligustrum japonicum*), facing east.

Note poor structure, deadwood and shaping.

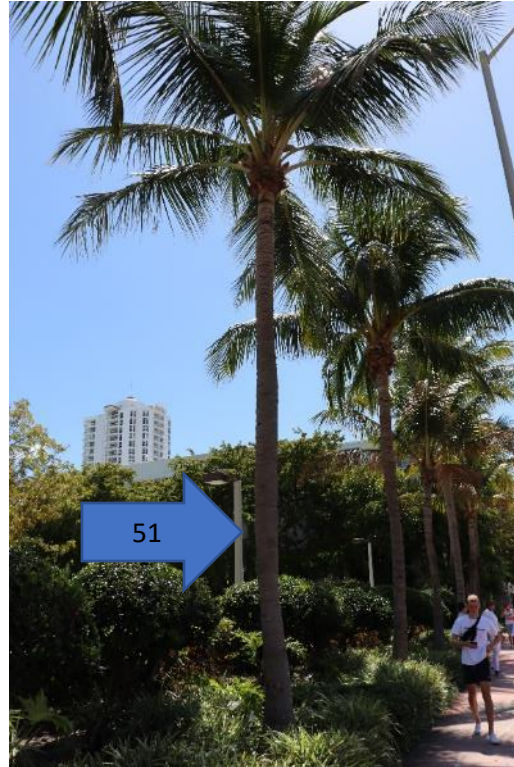
Tree Fifty-One

Coconut Palm (*Cocos nucifera*), facing south.

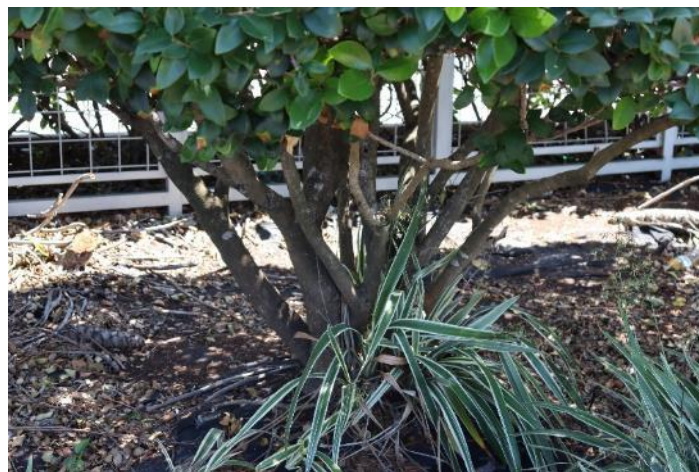
Tree Fifty-Two

Ligustrum (*Ligustrum japonicum*), facing east.

Note poor structure, deadwood and shaping.

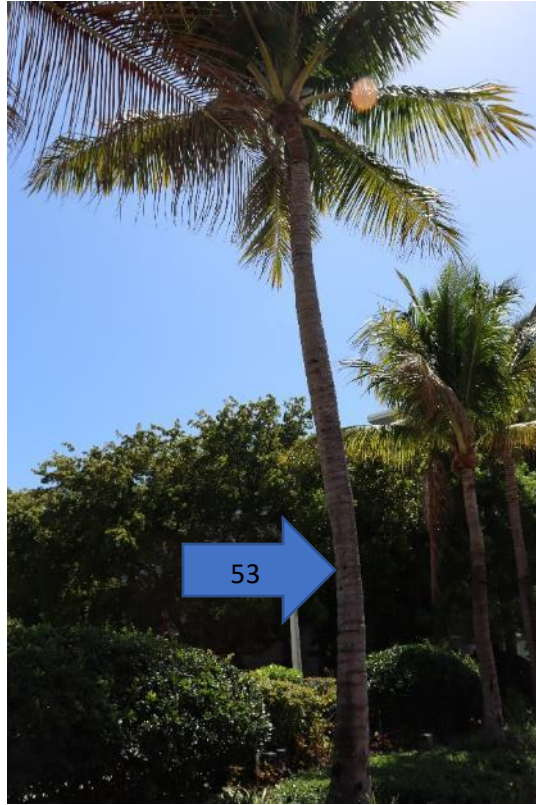
Tree Fifty-Three

Coconut Palm (*Cocos nucifera*), facing south.

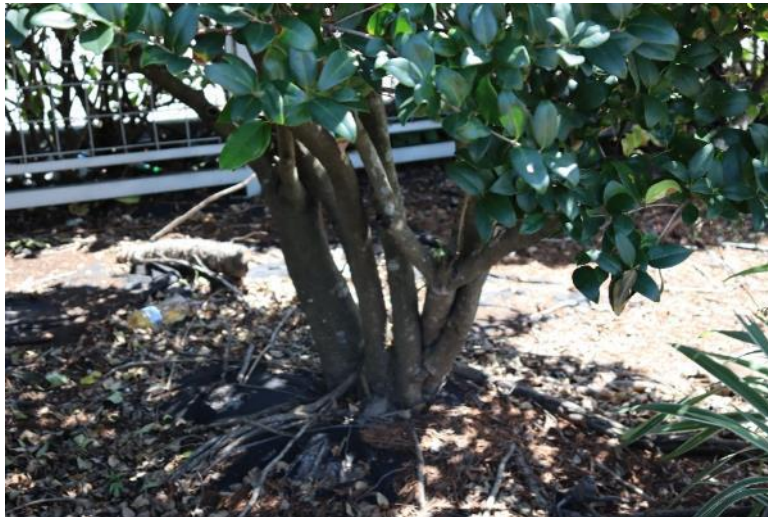
Tree Fifty-Four

Ligustrum (Ligustrum japonicum), facing east.

Note poor structure, deadwood and shaping.

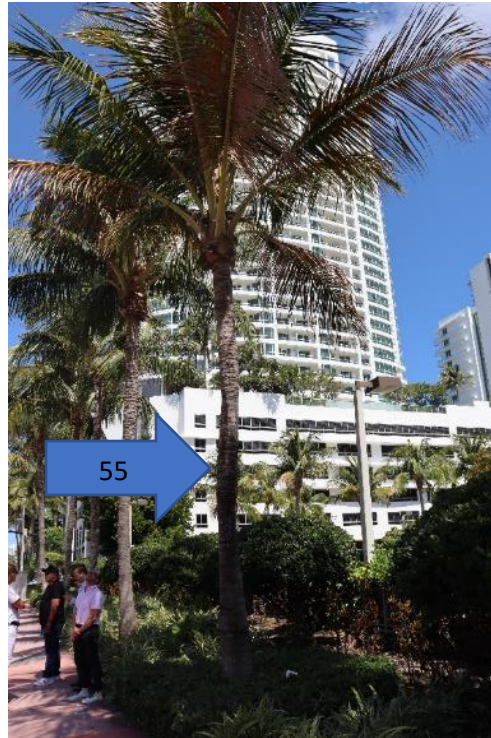
Tree Fifty-Five

Coconut Palm (*Cocos nucifera*), facing north.

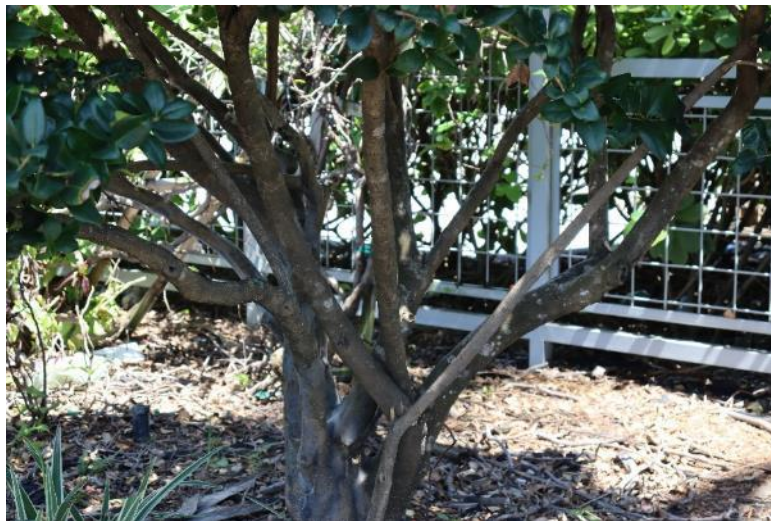
Tree Fifty-Six

Ligustrum (*Ligustrum japonicum*), facing east.

Note poor structure, deadwood and shaping.
