# ***Tree Resource Evaluation for 1753 & 1771 N. View Drive, Miami Beach***

***Sunset Islands Land Trust  
1771 North View Drive  
Miami Beach, FL 33140***

***Jeff Shimonski  
President, Tropical Designs of Florida  
Member, American Society of Consulting Arborists  
ISA Certified Arborist Municipal Specialist FL-1052AM  
ISA Tree Risk Assessment Qualification  
LIAF Florida Certified Landscape Inspector 2016-0175  
305-773-9406  
Jeff@TropicalArboriculture.com***

***October 29, 2020***

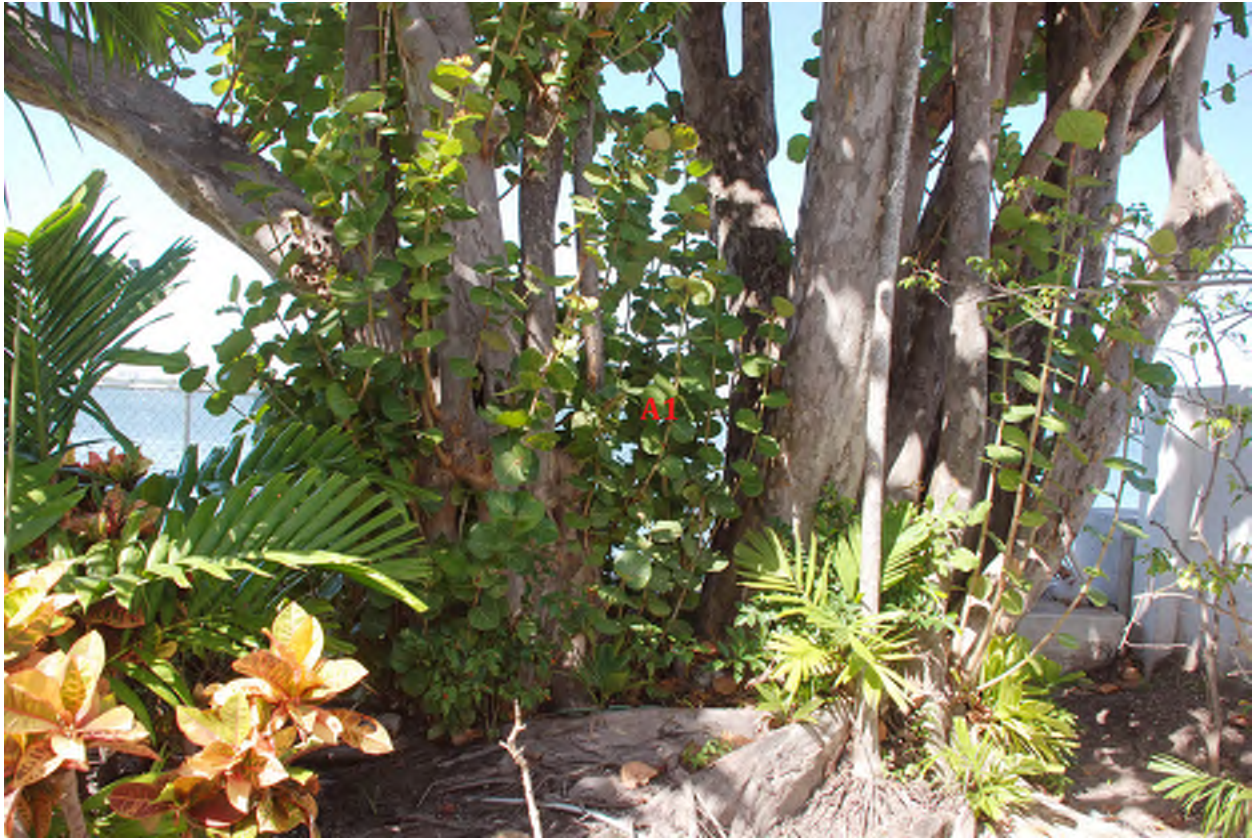
**Photo 2 above is a closer view of the multiple trunks of tree A1.**

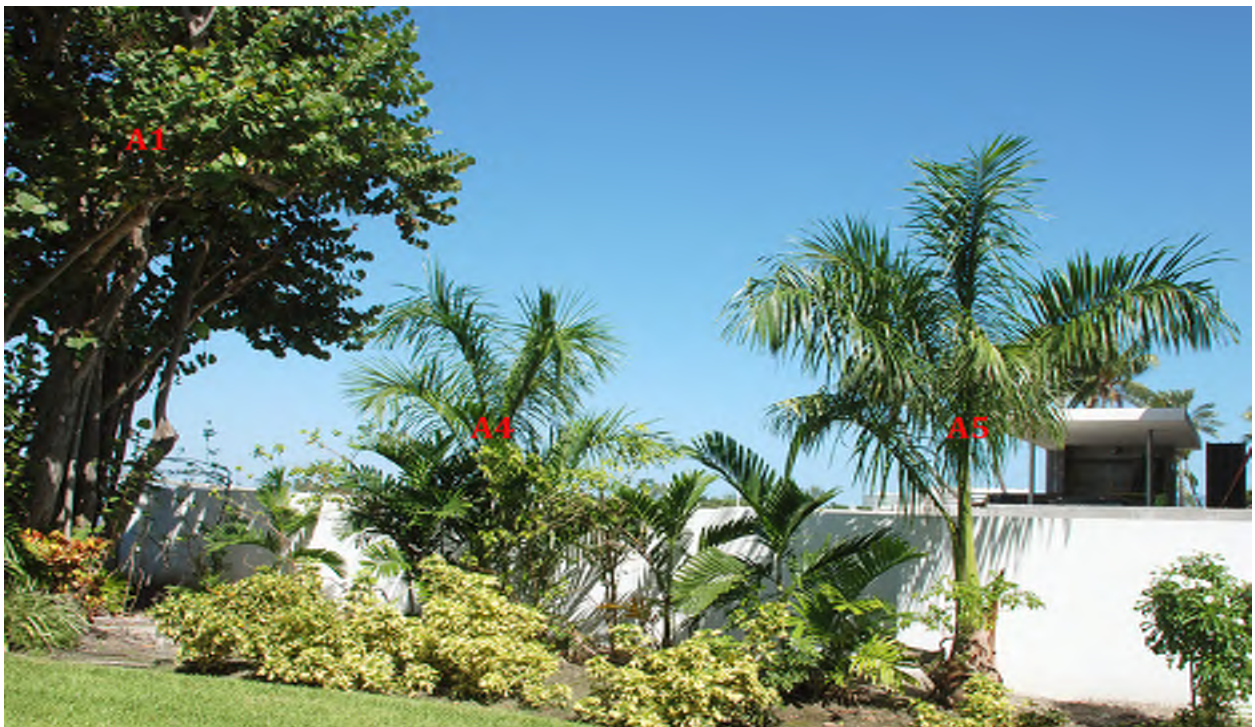
**Photo 3 above is palms A4 & A5.**

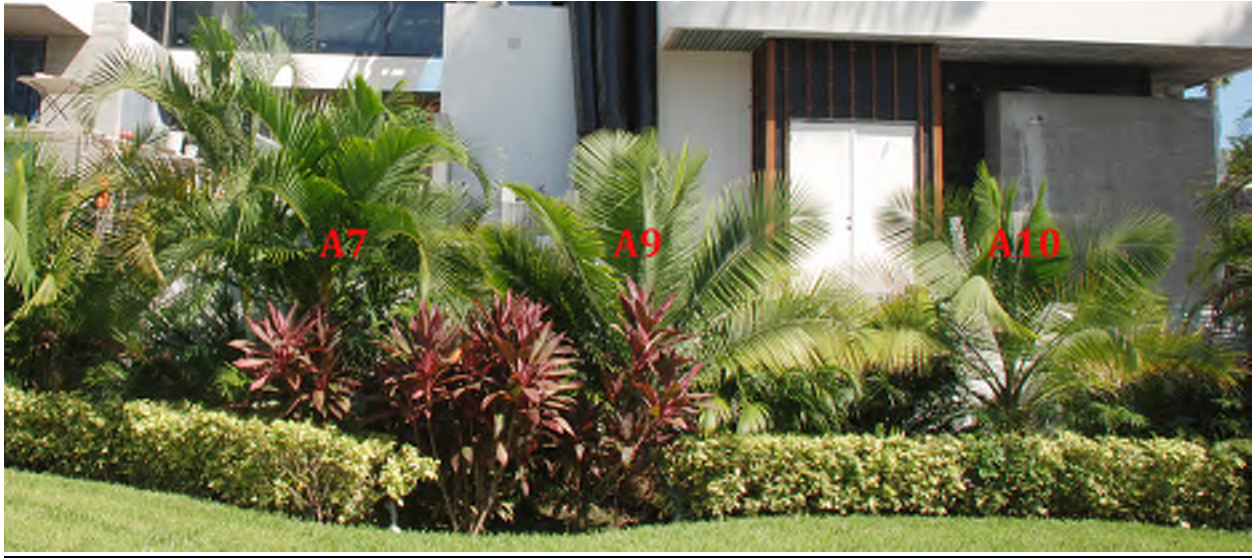
**Photo 5 above is palms A7, A9 & A10**

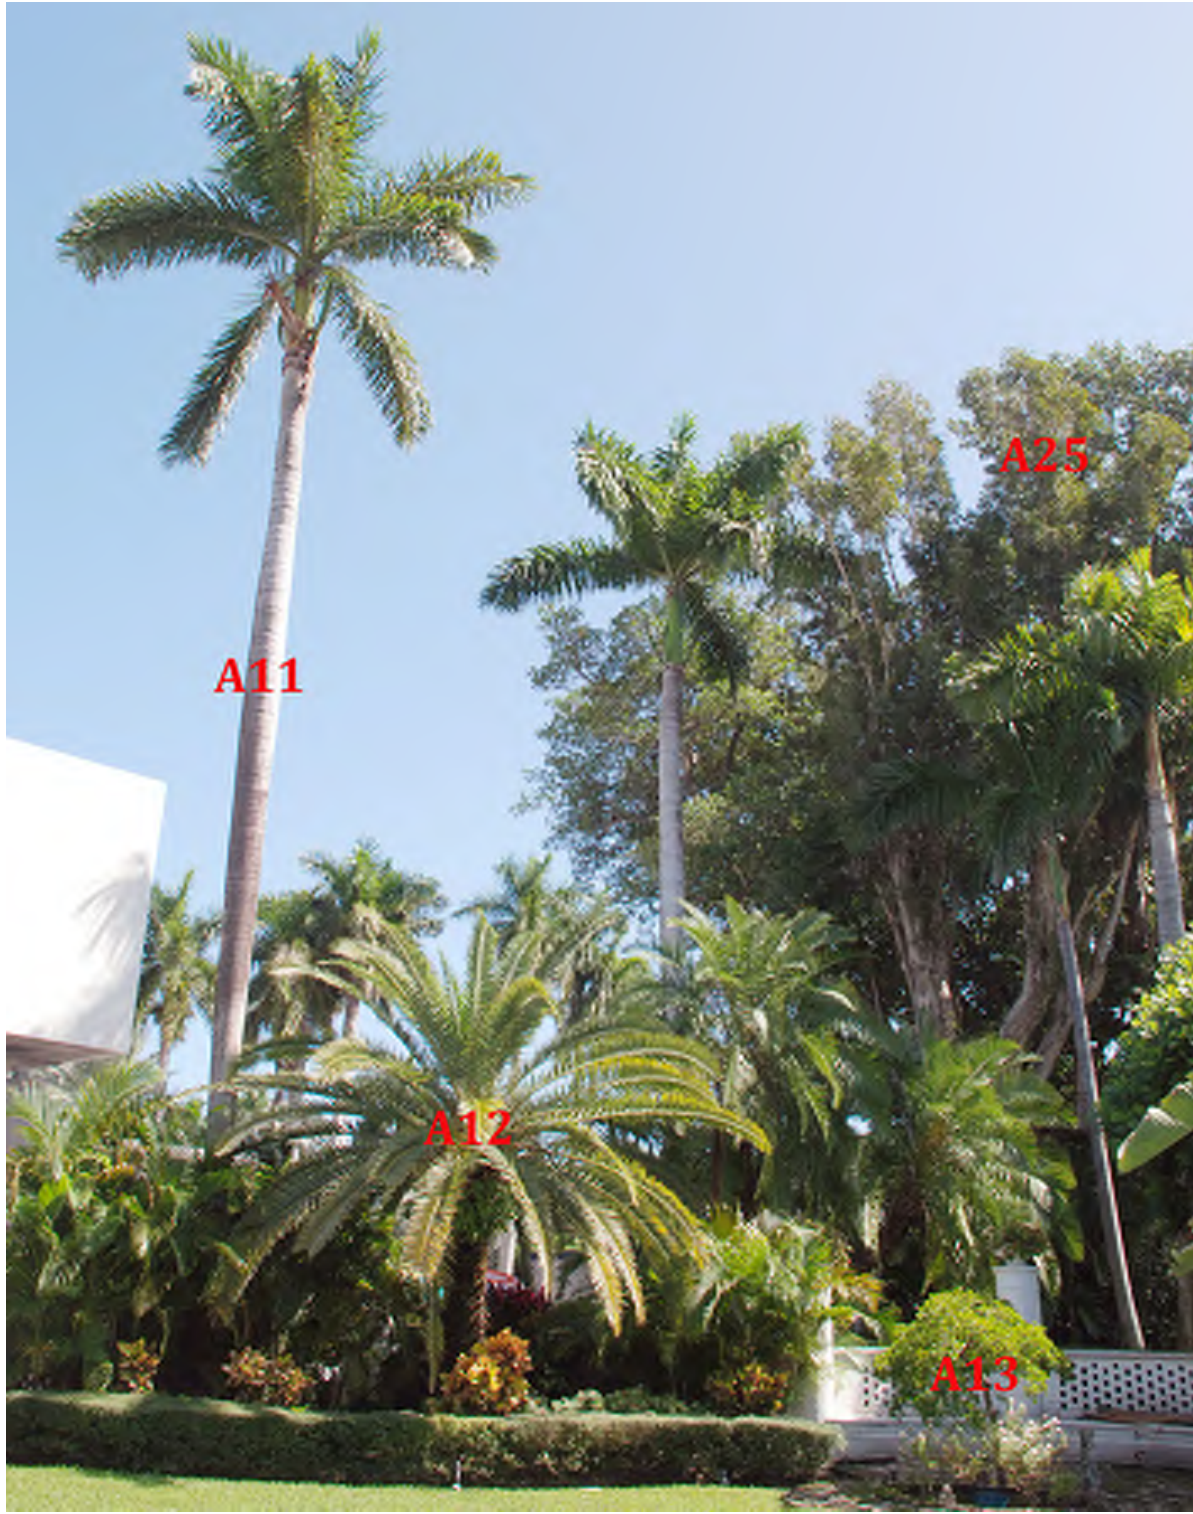
**Photo 7 above is palms A11 & A12.**

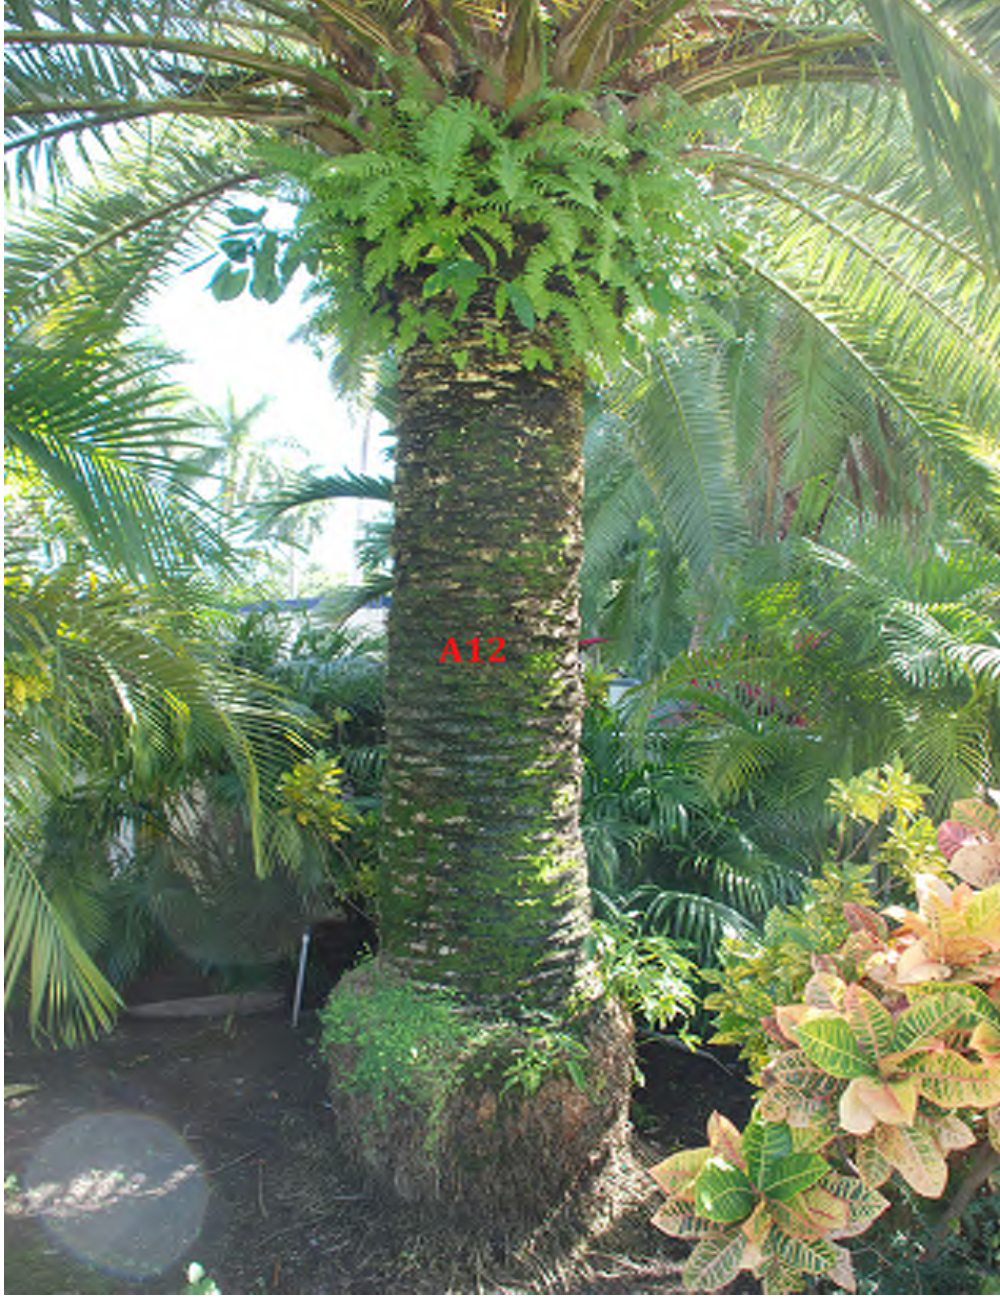
**Photo 8 above is the trunk of palm A12.**

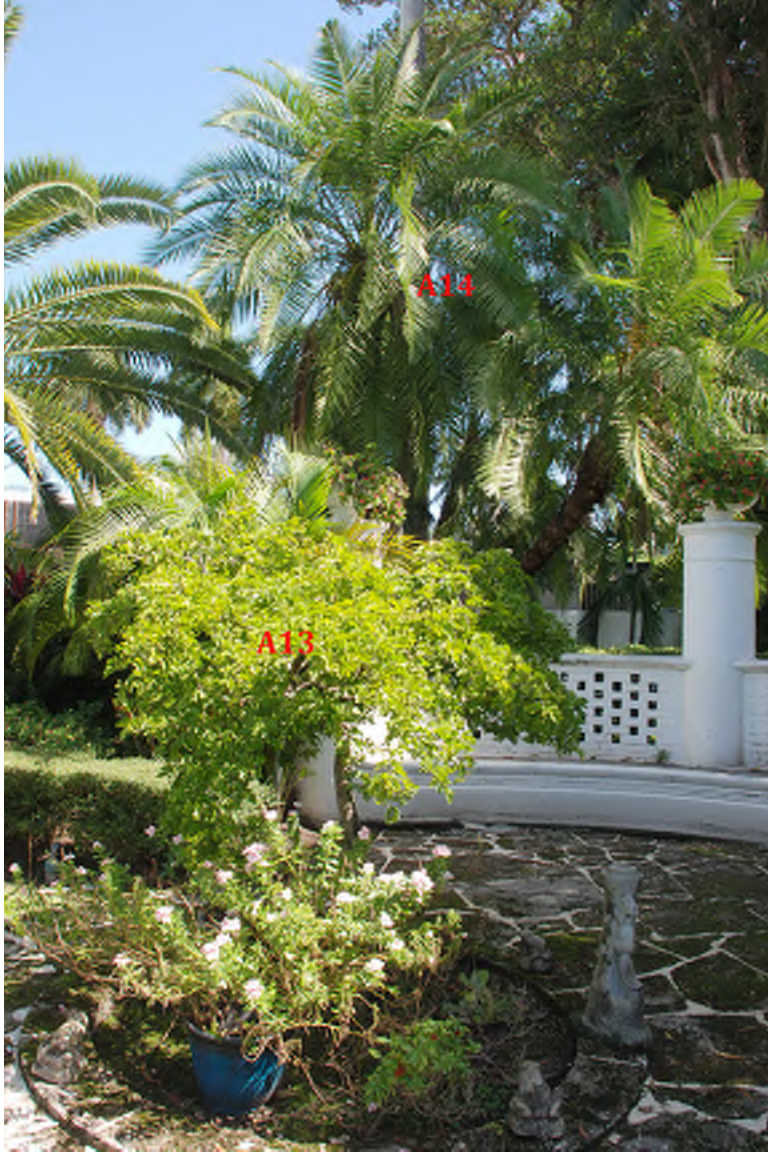
**Photo 9 above is tree A13.**

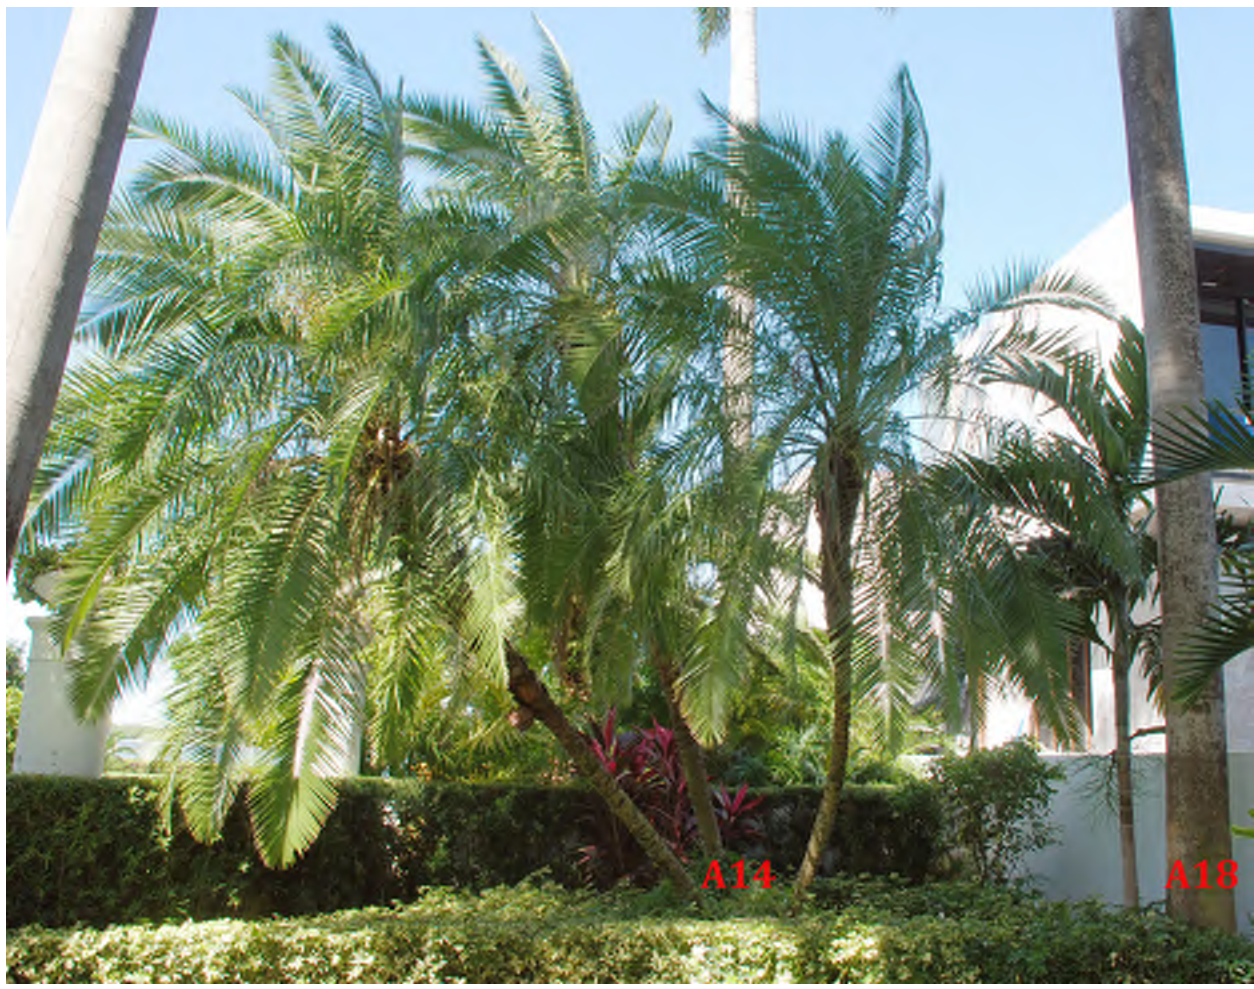
**Photo 10 above is multi-trunked palm A14.**

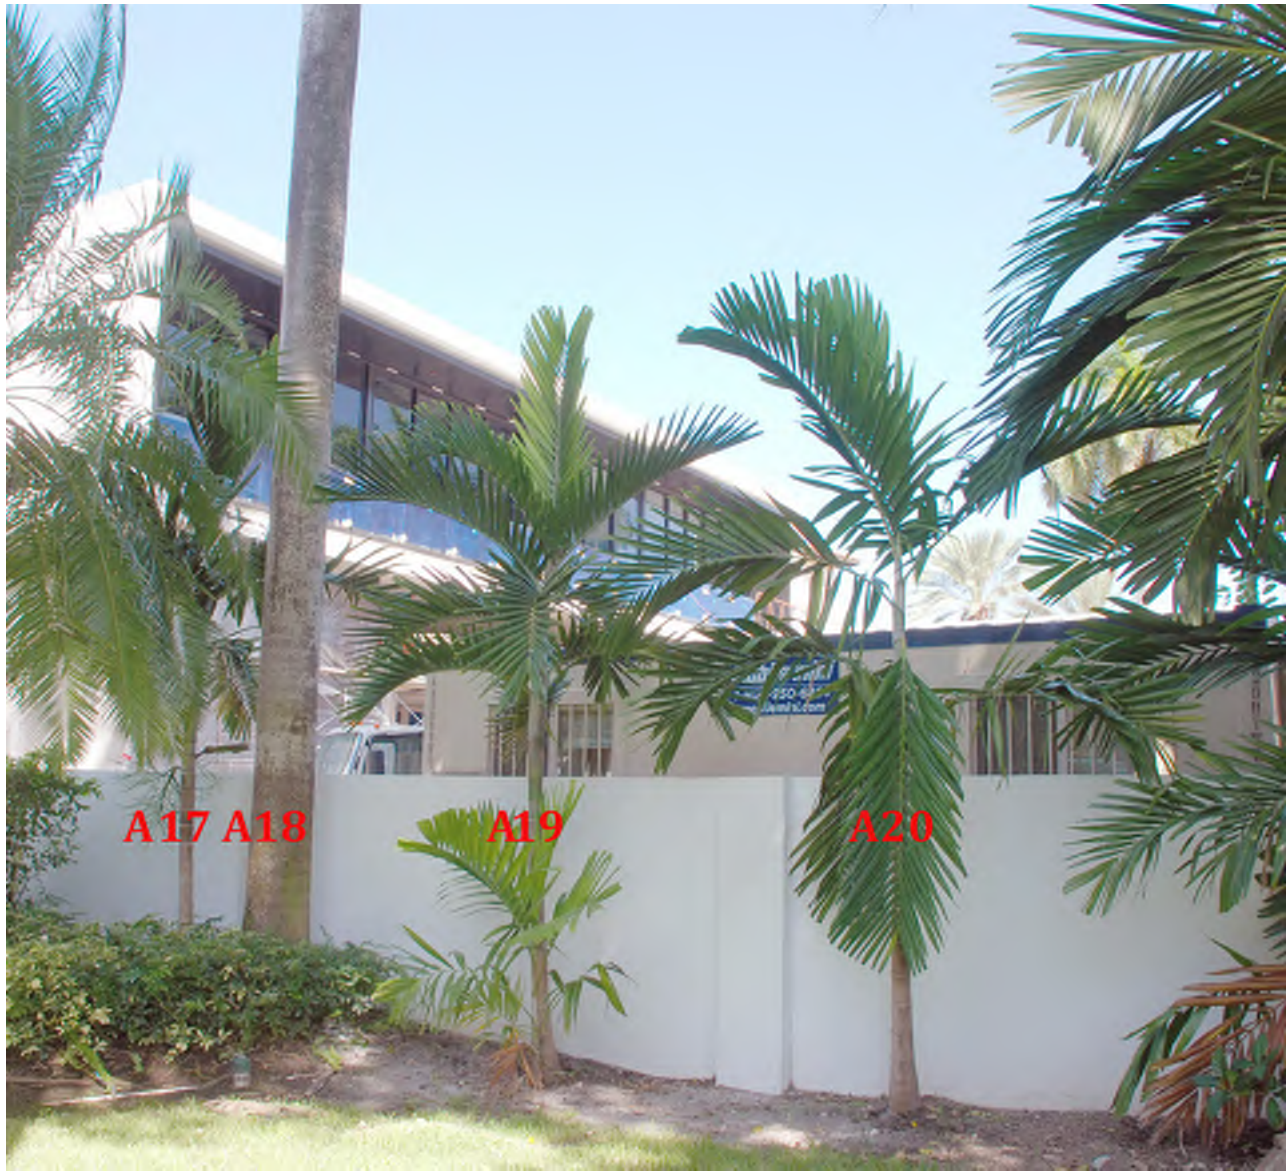
**Photo 11 above is palms A17, A18, A19 & A20.**

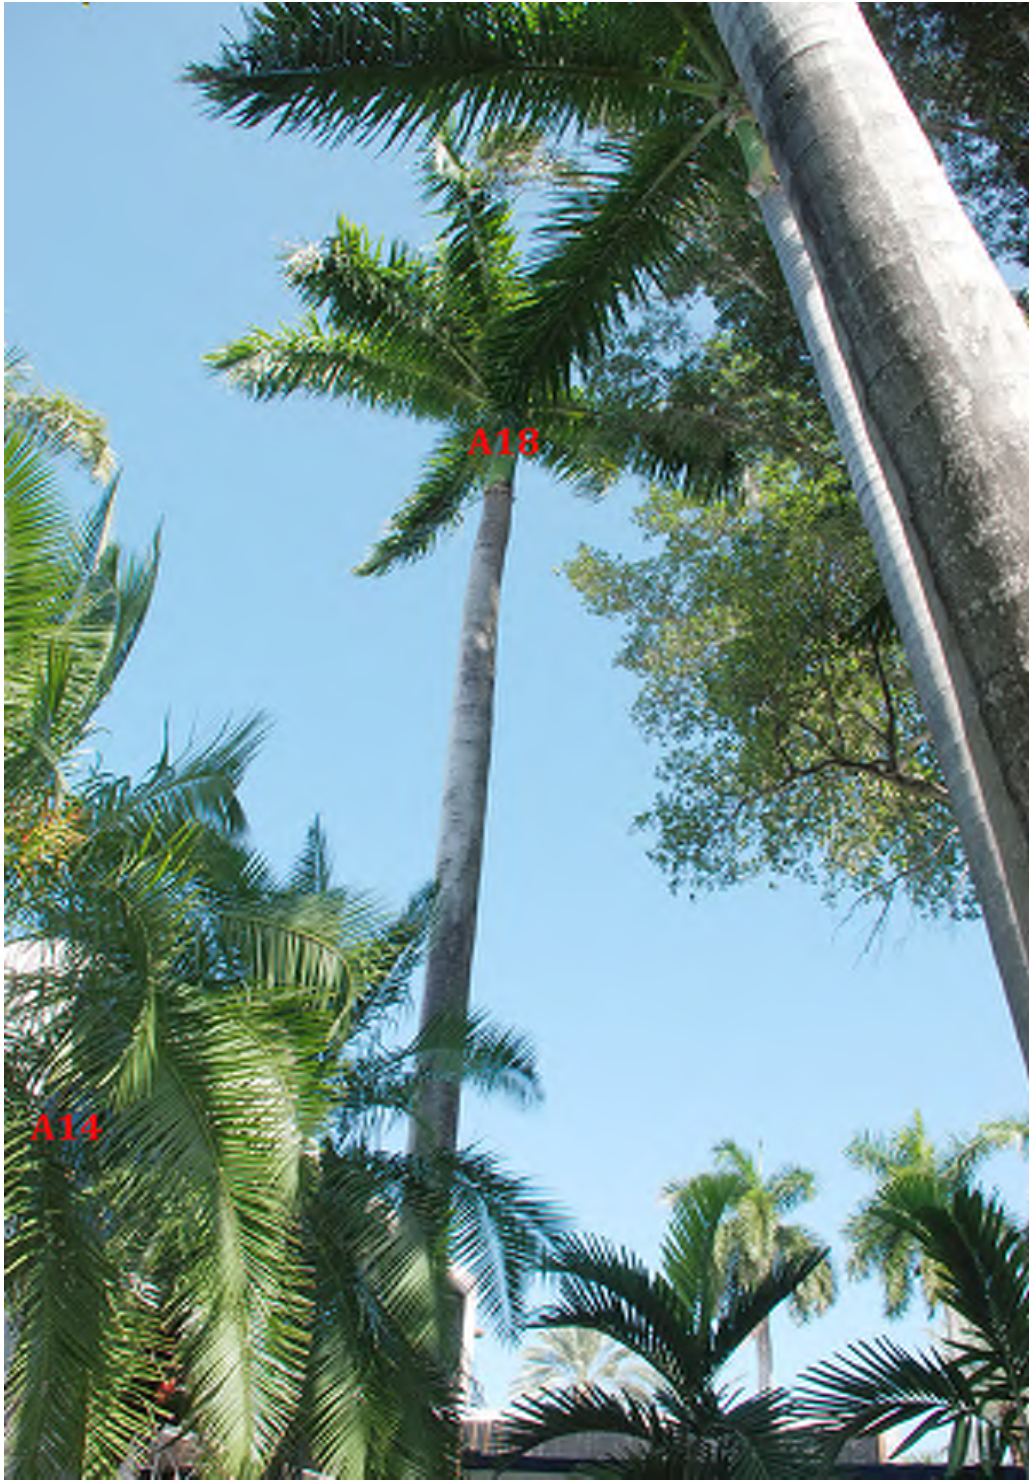
**Photo 12 above is palm A18.**

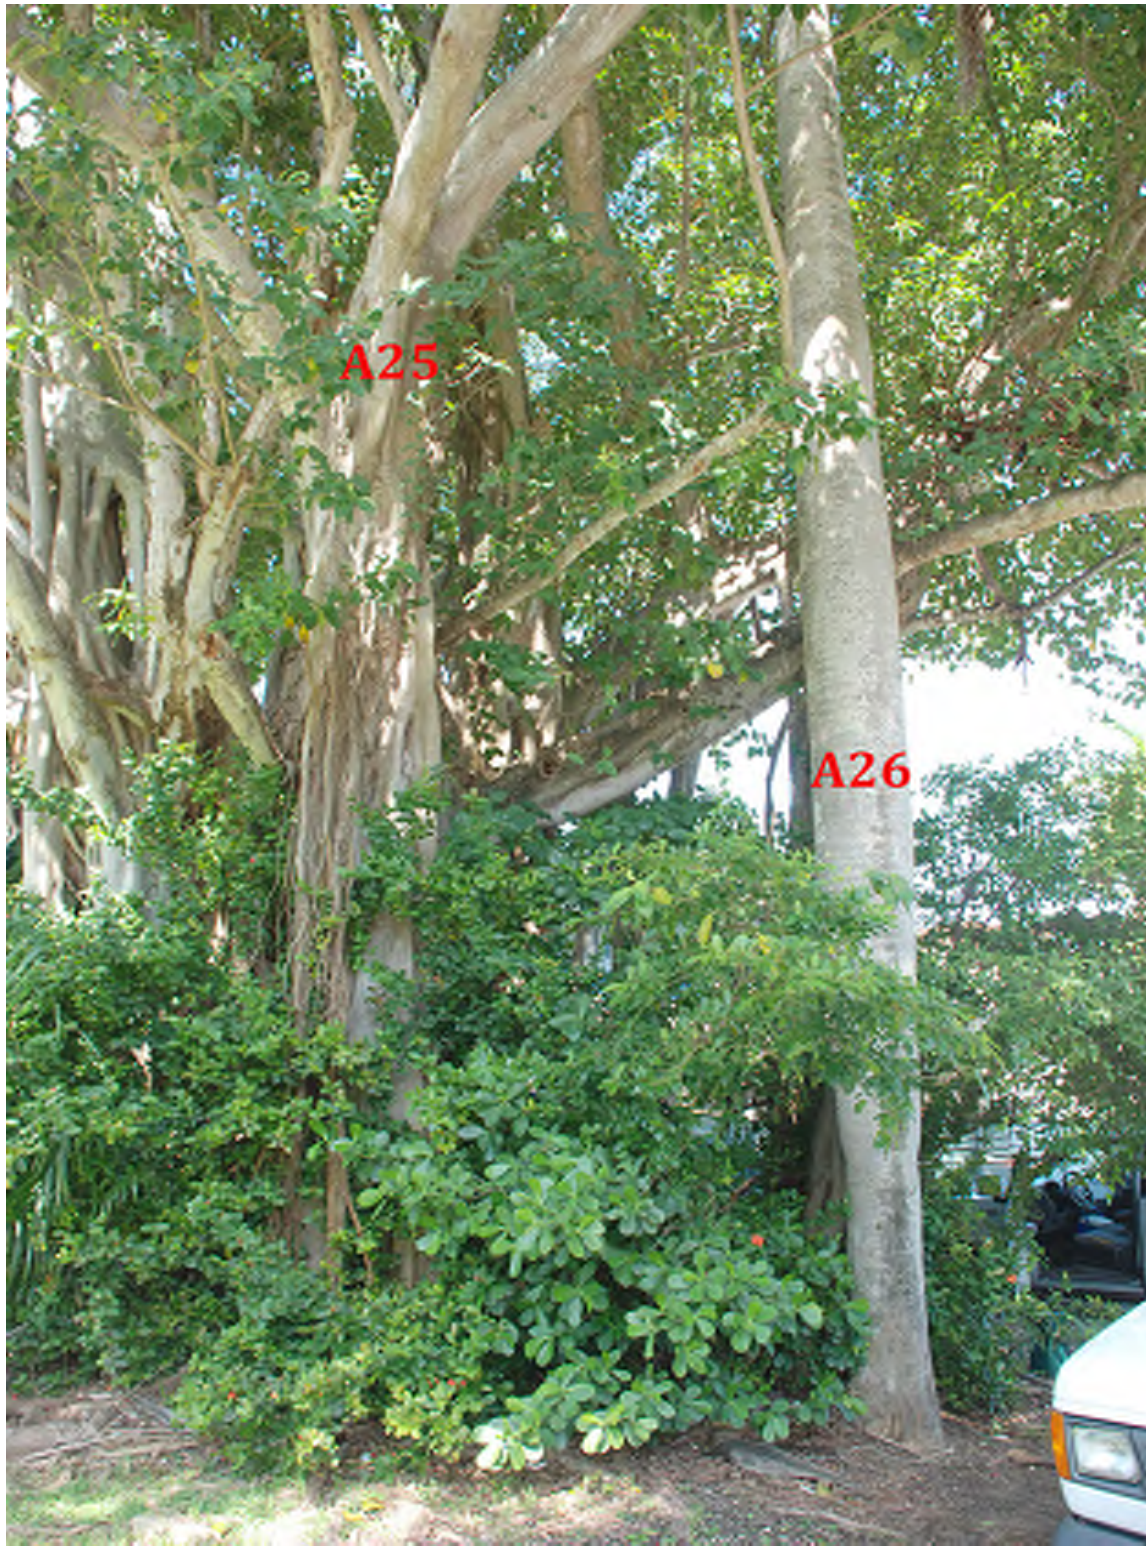
**Photo 18 above is the east side of tree A25 and palm A26.**

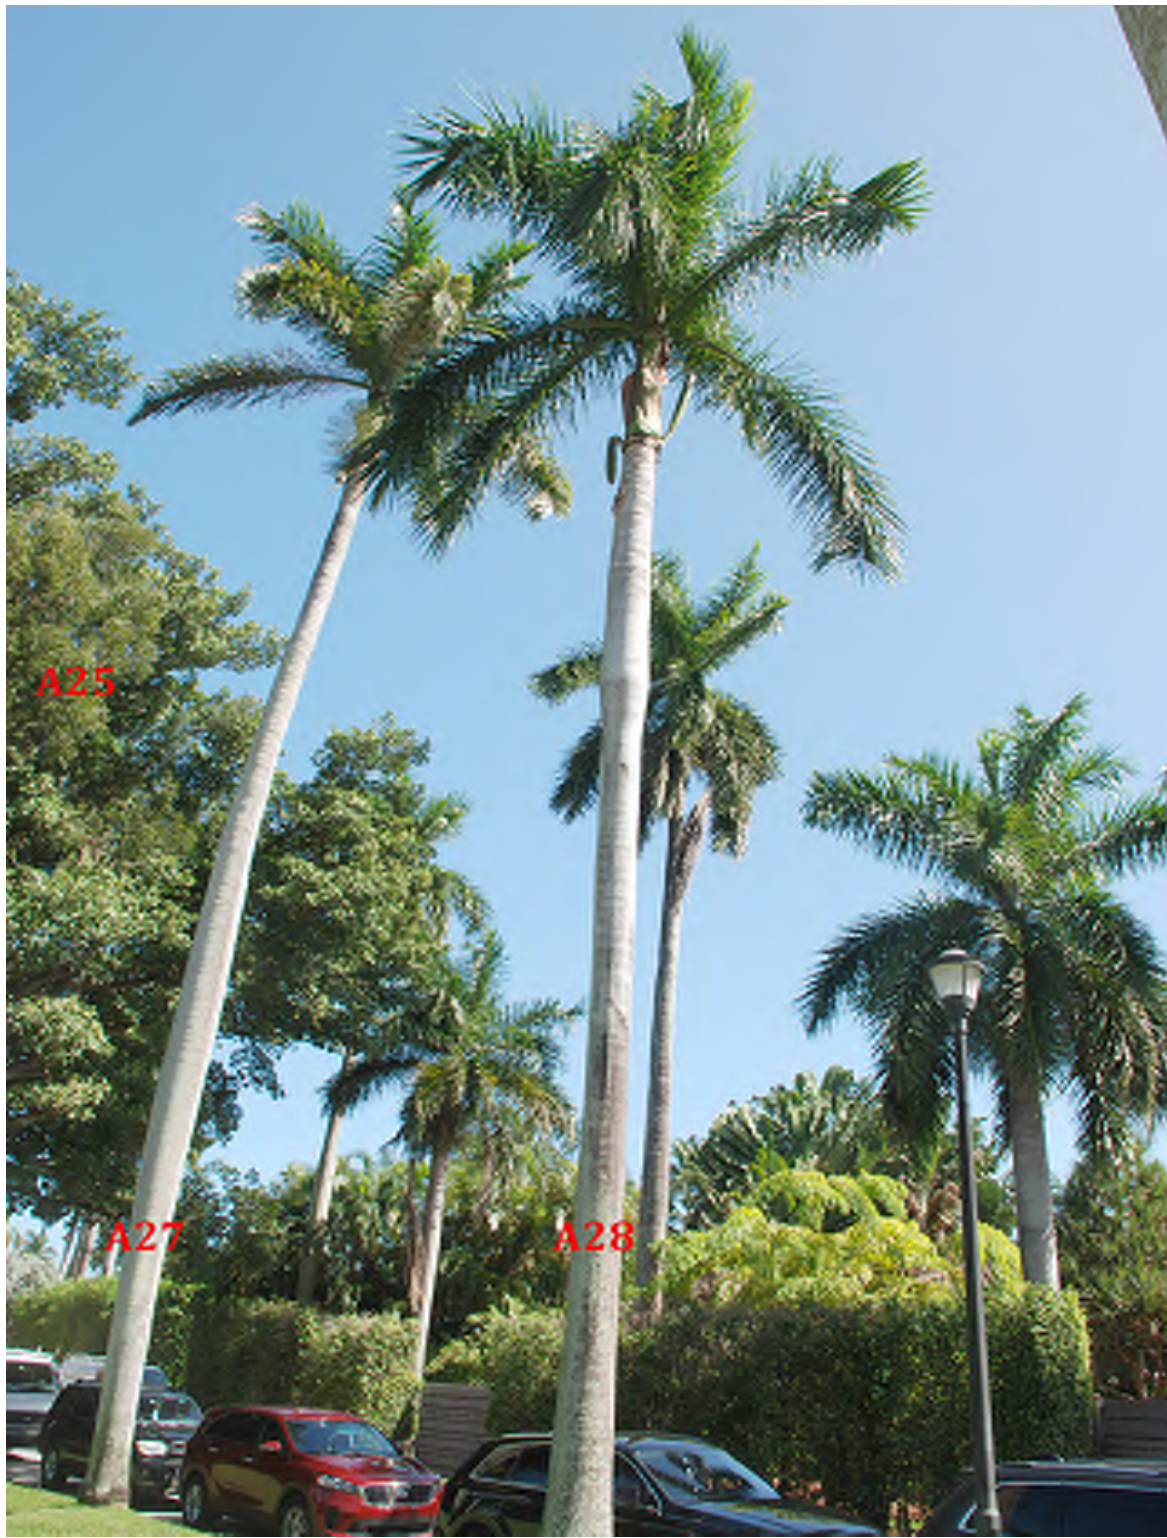
**Photo 19 above is palms A27 & A28.**

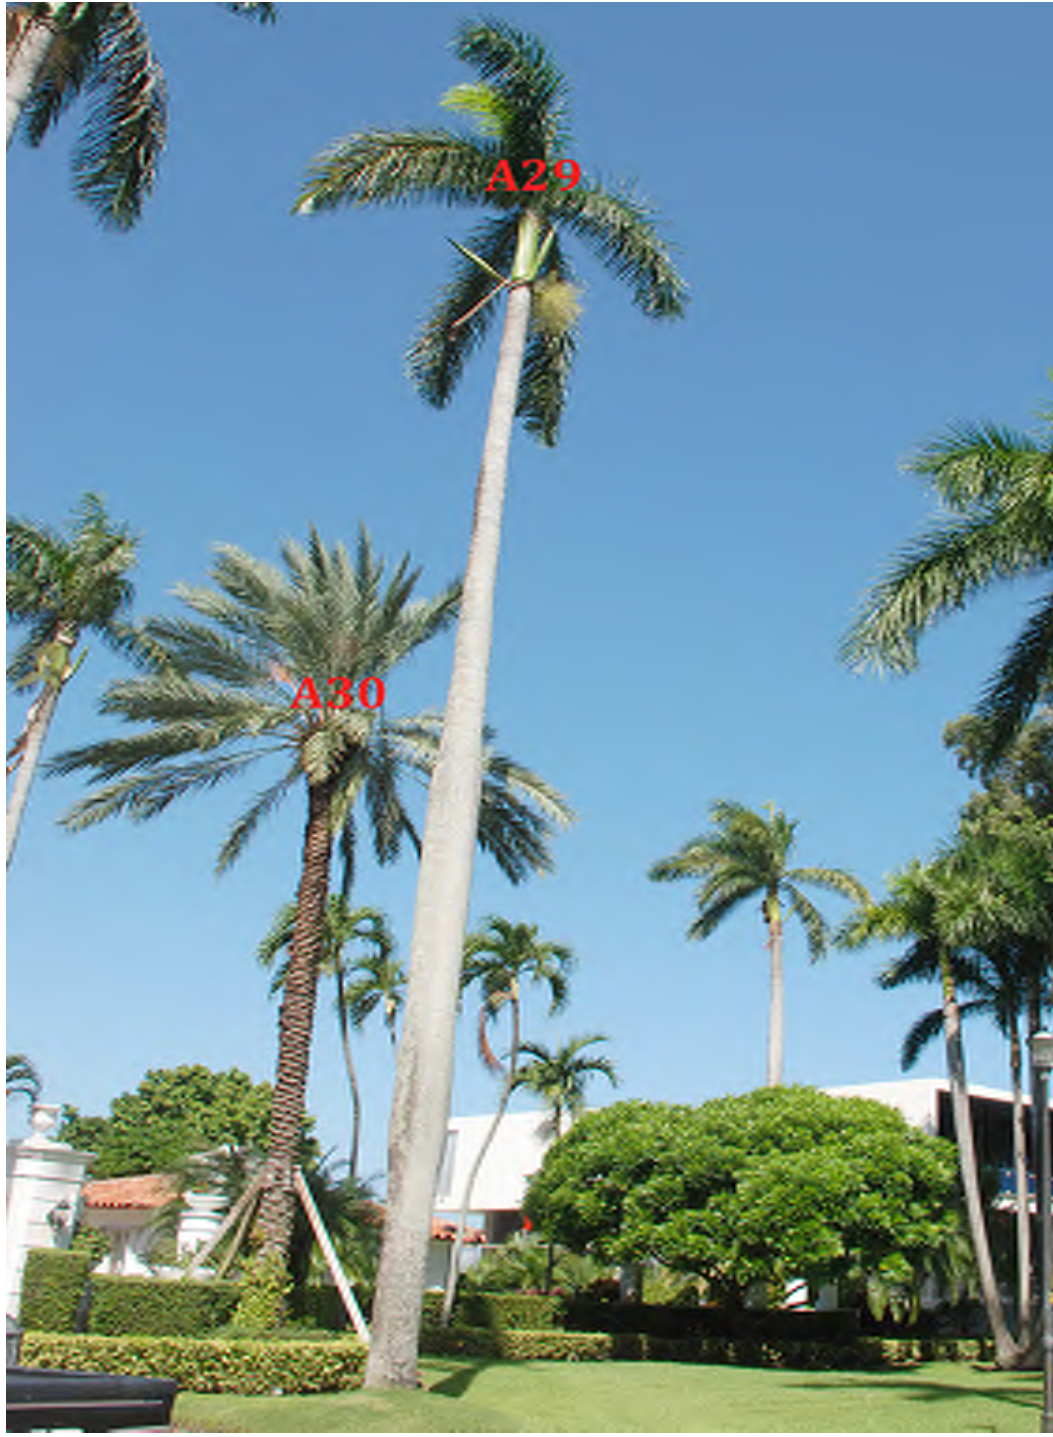
**Photo 20 above is palms A29 & A30.**

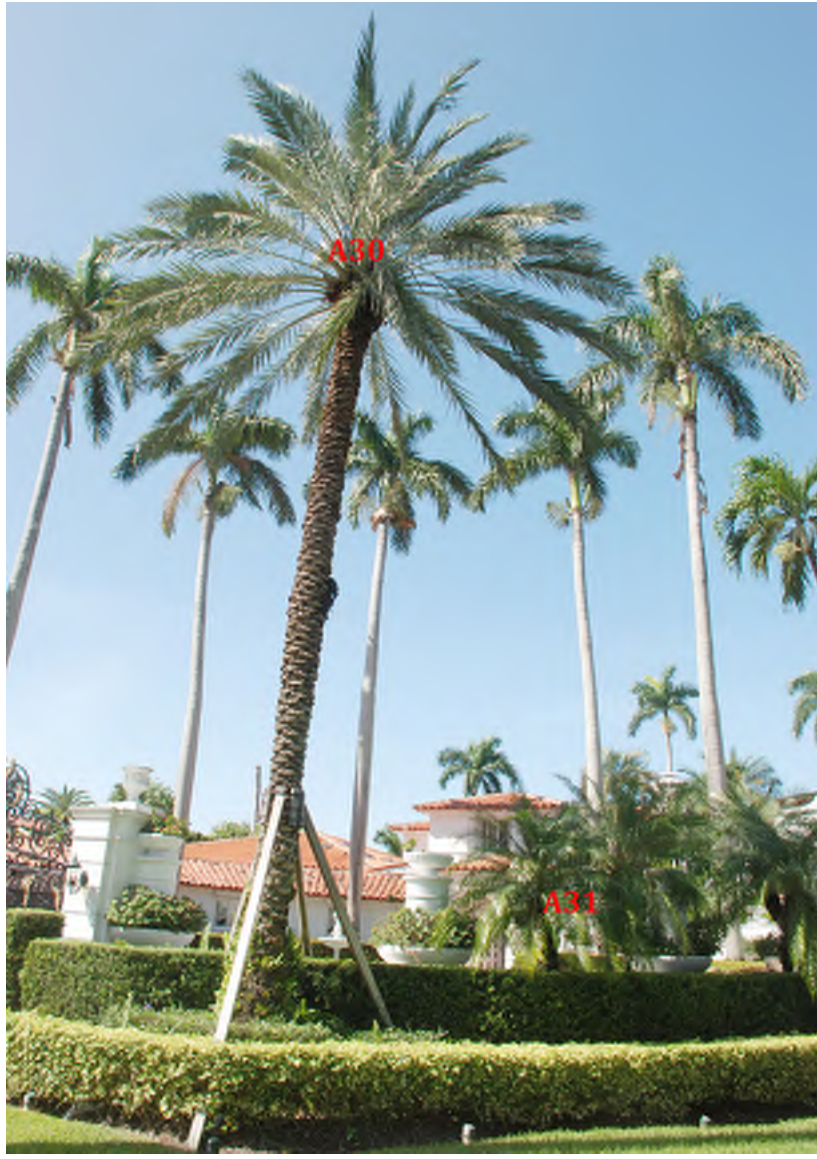
**Photo 21 above is palm A30.**

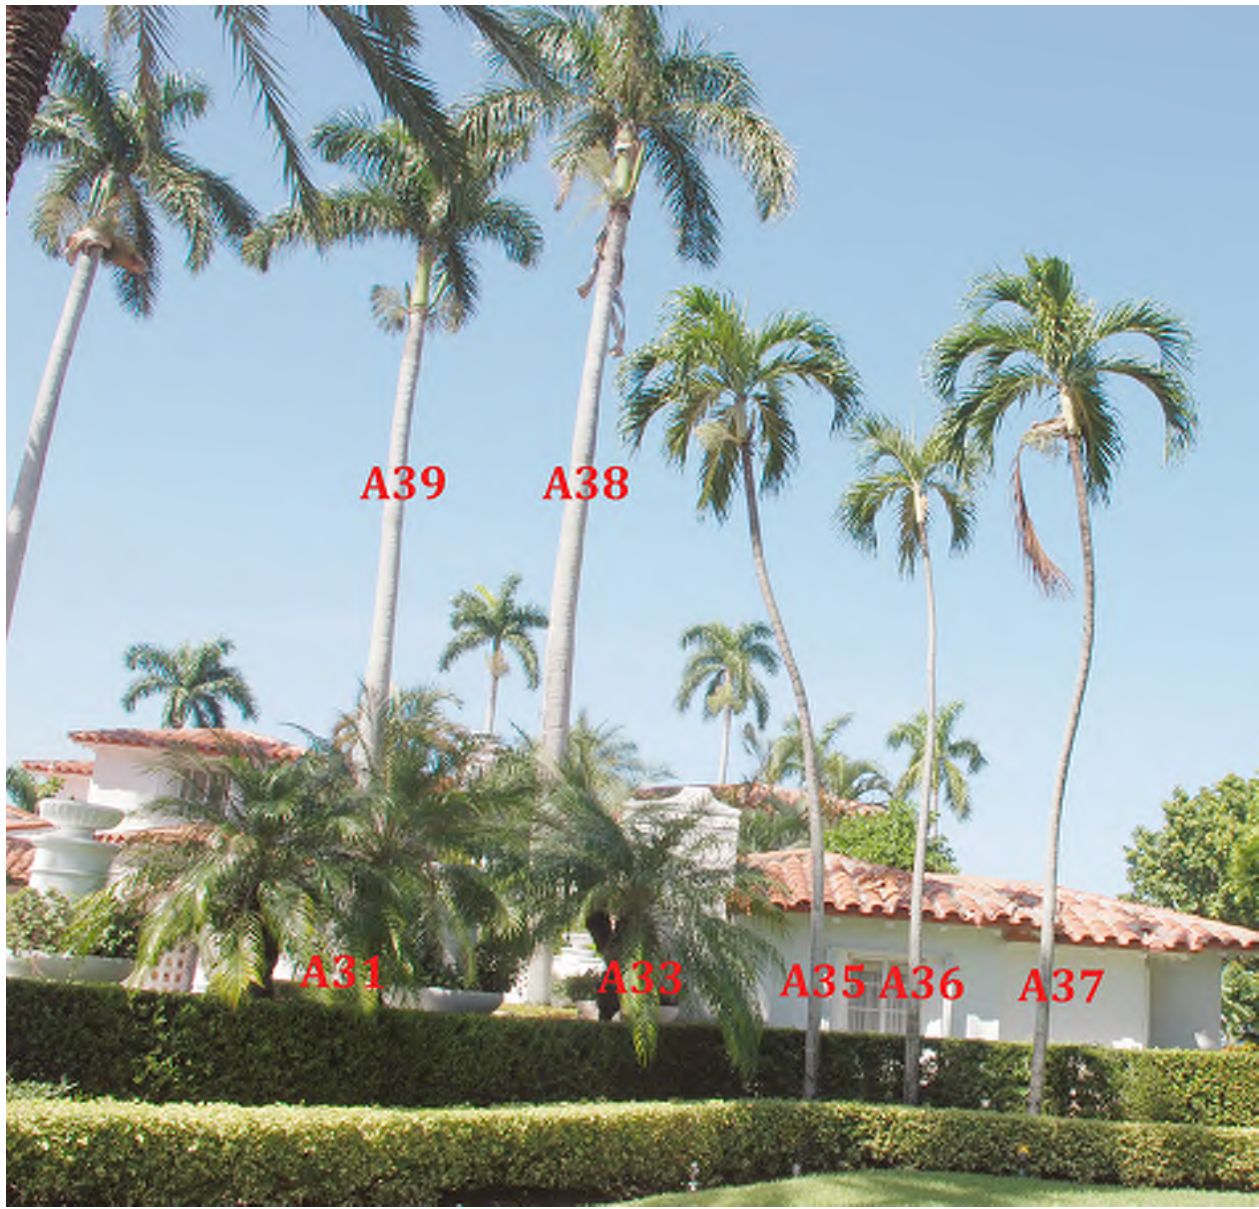
**Photo 22 above is double-trunked palms A31 & A33 and single-trunked palms A35, A36 & A37.**

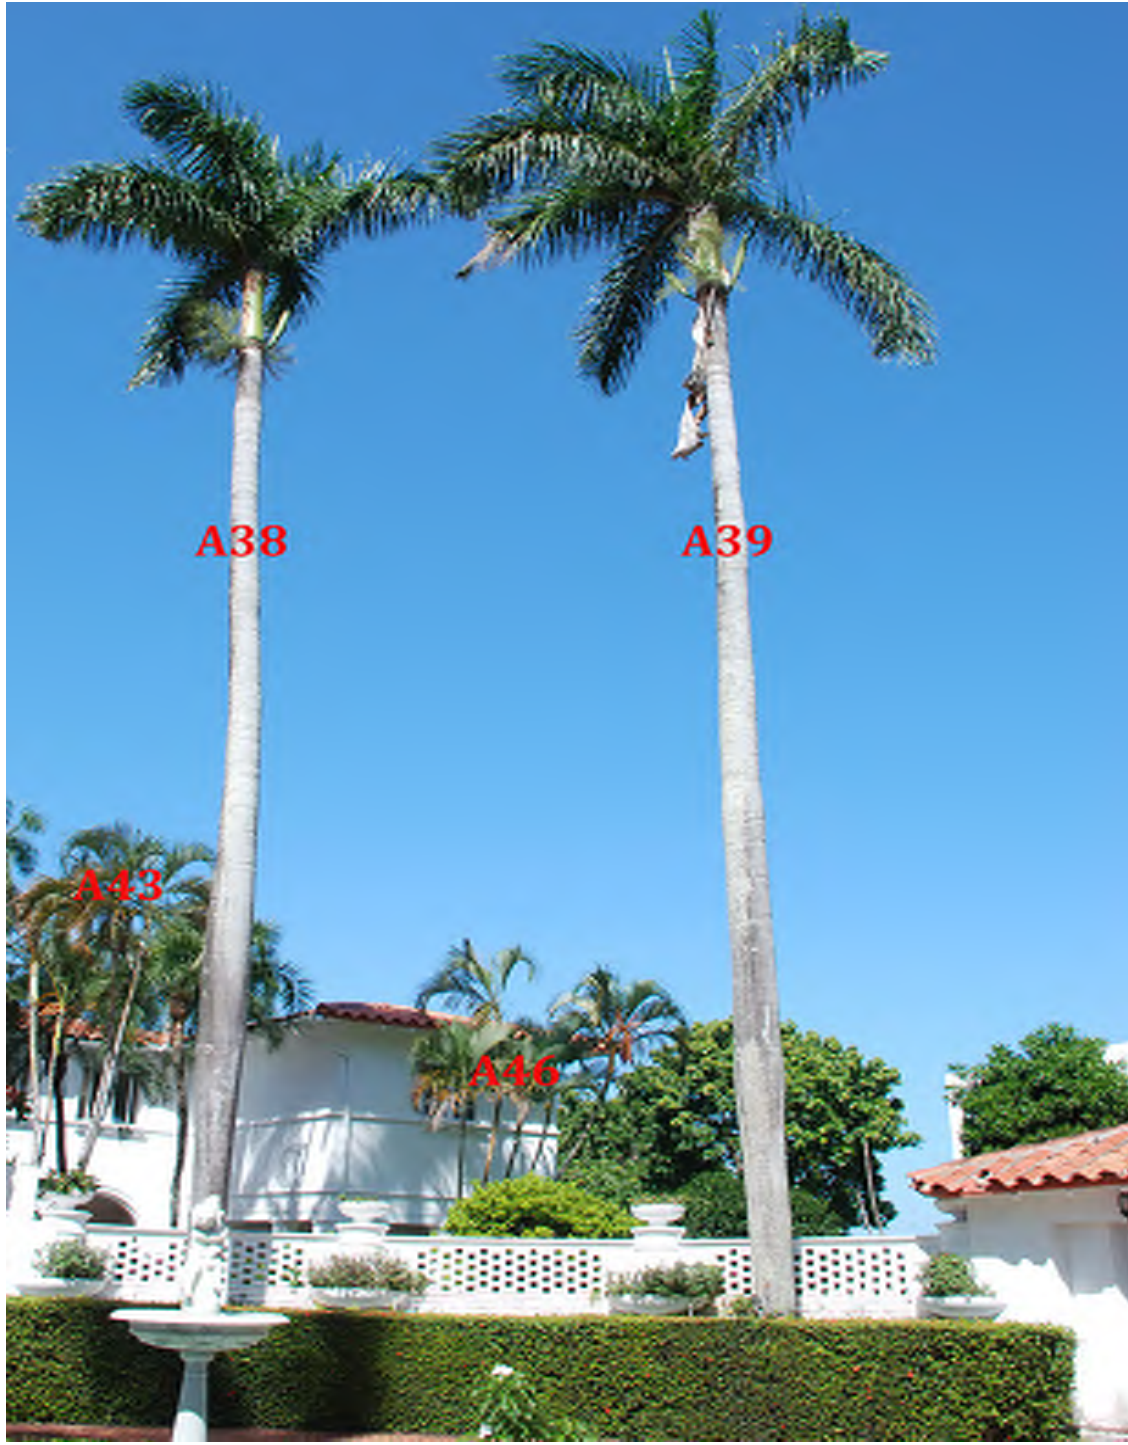
**Photo 23 above is palms A38 & A39.**

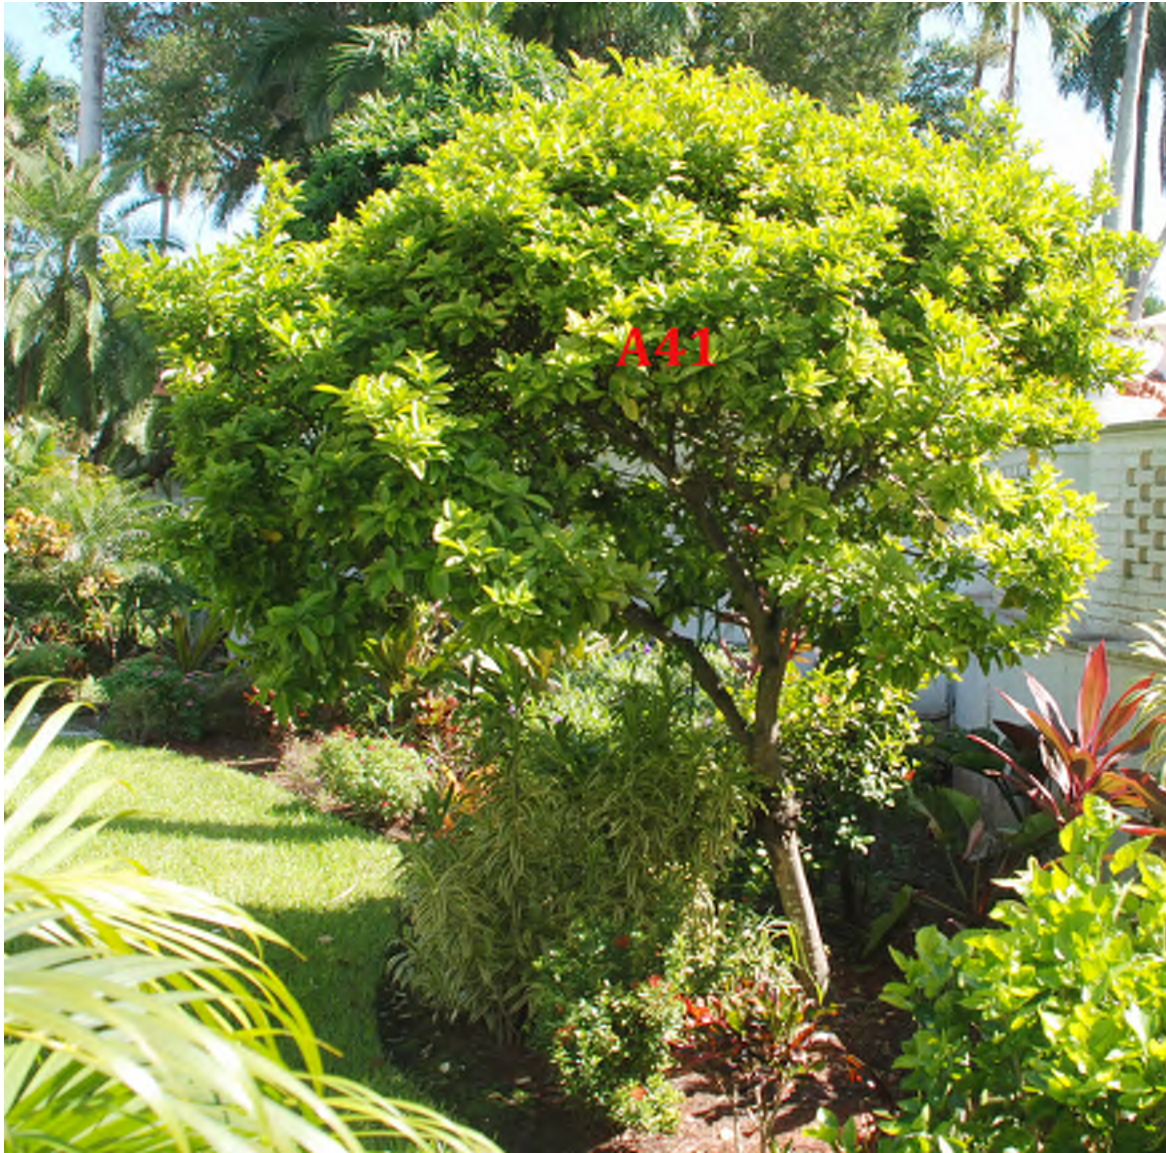
**Photo 26 is tree A41.**

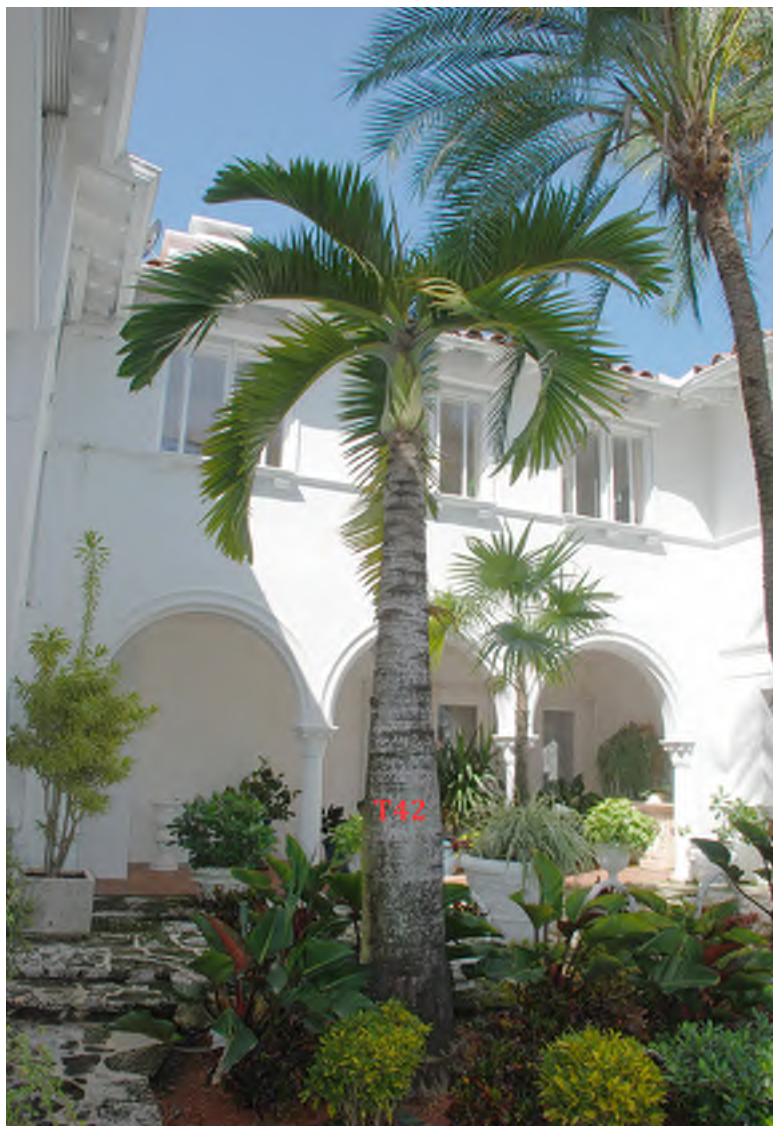
**Photo 27 above is palm A42.**
