# ***Tree Resource Evaluation for 1753 & 1771 N. View Drive, Miami Beach***

***Sunset Islands Land Trust  
1771 North View Drive  
Miami Beach, FL 33140***

***Jeff Shimonski  
President, Tropical Designs of Florida  
Member, American Society of Consulting Arborists  
ISA Certified Arborist Municipal Specialist FL-1052AM  
ISA Tree Risk Assessment Qualification  
LIAF Florida Certified Landscape Inspector 2016-0175  
305-773-9406  
Jeff@TropicalArboriculture.com***

***October 29, 2020***

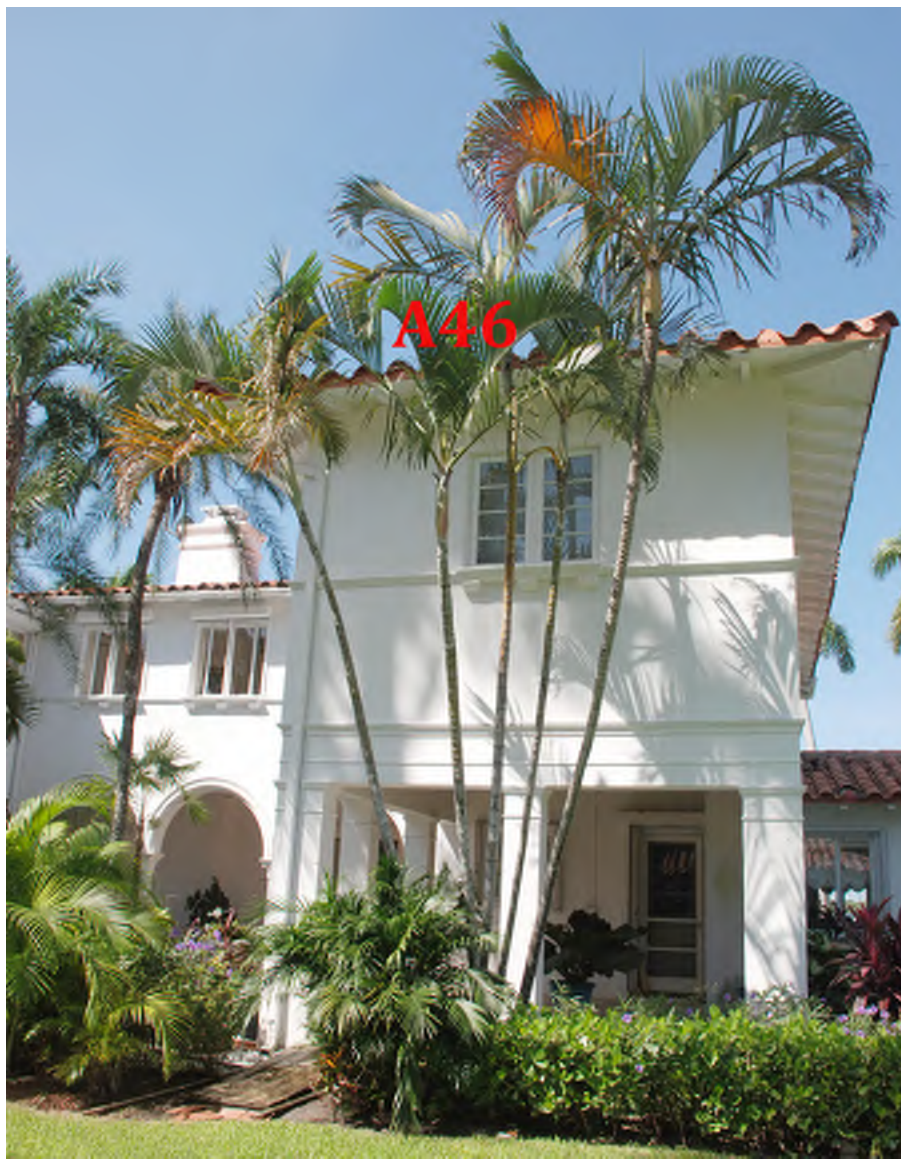
**Photo 29 above is palm A46. See following photo.**

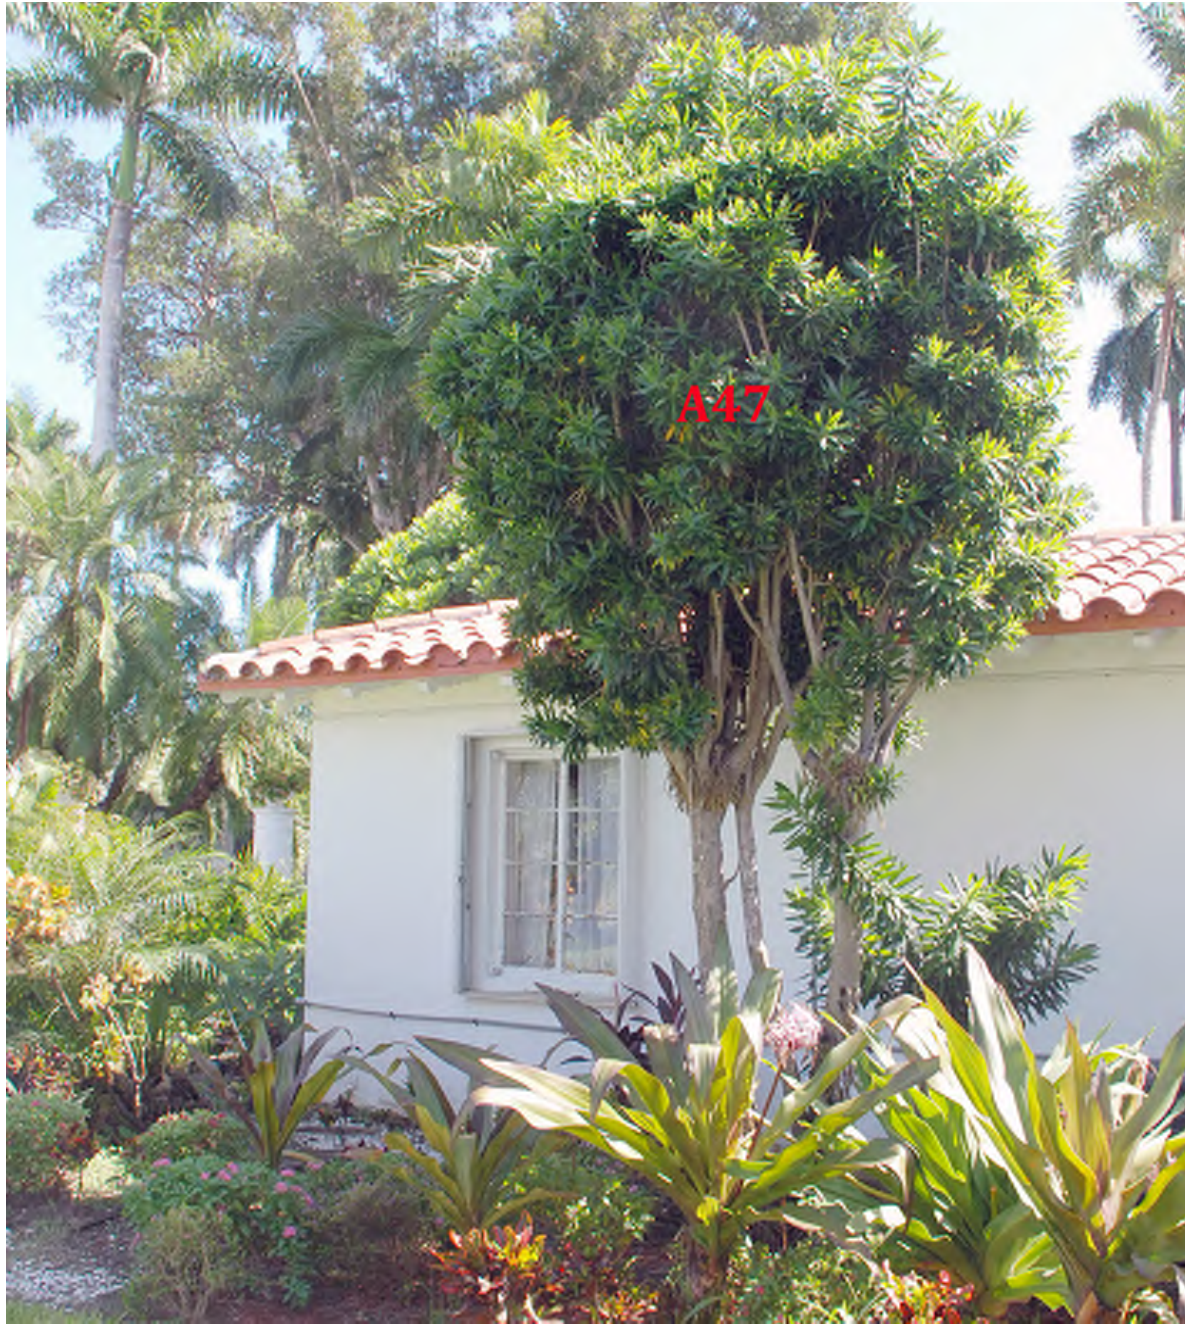
**Photo 31 above is tree A47.**

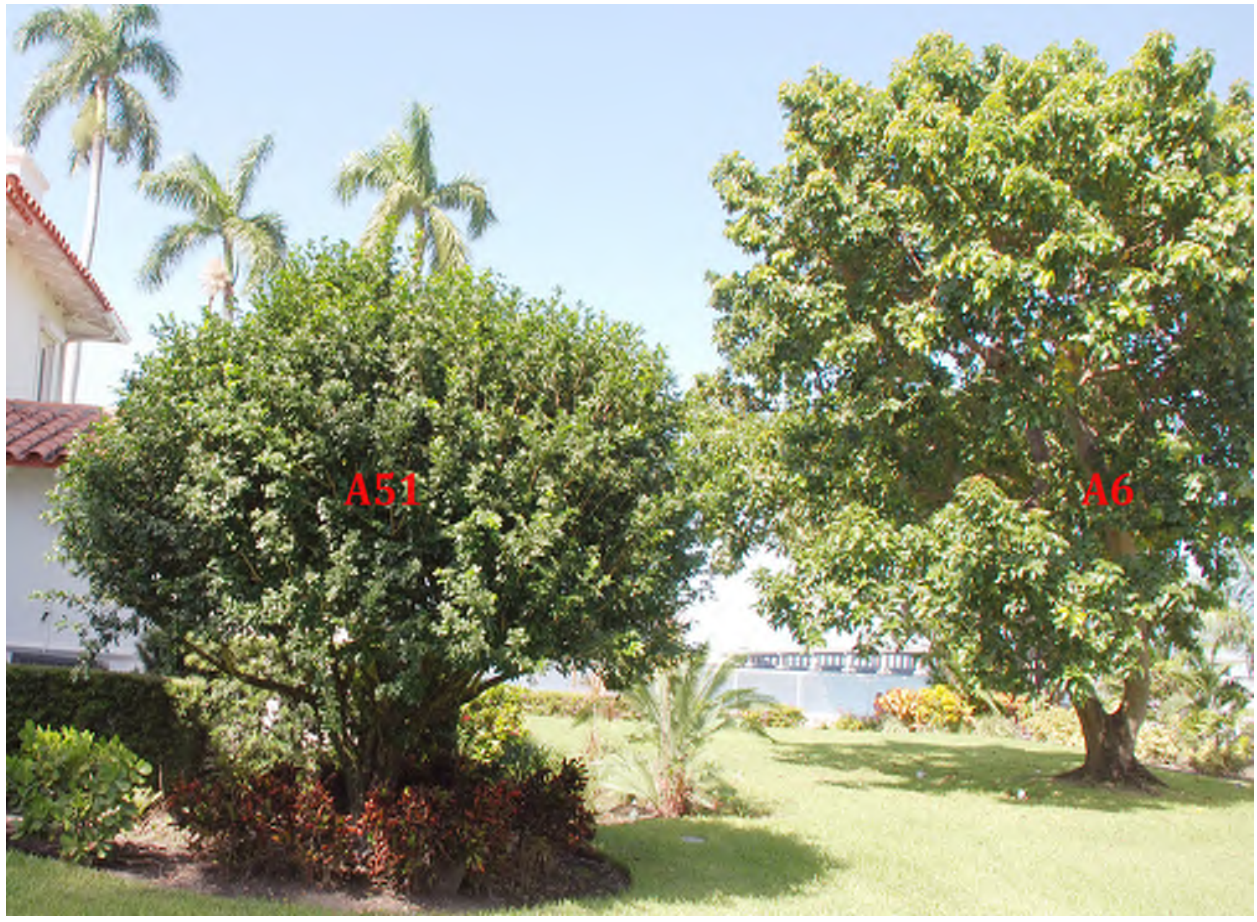
**Photo 33 above is trees A51 & A6.**

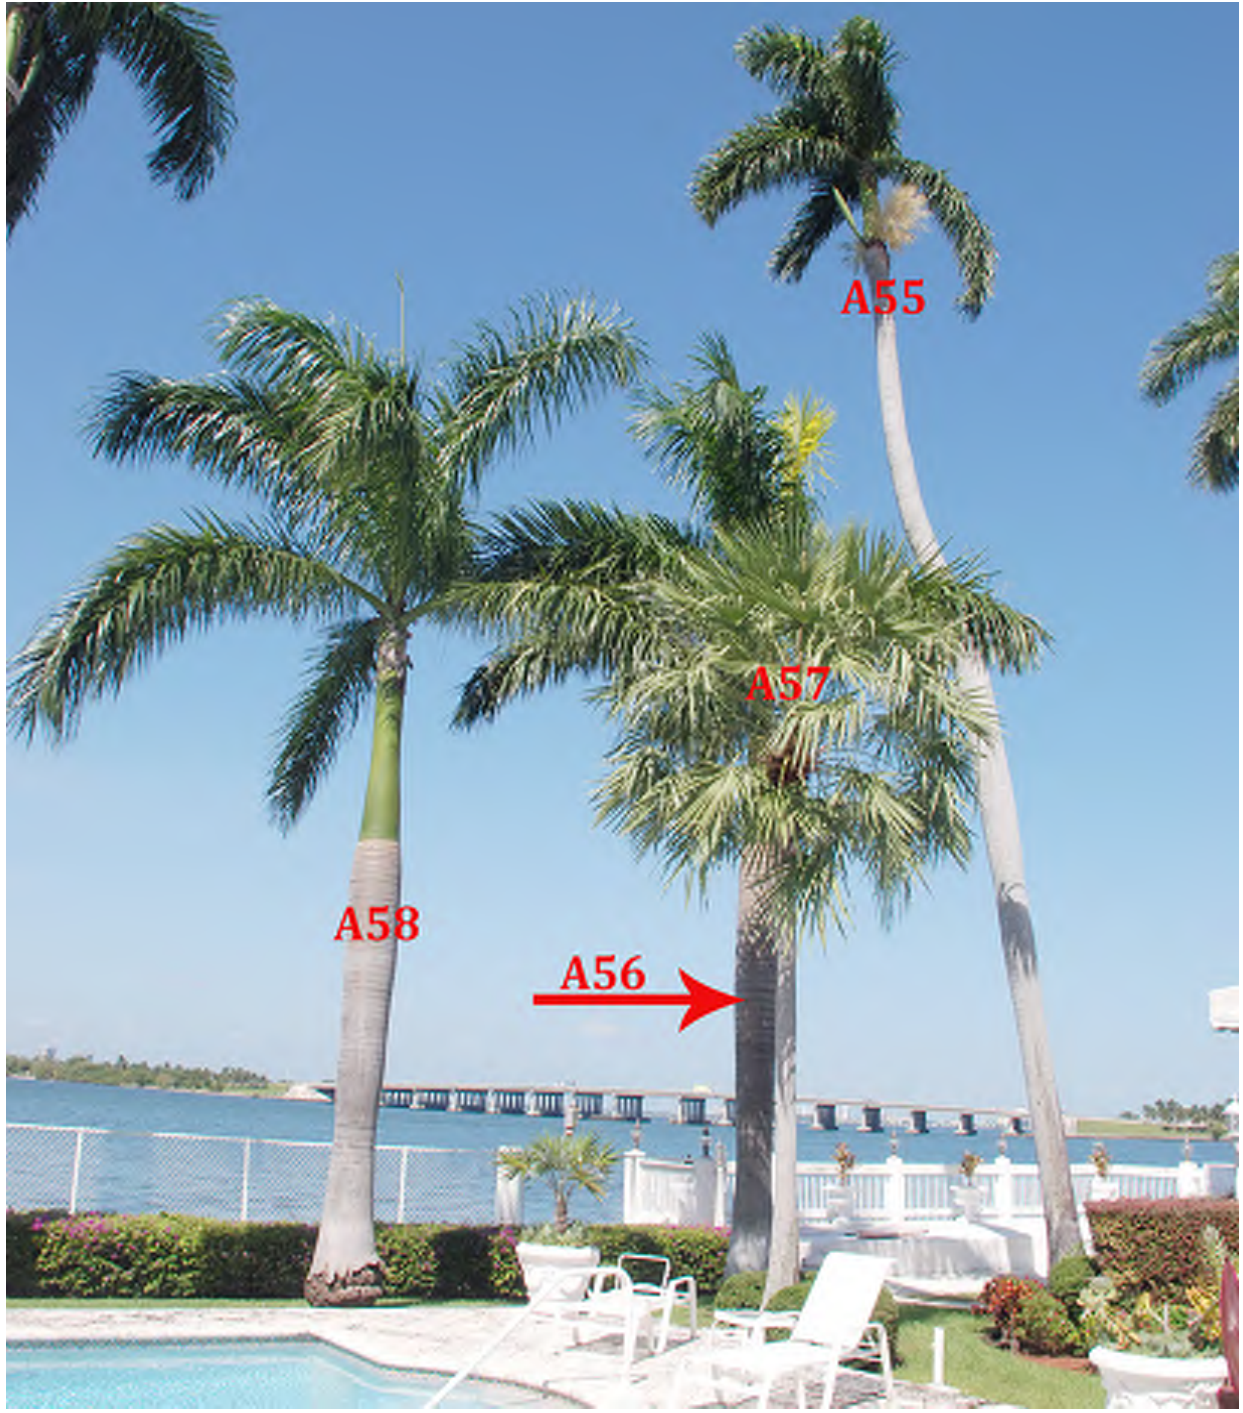
**Photo 35 above is palms A55, A56, A57 & A58.**

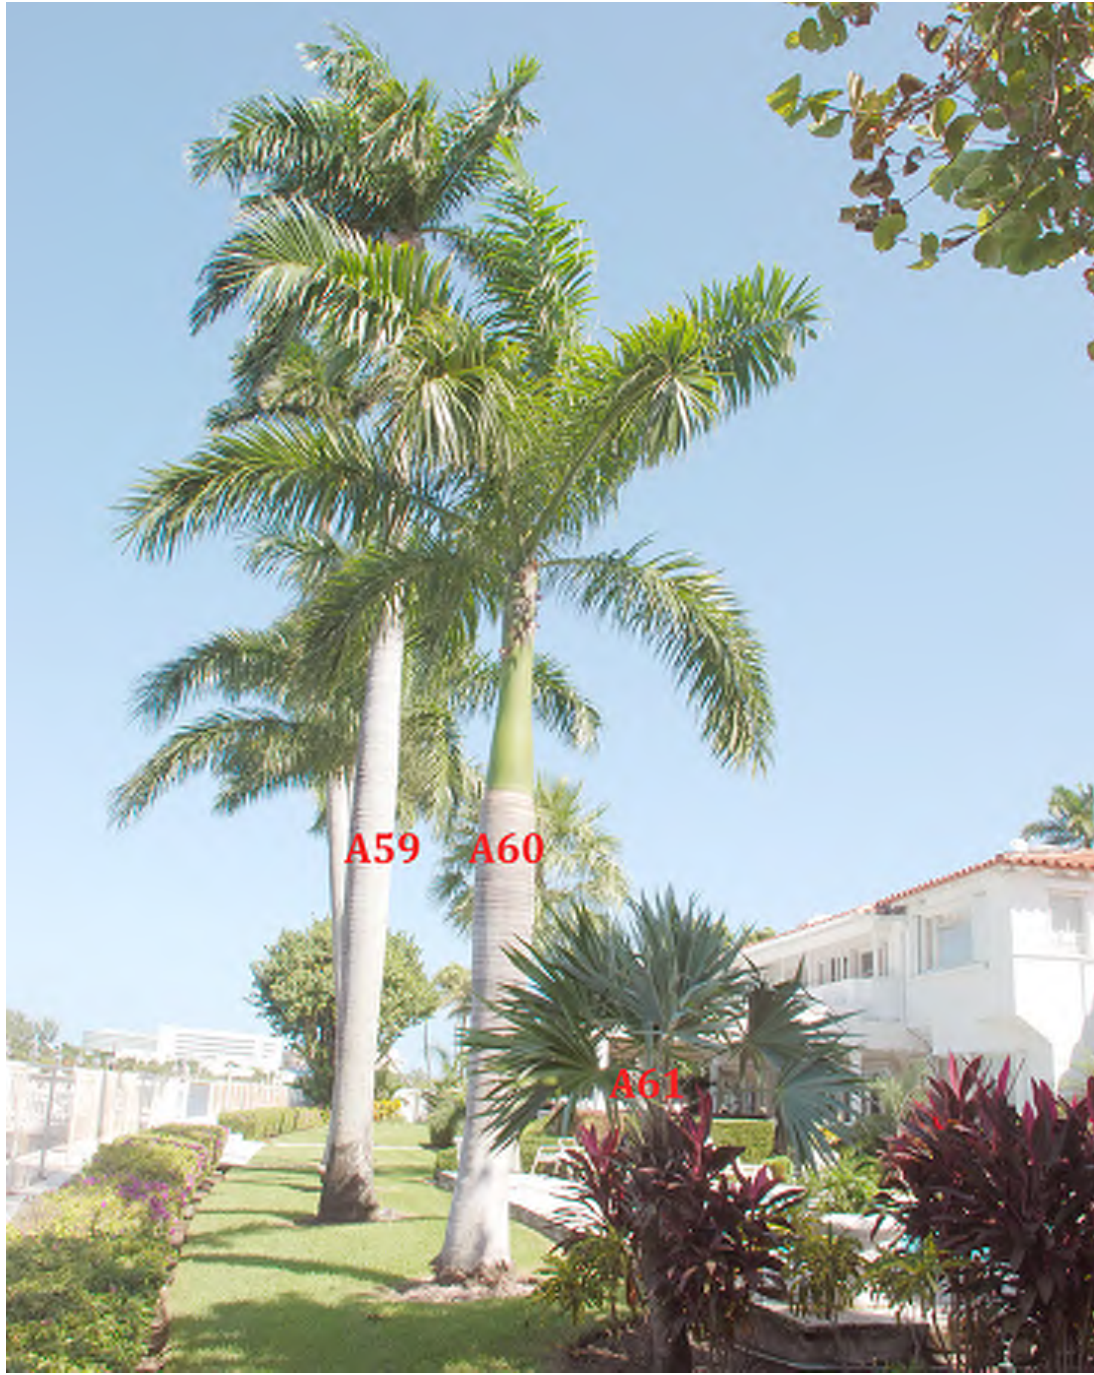
**Photo 36 above is palms A59, A60 & A61.**

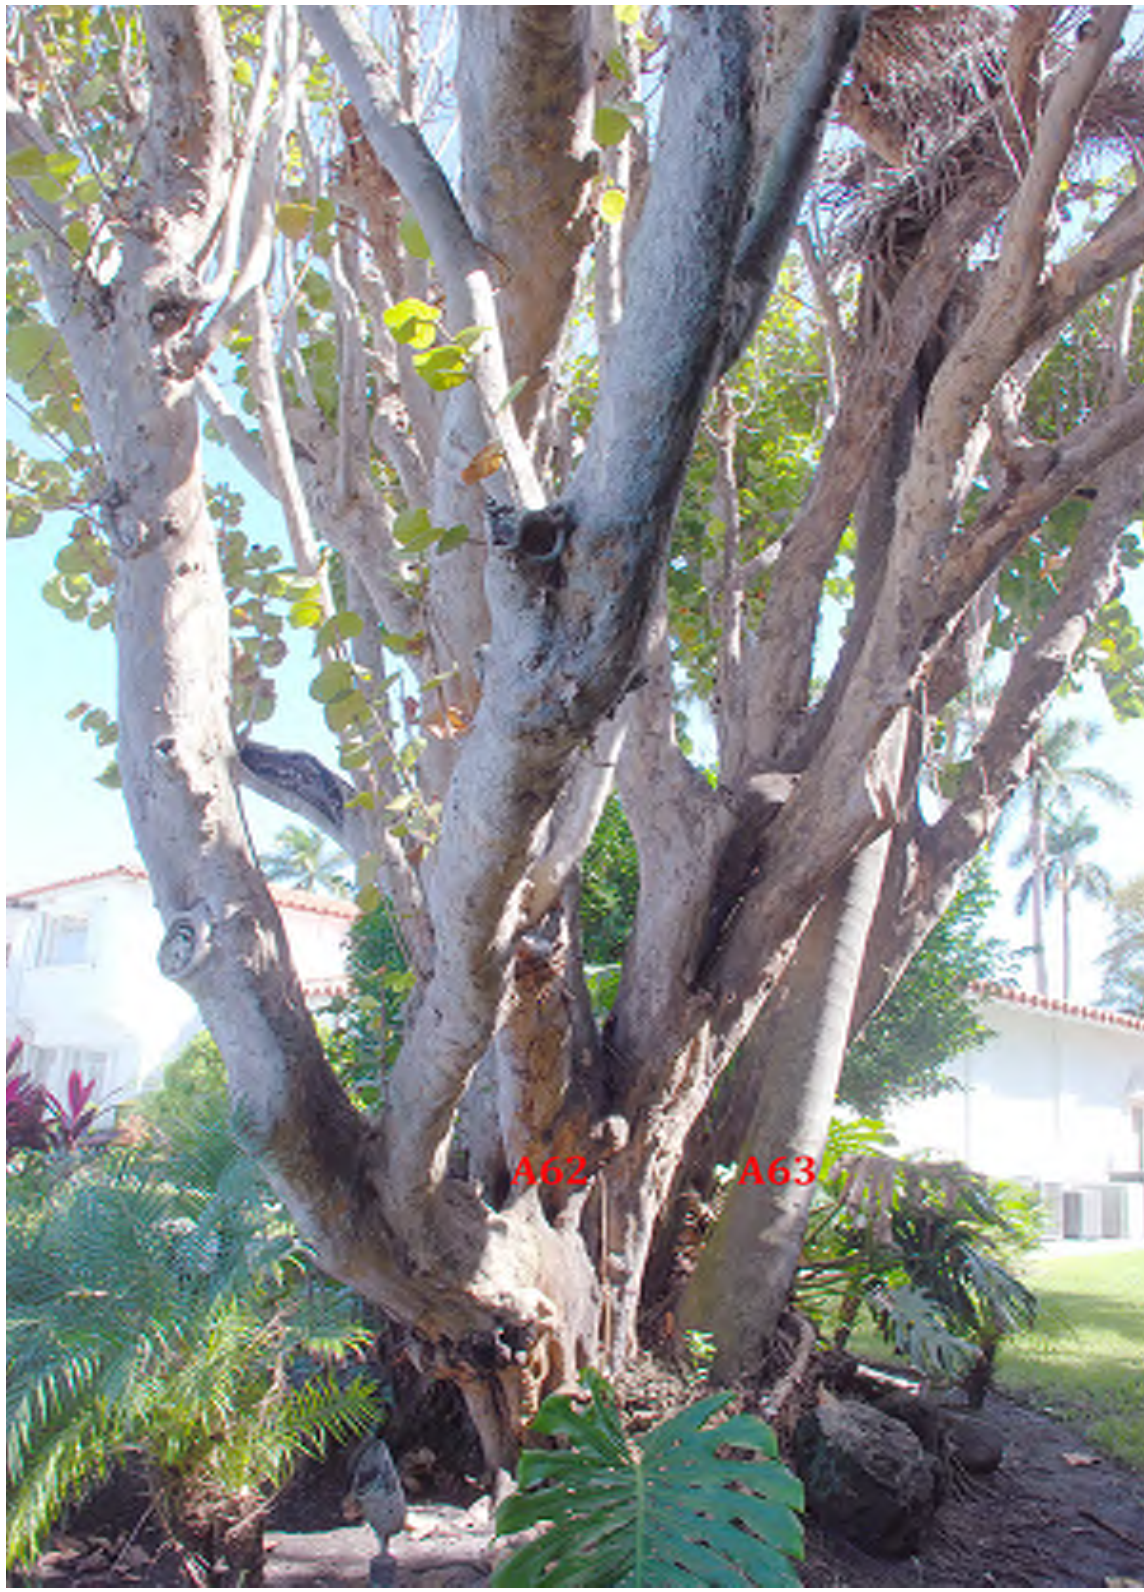
**Photo 38 above is tree A62 & palm A63.**

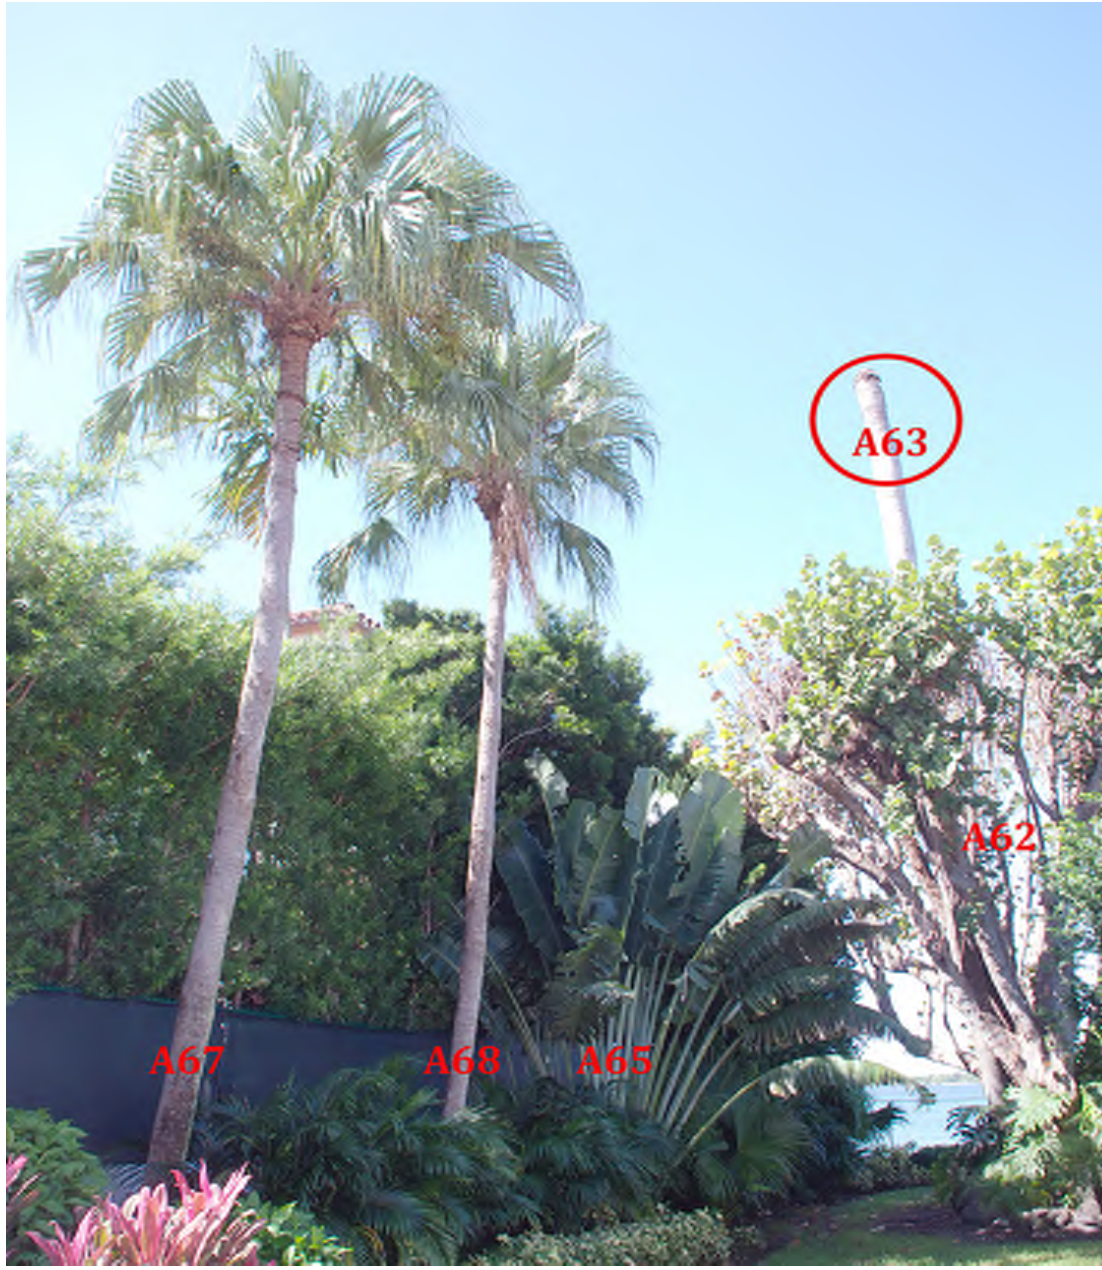
**Photo 40 above is palms A67 & A68.**

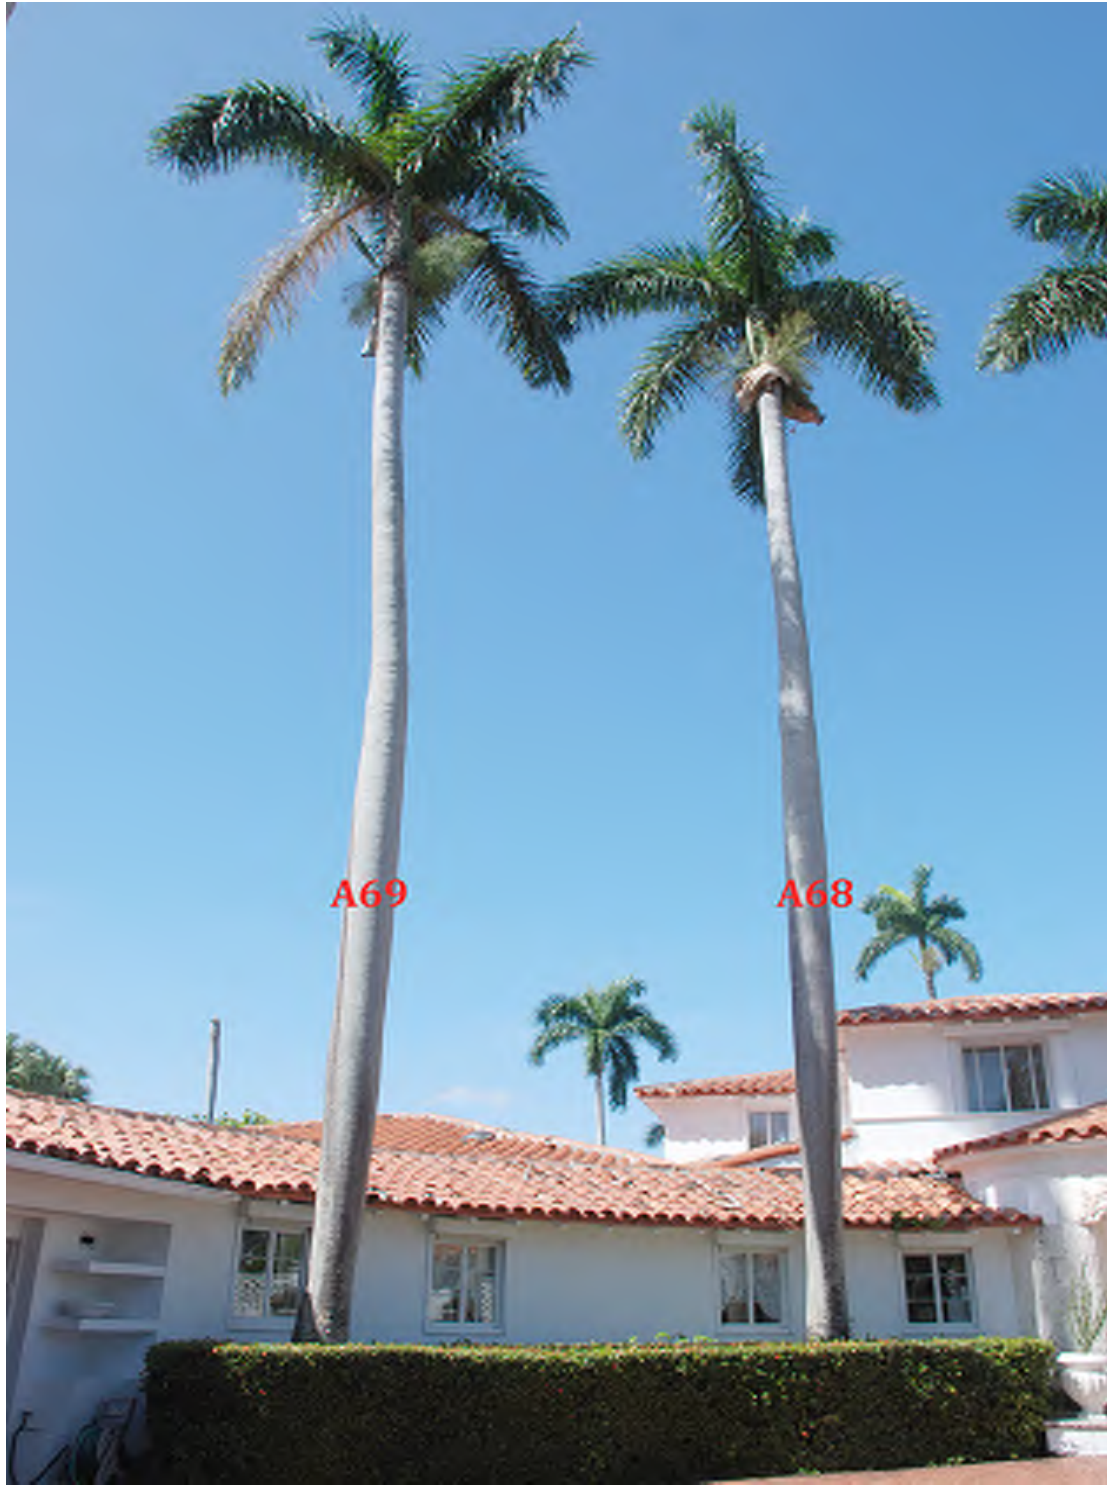
**Photo 41 above is palms A68 & A69.**

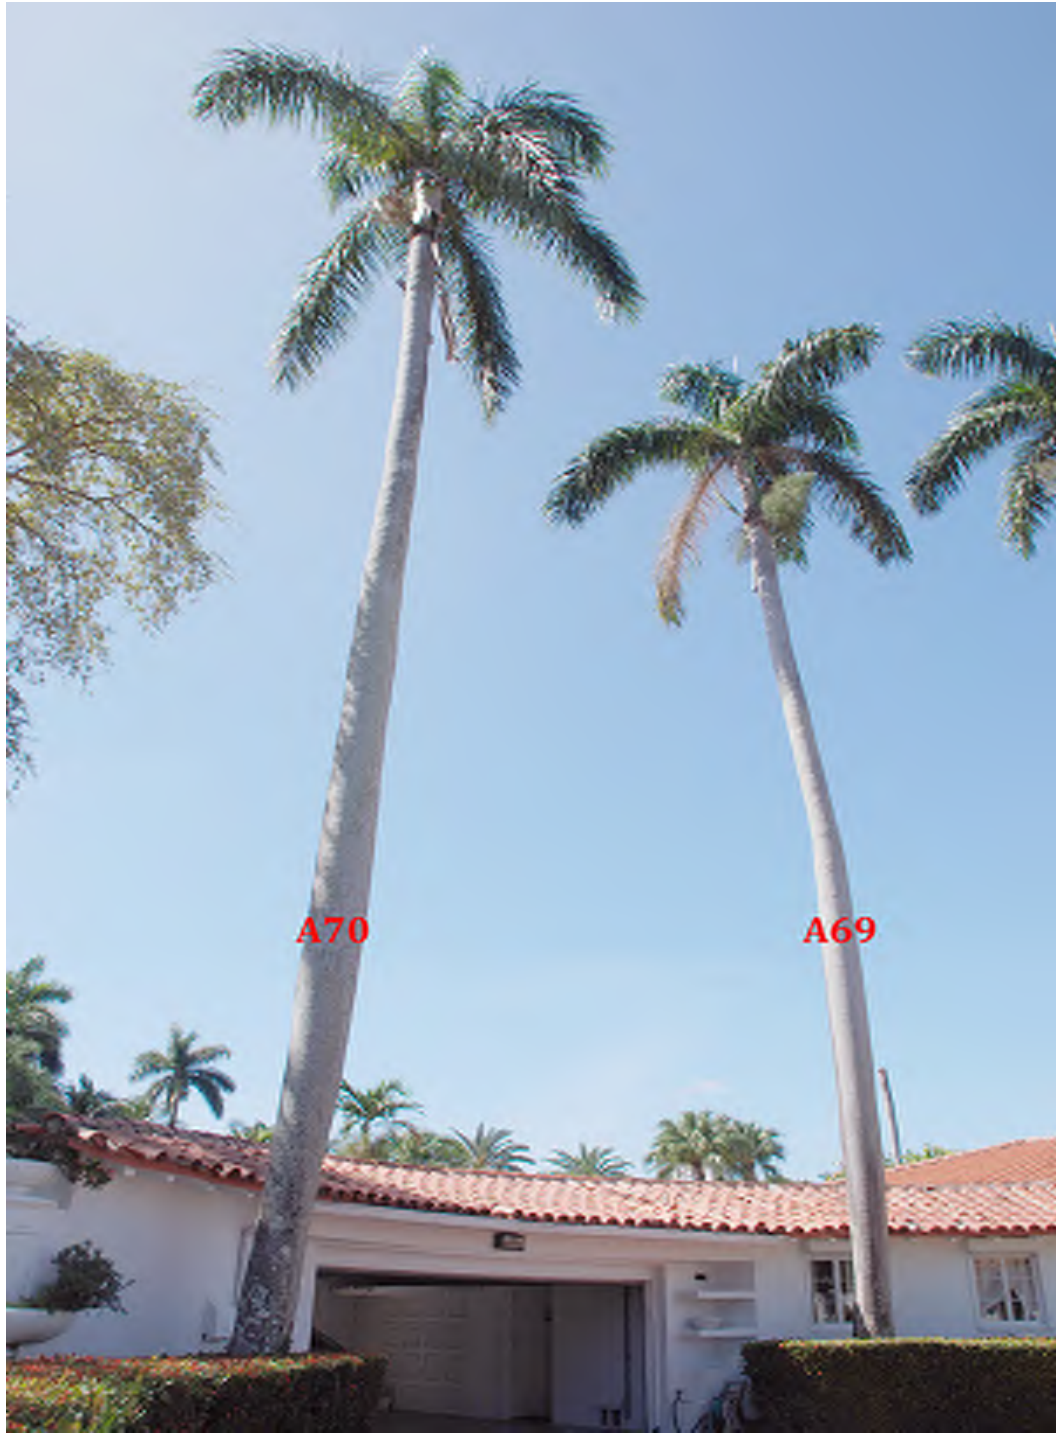
**Photo 42 above is palms A69 & A70.**

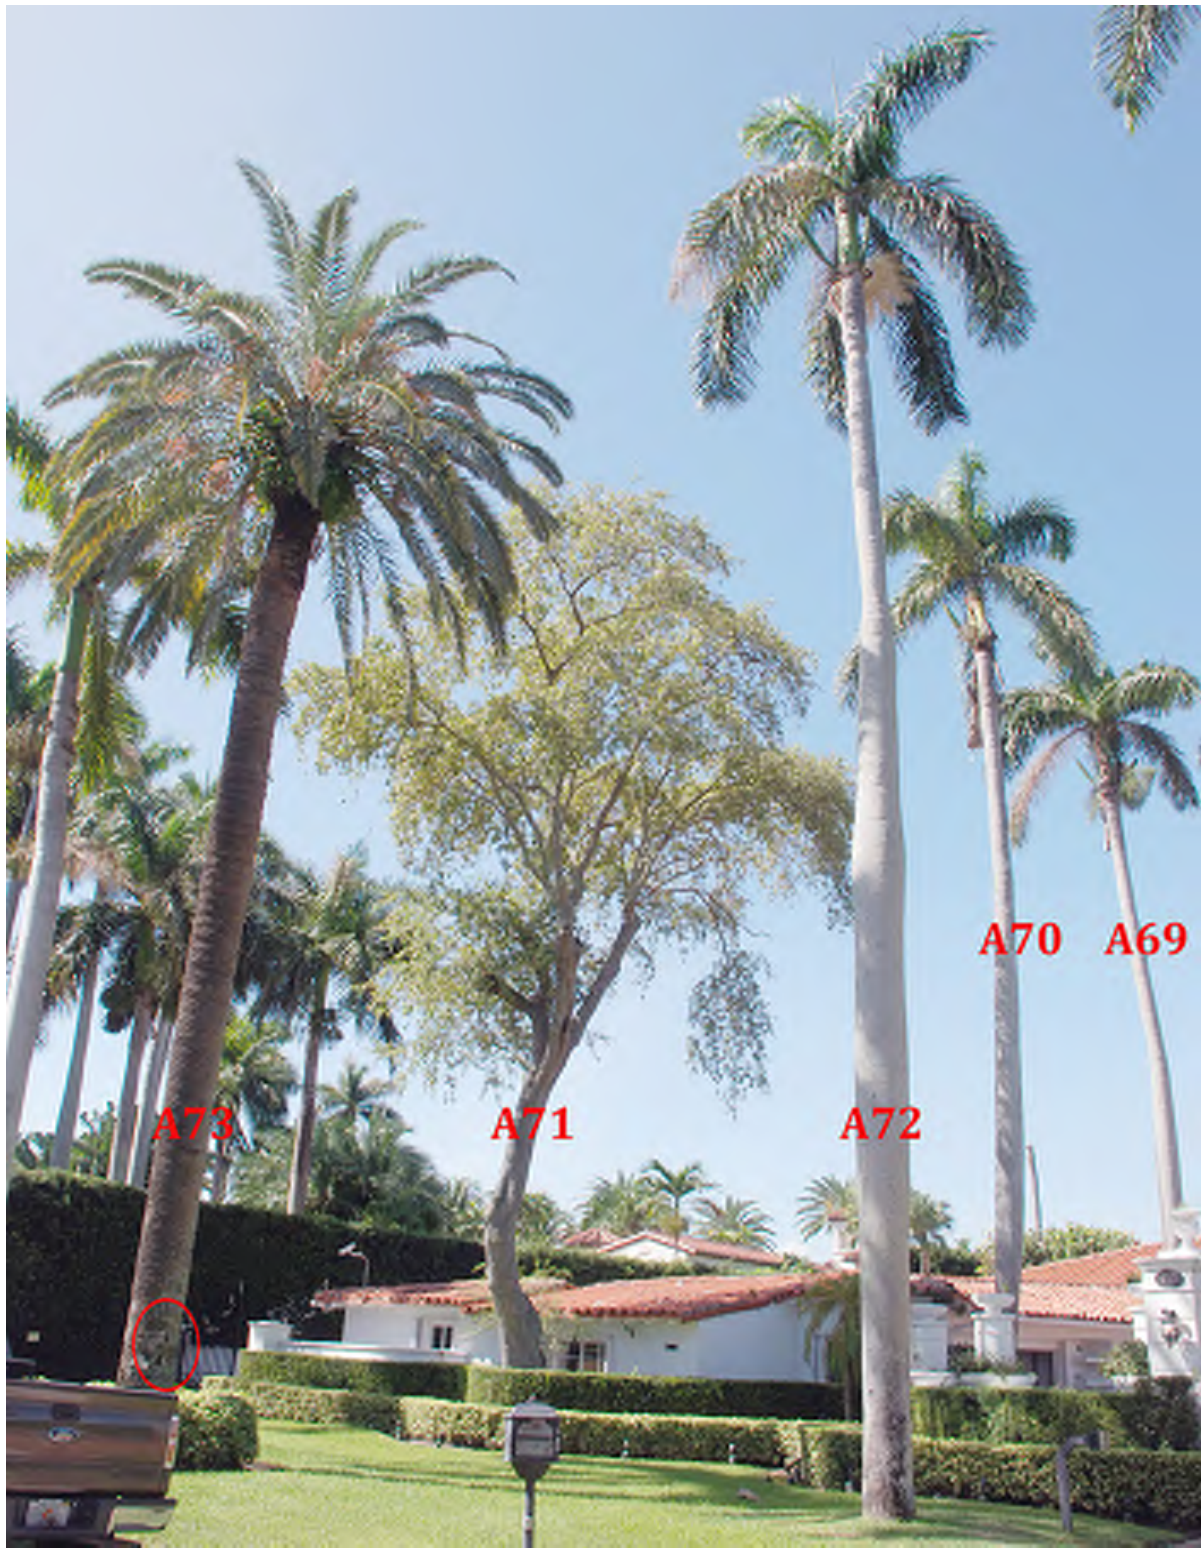
**Photo 46 above is tree A71, palms A69, A70, A72 & A73. See following photo.**

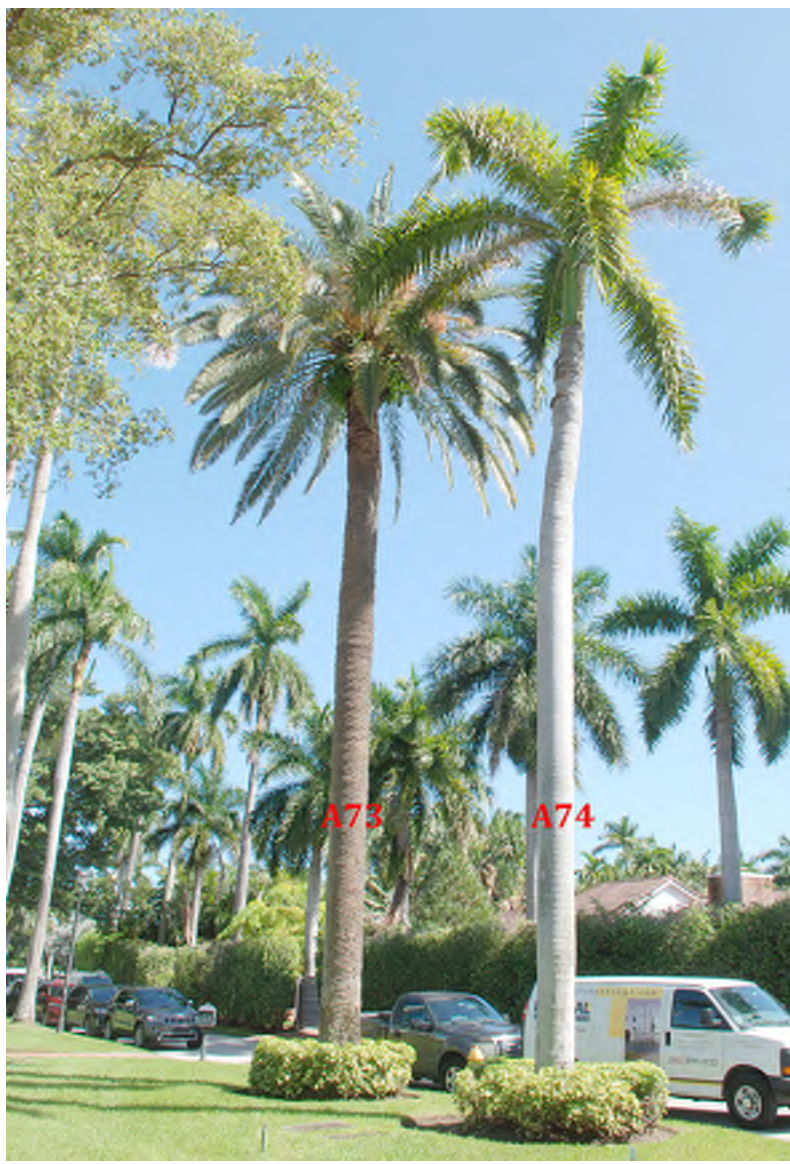
**Photo 49 above is palms A73 & A74.**

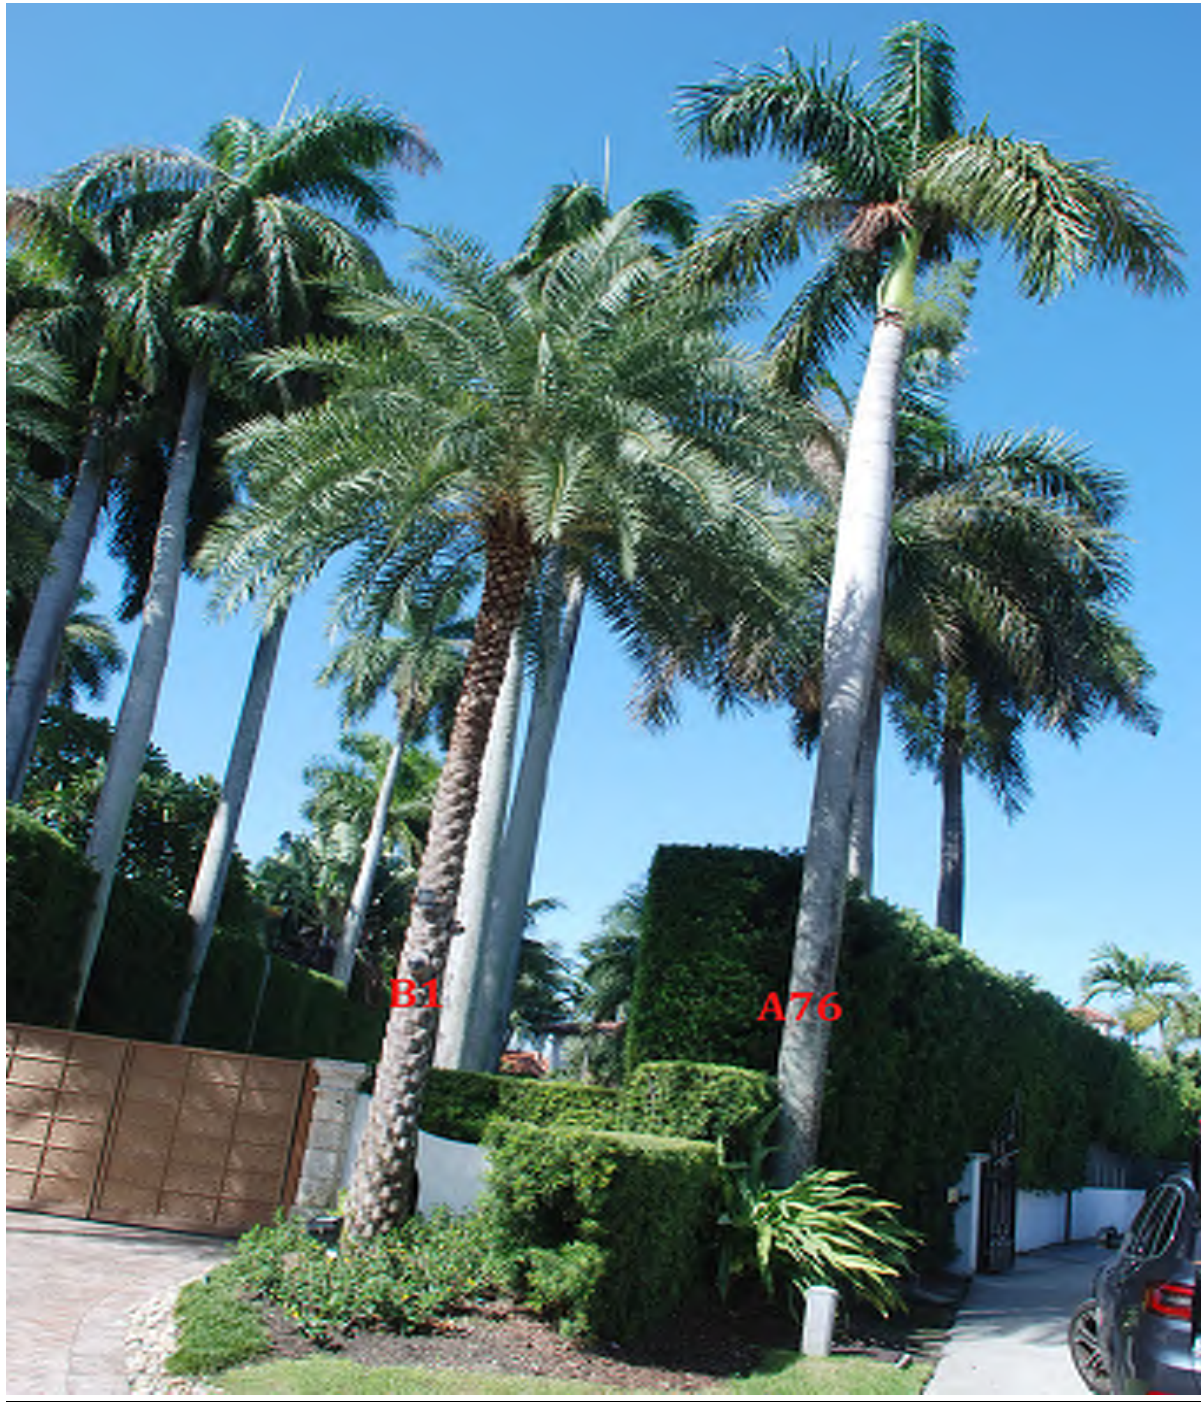
**Photo 51 above is palms A76 & B1.**

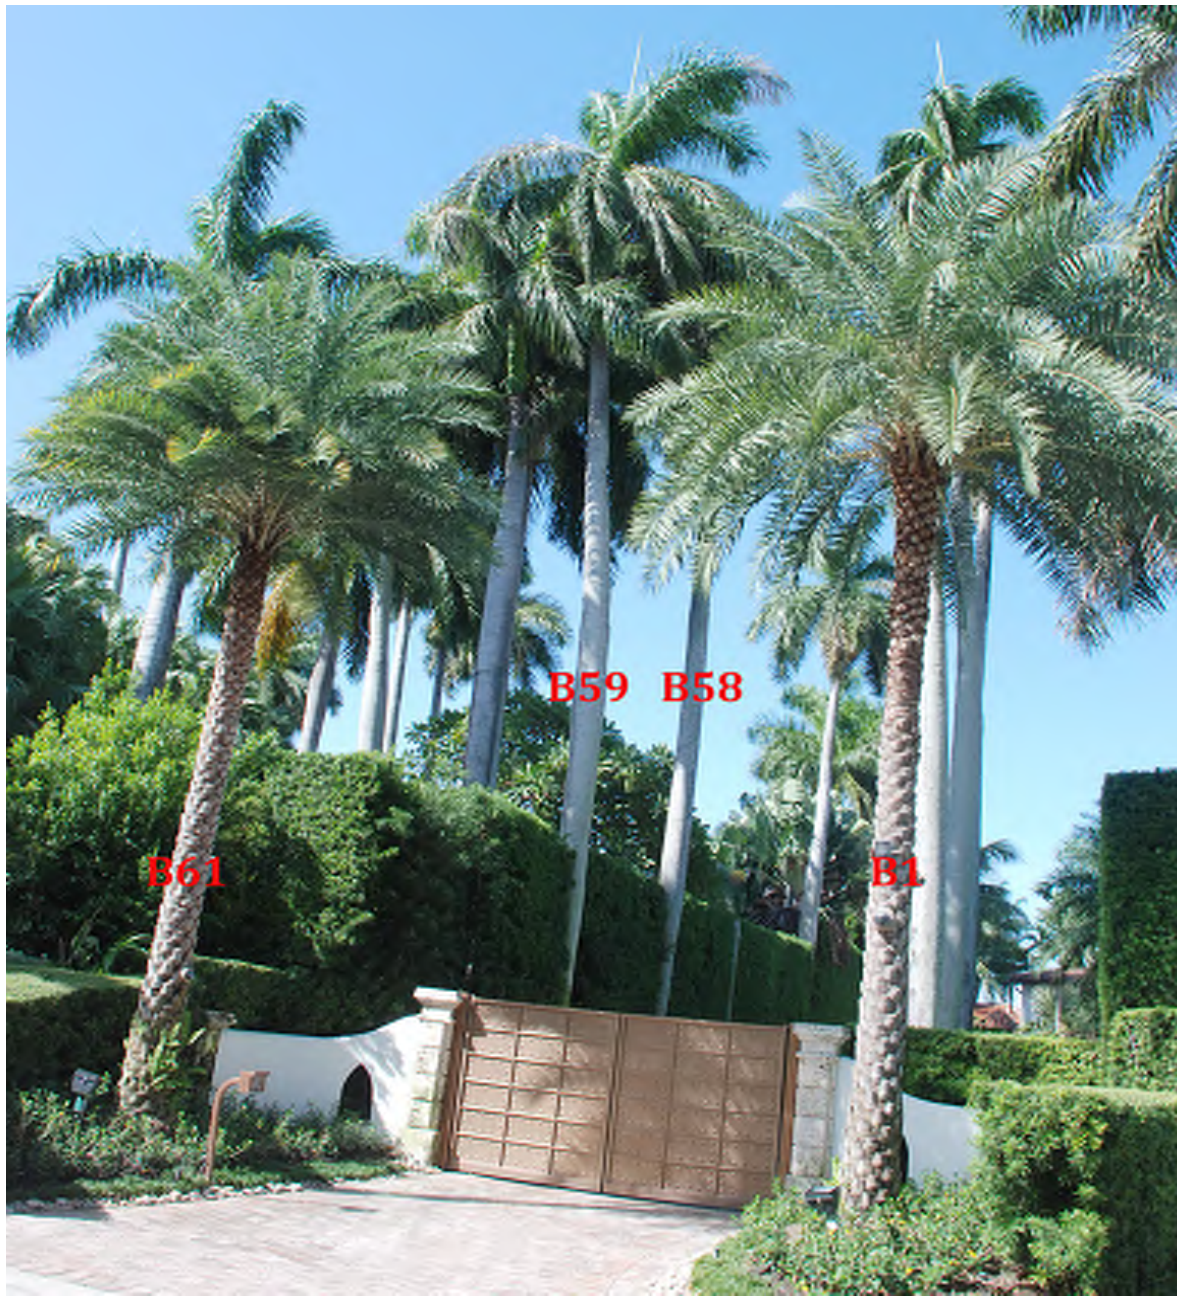
**Photo 52 above is palms B1 & B61.**

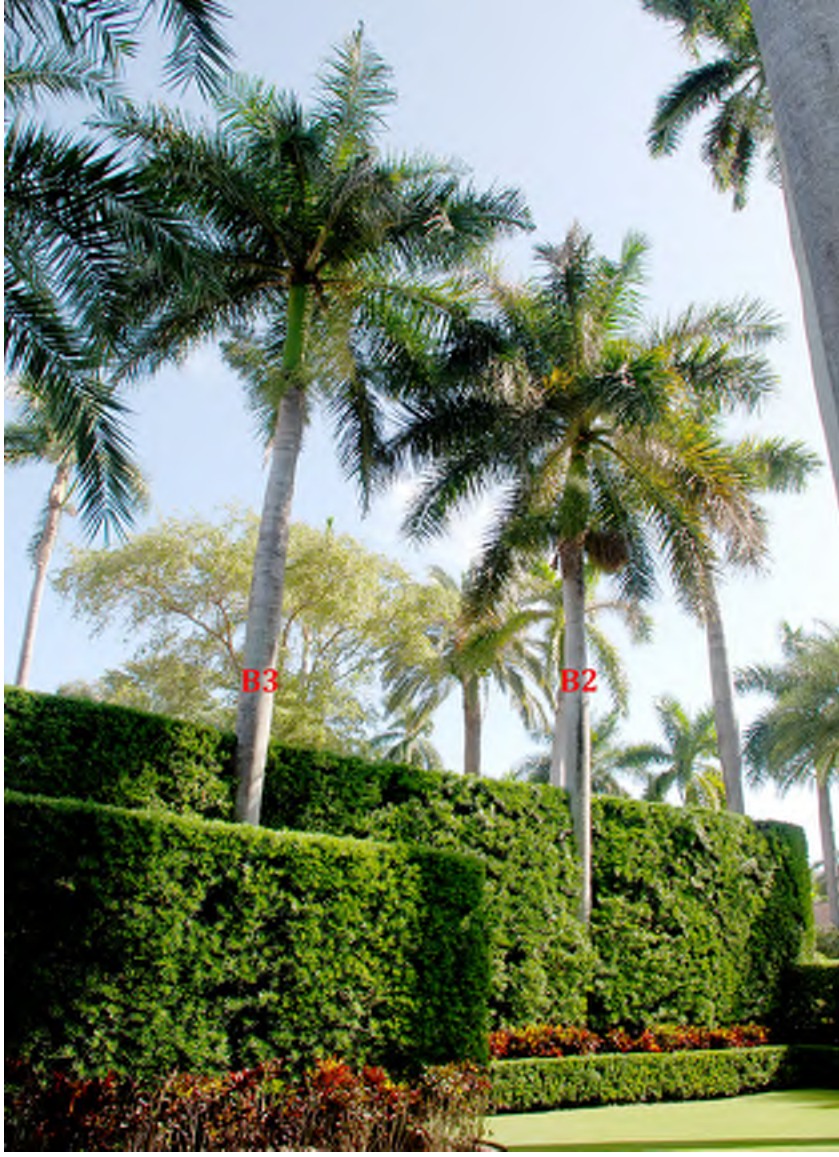
**Photo 53 above is palms B2 & B3.**

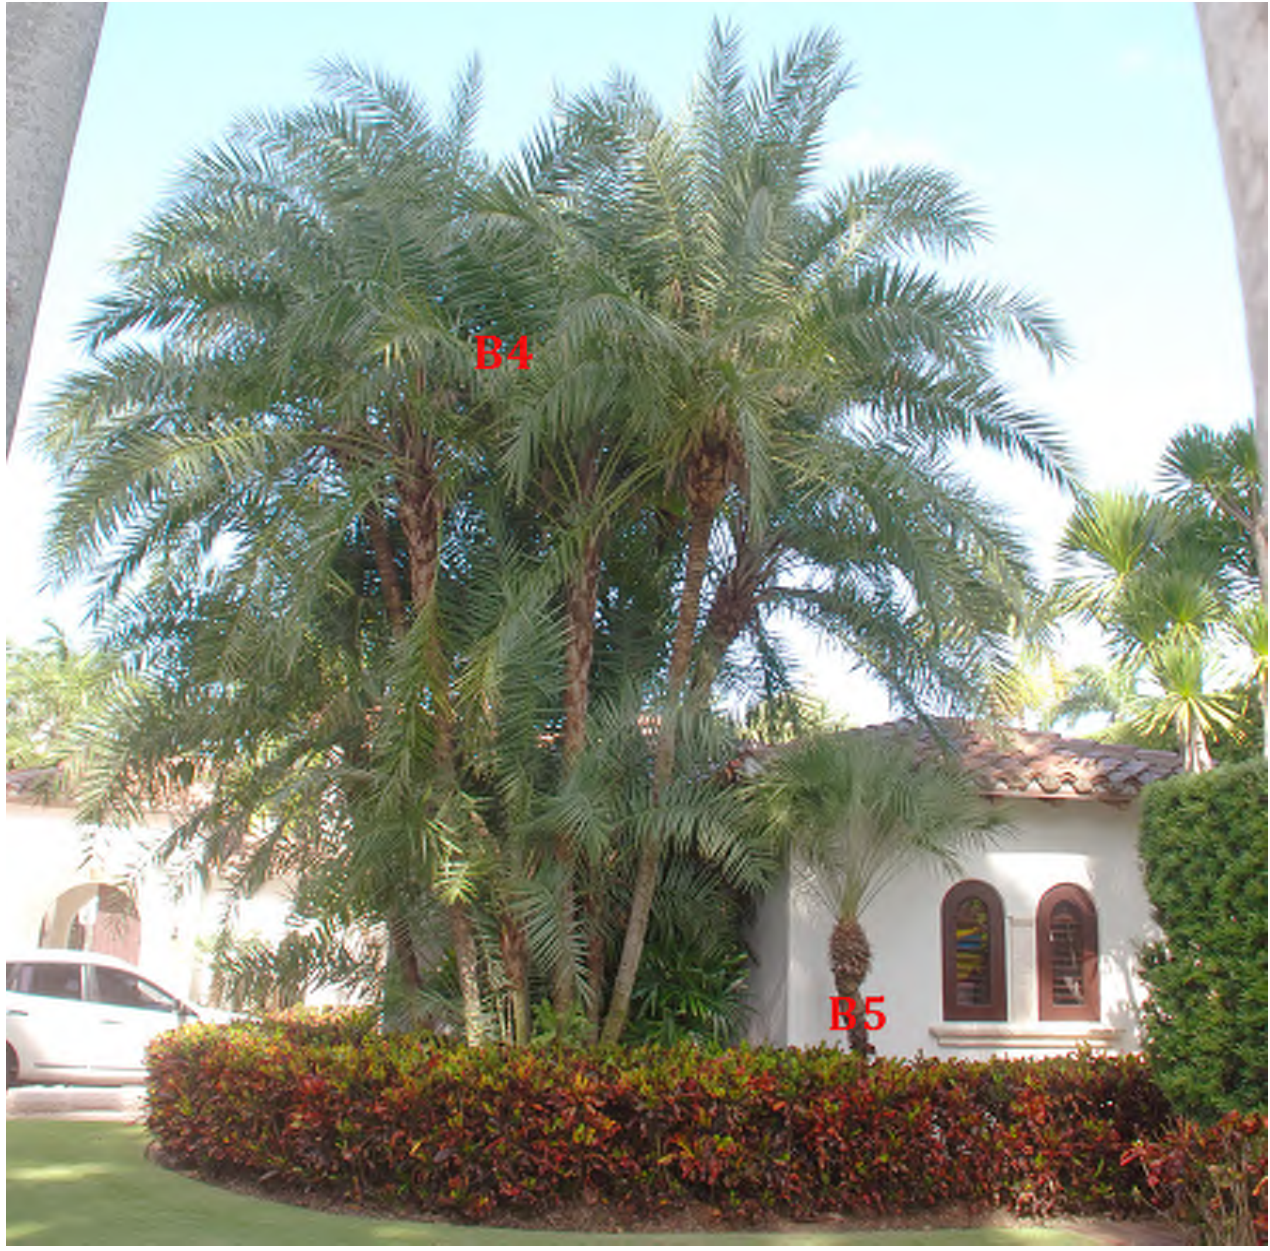
**Photo 54 above is palms B4 & B5.**
