# ***Tree Resource Evaluation for 1753 & 1771 N. View Drive, Miami Beach***

***Sunset Islands Land Trust  
1771 North View Drive  
Miami Beach, FL 33140***

***Jeff Shimonski  
President, Tropical Designs of Florida  
Member, American Society of Consulting Arborists  
ISA Certified Arborist Municipal Specialist FL-1052AM  
ISA Tree Risk Assessment Qualification  
LIAF Florida Certified Landscape Inspector 2016-0175  
305-773-9406  
Jeff@TropicalArboriculture.com***

***October 29, 2020***

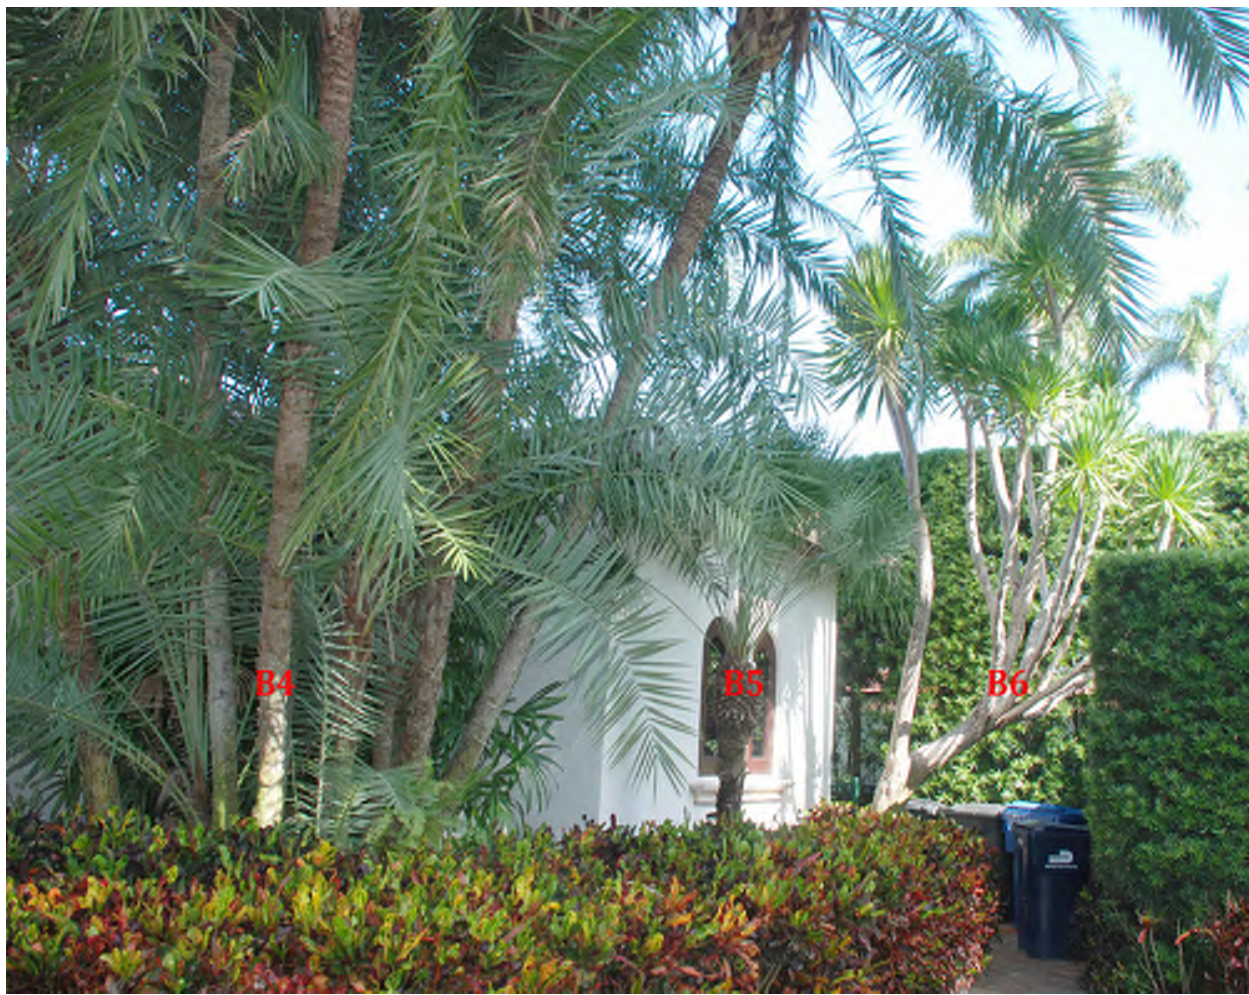
**Photo 55 above is palms B4, B5 & yucca B6.**

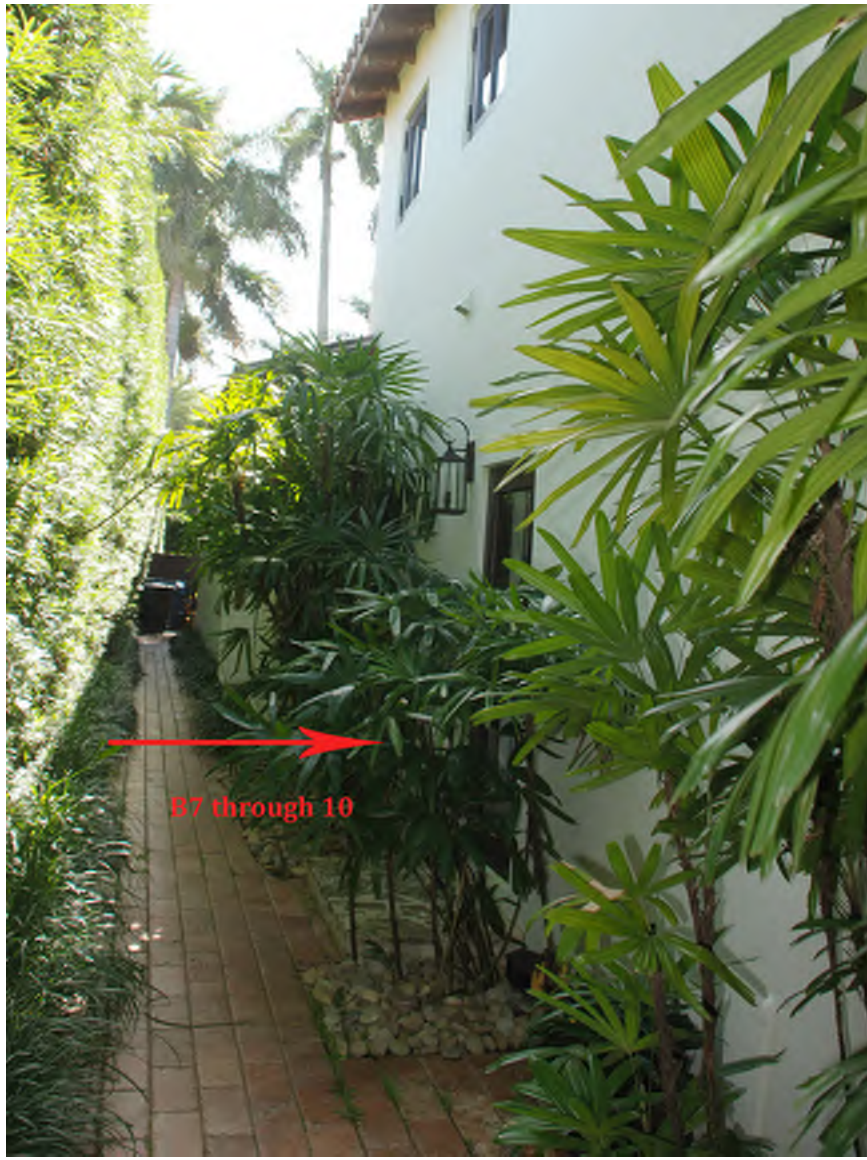
Photo 56 above is a hedge of *Rhapis excelsa*.

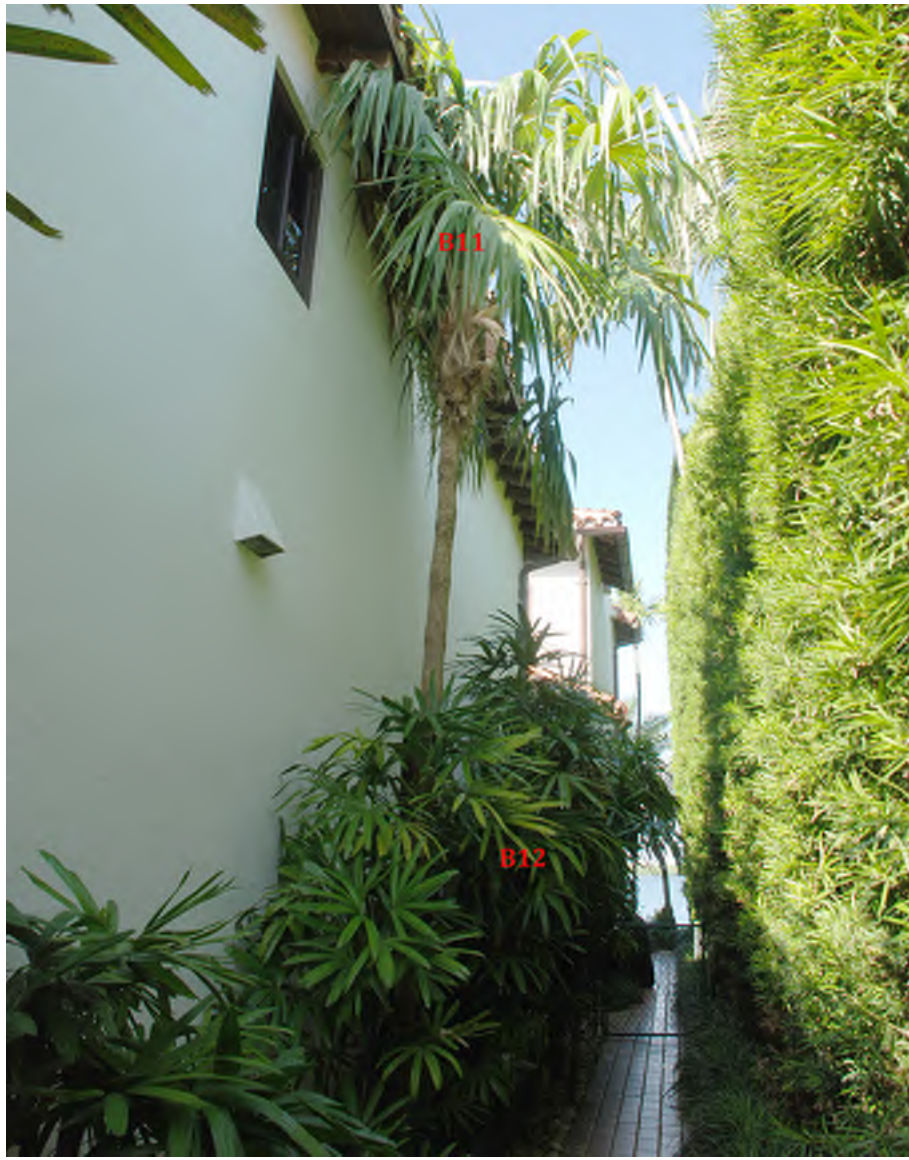
**Photo 57 above is palm B11.**

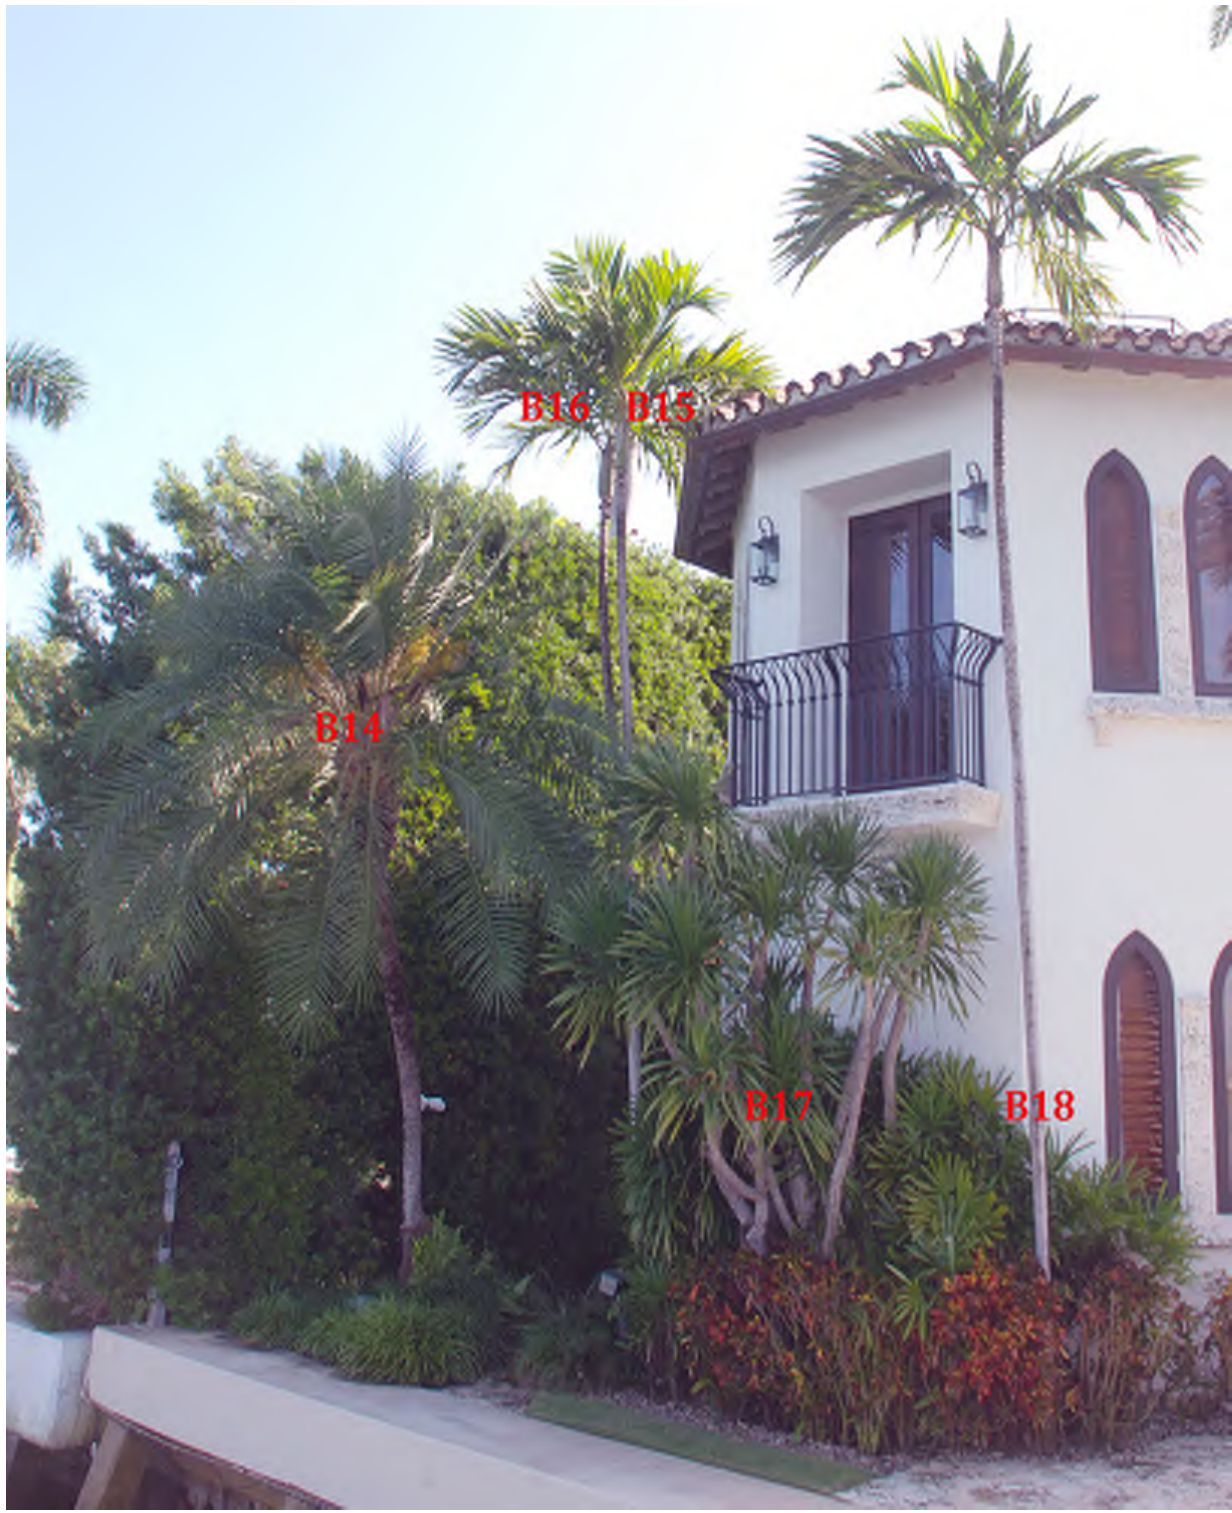
**Photo 58 above is palms B14, B15, B16 and B18 and yucca B17.**

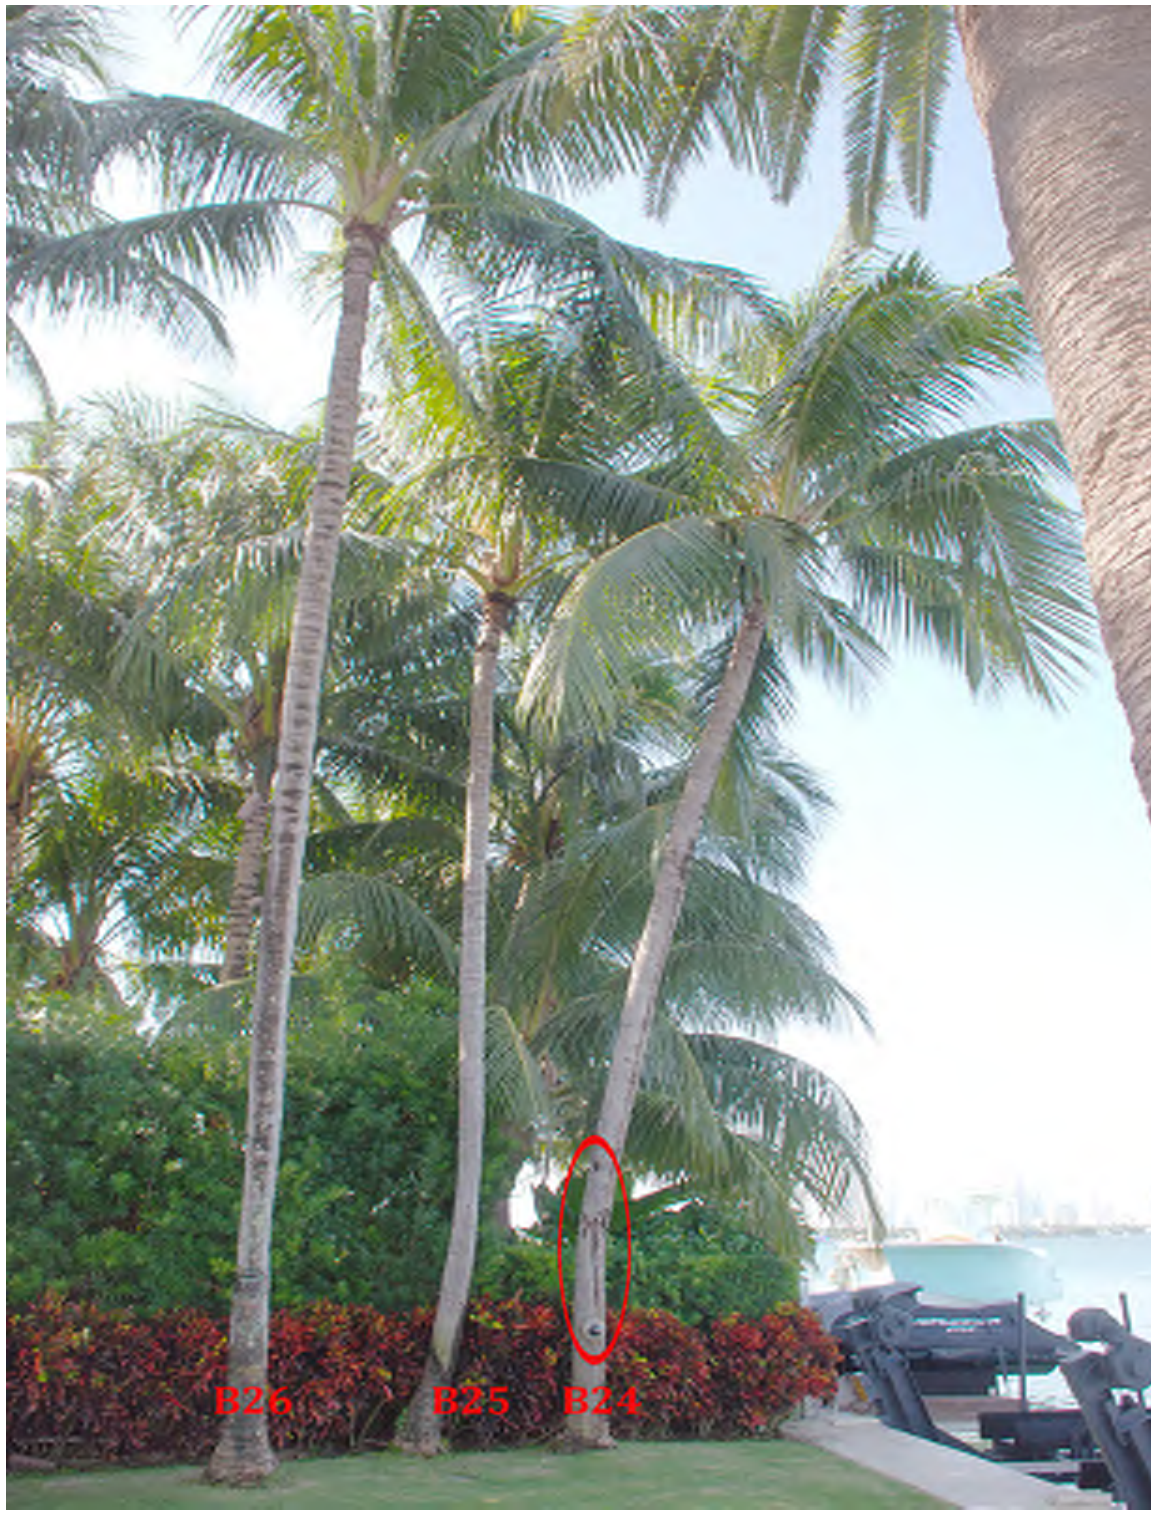
**Photo 61 above is palms B24, B25 & B26. See following photo.**

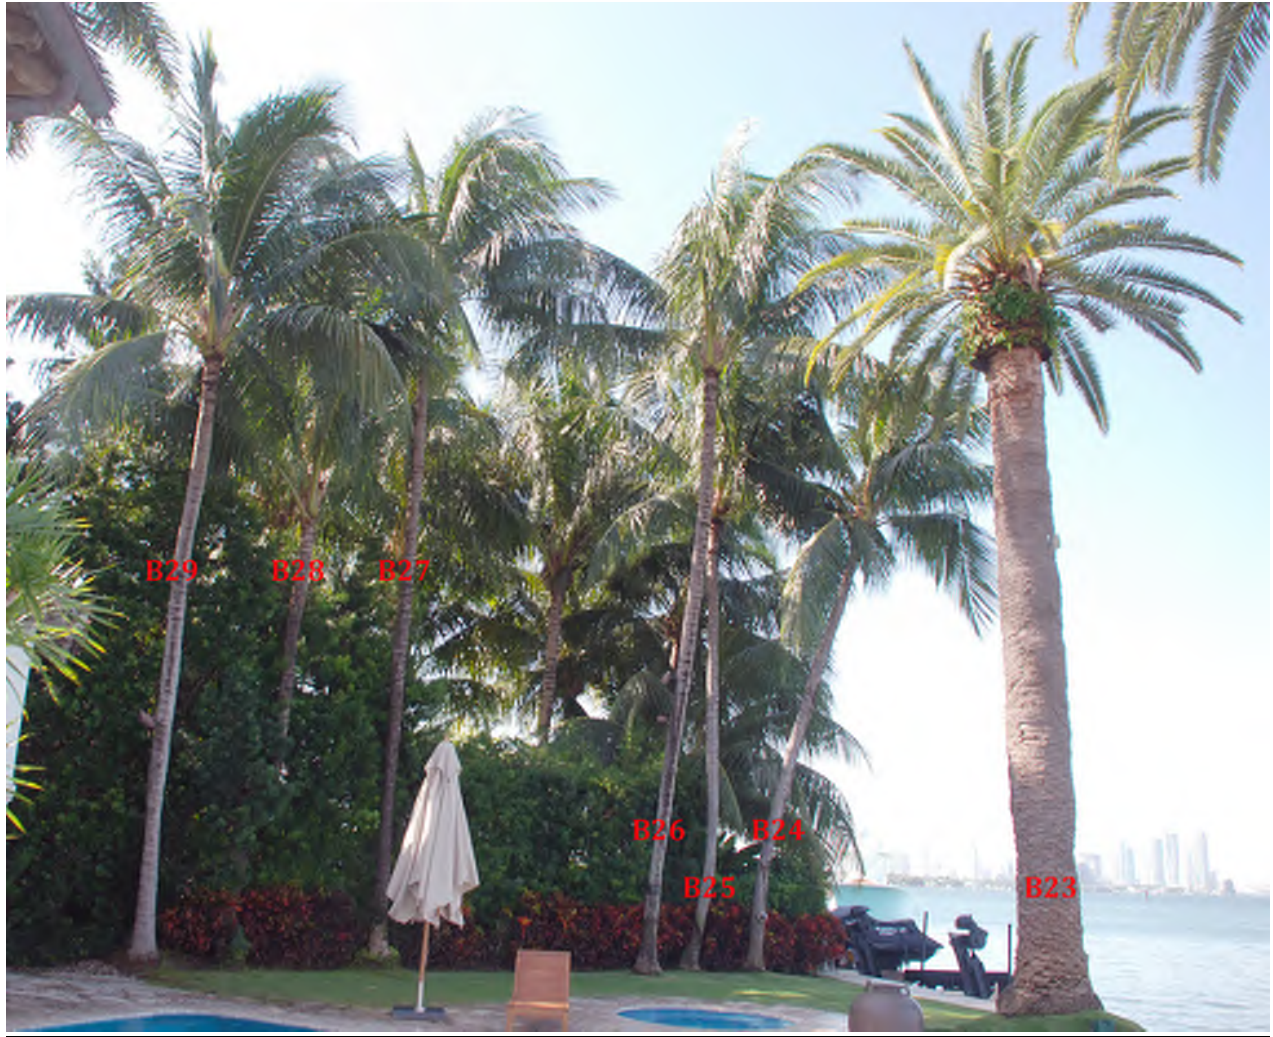
**Photo 63 above is palms B23, B24, B25, B26, B27 B28 & B29. See following photo.**
