Tree Resource Evaluation for 4000 Alton Road, Miami Beach

May 11, 2020

I performed a tree resource evaluation on the property located at 4000 Alton Road, Miami Beach on May 2nd and 3rd 2020. The approximate locations of these trees and palms can be found on the schematic in Appendix B.

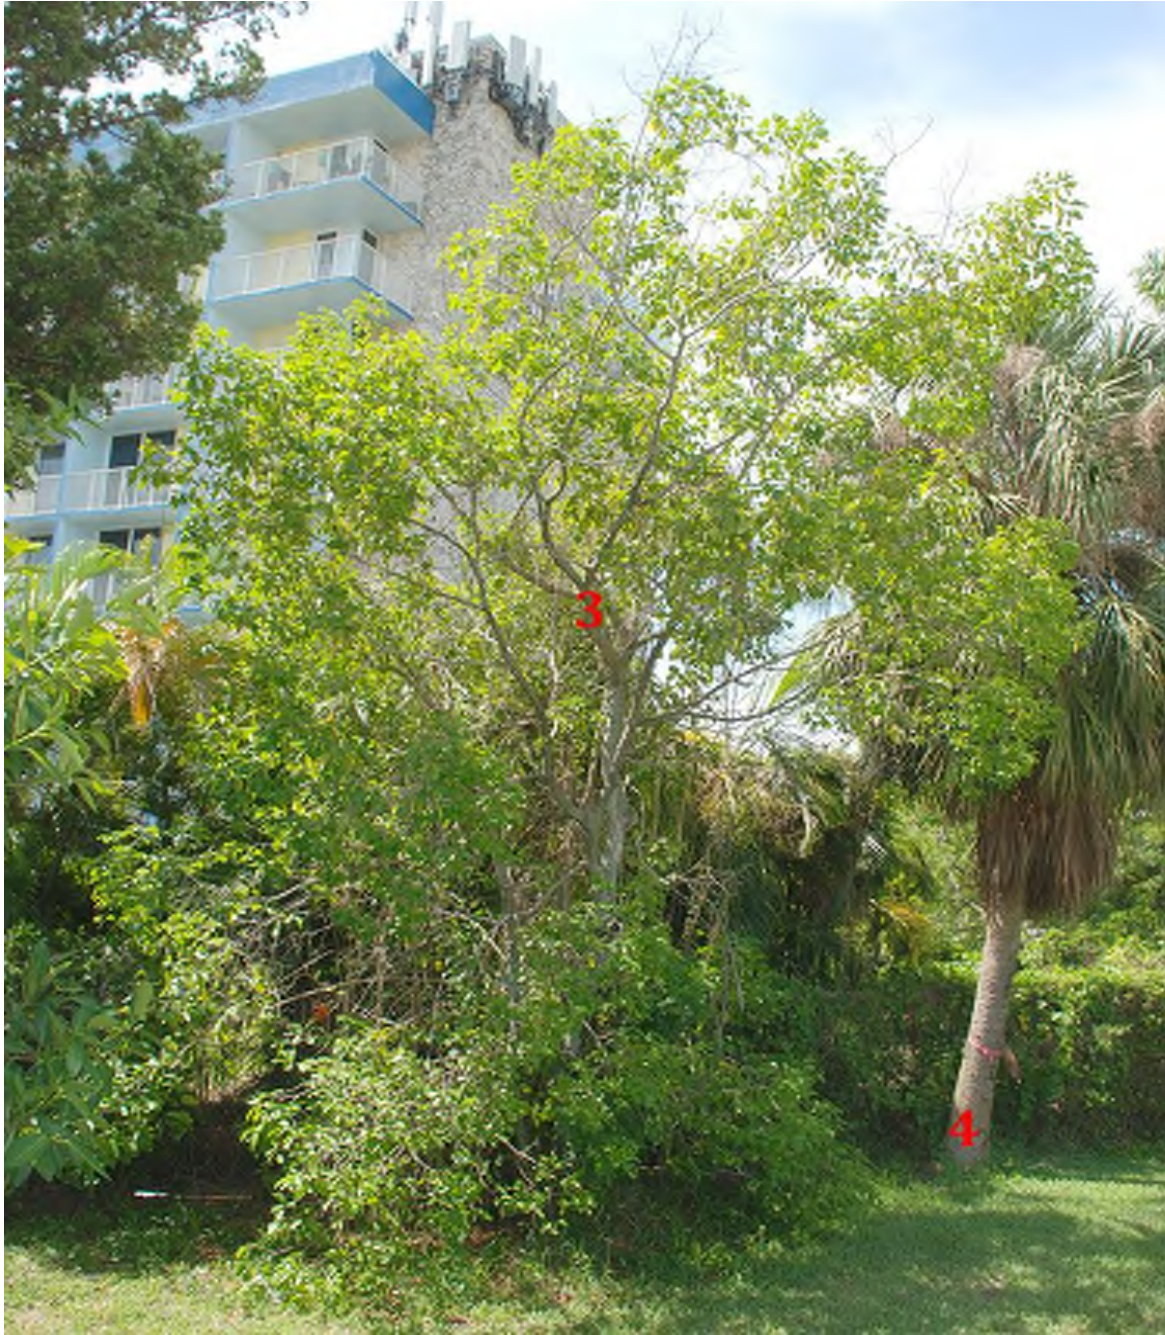
Photo 3 above is tree 3.

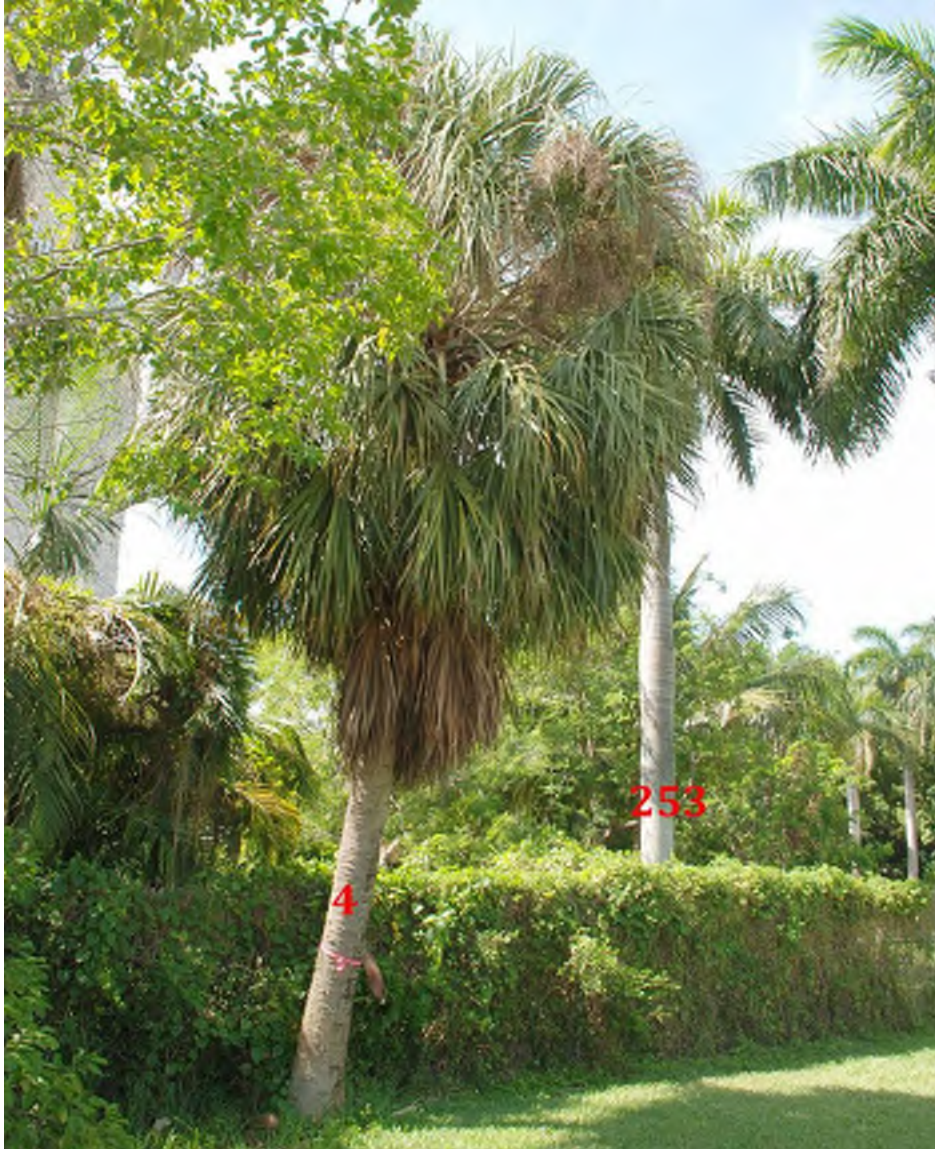
Photo 3 above is palms 4 & 253.

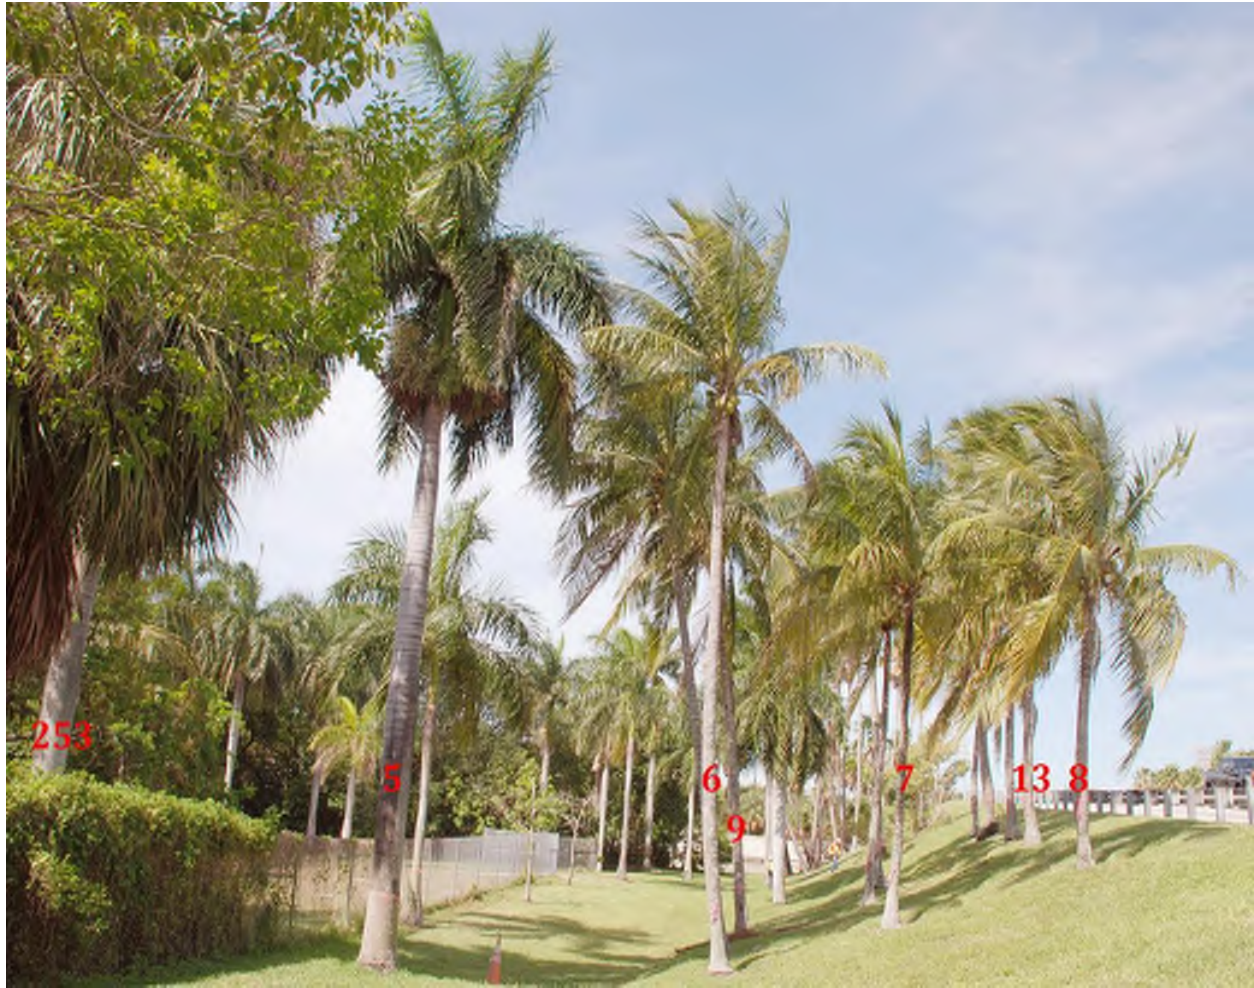
Photo 4 above is palms 5, 6, 7, 8, 9 & 13.

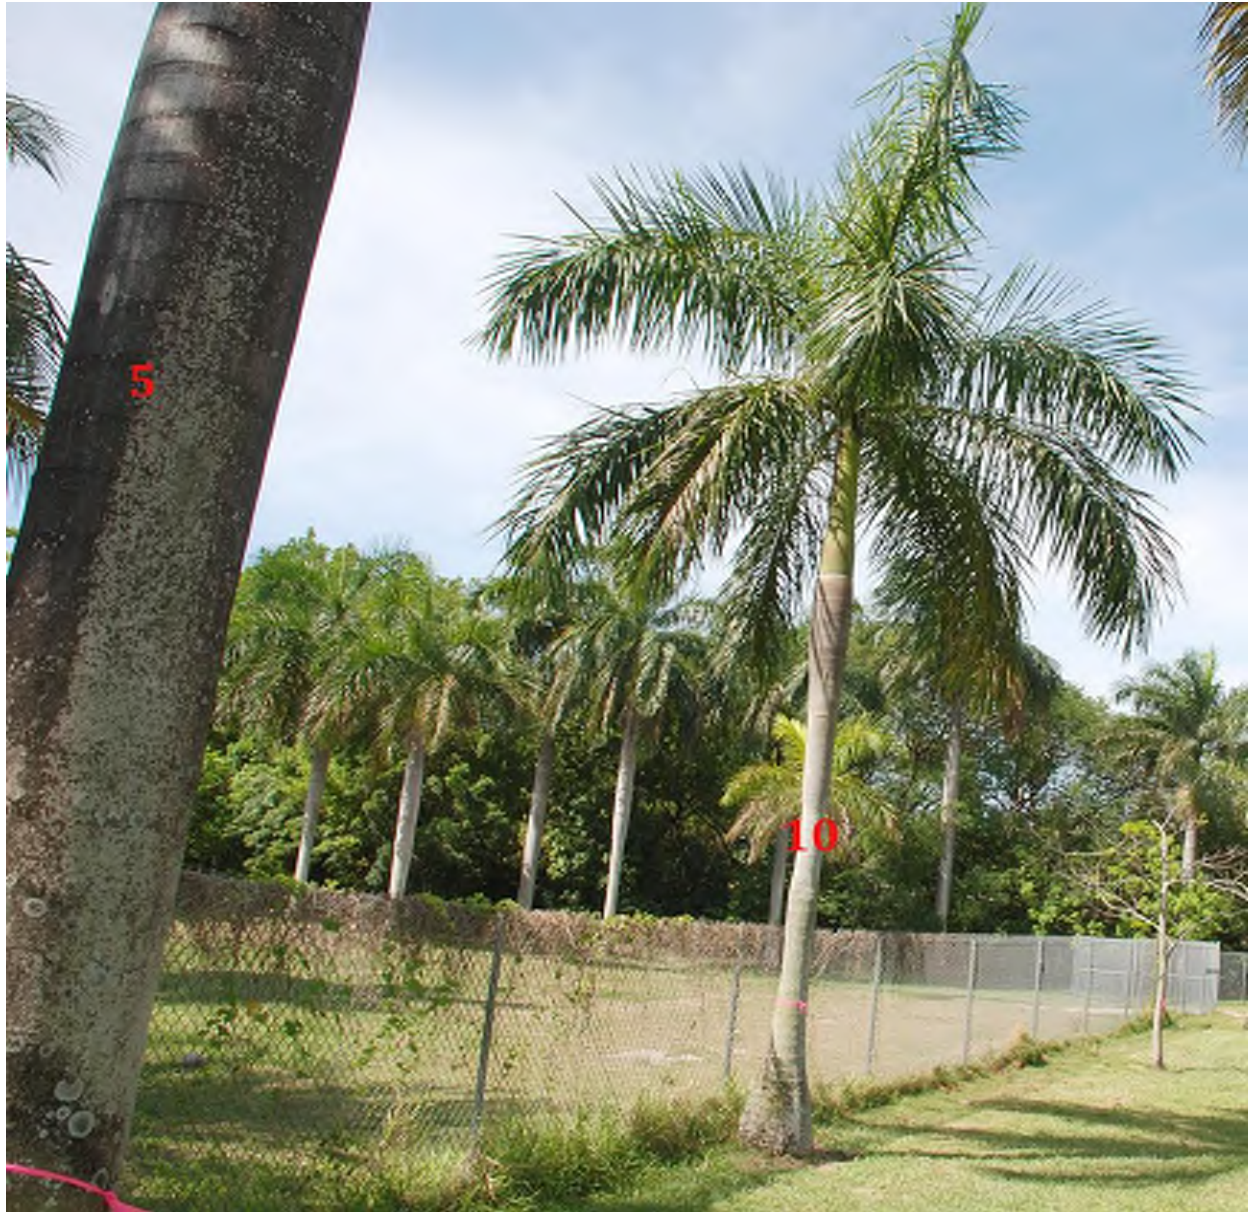
Photo 5 above is palm 10. See following photo.

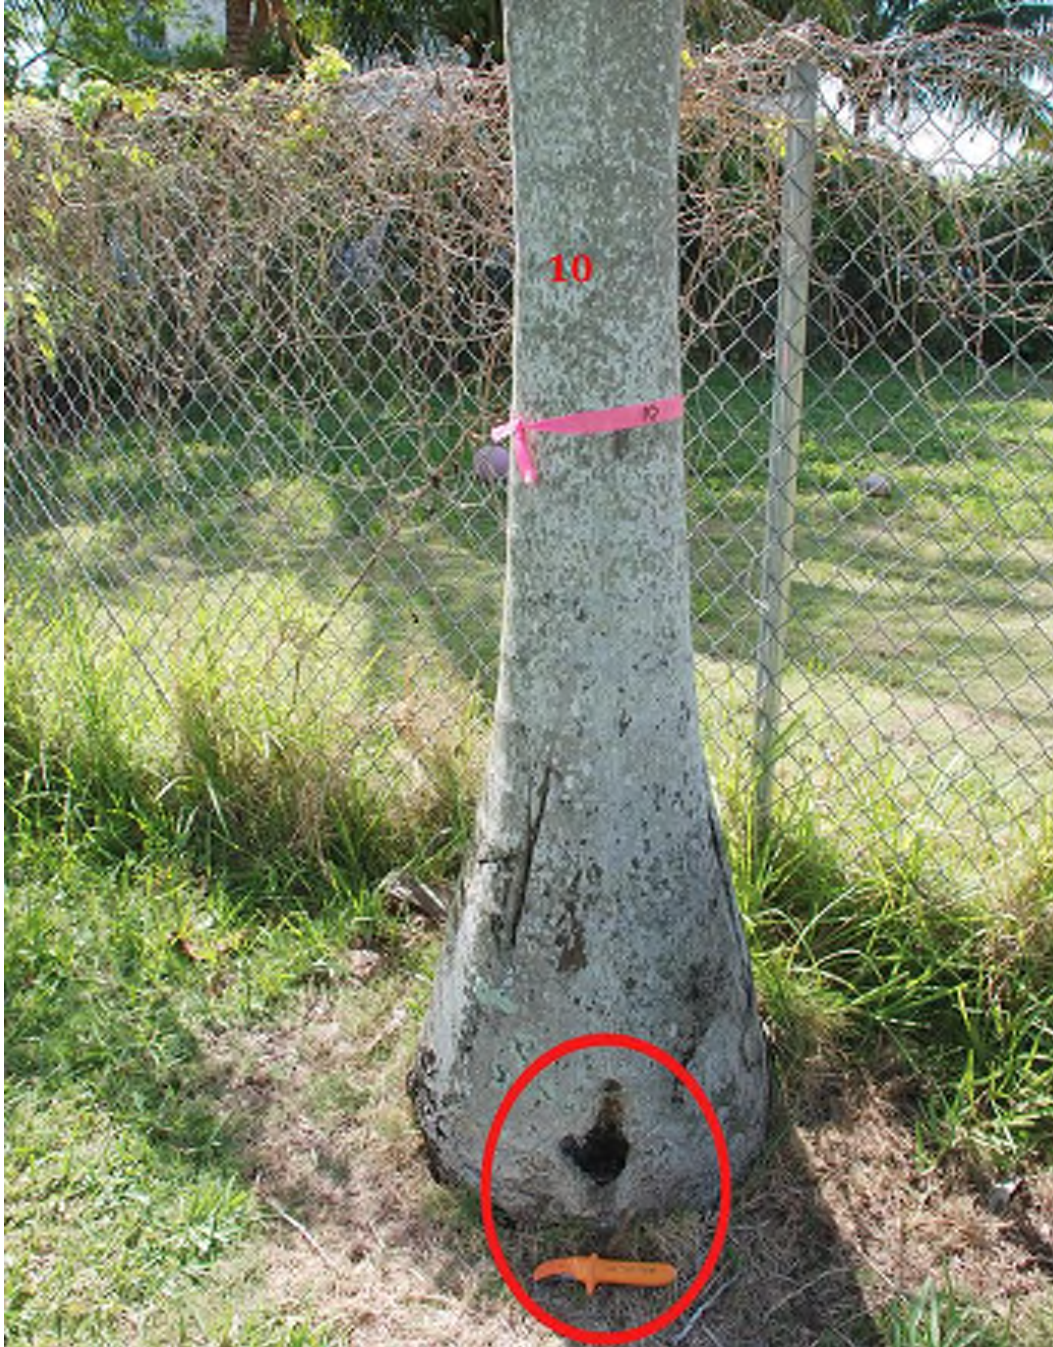
Photo 6 above the trunk of palm 10 with a small cavity indicated. This is not affecting the palm's vascular system or structural integrity. The orange knife is 7 inches in length.

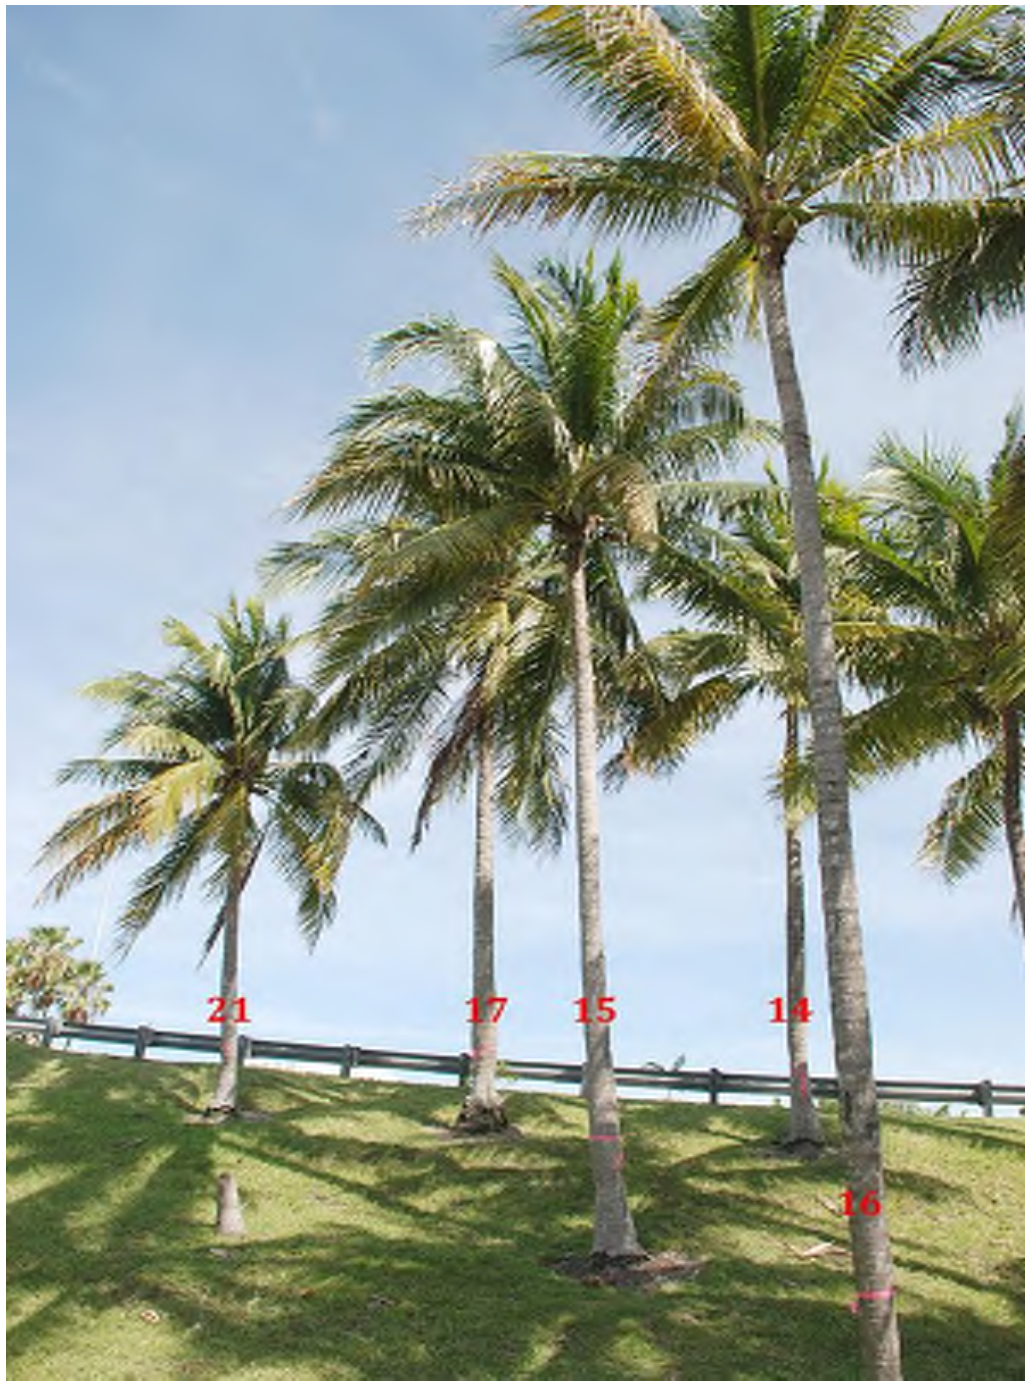
Photo 10 above is palms 14, 15, 16, 17 & 21.

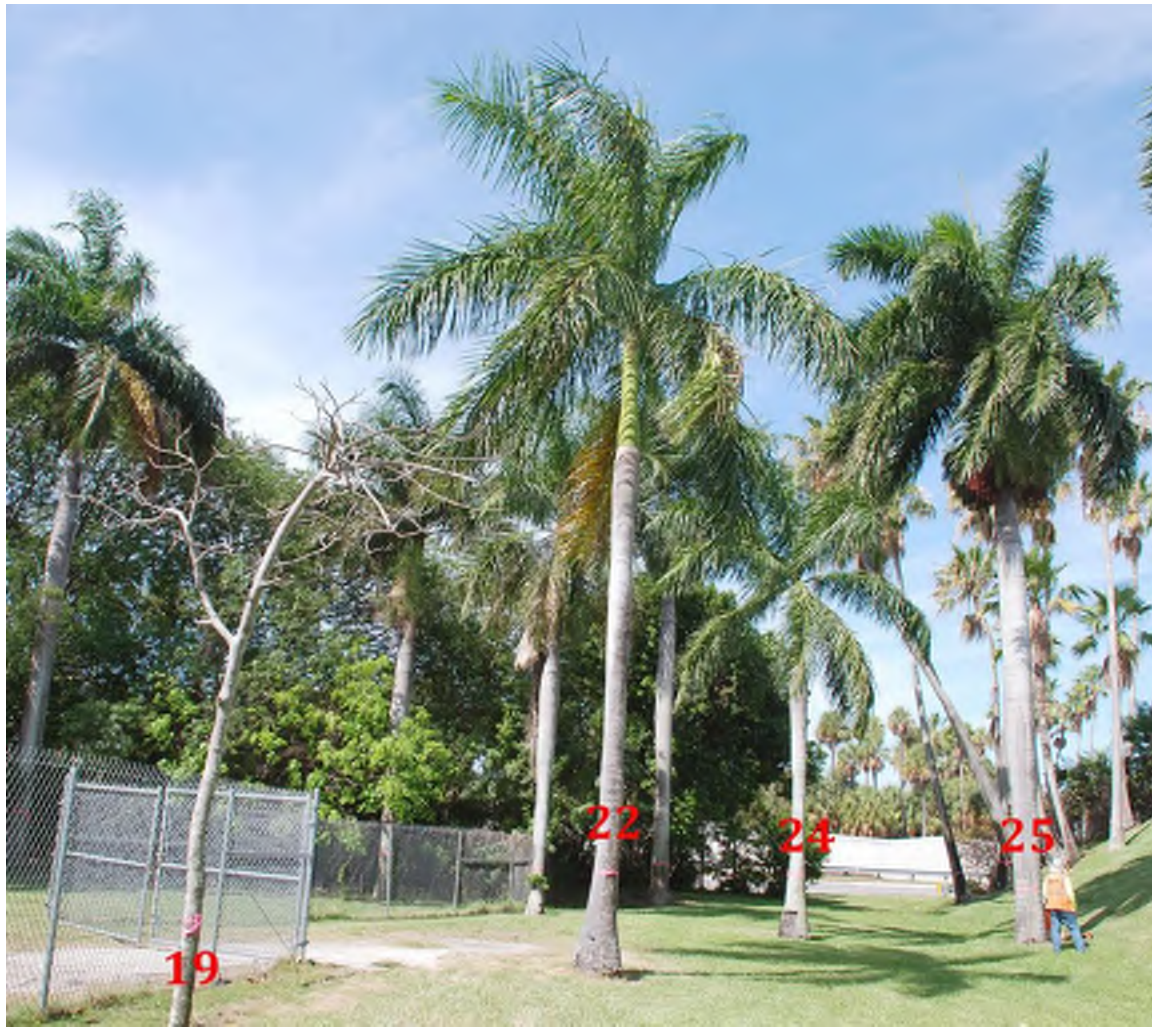
Photo 11 above is palms 22, 24 & 25.

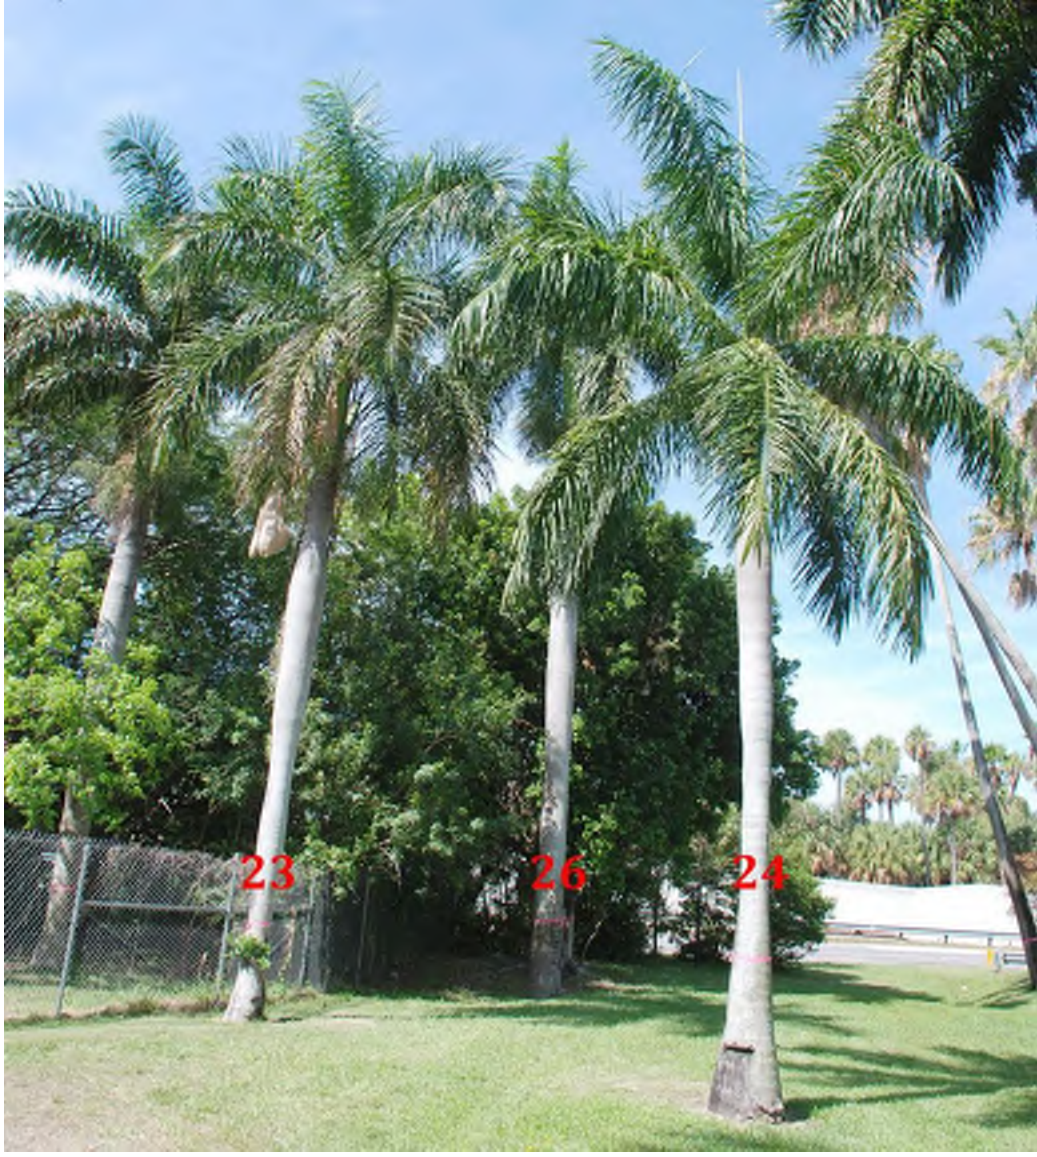
Photo 12 above is palms 23, 24 & 26.

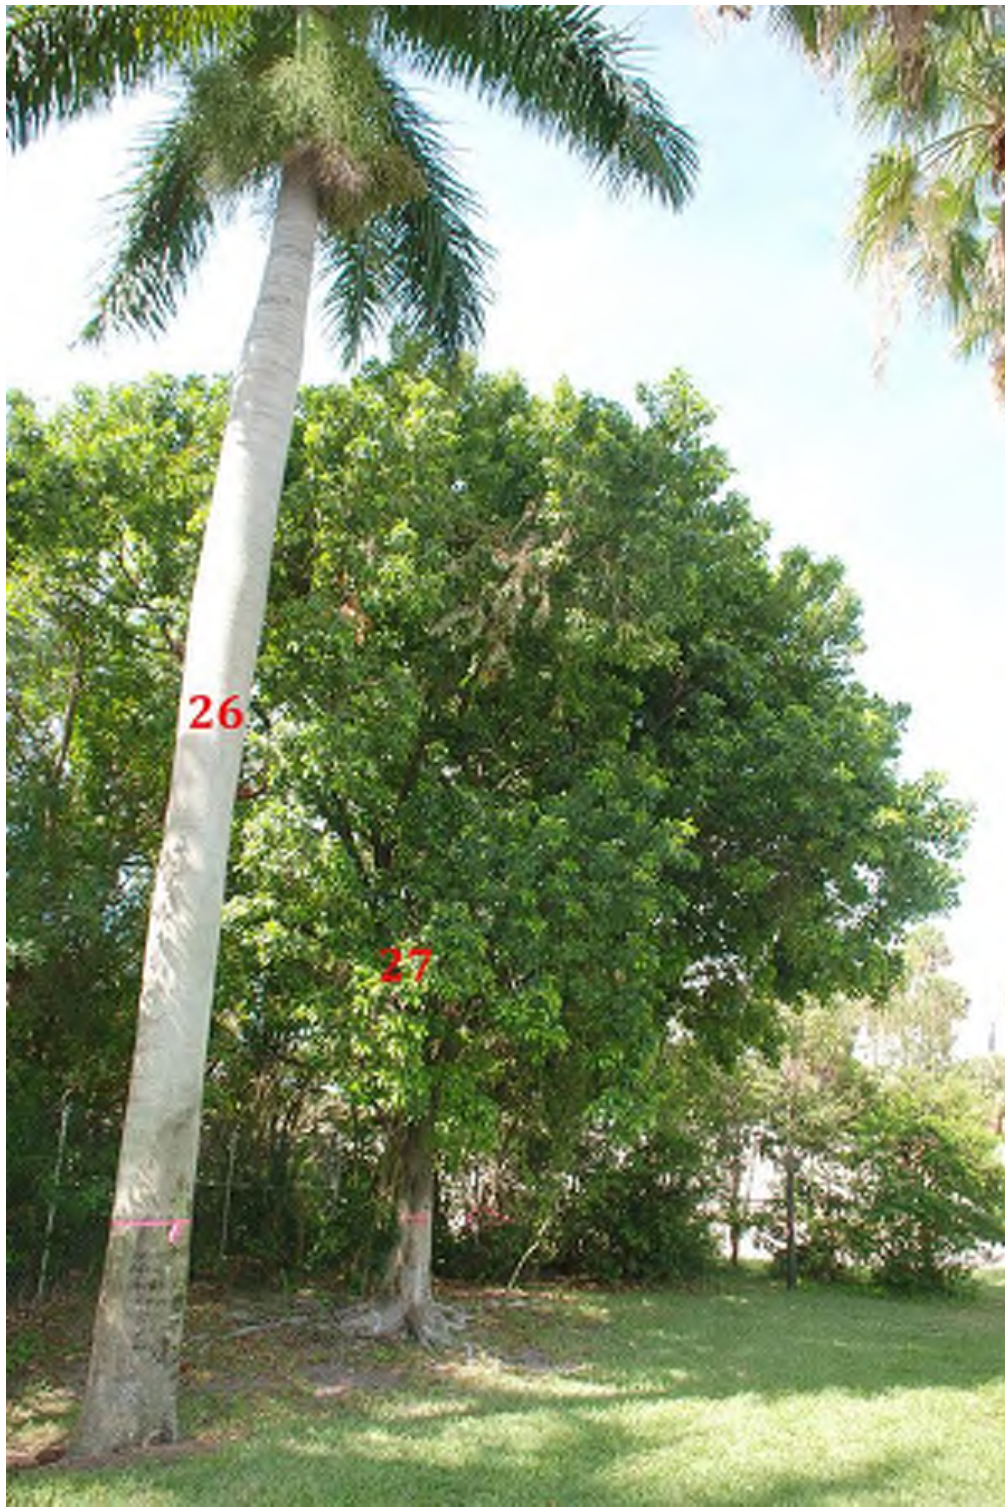
Photo 14 above is palm 26 & tree 27.

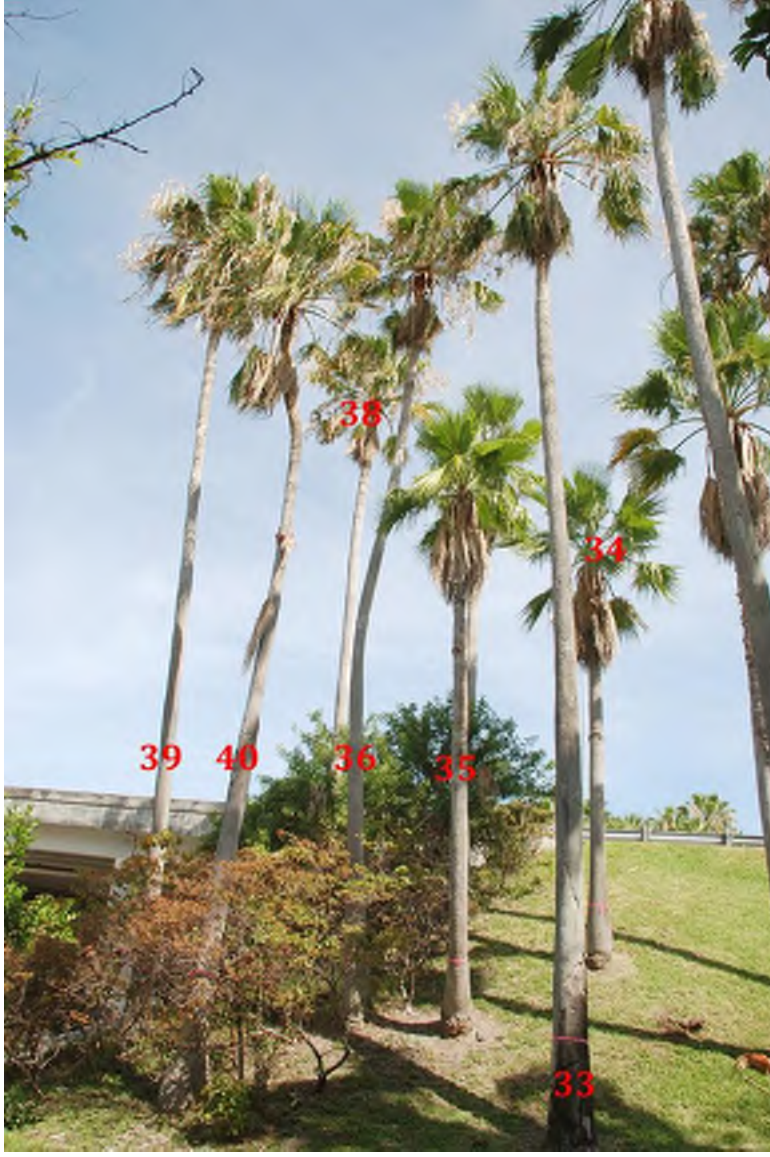
Photo 17 above is palms 33, 34, 35, 36, 39 & 40.

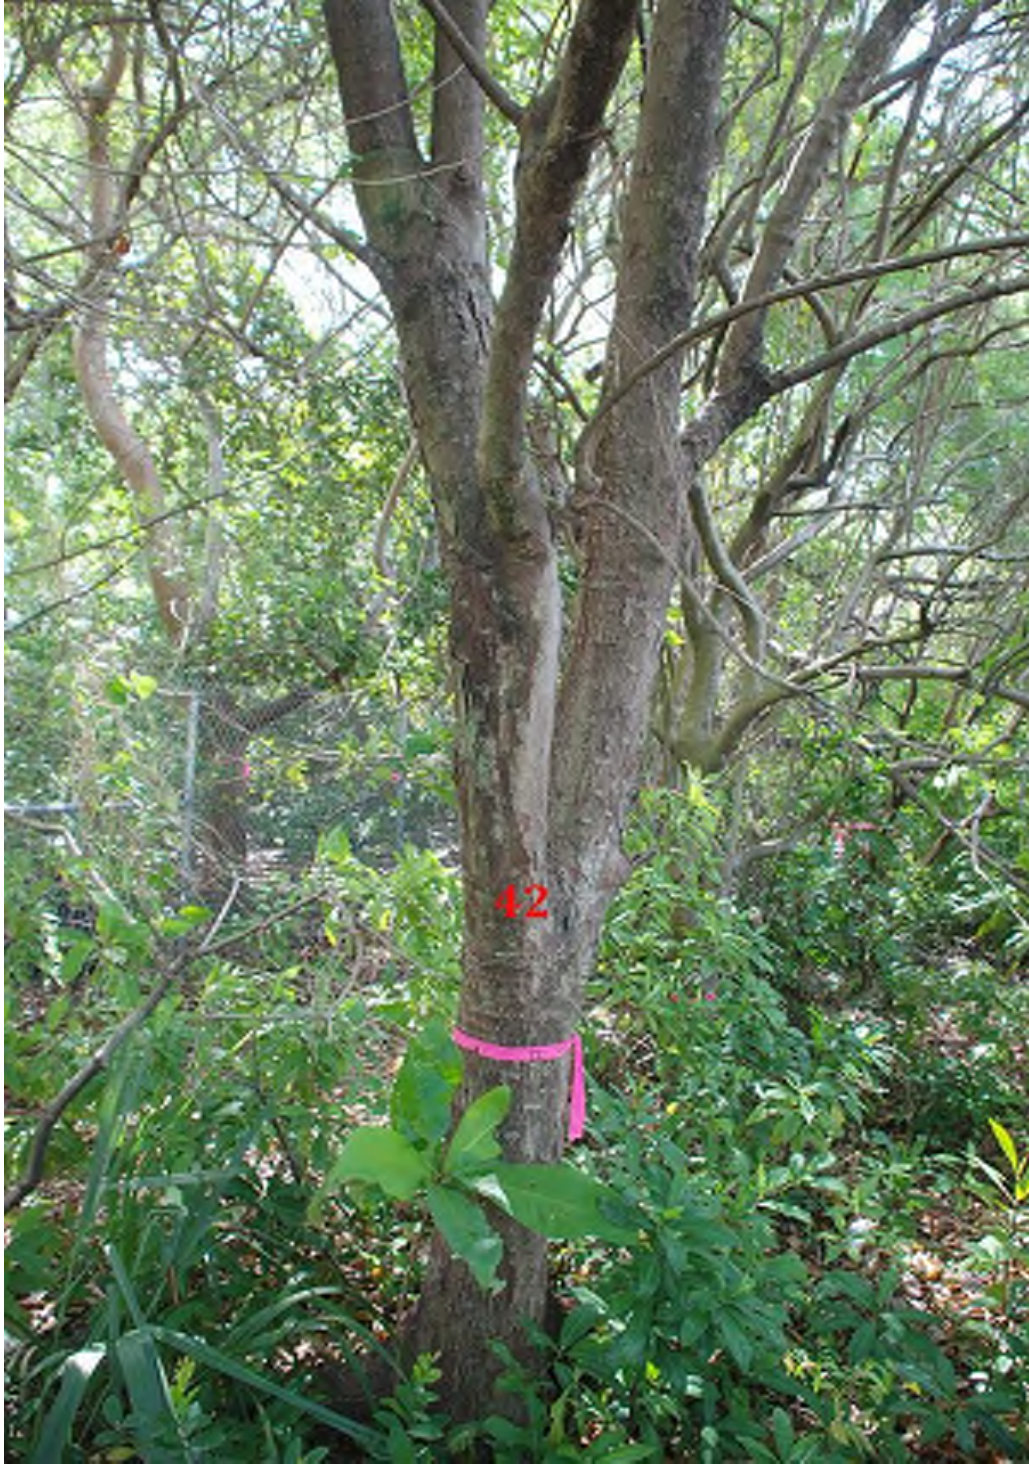
Photo 18 above is the trunk of tree 42.

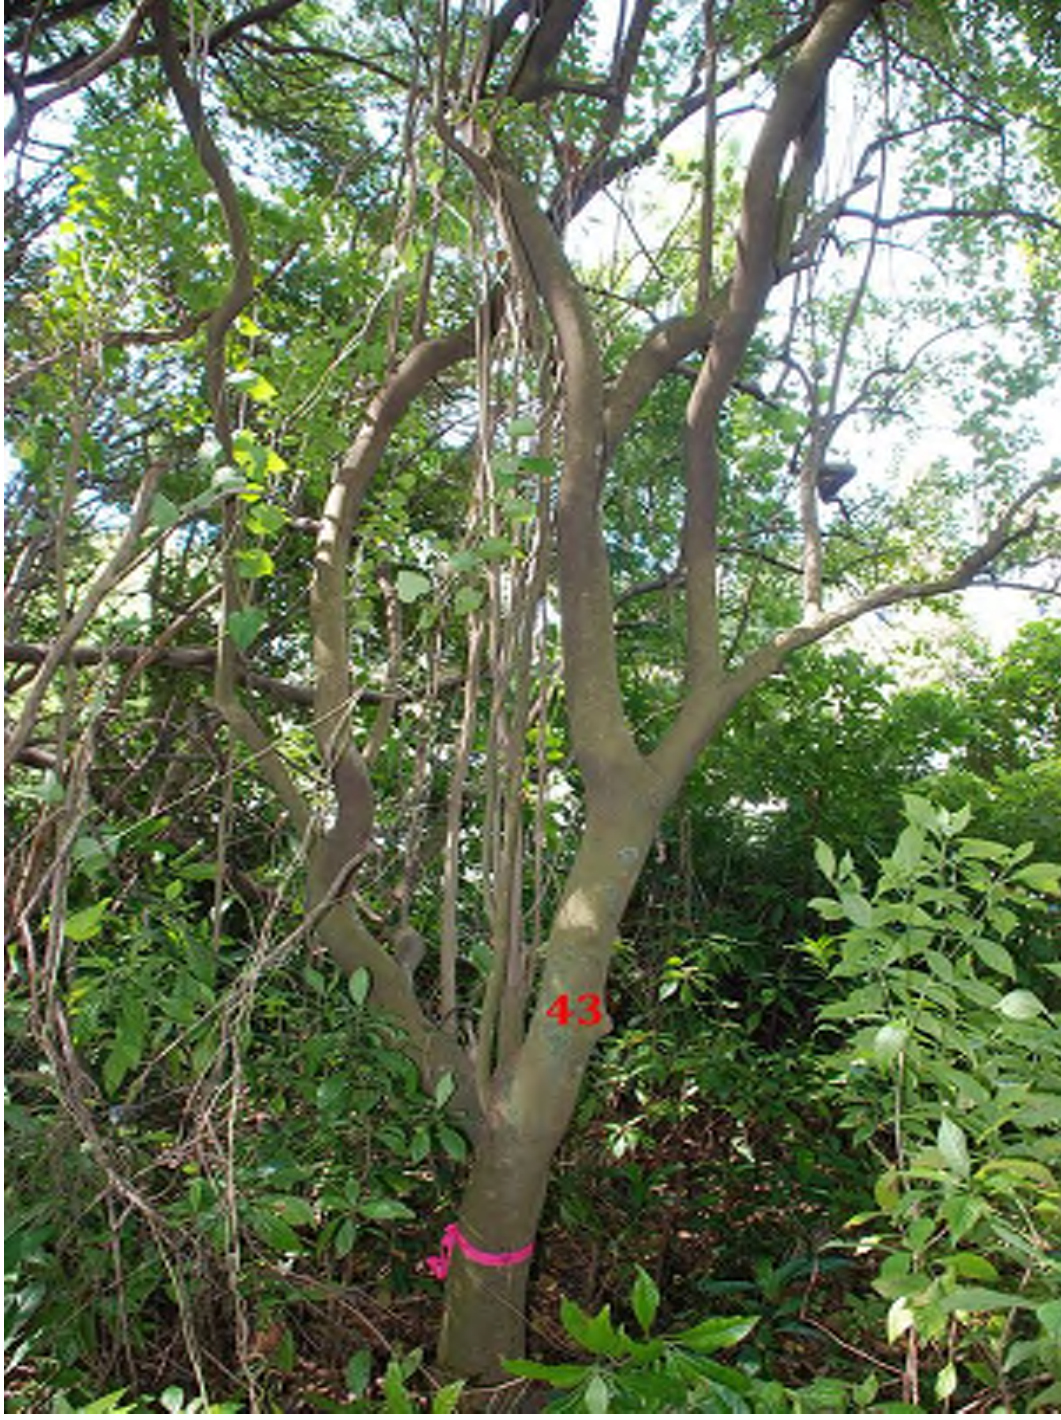
Photo 19 above is the trunk of tree 43.

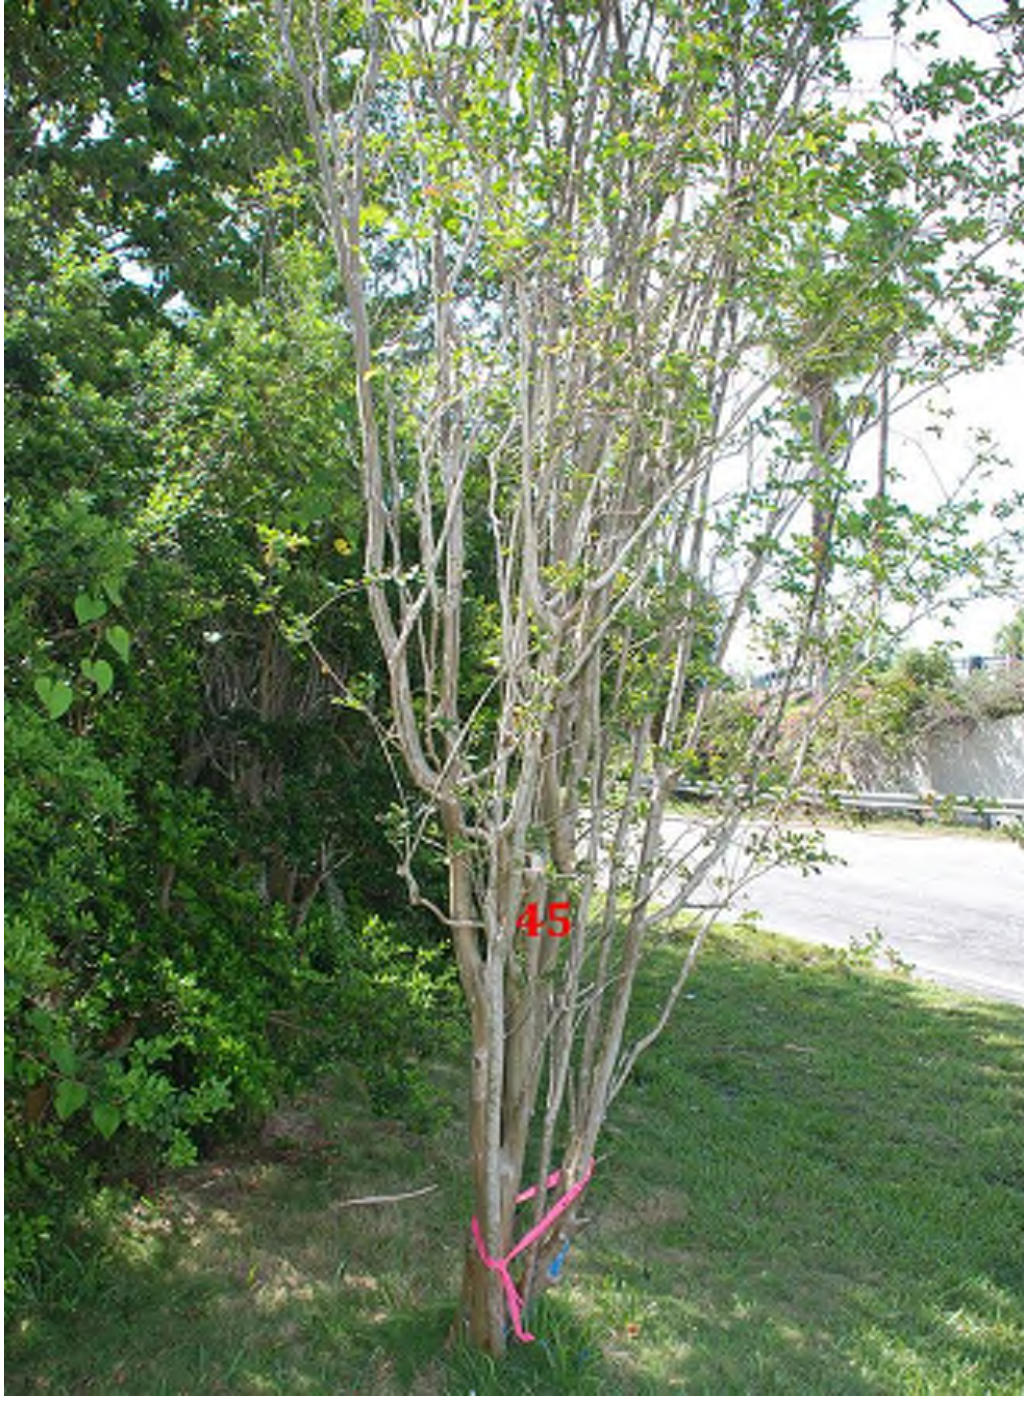
Photo 20 above is tree 45.

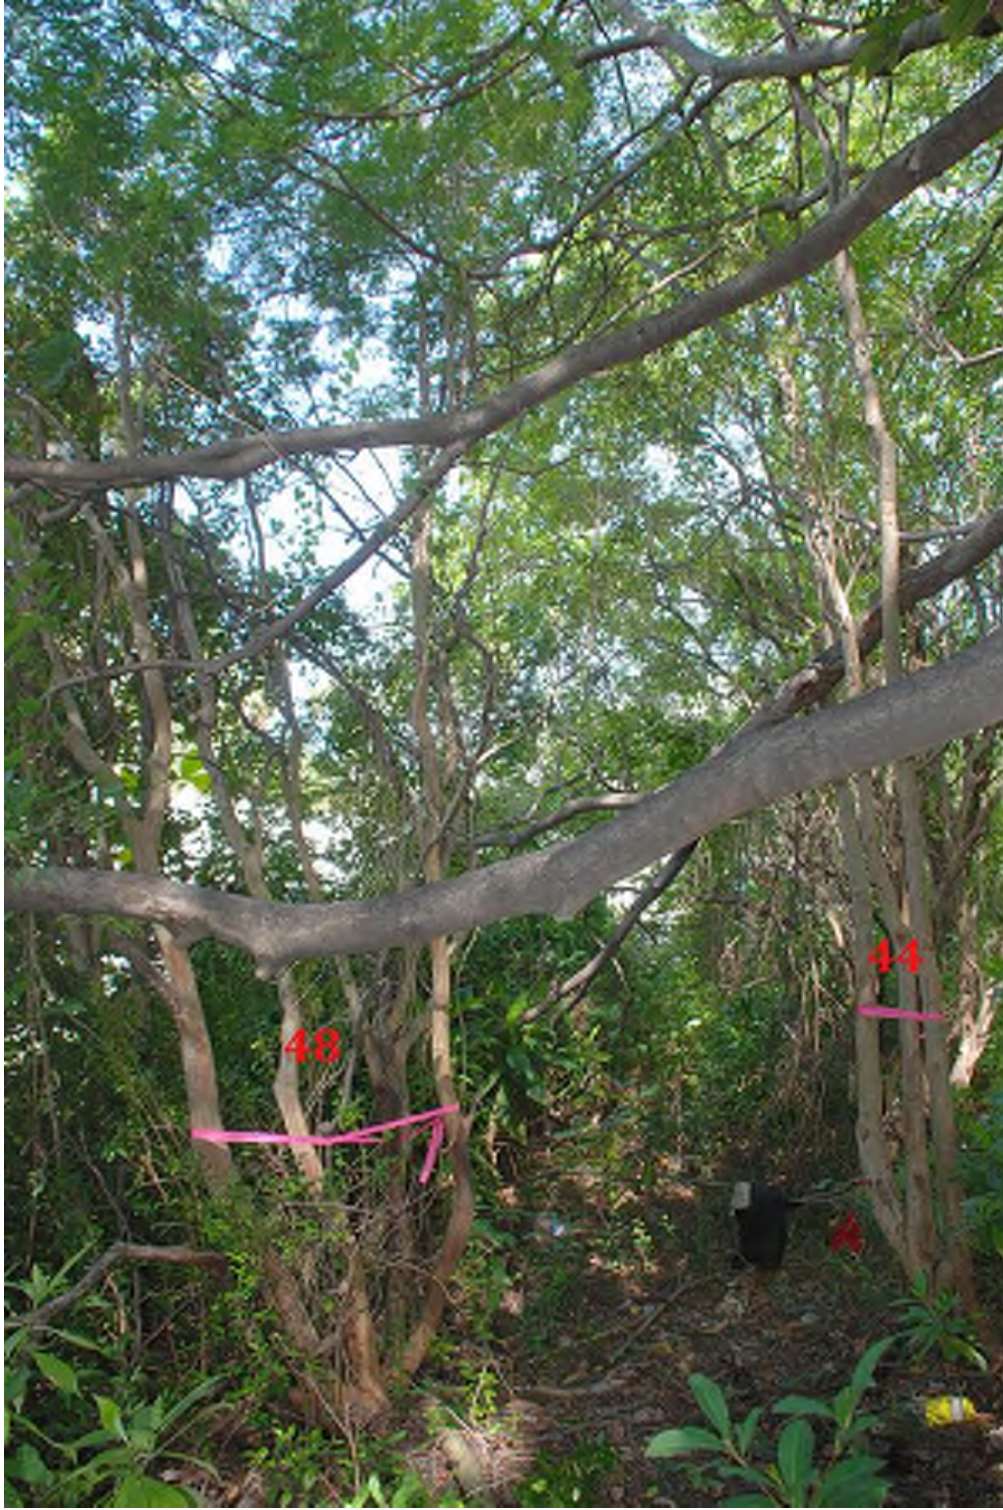
Photo 21 above is trees 44 & 48.

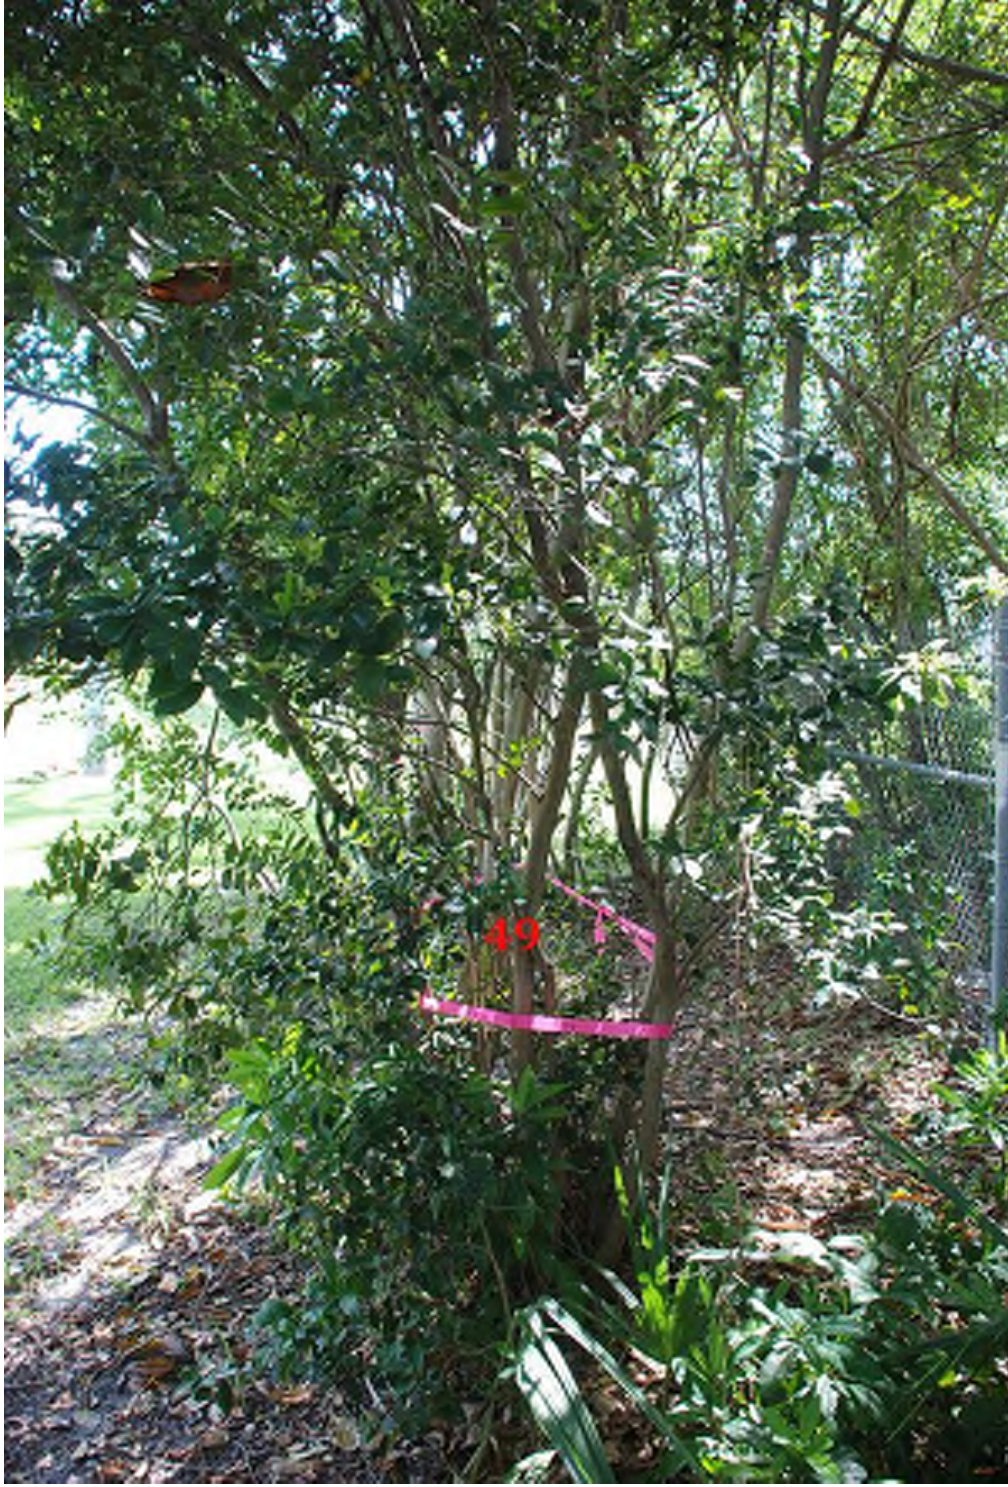
Photo 22 above is tree 49.

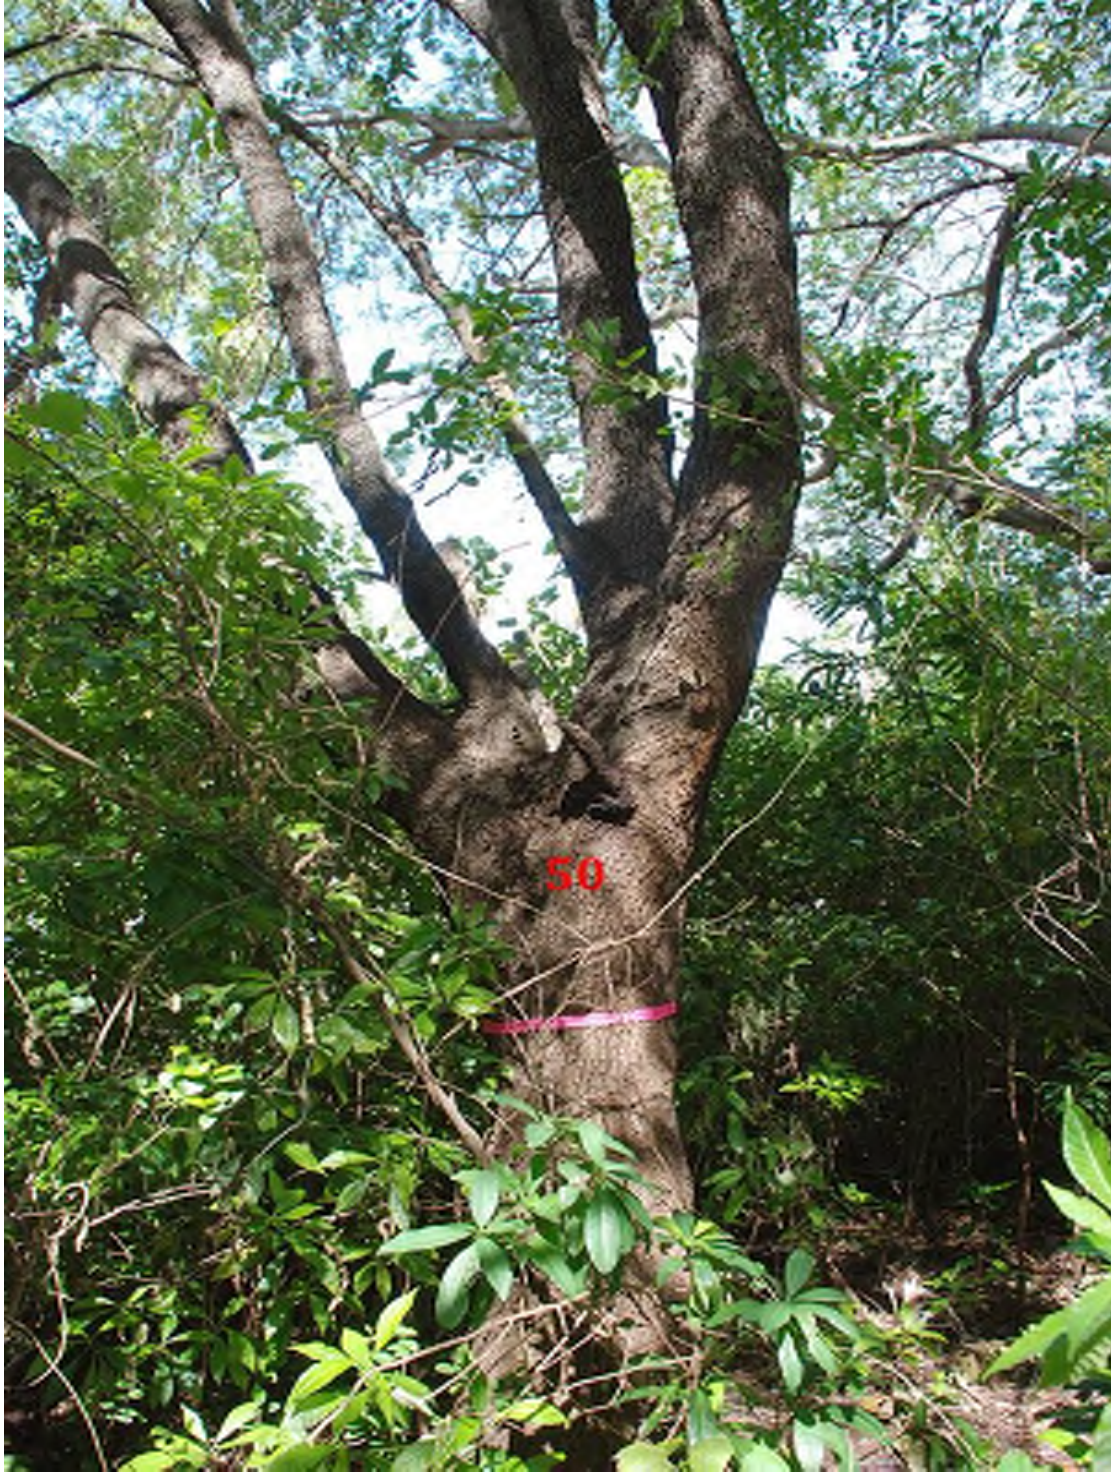
Photo 23 above is tree 50.

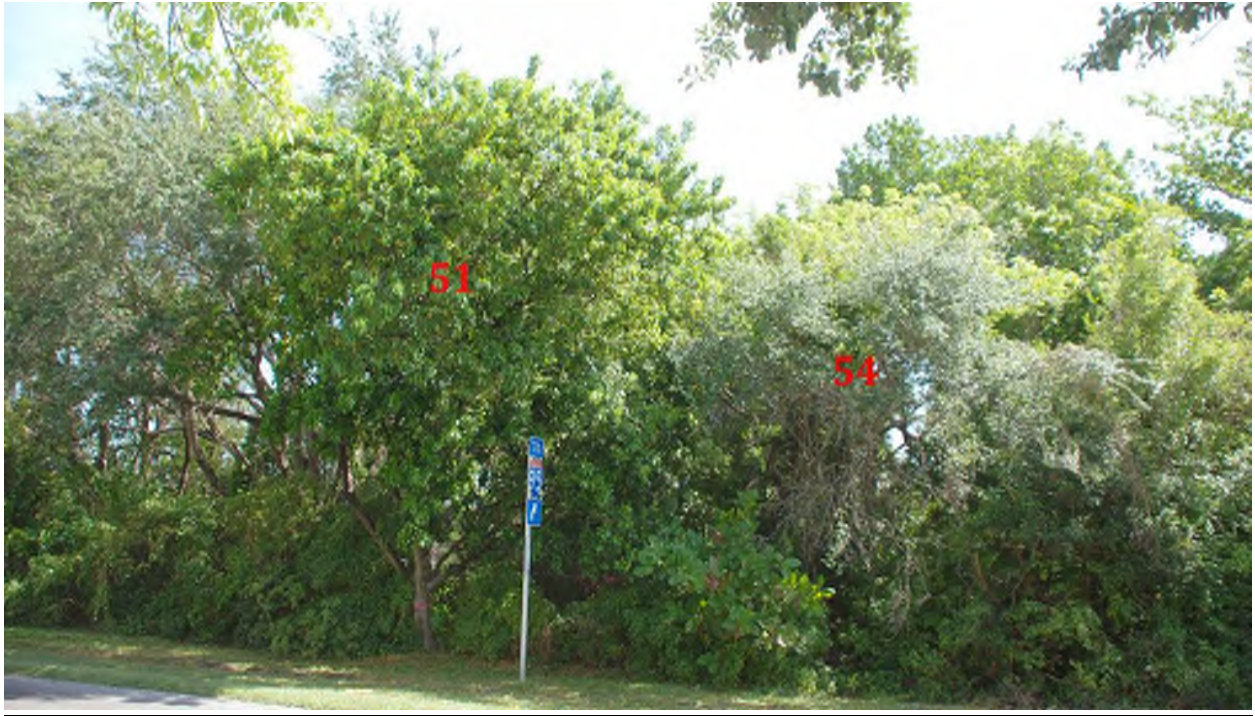
Photo 24 above is trees 51 & 54 viewed from the south.
