Tree Resource Evaluation for 4000 Alton Road, Miami Beach

May 11, 2020

I performed a tree resource evaluation on the property located at 4000 Alton Road, Miami Beach on May 2nd and 3rd 2020. The approximate locations of these trees and palms can be found on the schematic in Appendix B.

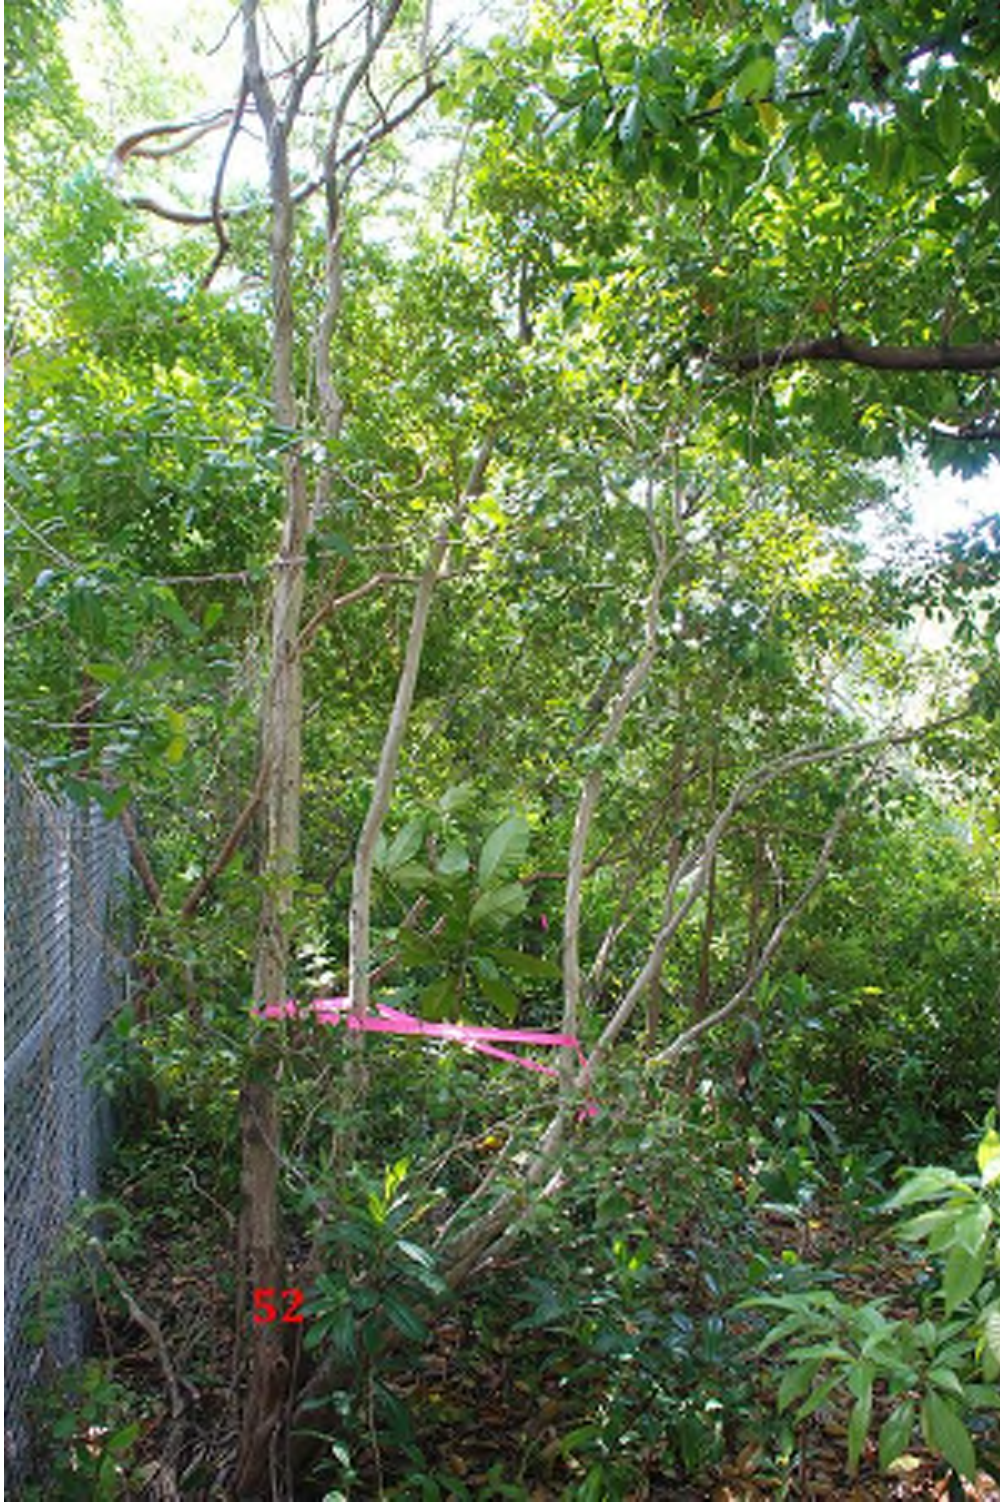
Photo 26 above is tree 52.

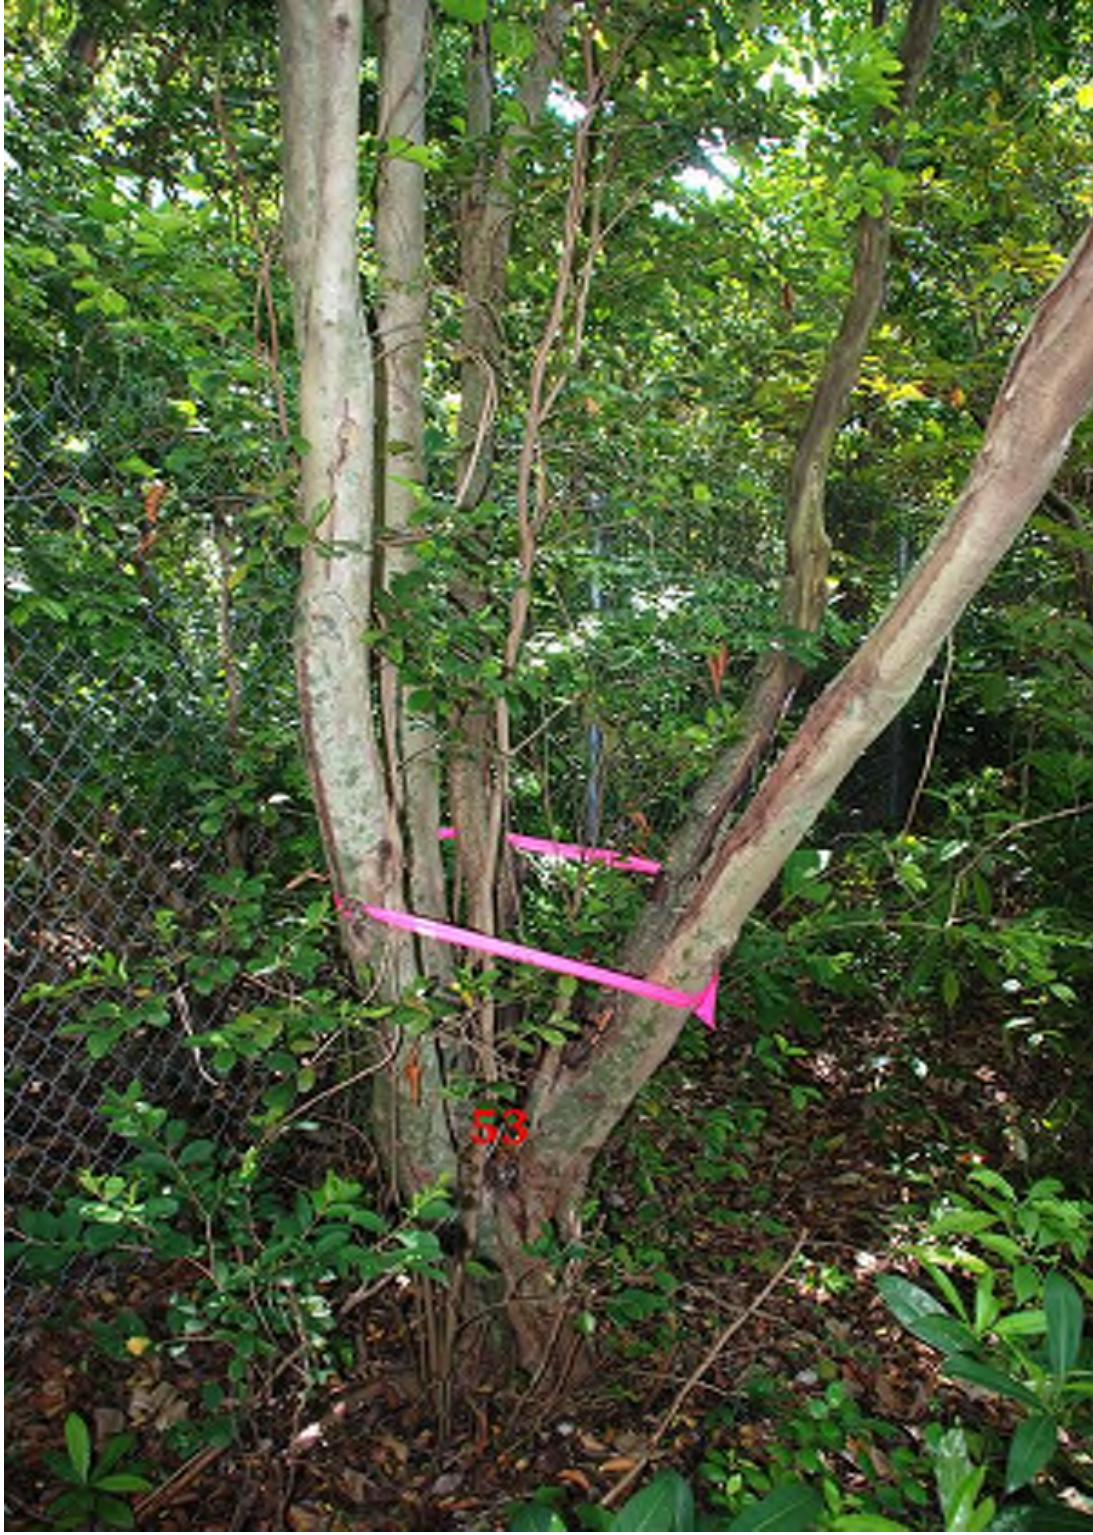
Photo 27 above is tree 53.

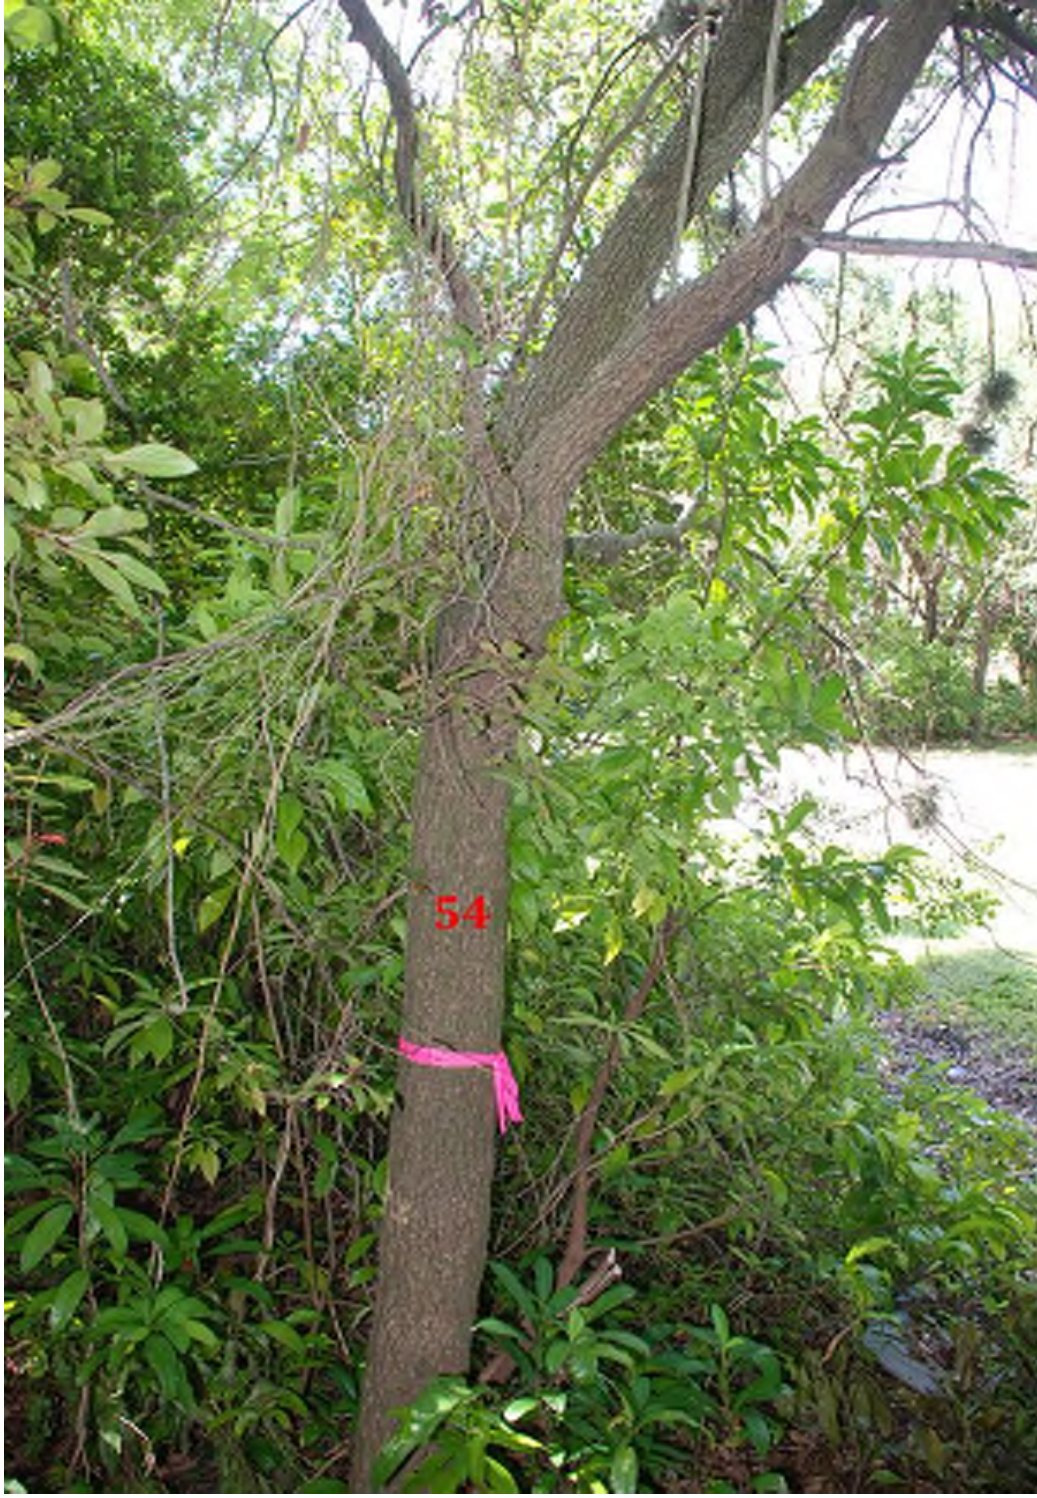
Photo 28 above is tree 54.

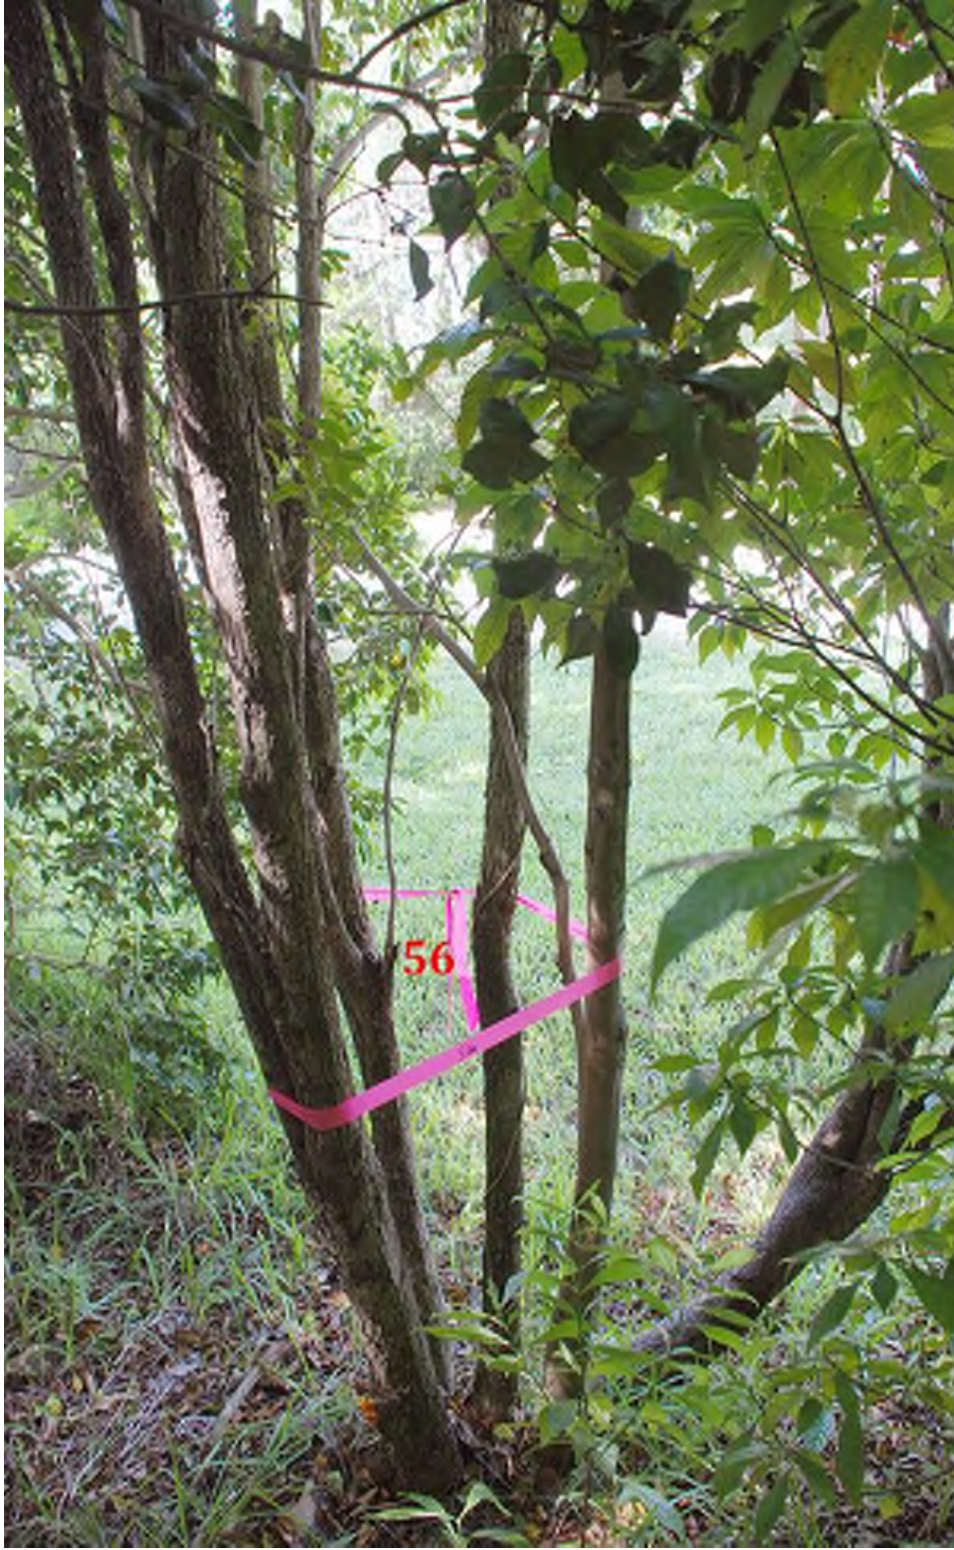
Photo 29 above is tree 56.

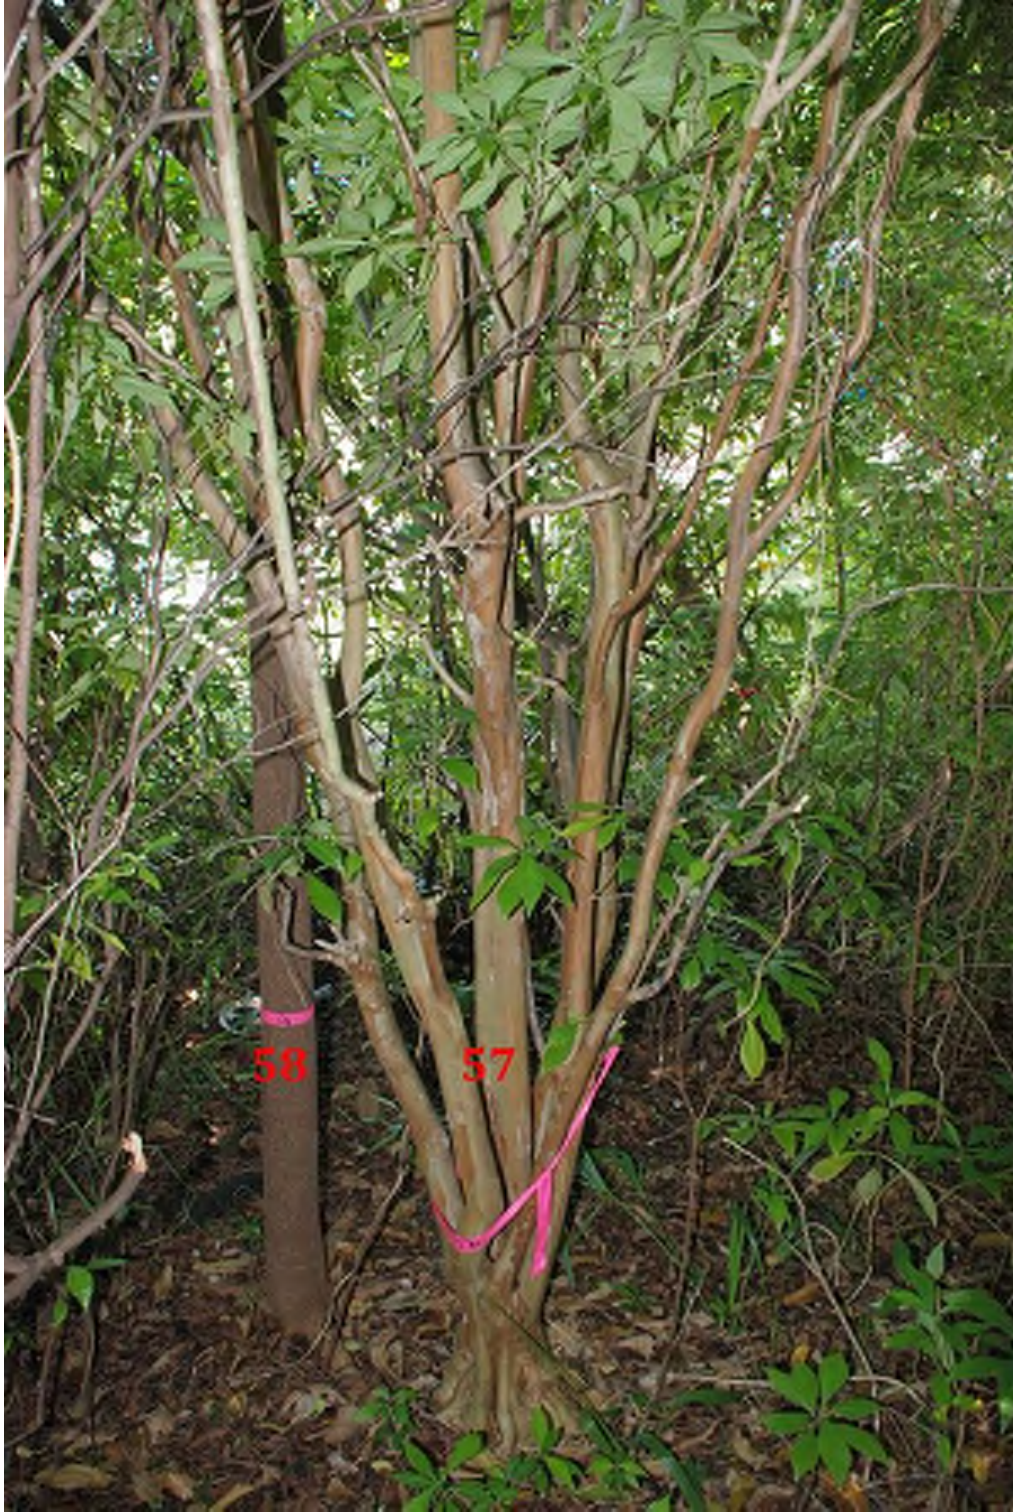
Photo 30 above is trees 57 & 58.

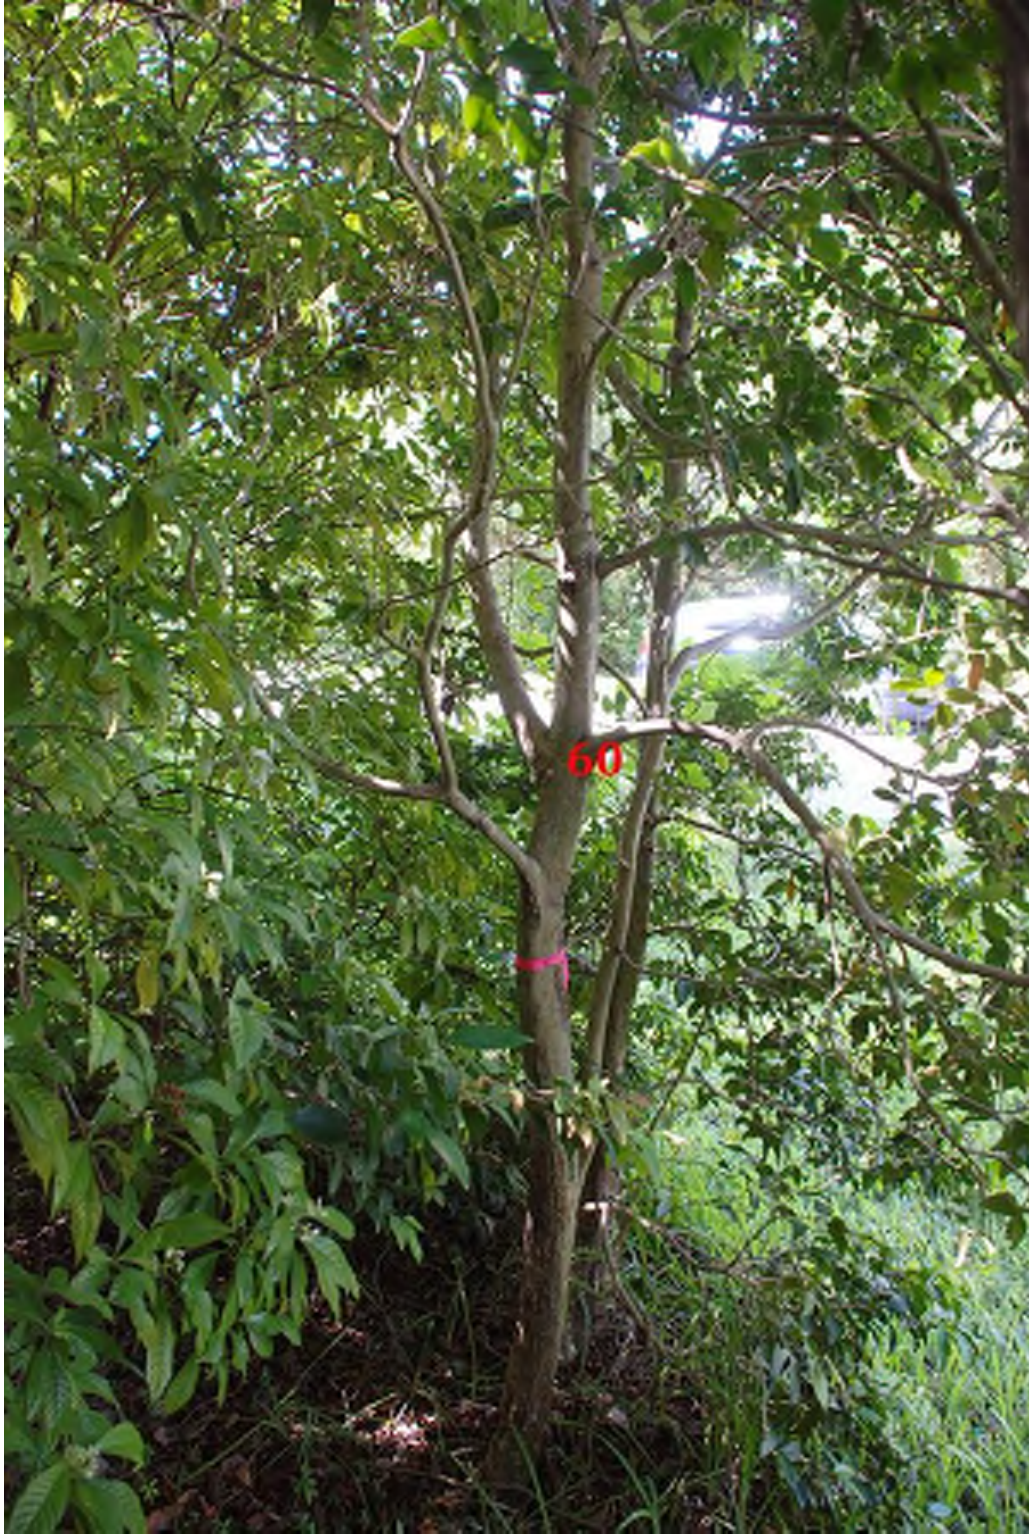
Photo 31 above is tree 60.

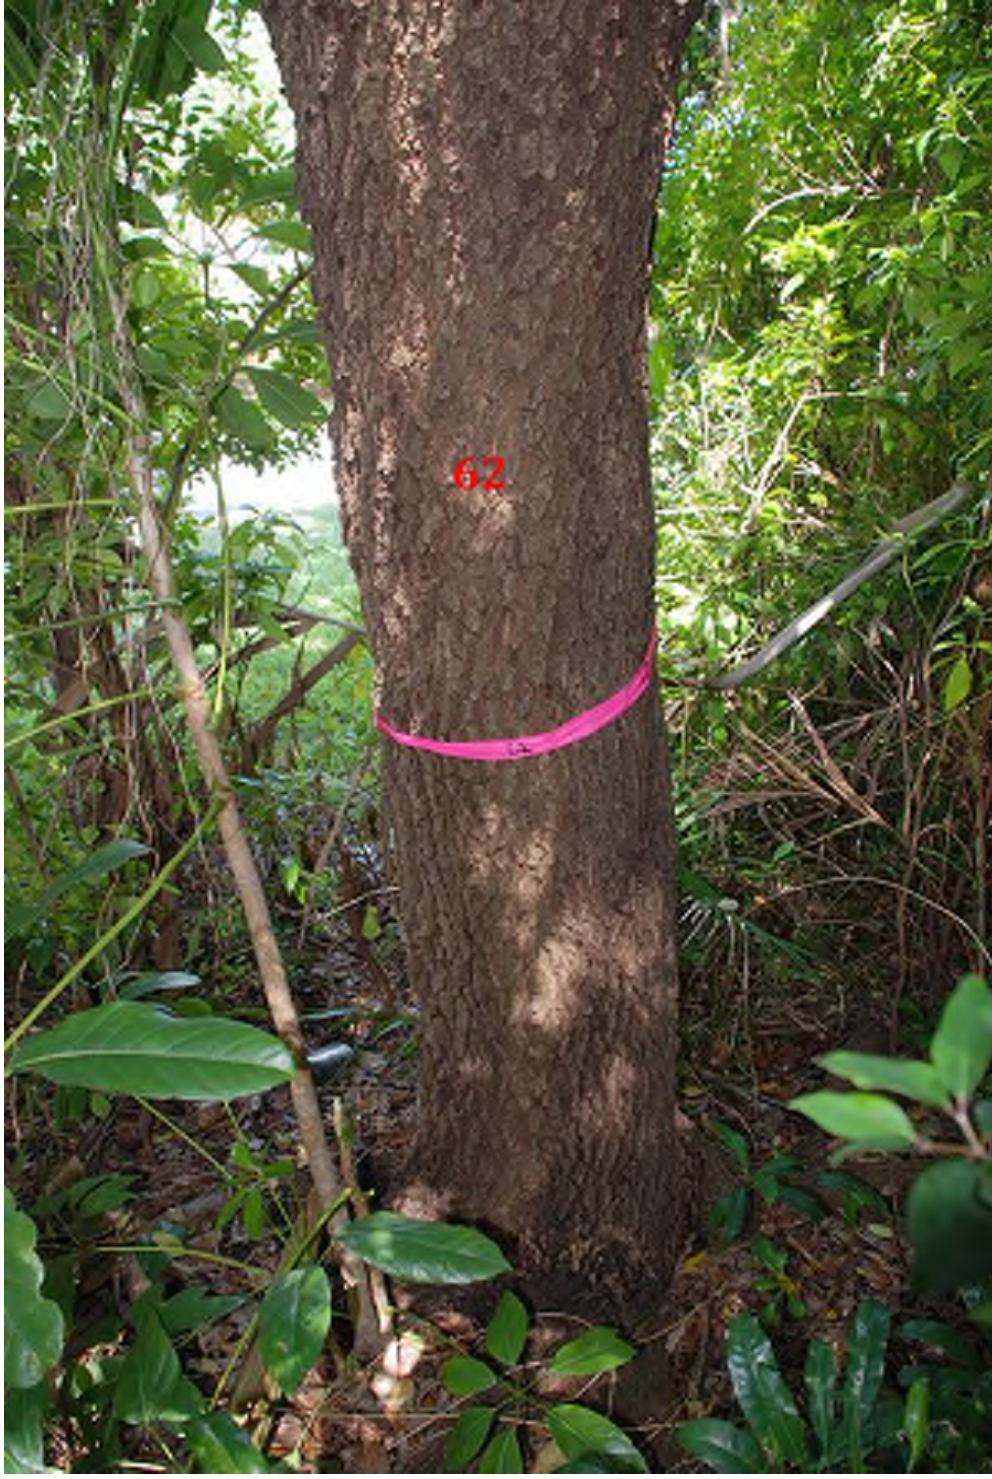
Photo 32 above is tree 62 with no signs of decay or cavities on the trunk or root collar.

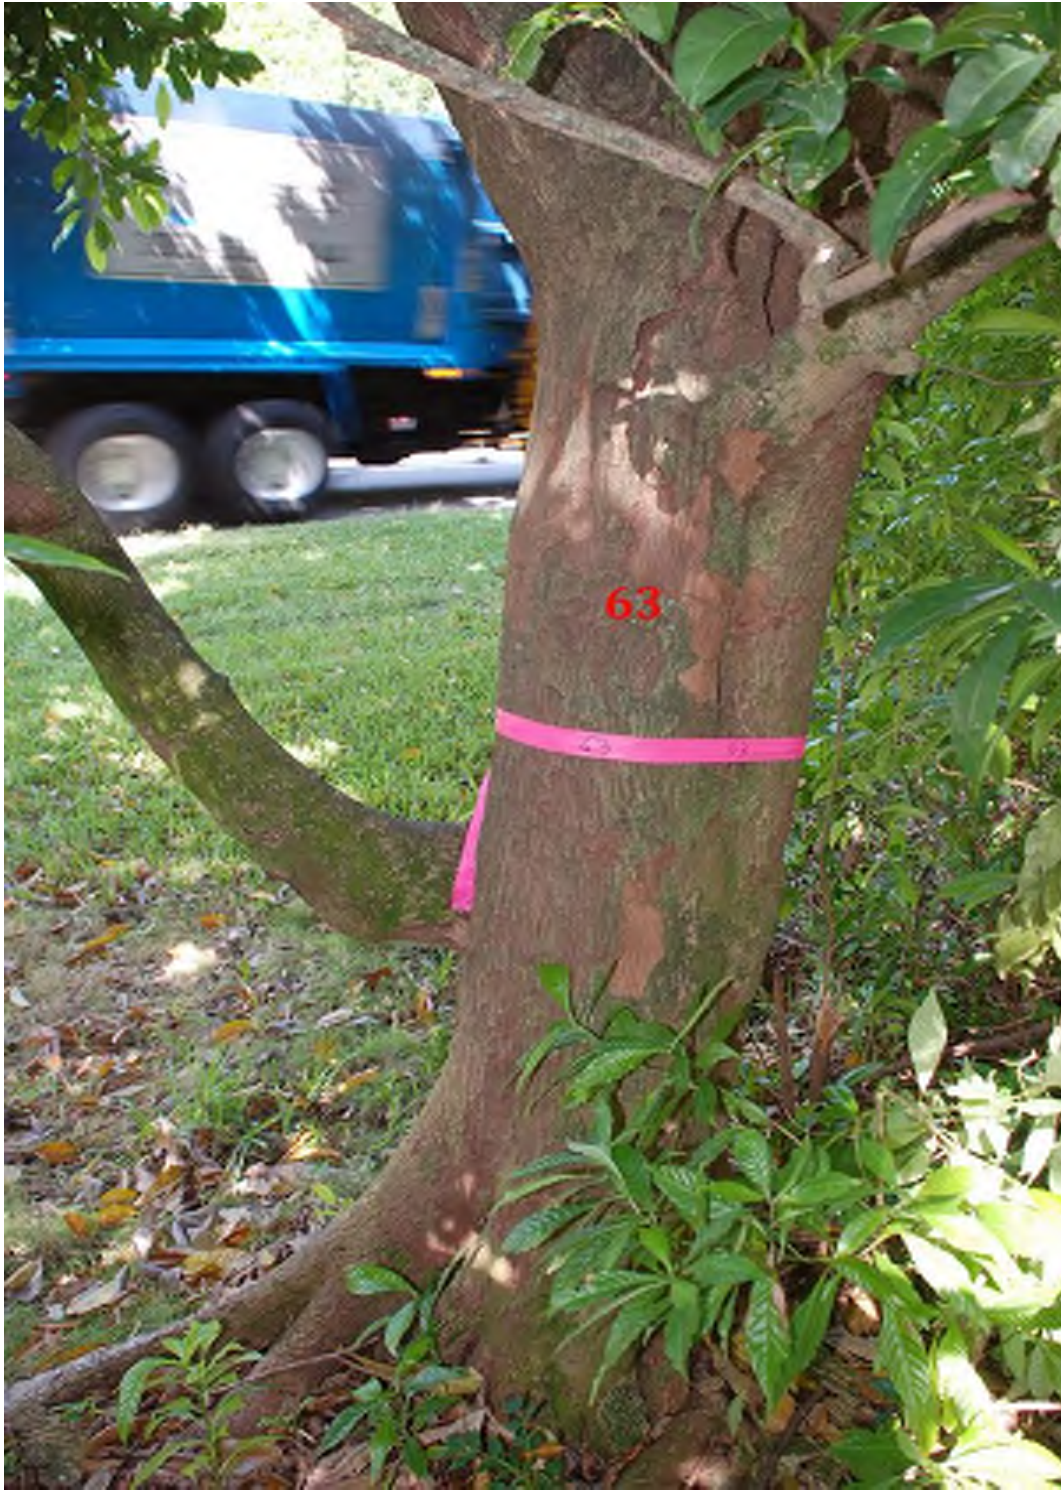
Photo 33 above is tree 63 with no signs of decay or cavities on the trunk or root collar.

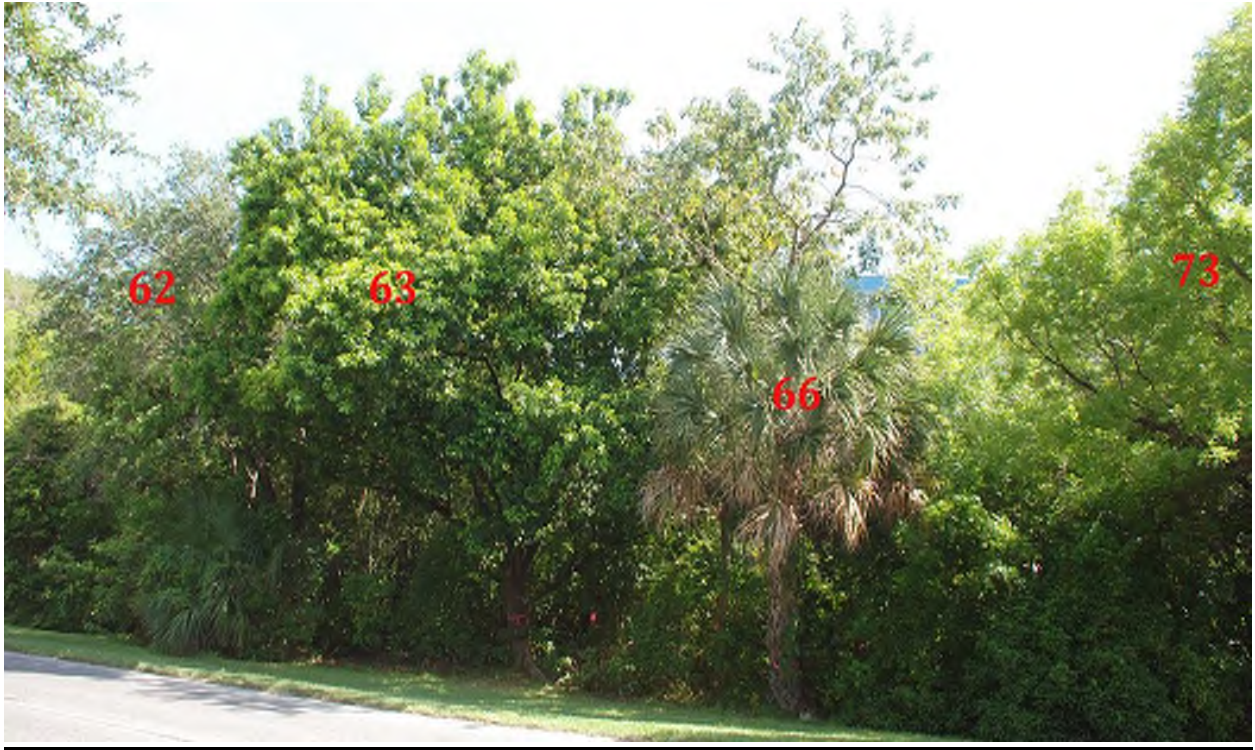
Photo 34 above is trees 62, 63, 73, and palm 66.

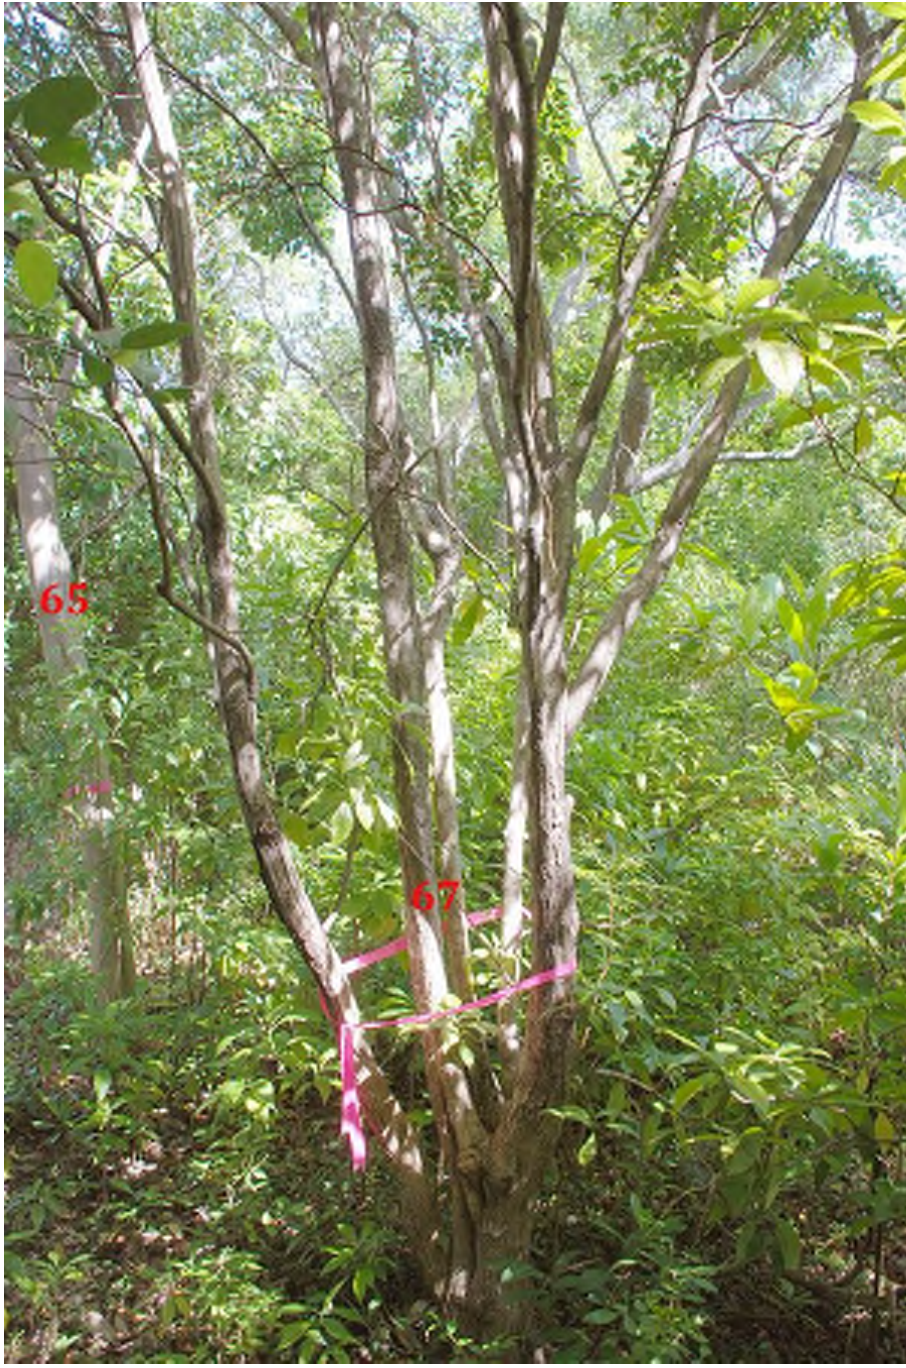
Photo 36 above is tree 67.

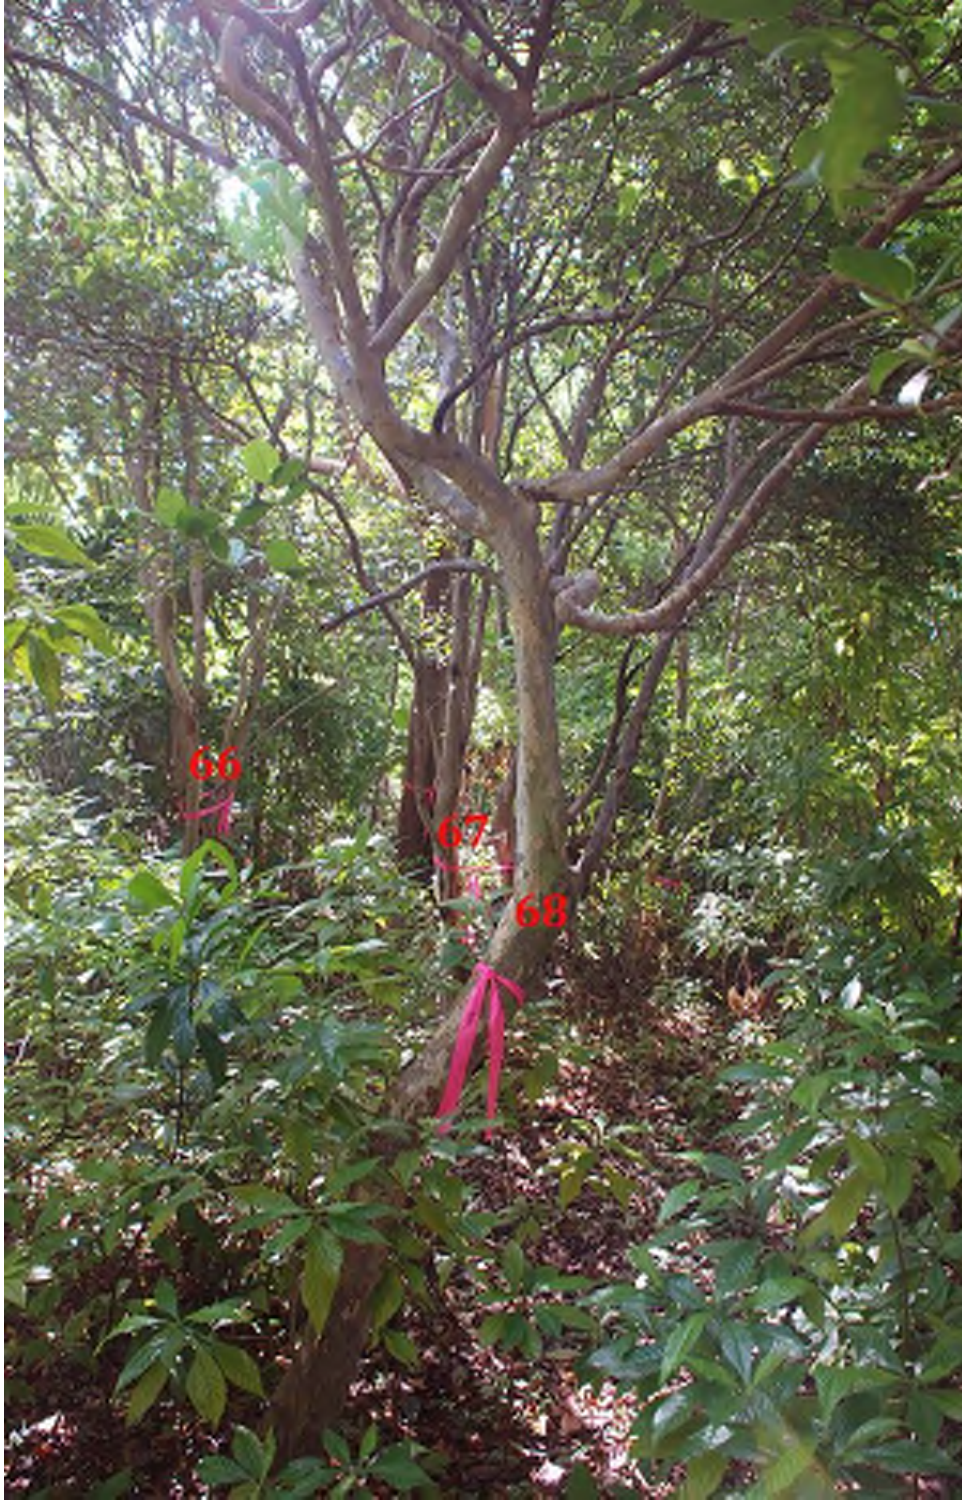
Photo 37 above is trees 66, 67 & 68.

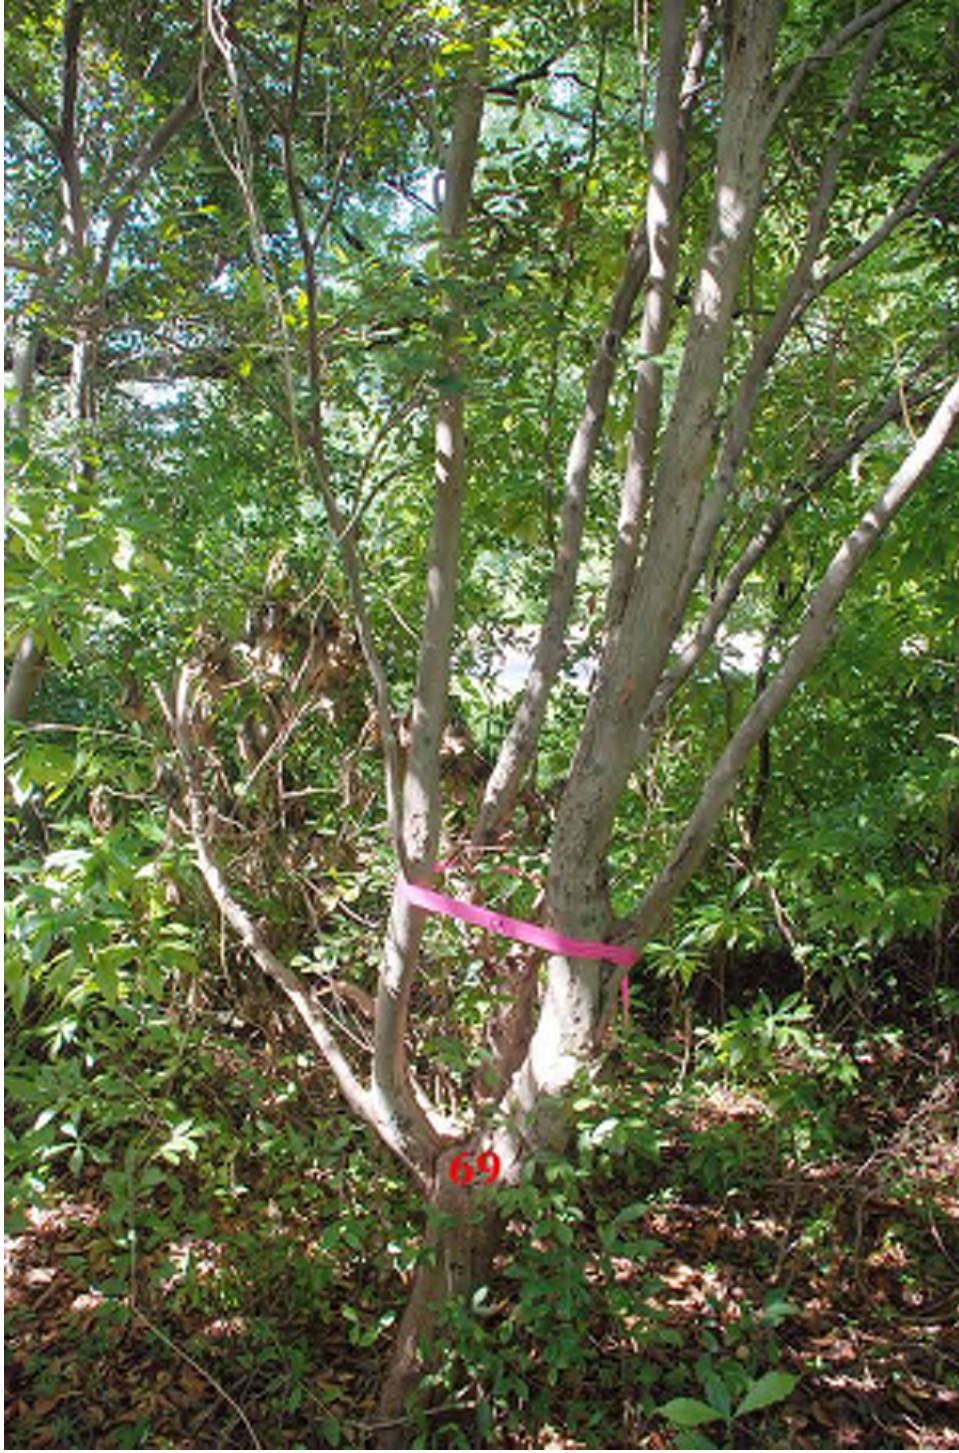
Photo 38 above is tree 69.

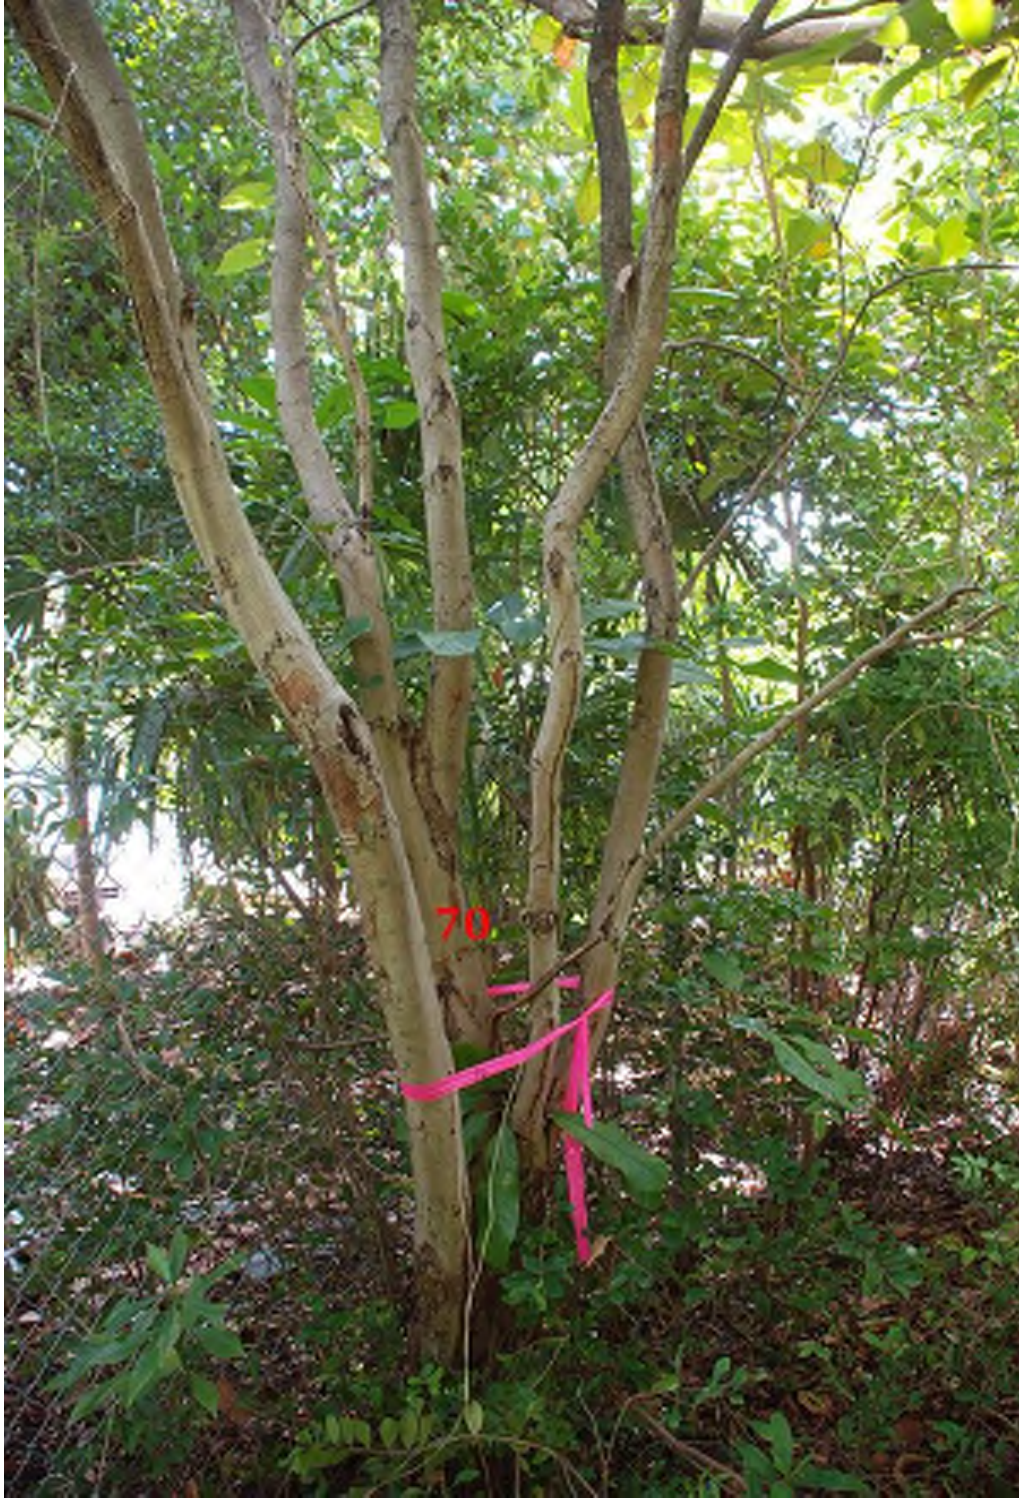
Photo 39 above is tree 70.

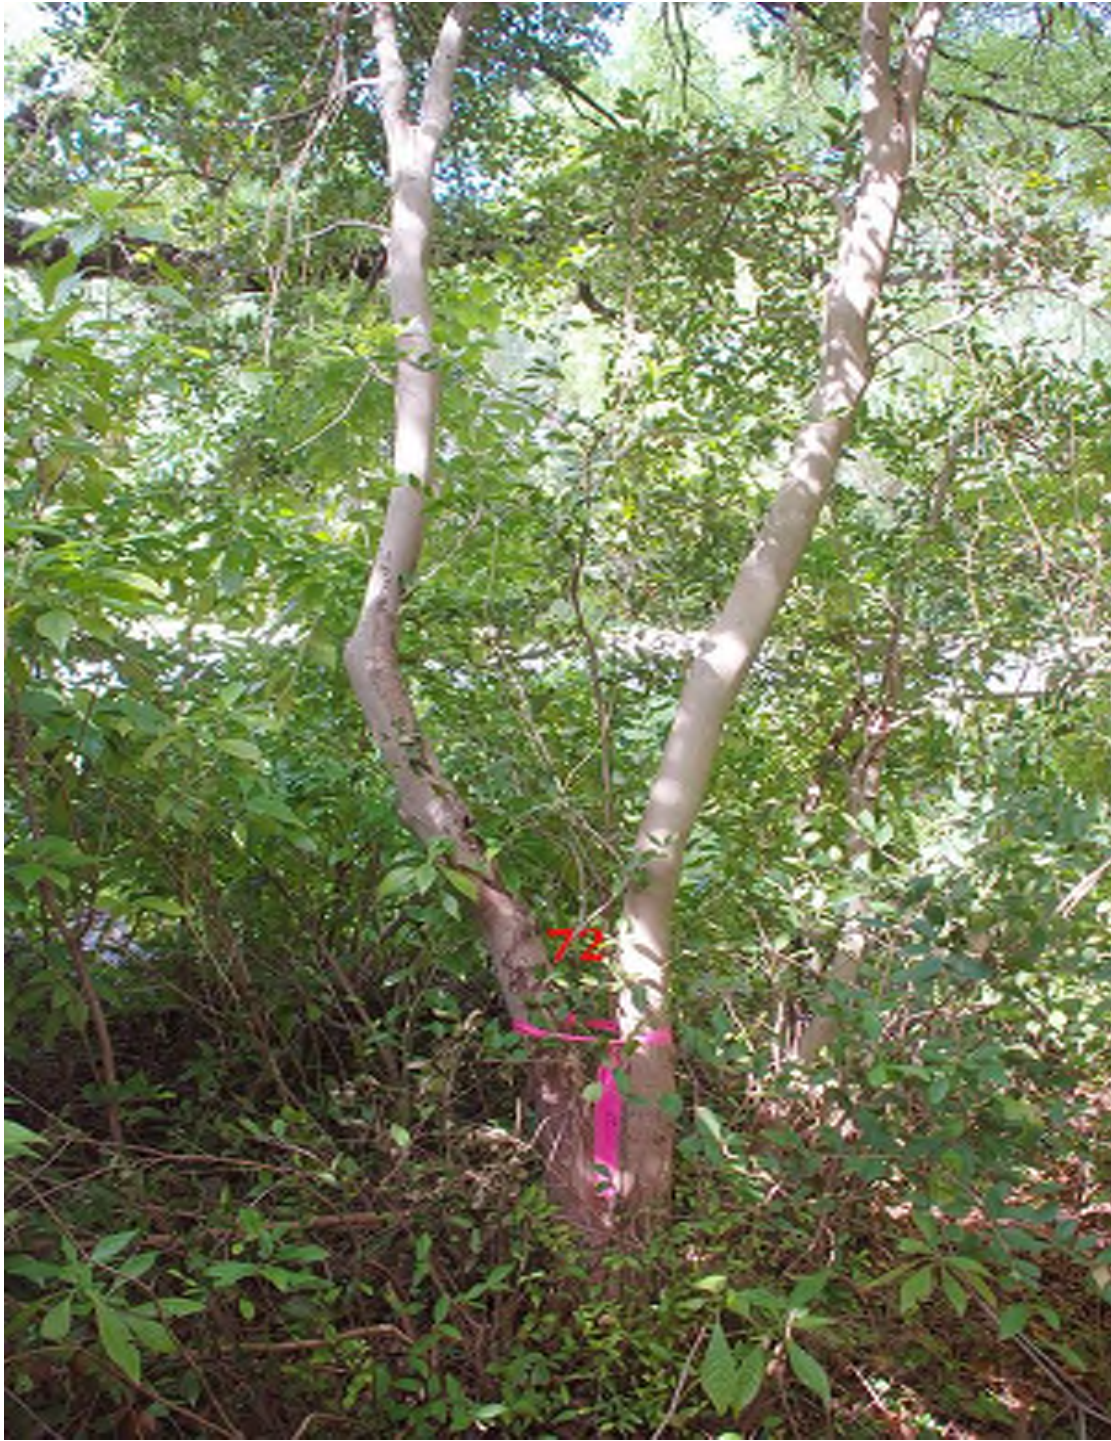
Photo 41 above is tree 72.

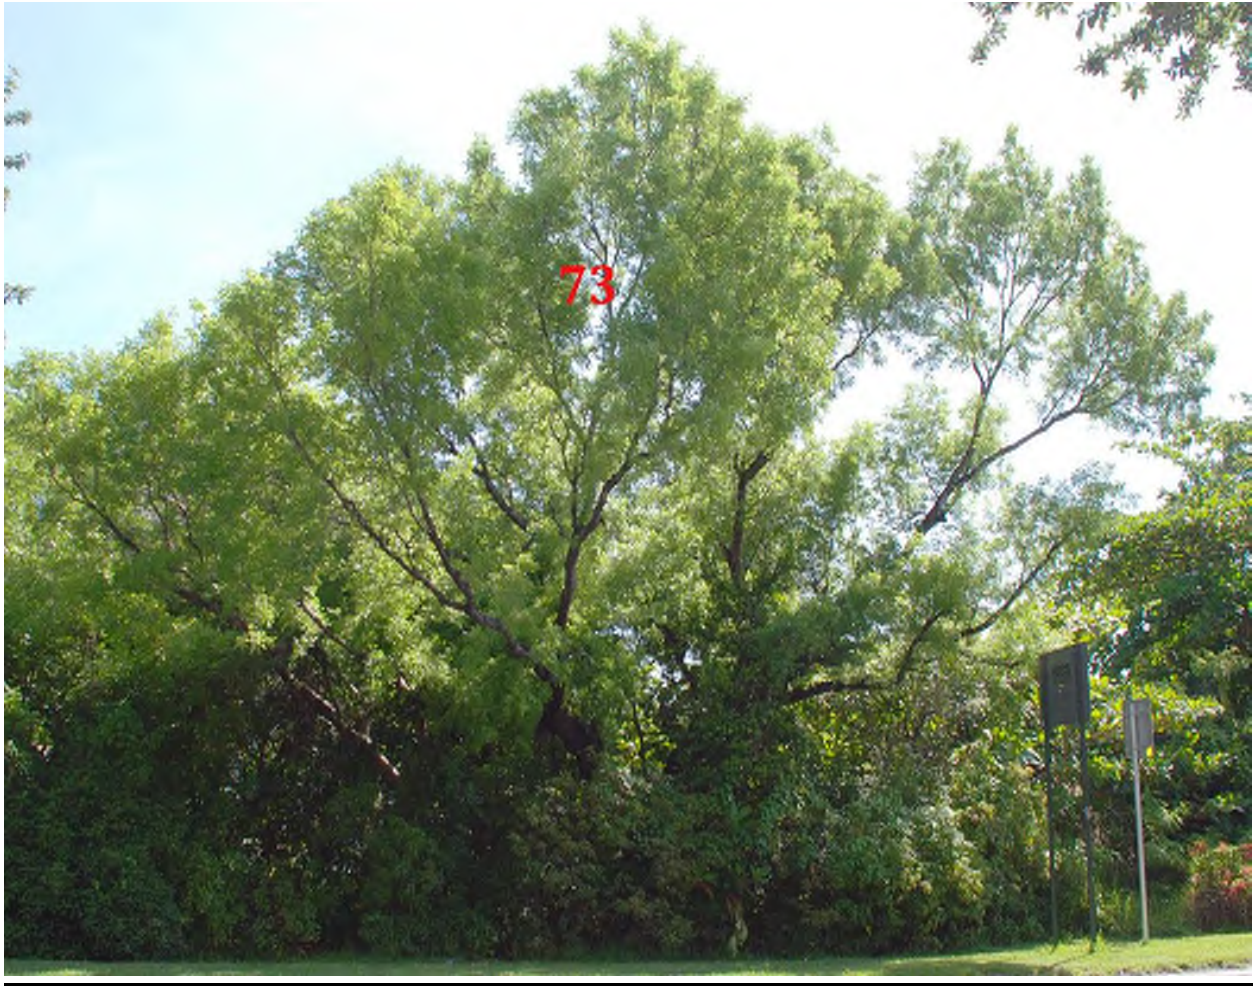
Photo 42 above is tree 73 viewed from the south.
