Tree Resource Evaluation for 4000 Alton Road, Miami Beach

May 11, 2020

I performed a tree resource evaluation on the property located at 4000 Alton Road, Miami Beach on May 2nd and 3rd 2020. The approximate locations of these trees and palms can be found on the schematic in Appendix B.

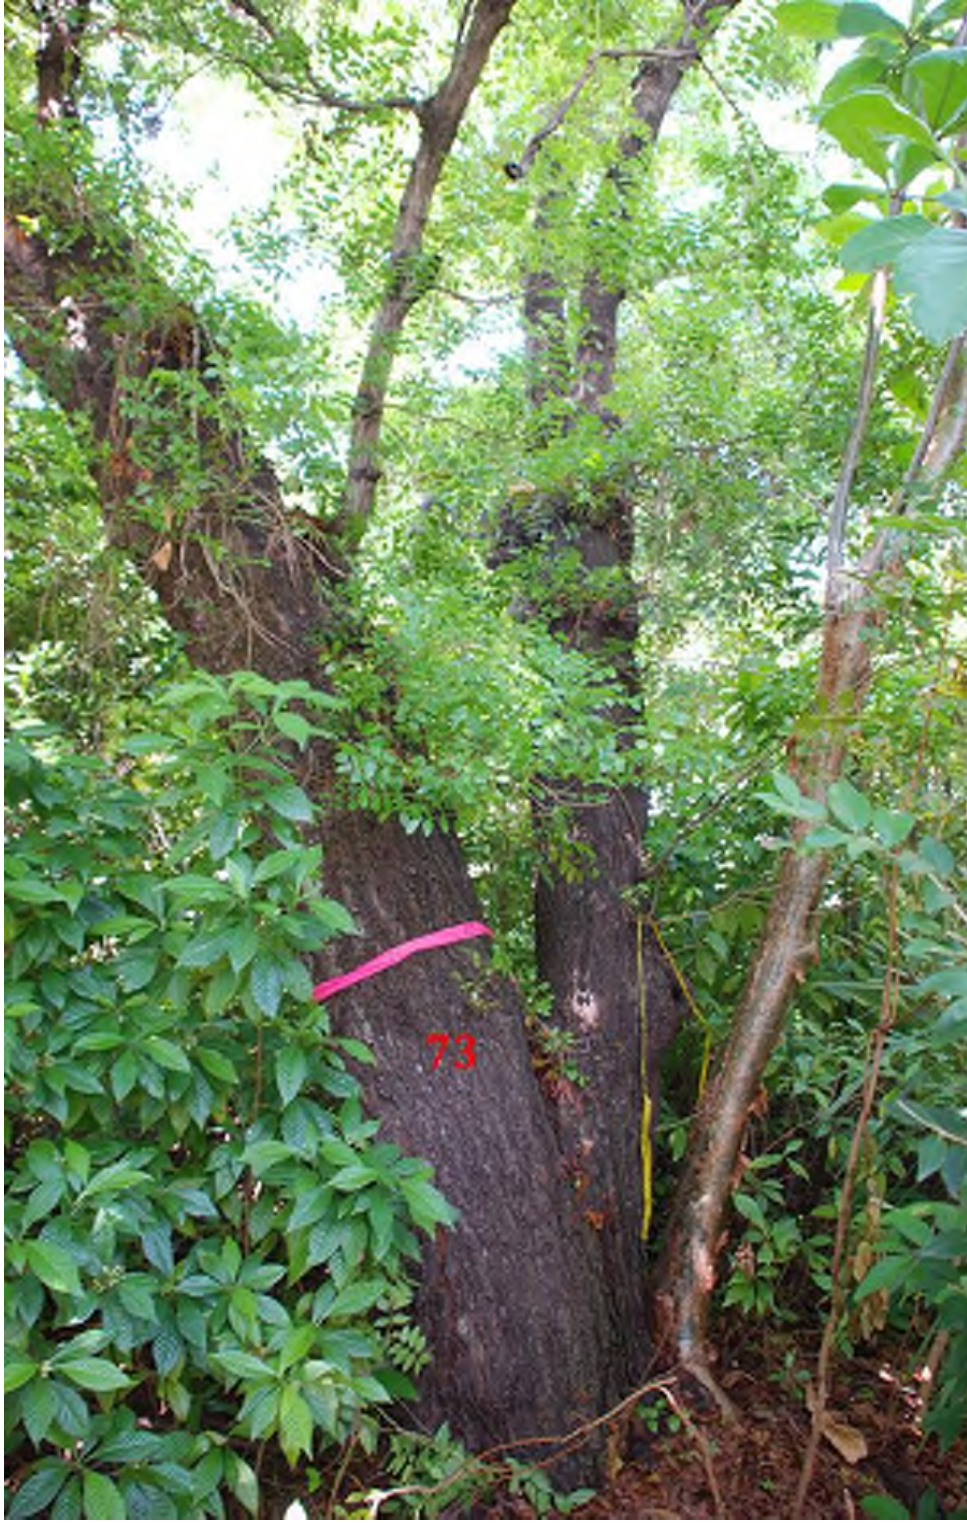
Photo 43 above is the trunk of tree 73.

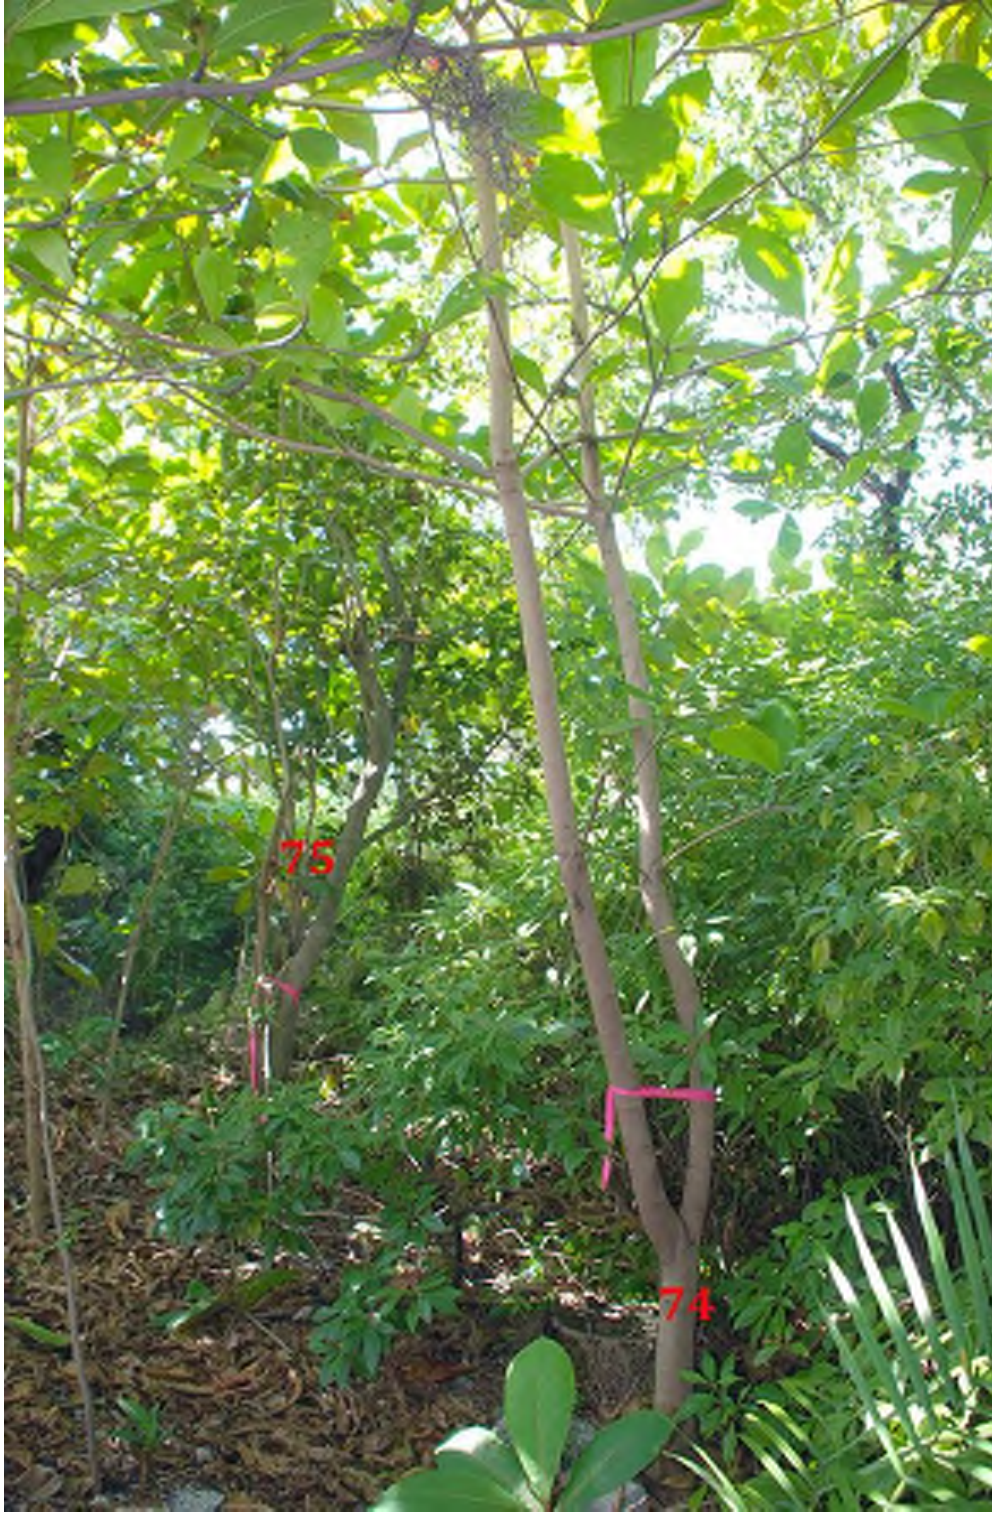
Photo 44 above is trees 74 & 75.

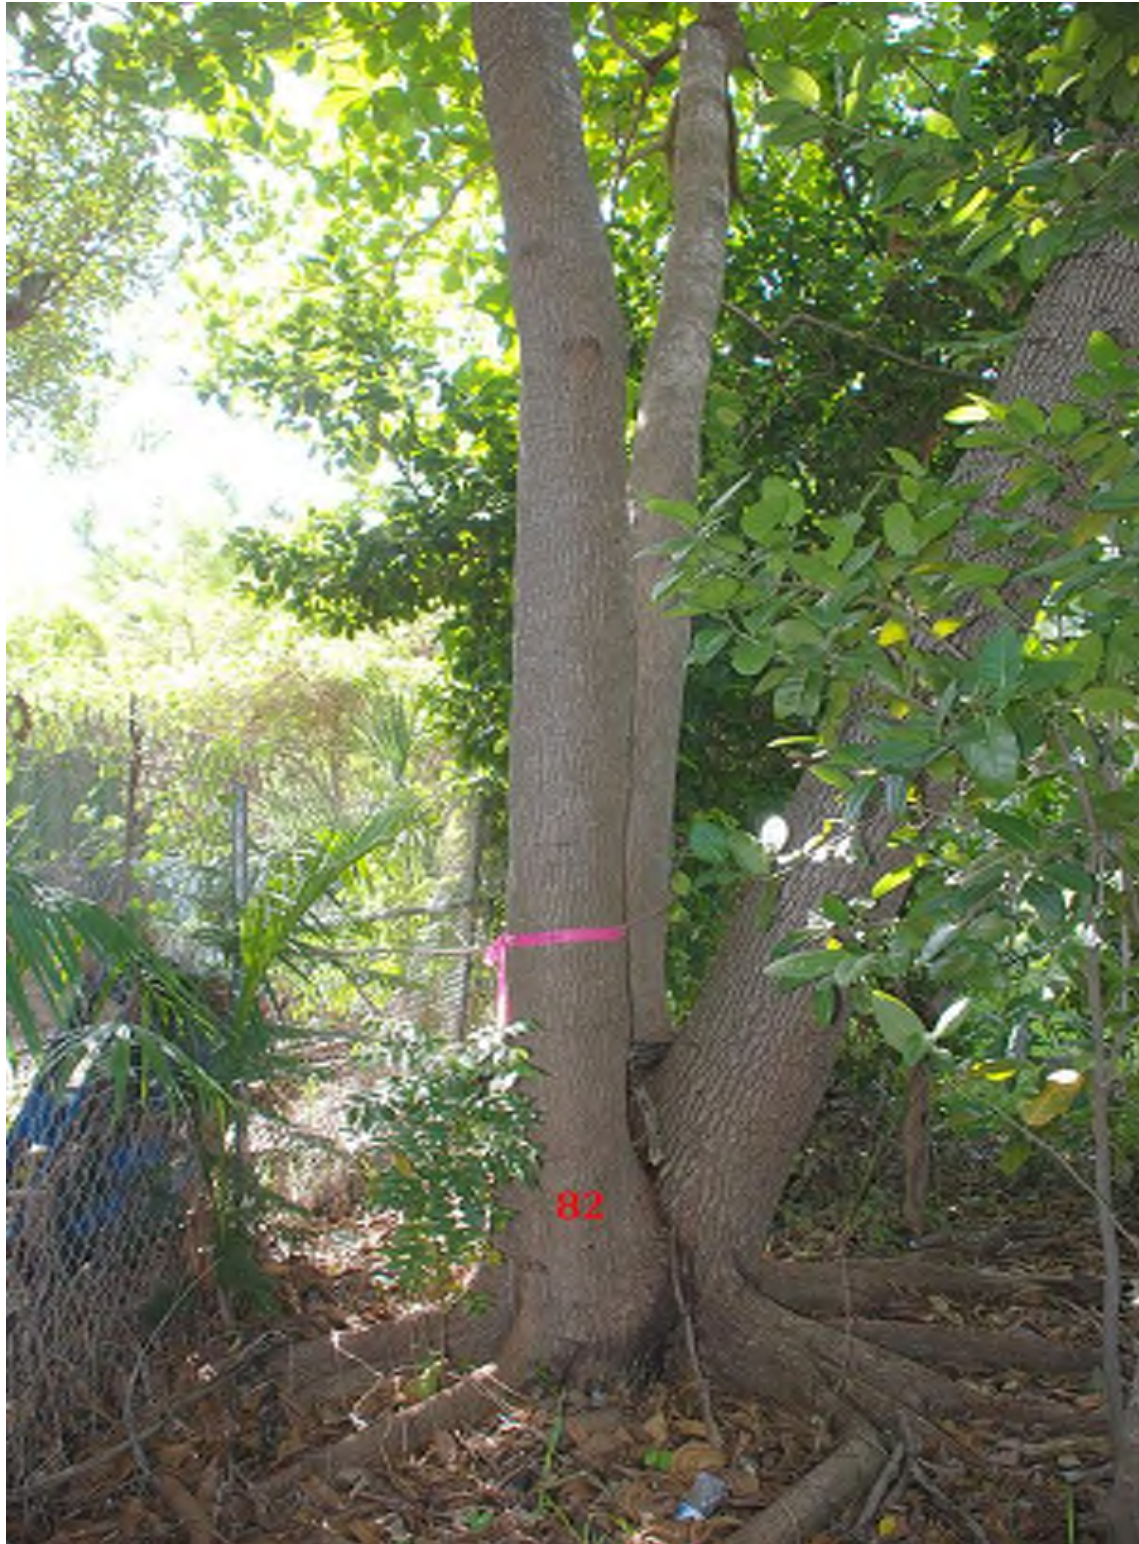
Photo 51 above is tree 82 with no signs of decay or cavities on the trunk(s).

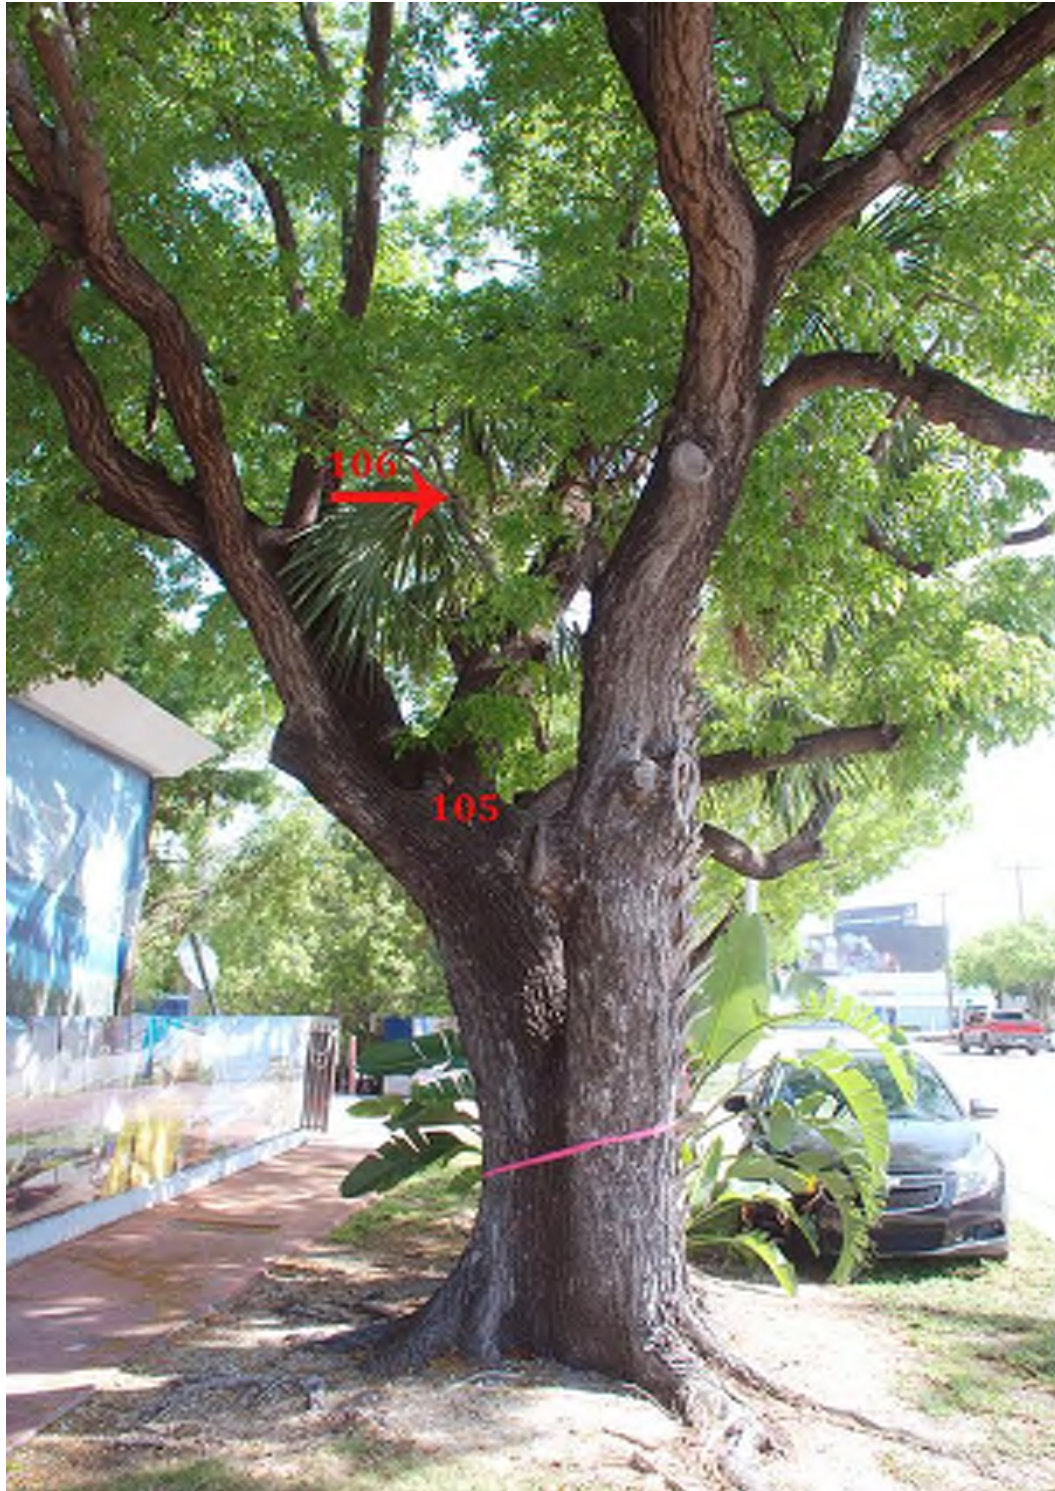
Photo 65 above is the trunk of tree 105 with no decay or cavities noted on the trunk or root collar.

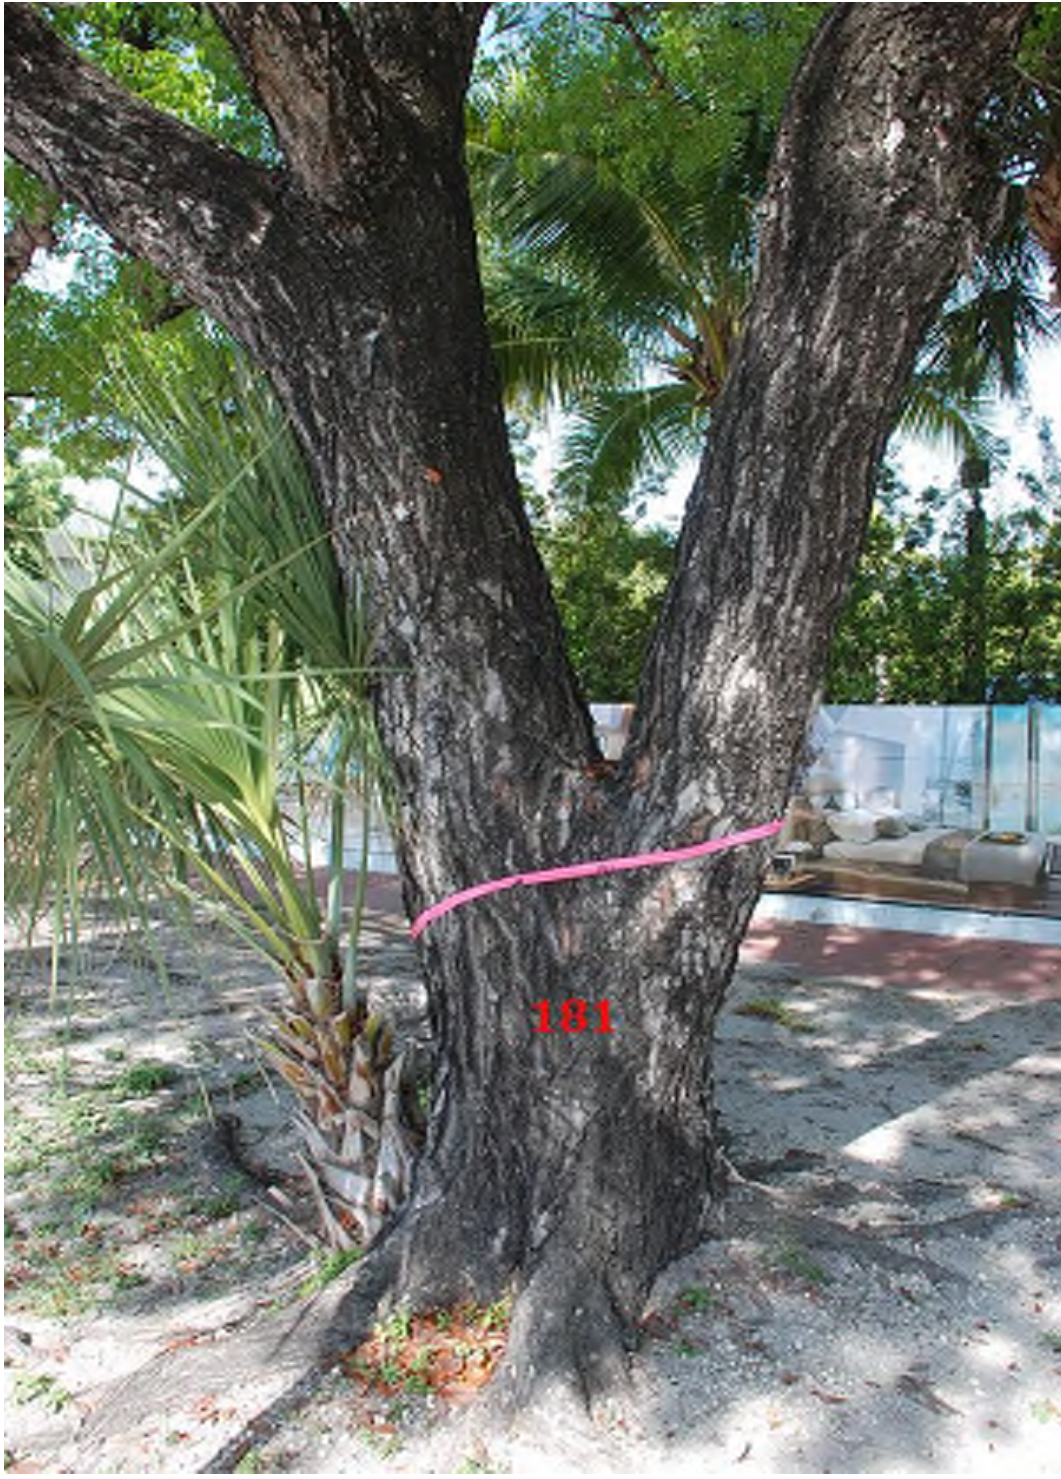
Photo 90 above is the trunk of tree 181 with no signs of decay or cavities on the trunk or root collar.

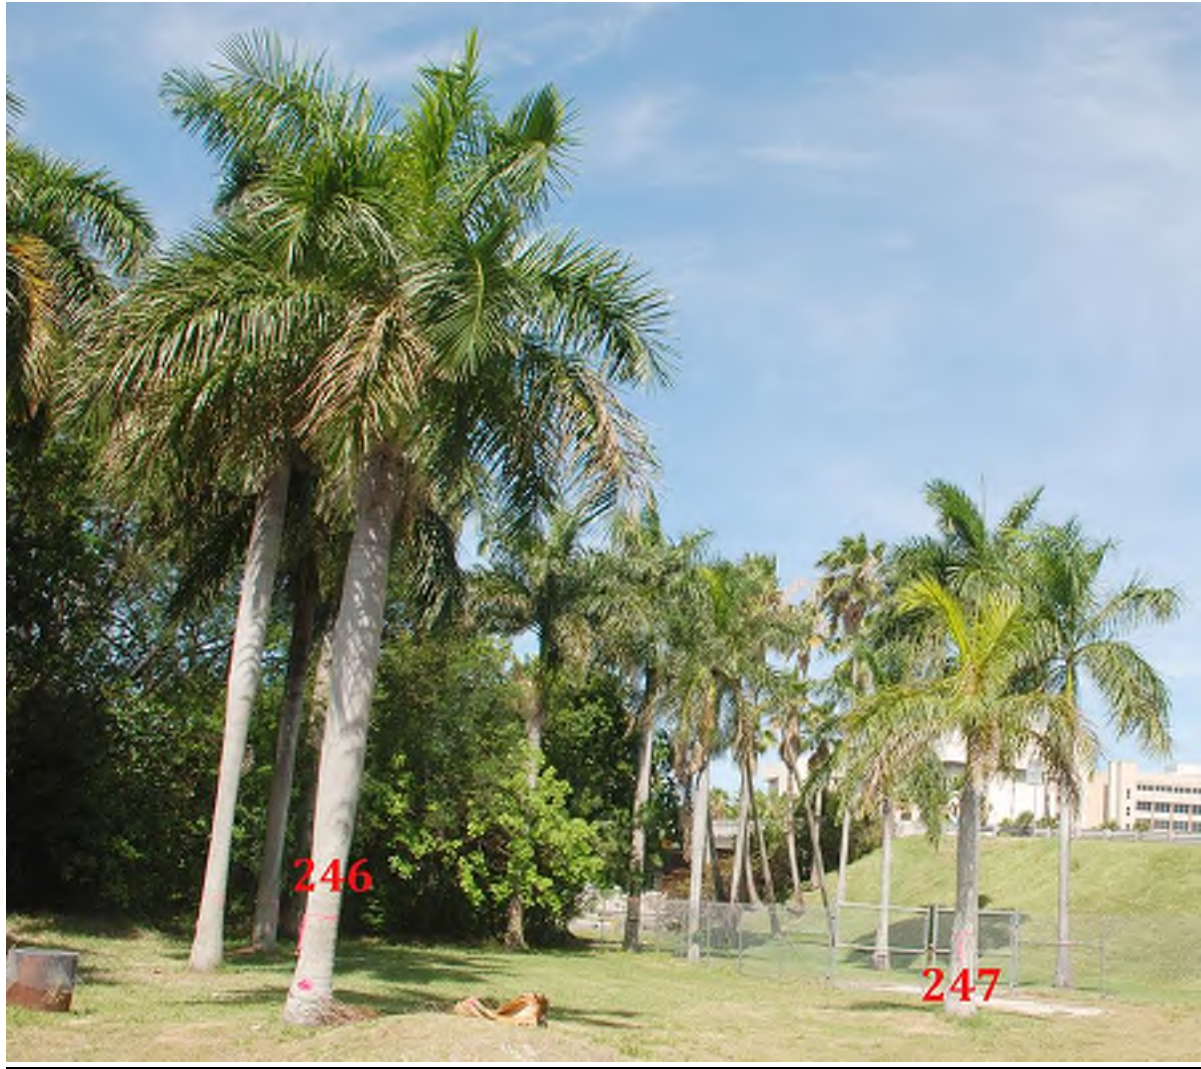
Photo 136 above is palms 246 & 247.
