# ***Tree Resource Evaluation for 4000 Alton Road, Miami Beach***

***May 11, 2020***

## **Summary**

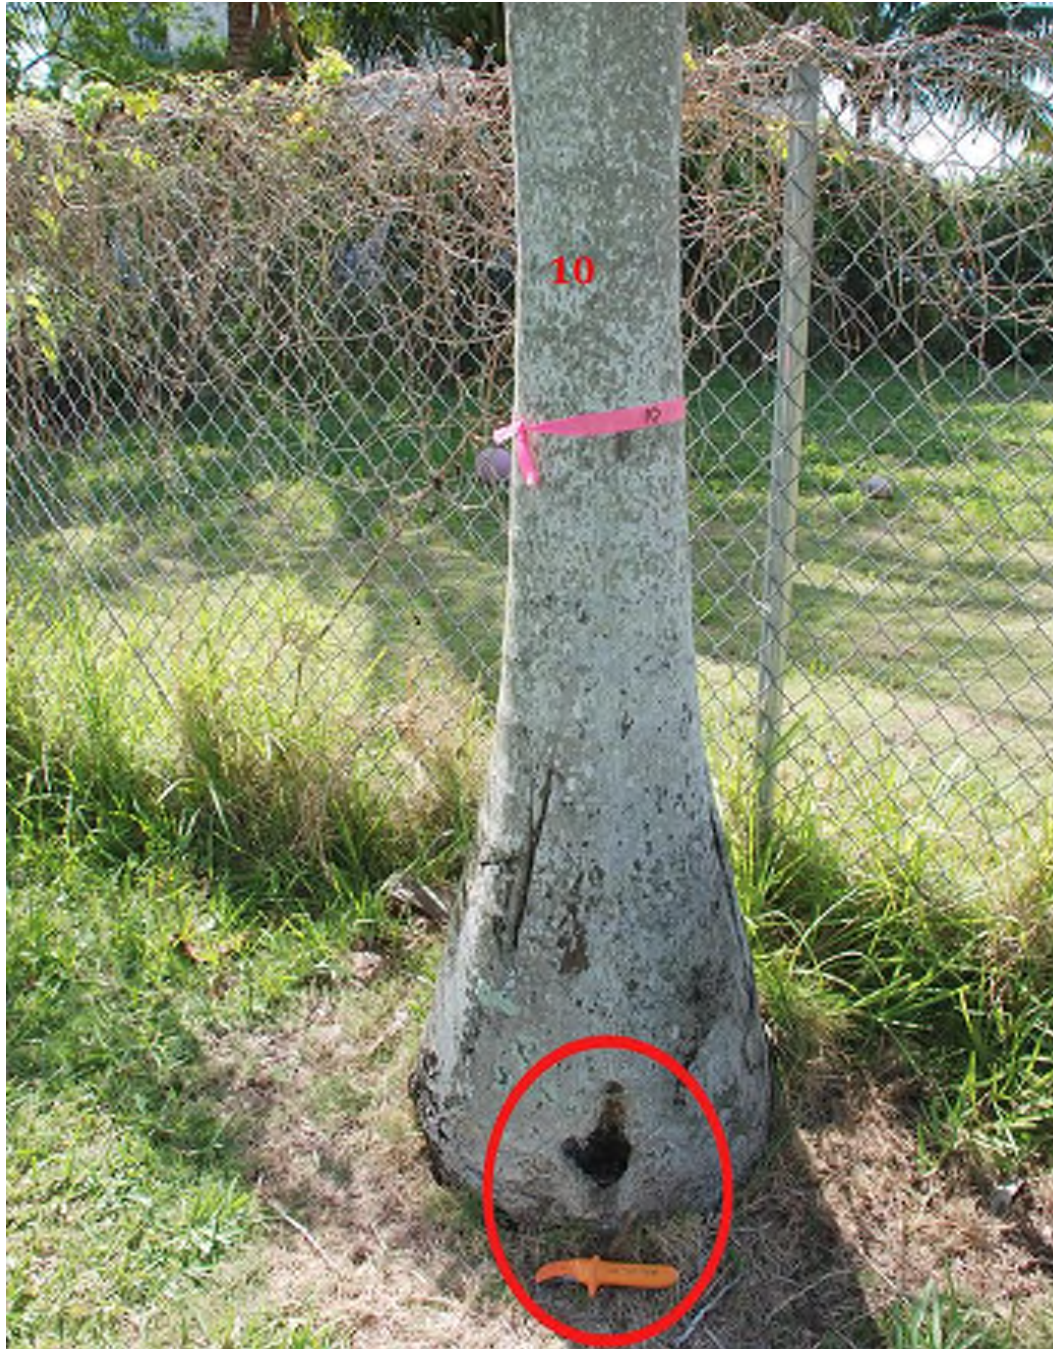
**Photo 6 above the trunk of palm 10 with a small cavity indicated. This is not affecting the palm's vascular system or structural integrity. The orange knife is 7 inches in length.**

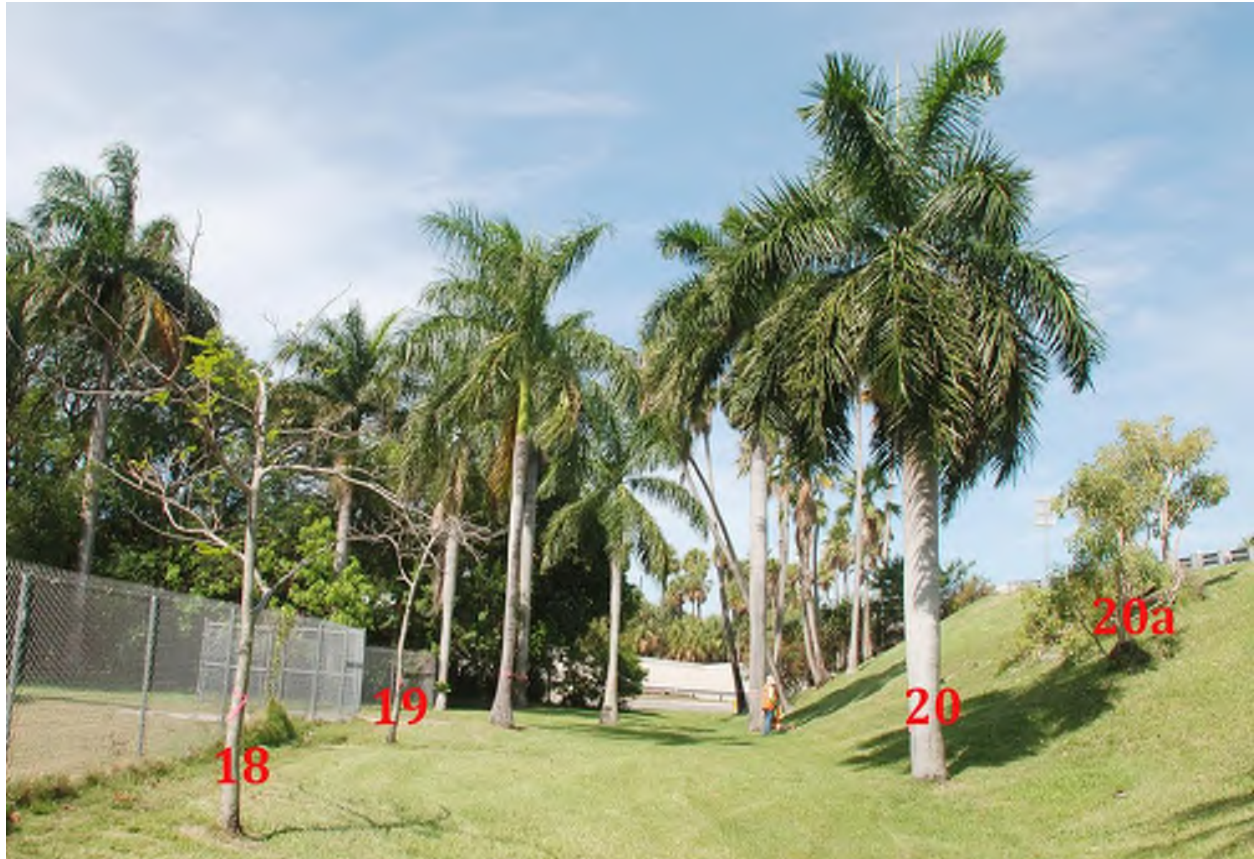
**Photo 7 above is tree 18 with a canopy that appears to be dying-back. This tree should be considered for removal.**

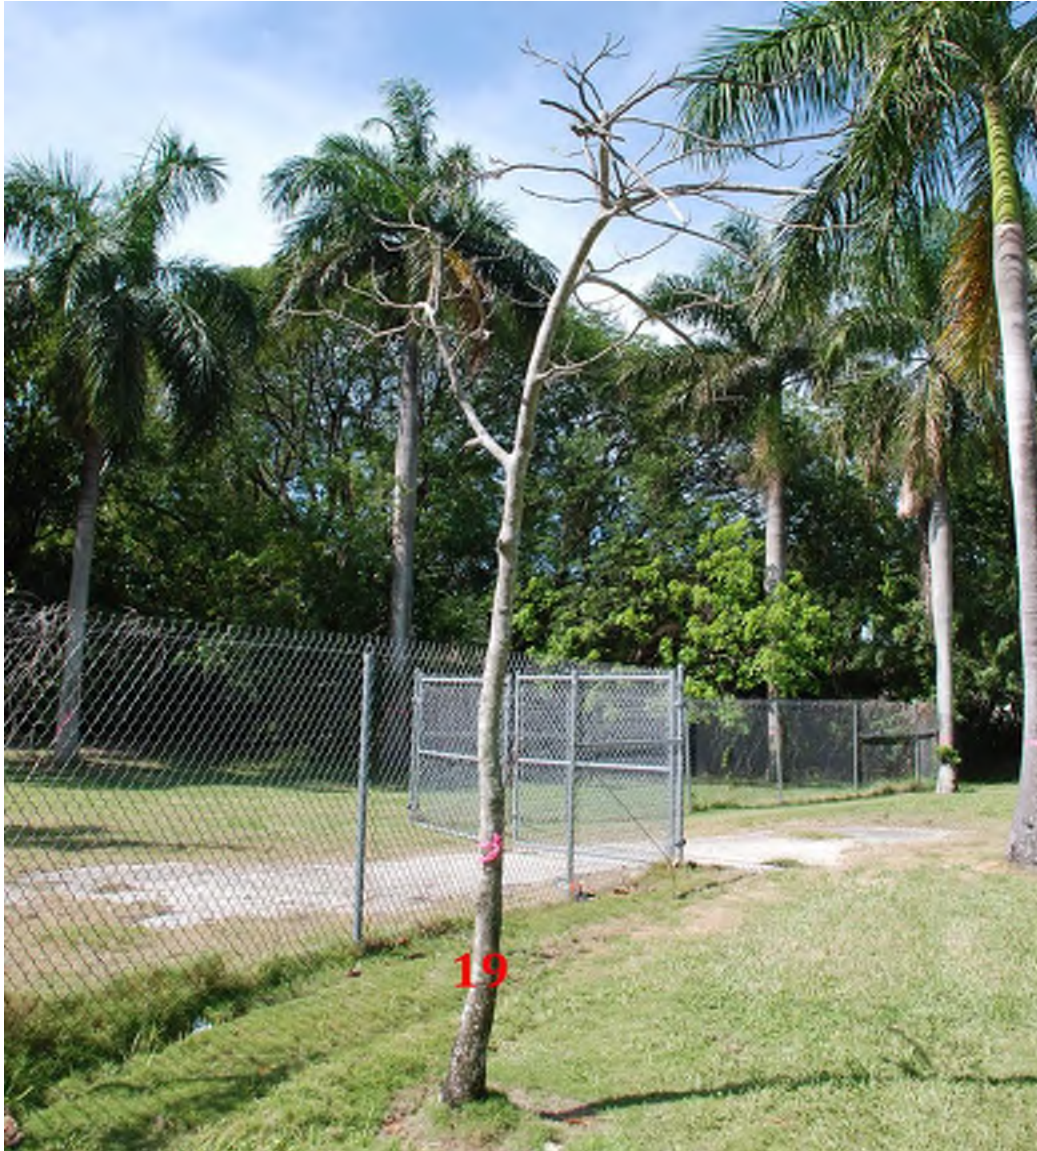
**Photo 8 above is tree 19 that is dead.**

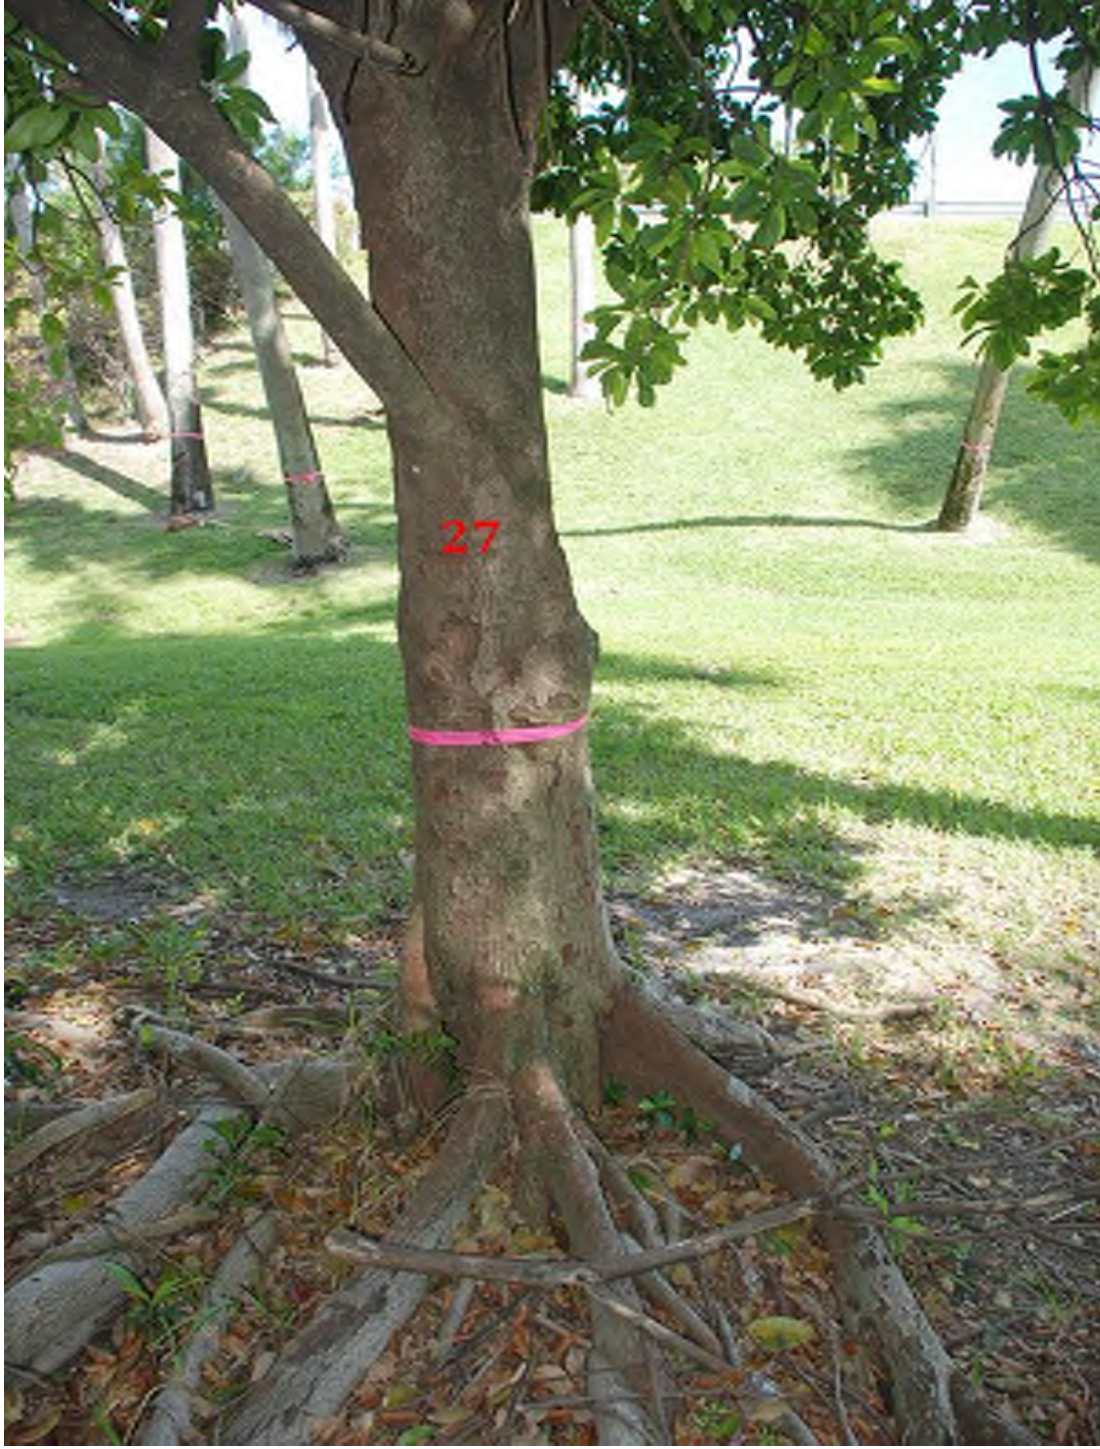
**Photo 15 above is the trunk of tree 27 showing no signs of cavities or decay.**

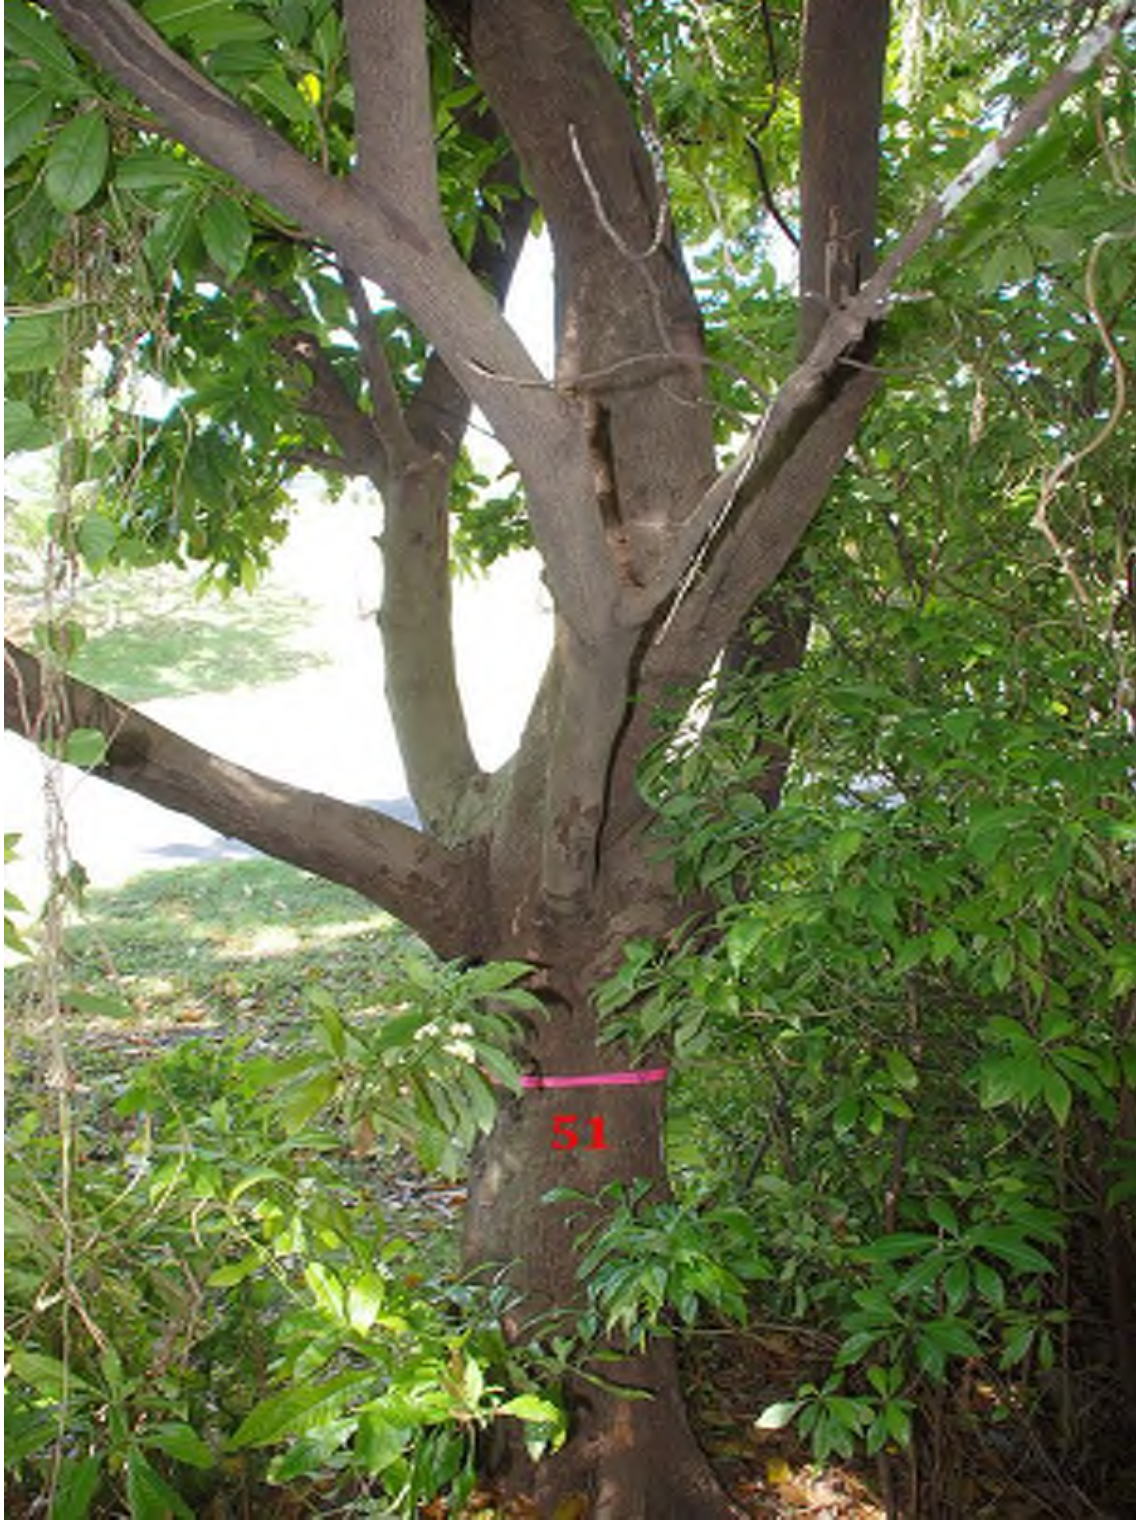
**Photo 25 above is the trunk of tree 51 with no signs of decay or cavities on the trunk or root collar.**

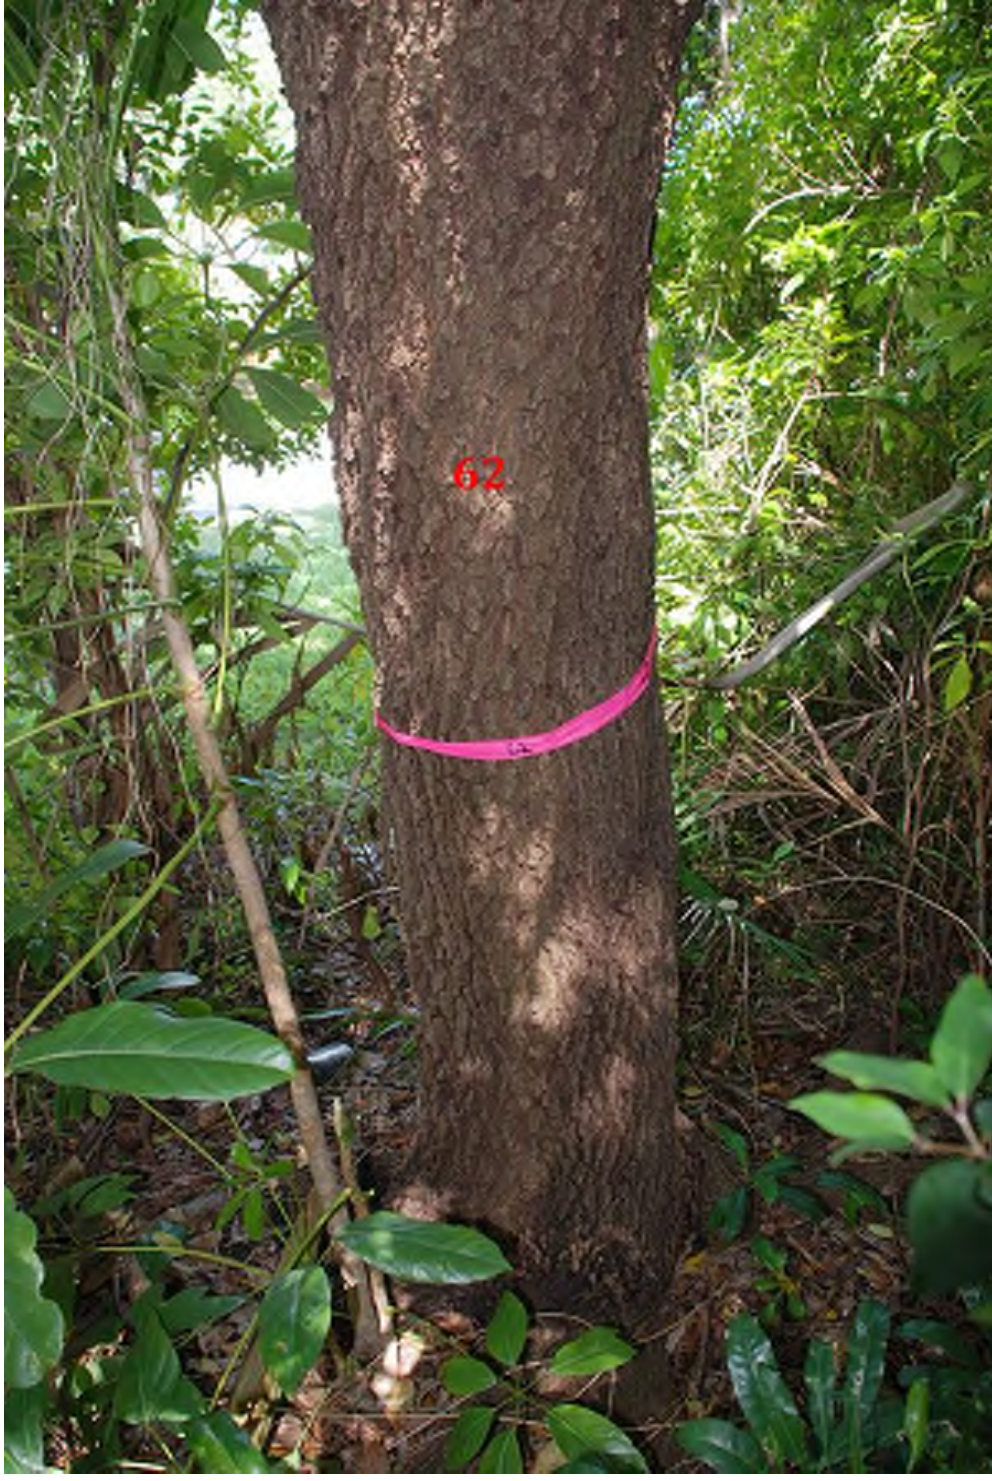
**Photo 32 above is tree 62 with no signs of decay or cavities on the trunk or root collar.**

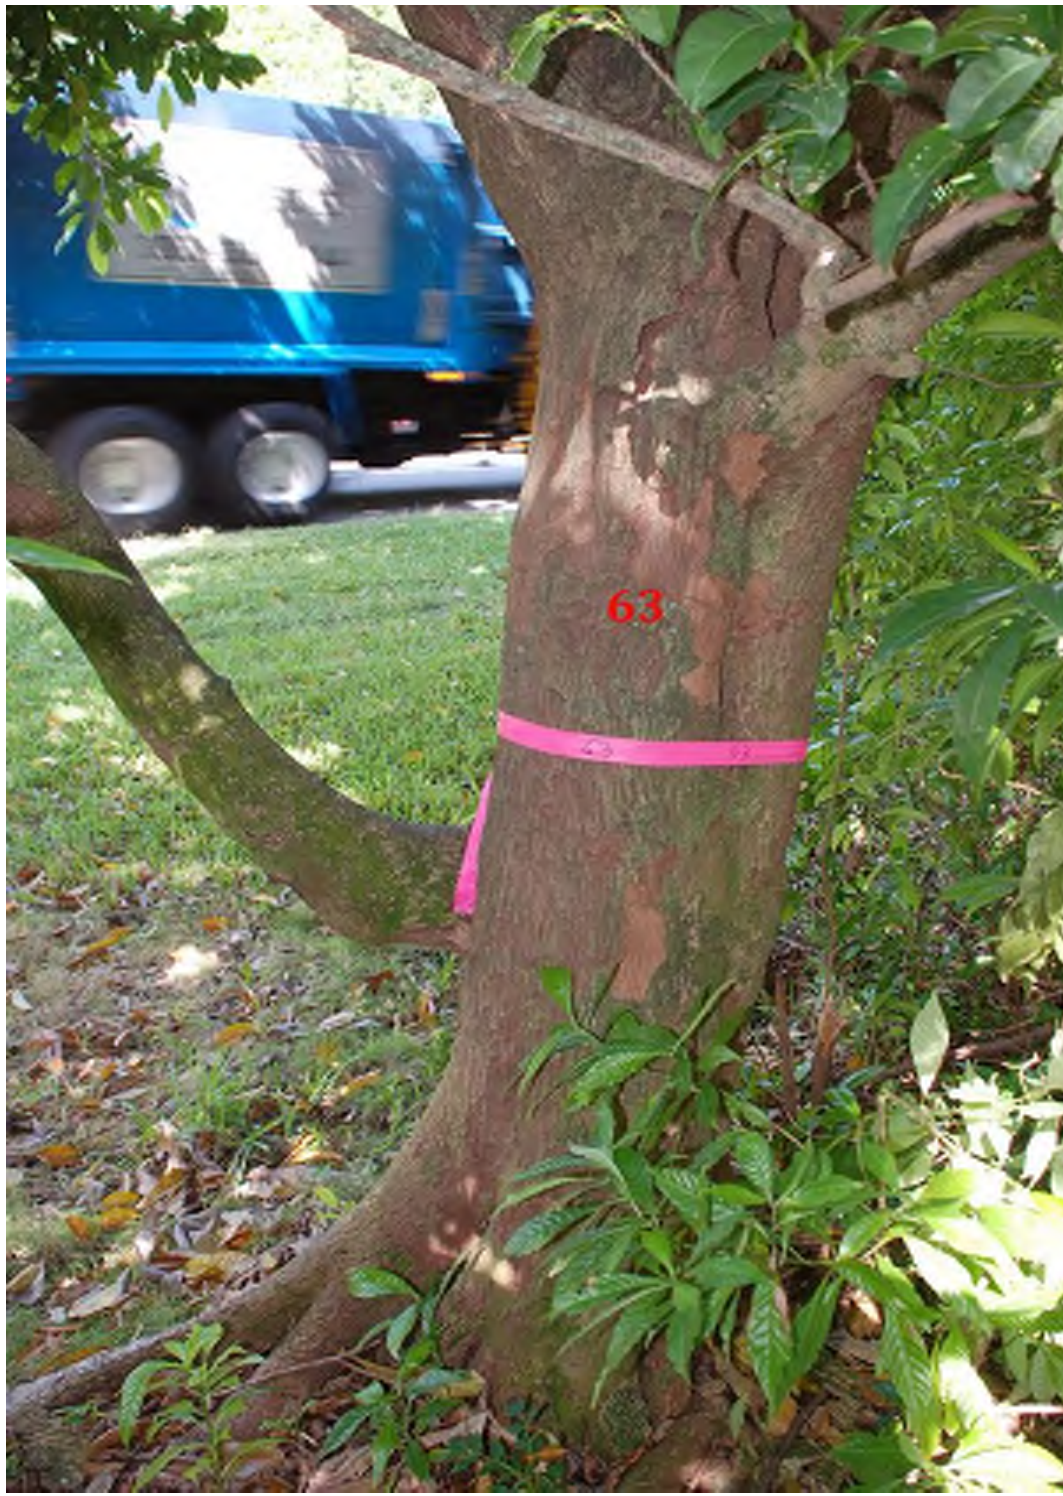
**Photo 33 above is tree 63 with no signs of decay or cavities on the trunk or root collar.**

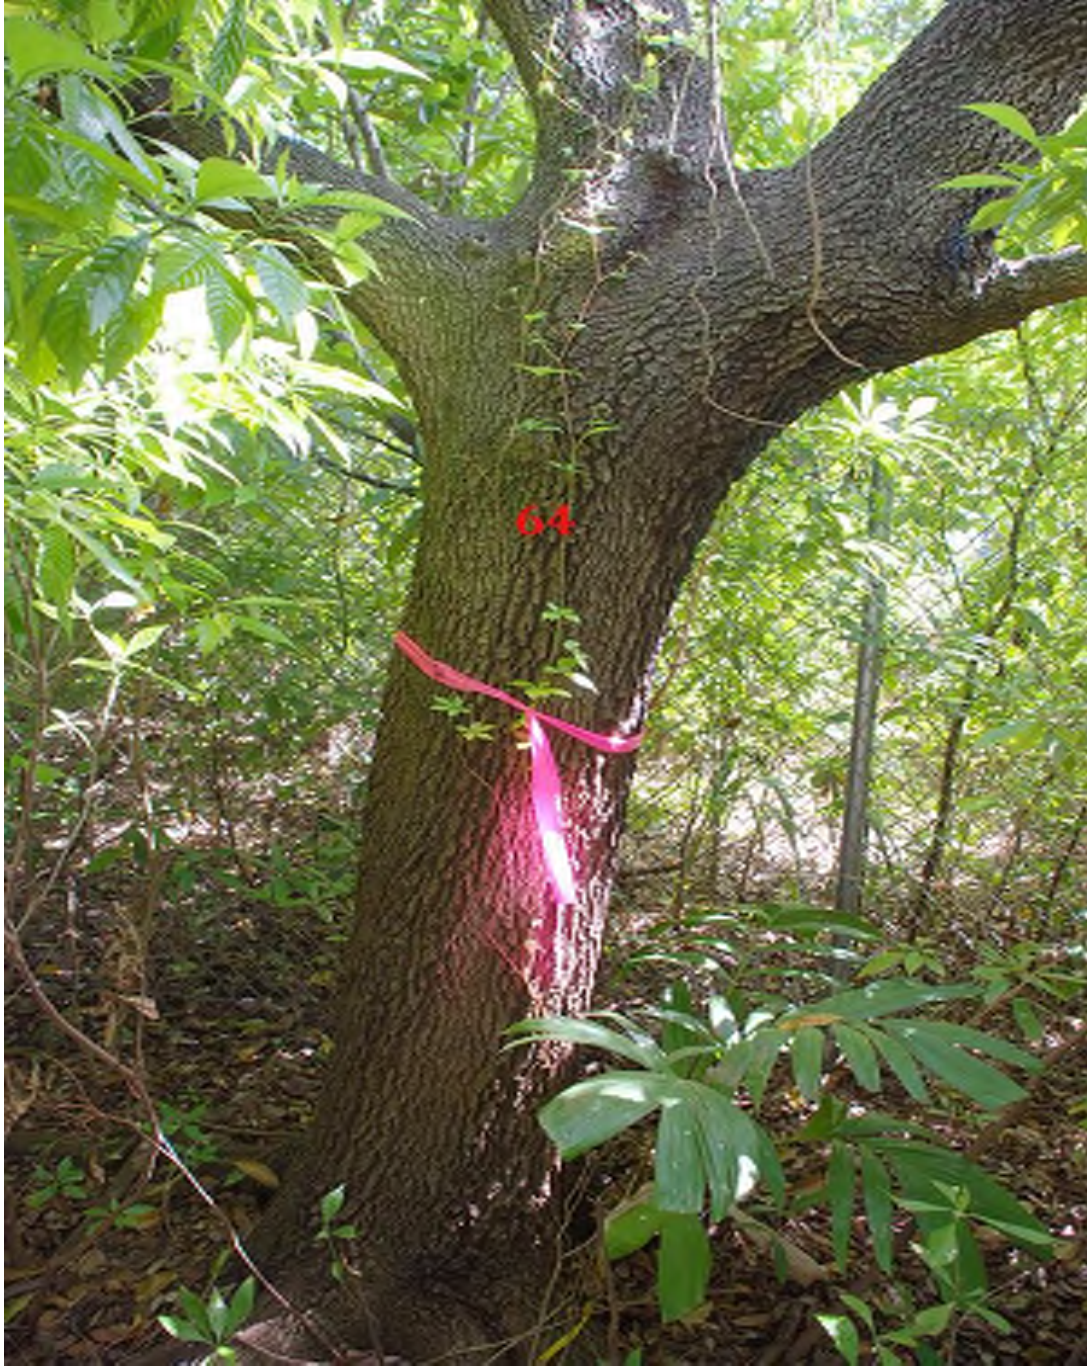
**Photo 35 is tree 64 with no signs of decay or cavities on the trunk or root collar.**

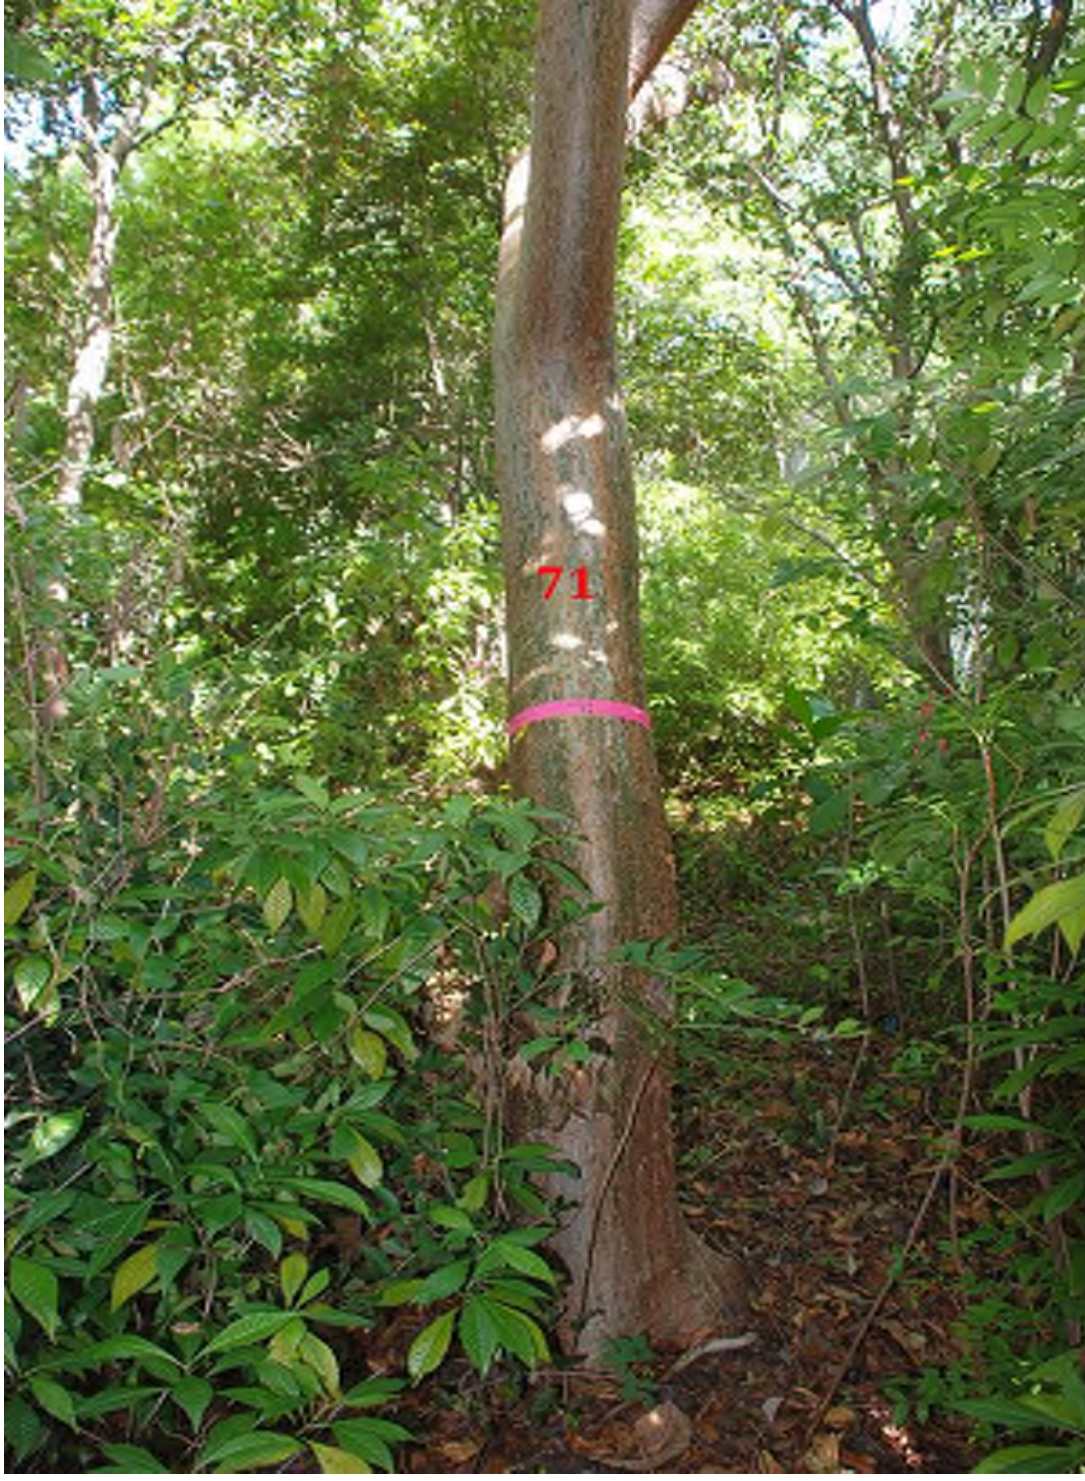
**Photo 40 above is tree 71 with no signs of decay or cavities on the trunk or root collar.**

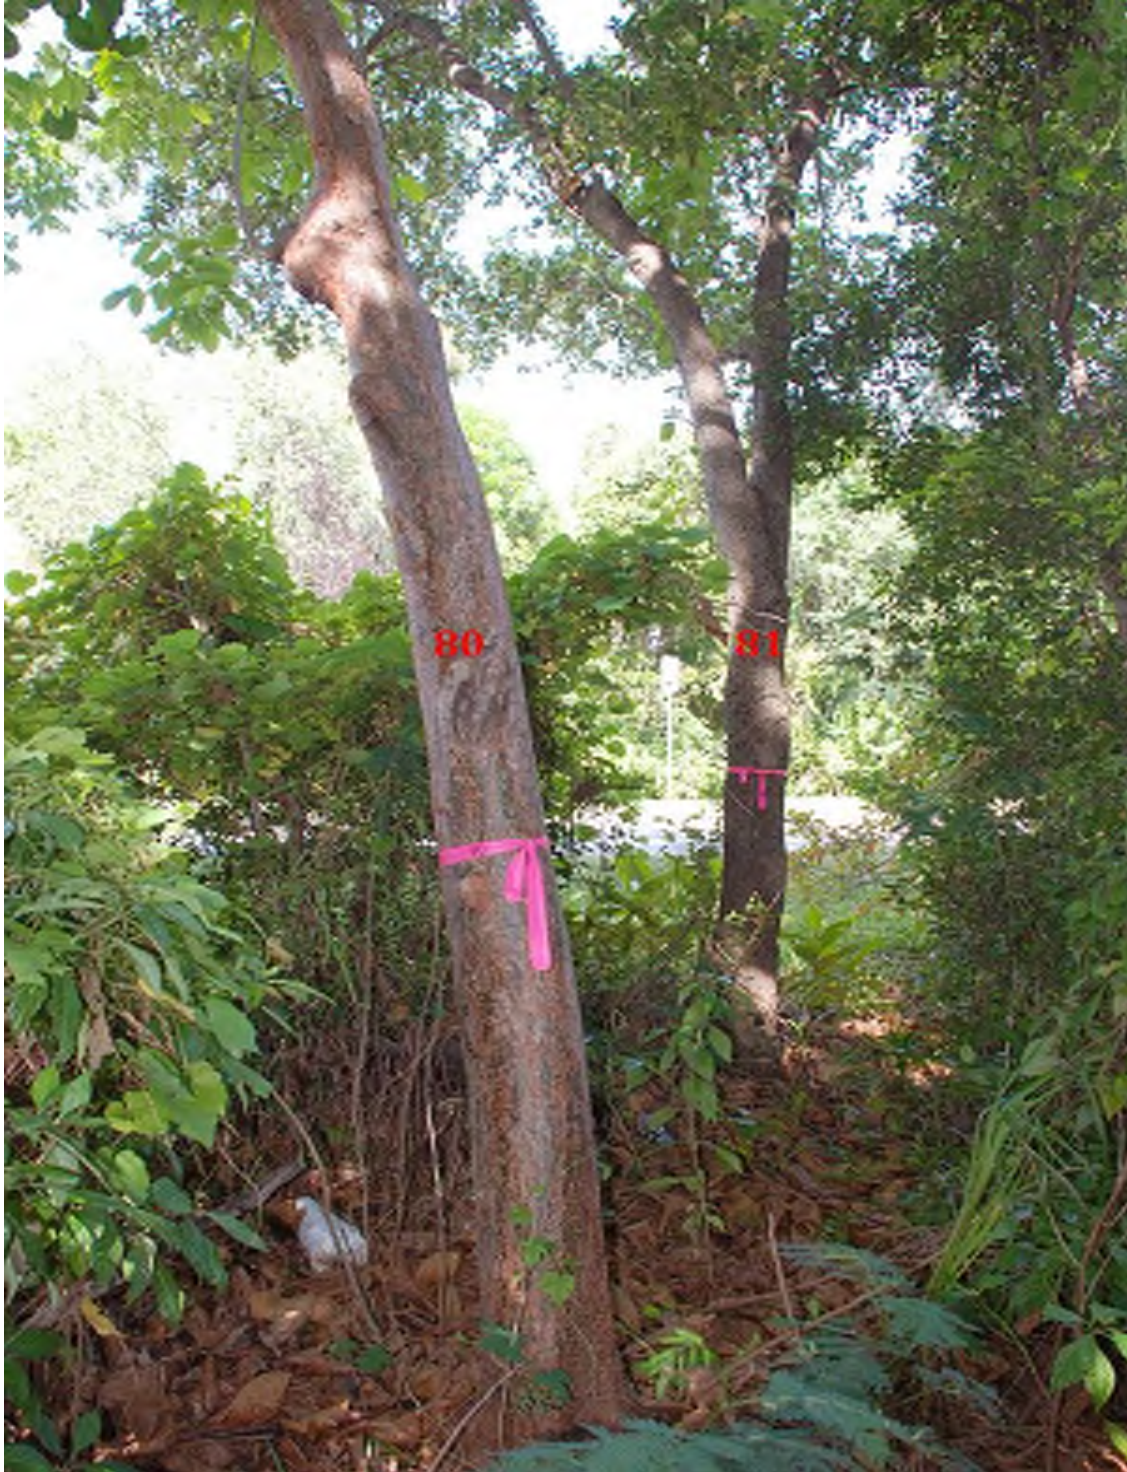
**Photo 48 above is trees 80 & 81 with no signs of decay or cavities on the trunk.**

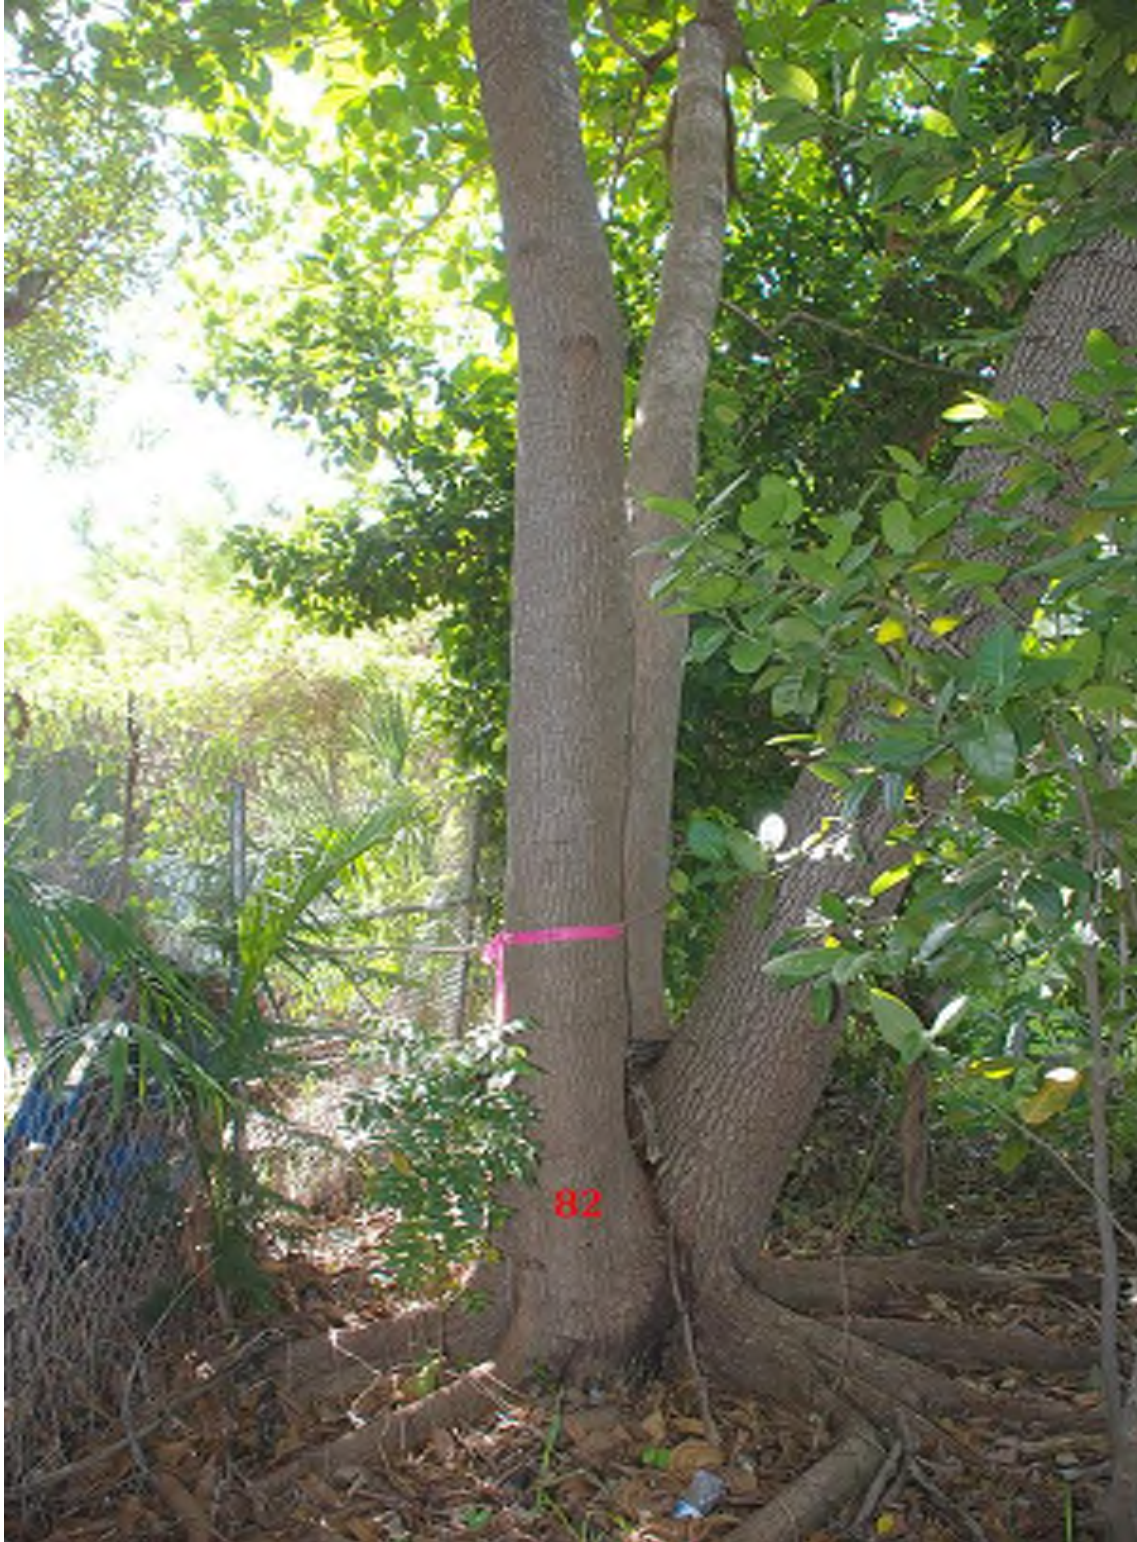
**Photo 51 above is tree 82 with no signs of decay or cavities on the trunk(s).**

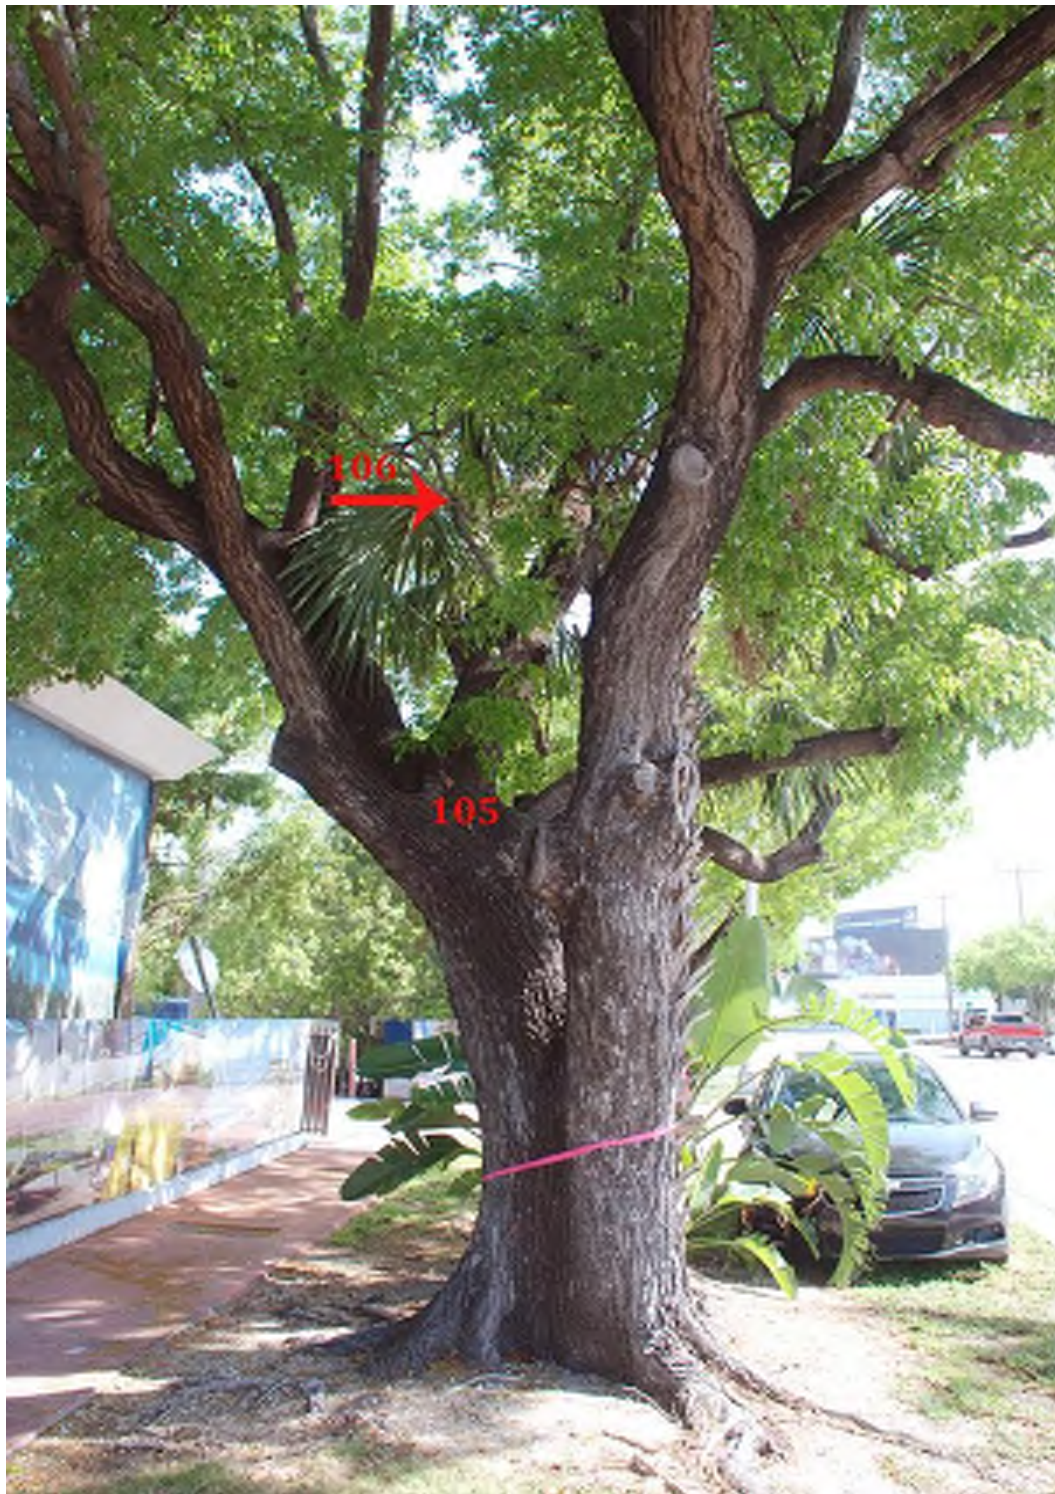
**Photo 65 above is the trunk of tree 105 with no decay or cavities noted on the trunk or root collar.**

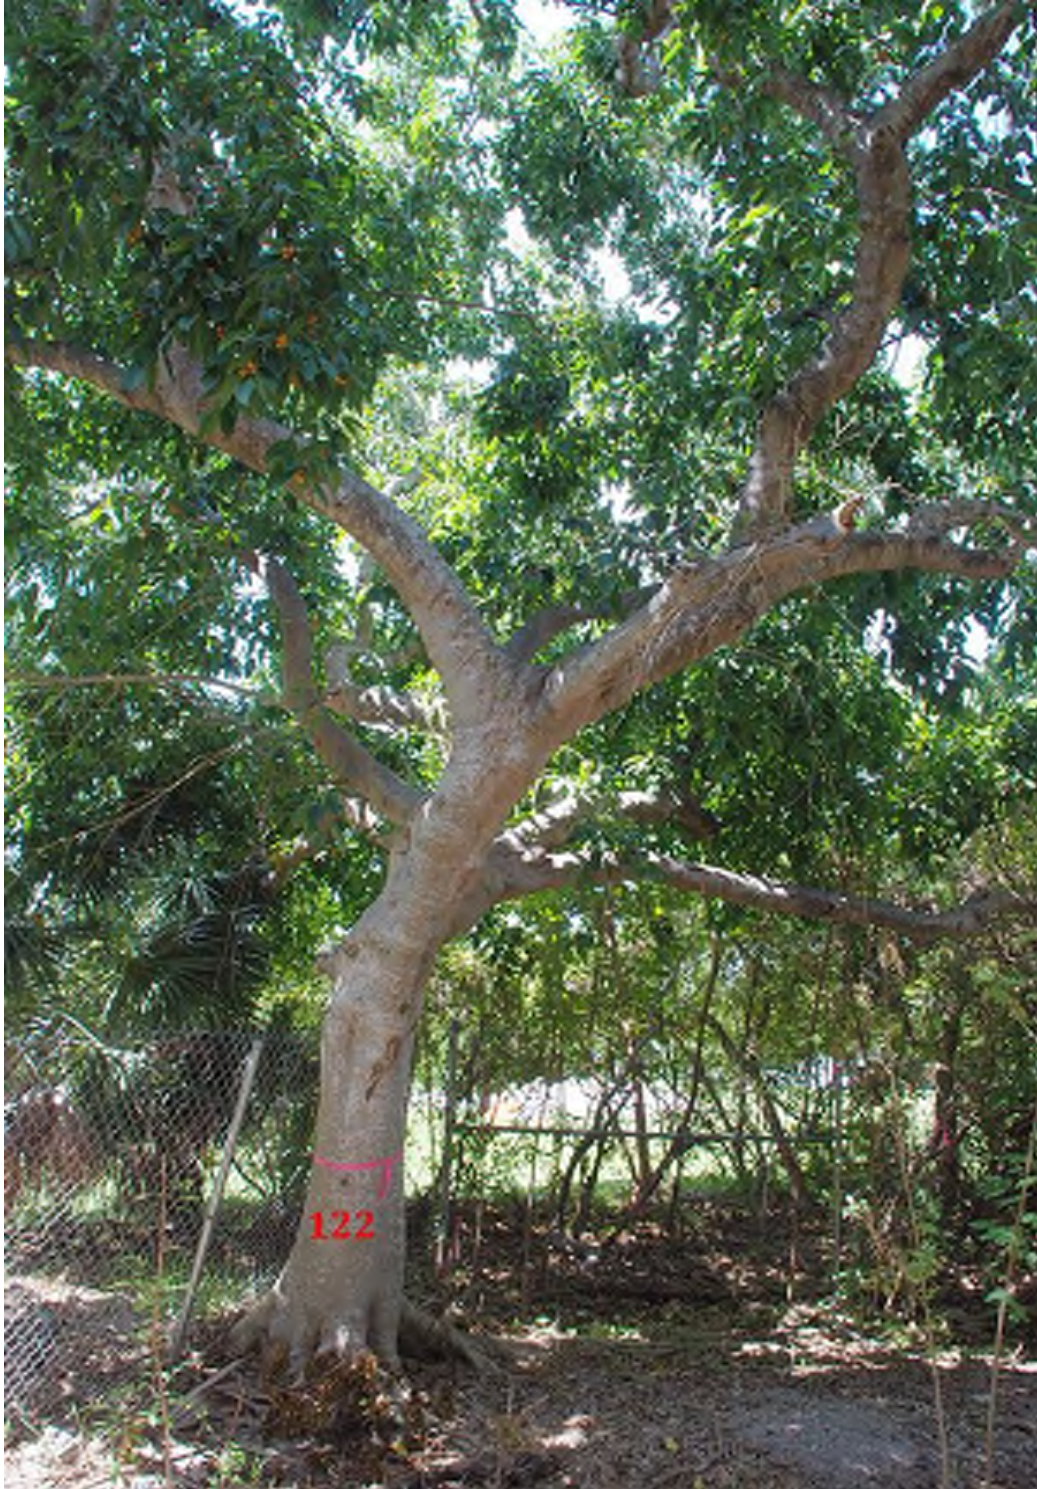
**Photo 72 above is tree 122 with no signs of cavities or active decay on the trunk or root collar.**

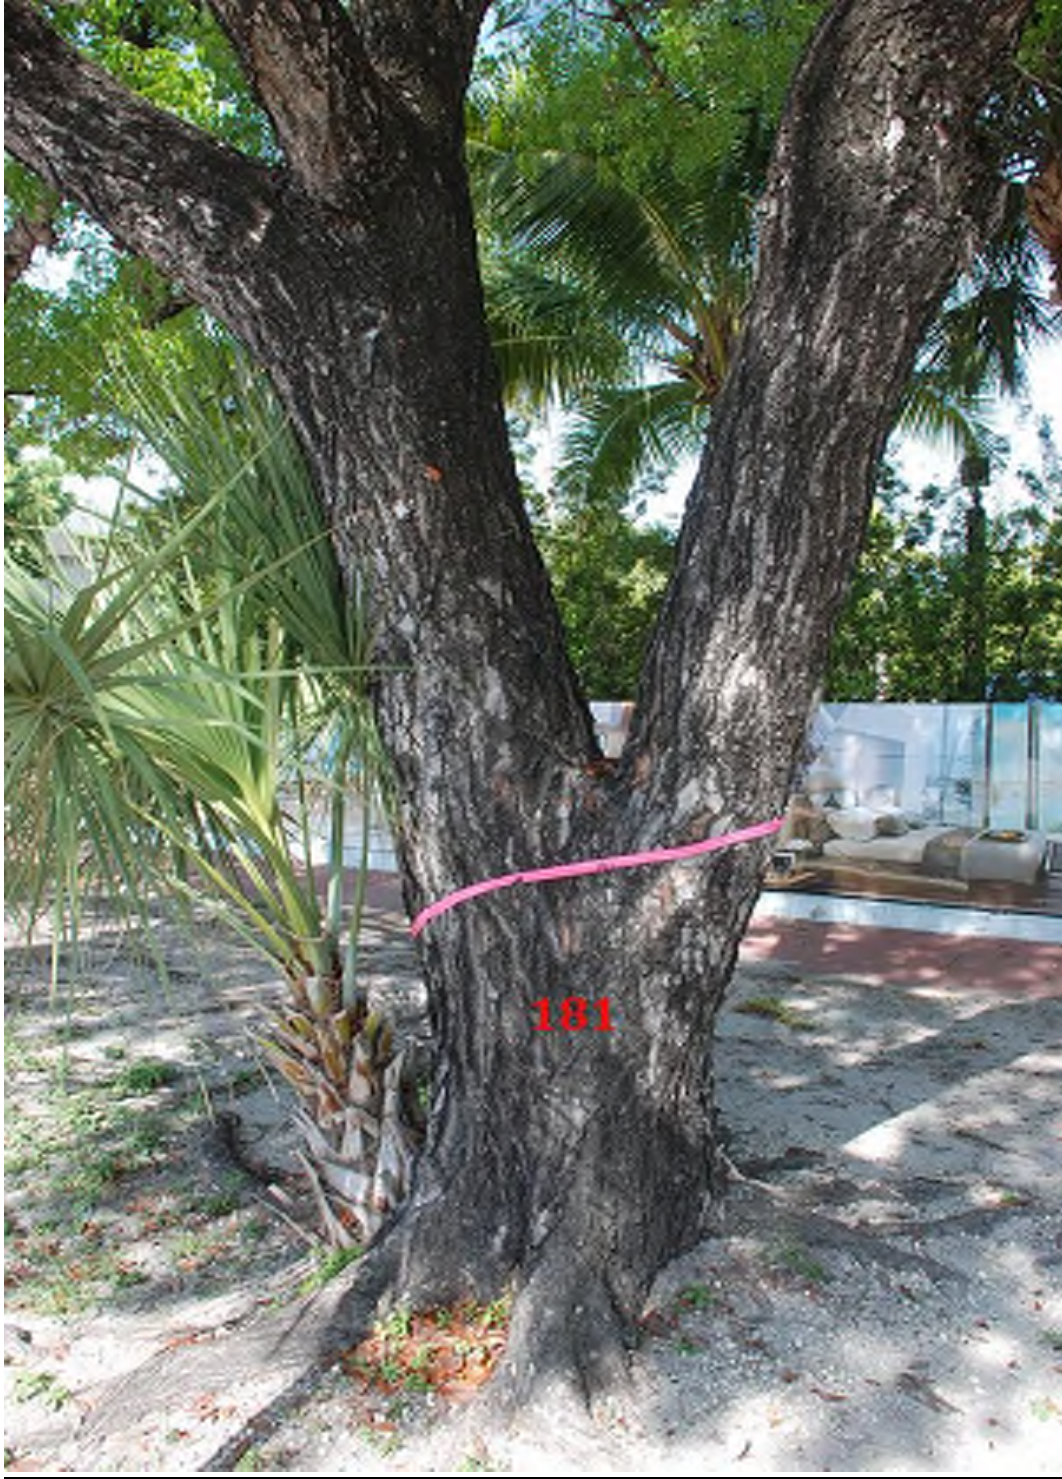
**Photo 90 above is the trunk of tree 181 with no signs of decay or cavities on the trunk or root collar.**

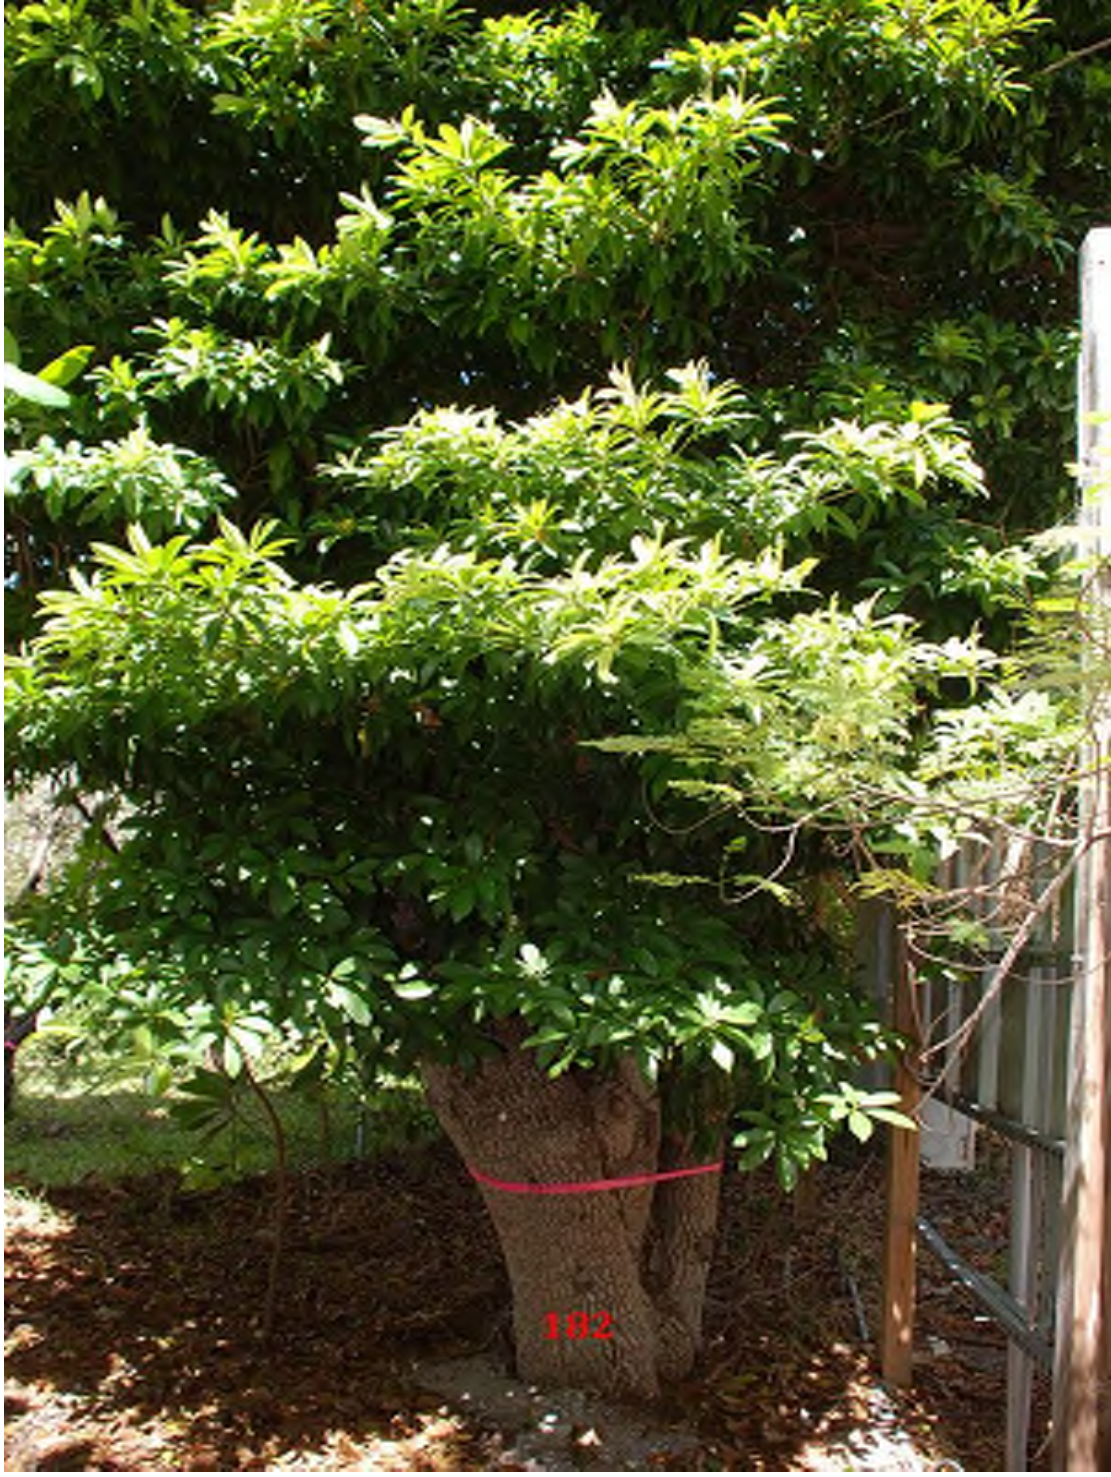
**Photo 92 above is the trunk of tree 182 with no signs of cavities or active decay on the trunk or root collar.**
