# ***Tree Resource Evaluation for 4000 Alton Road, Miami Beach***

***May 11, 2020***

## **Summary**

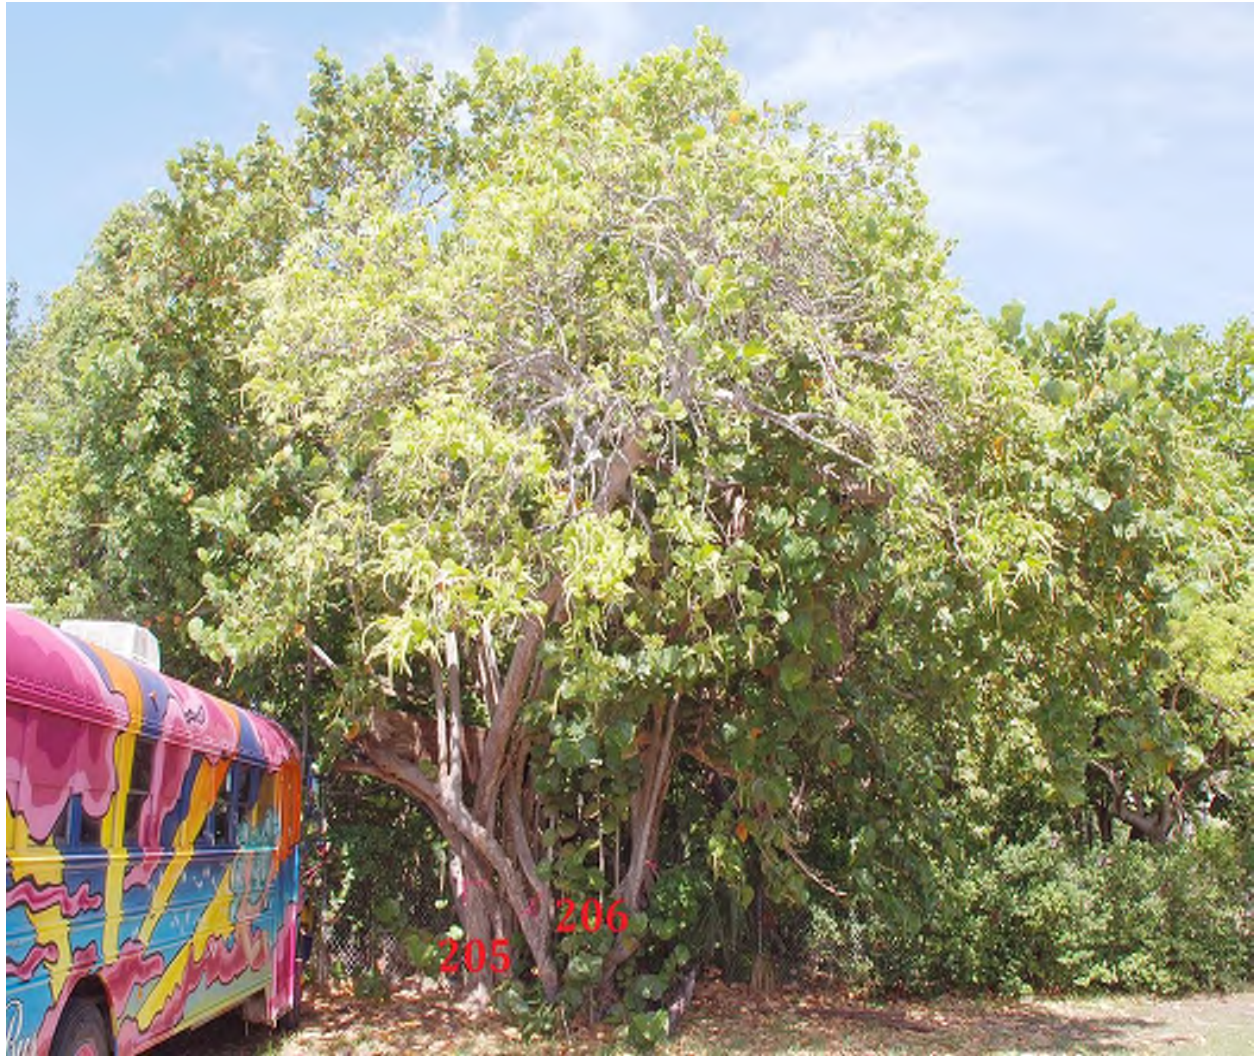
**Photo 103 above is trees 205 & 206 both with multiple trunks. I noted no signs of cavities or active decay on the trunks or root collar of these trees.**

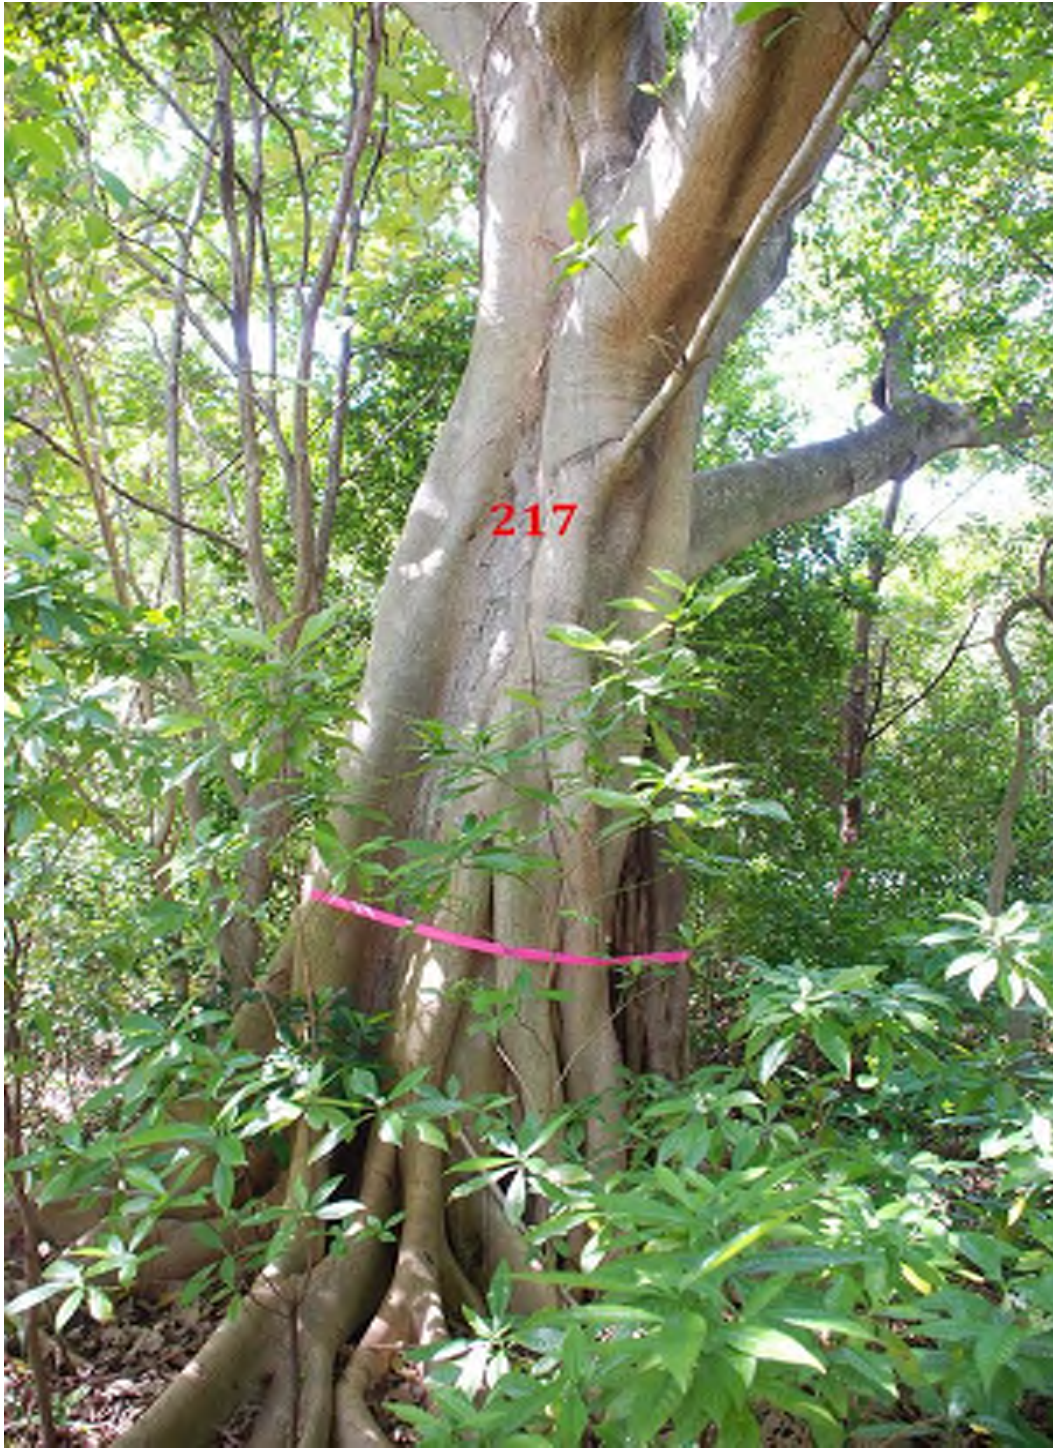
**Photo 110 above is tree 217 viewed from the west. I noted no signs of active decay or cavities on the trunk or root collar of this tree.**

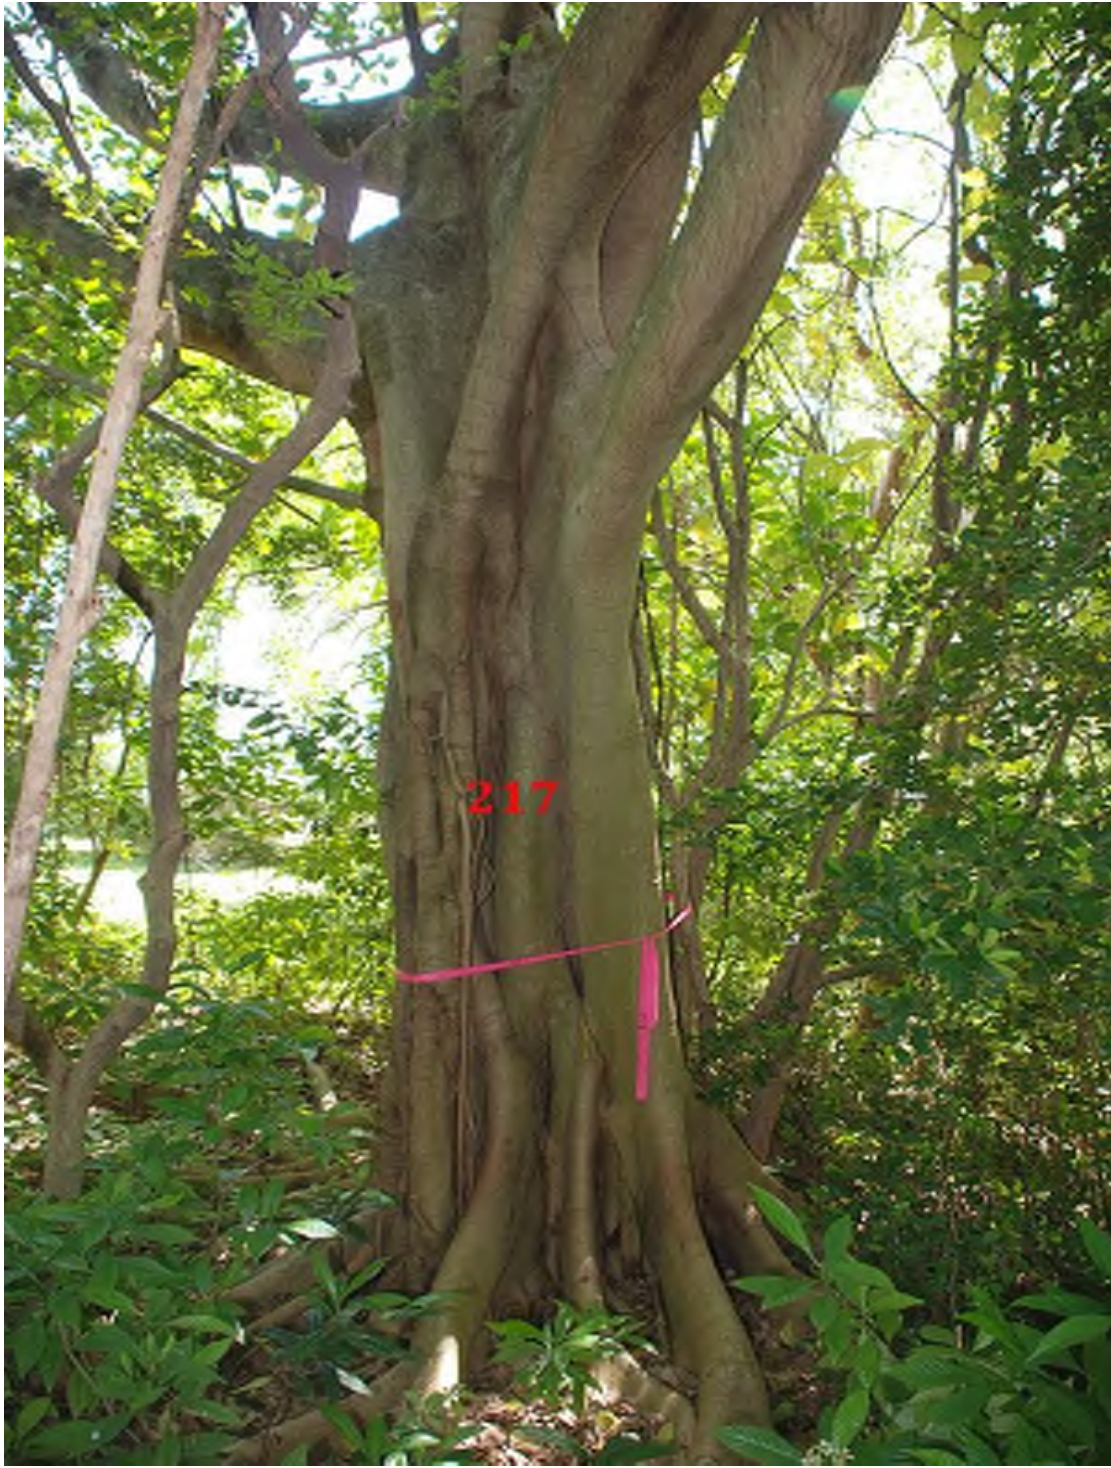
**Photo 111 above is tree 217 viewed from the east. I noted no signs of active decay or cavities on the trunk or root collar of this tree.**

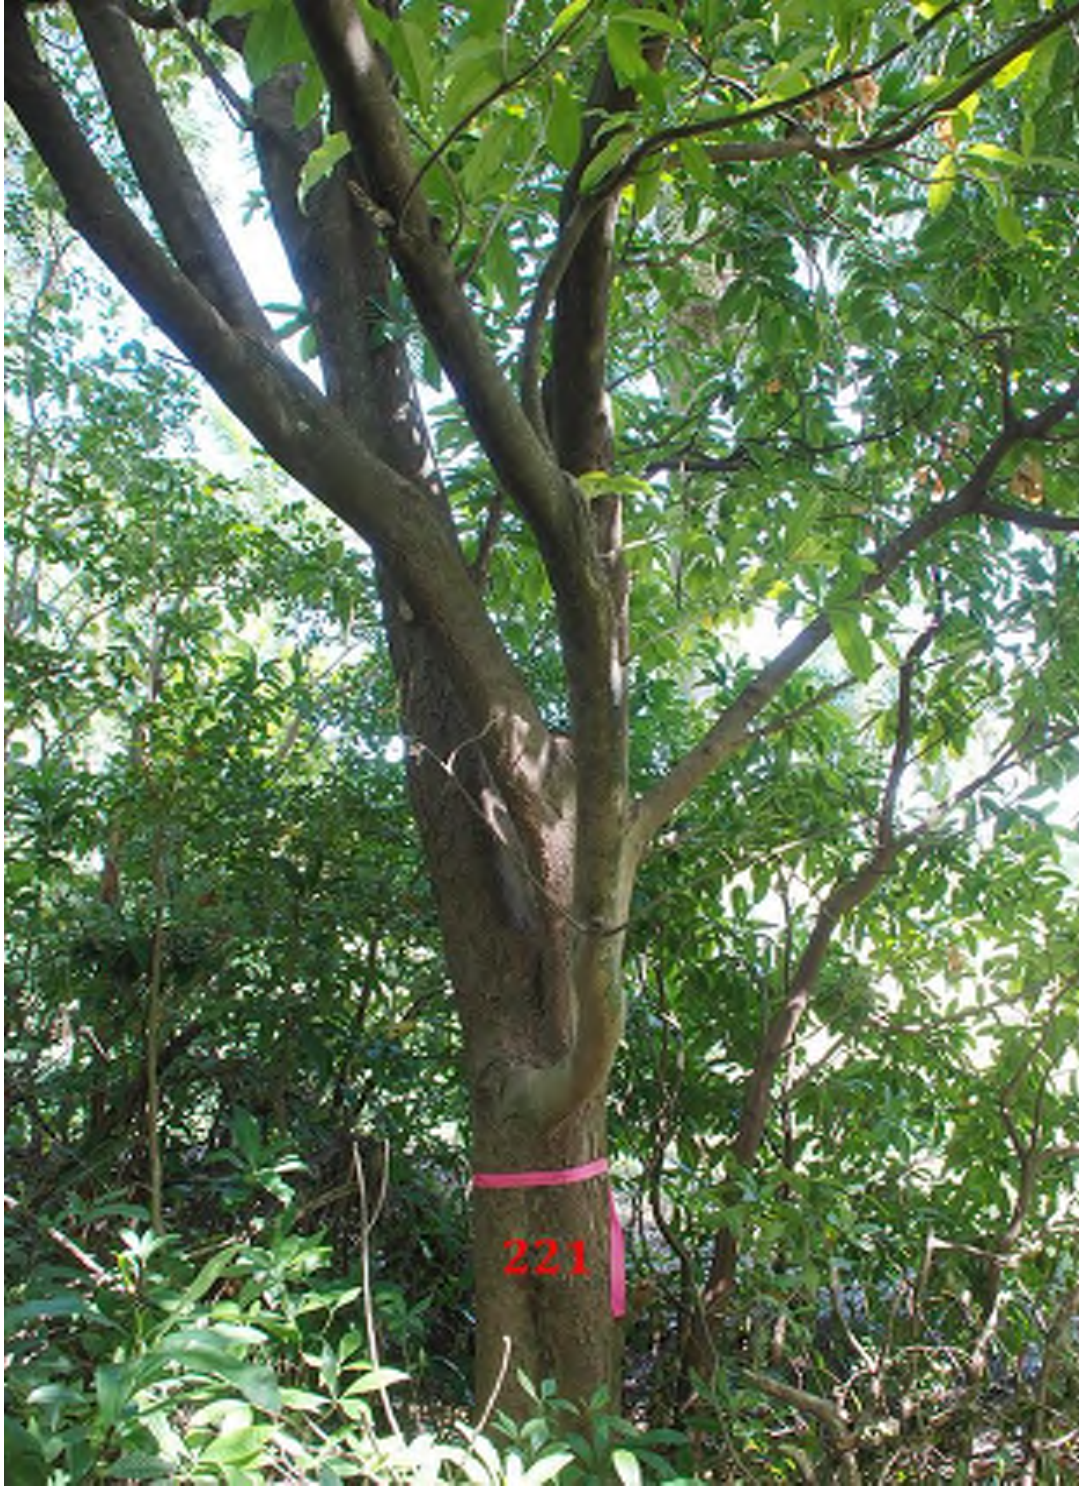
**Photo 115 above is tree 221. I noted no signs of active decay or cavities on the trunk or root collar of this tree.**

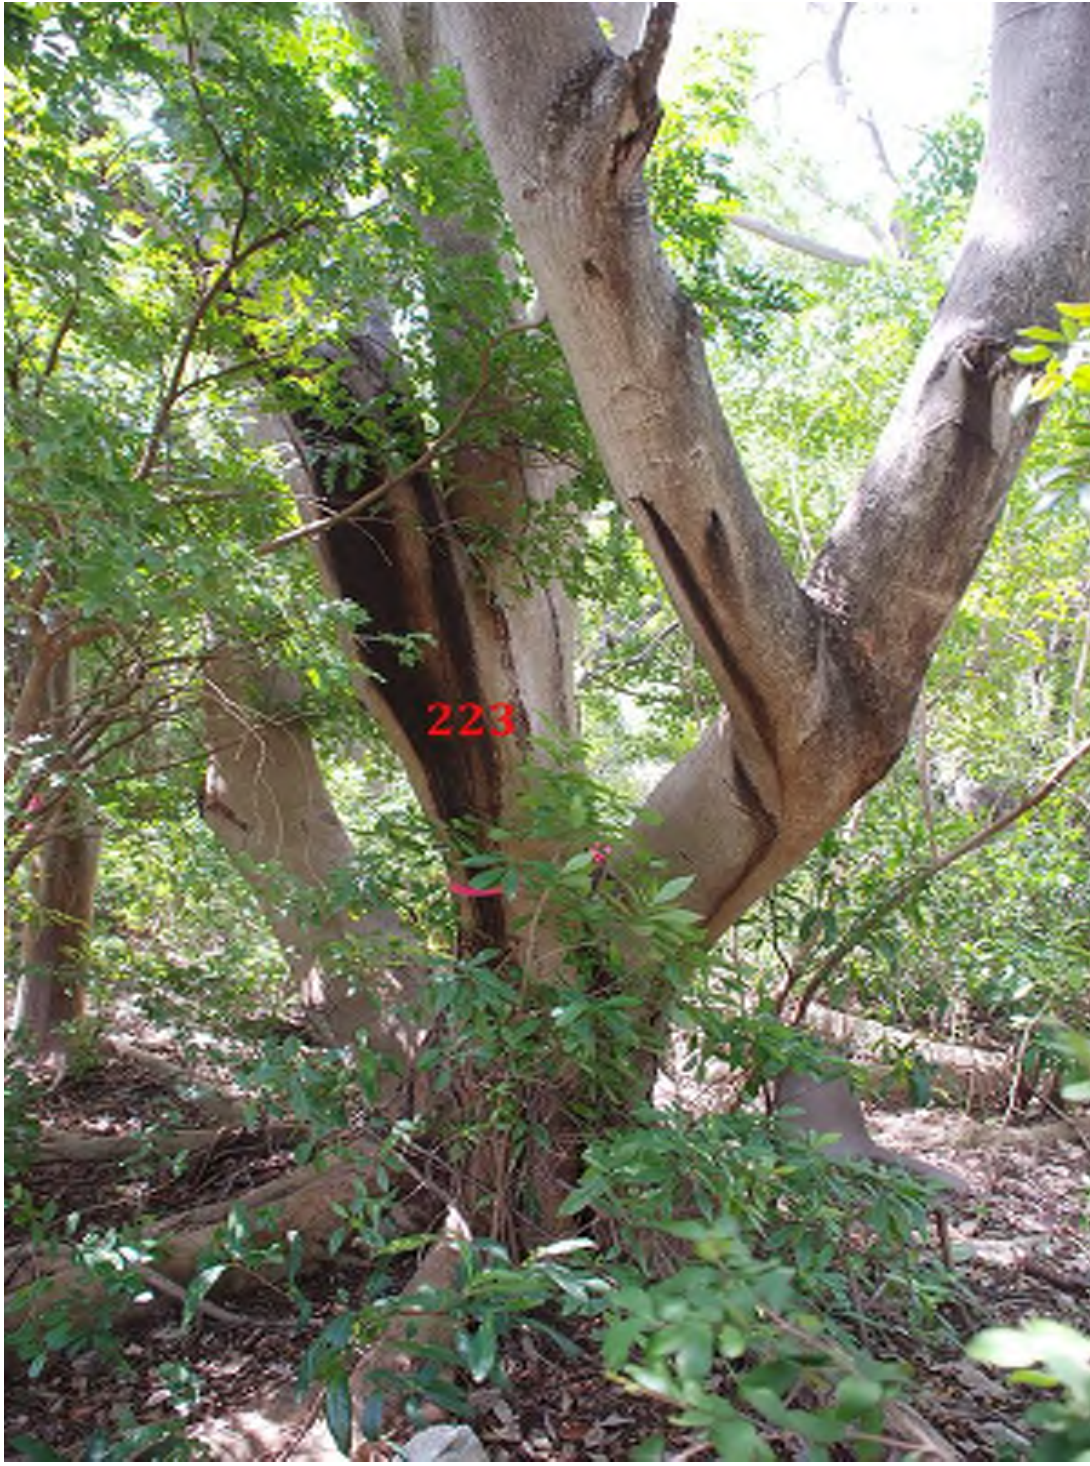
**Photo 118 above is tree 223 viewed from the east. I noted no signs of active decay or cavities on the trunk or root collar of this tree.**

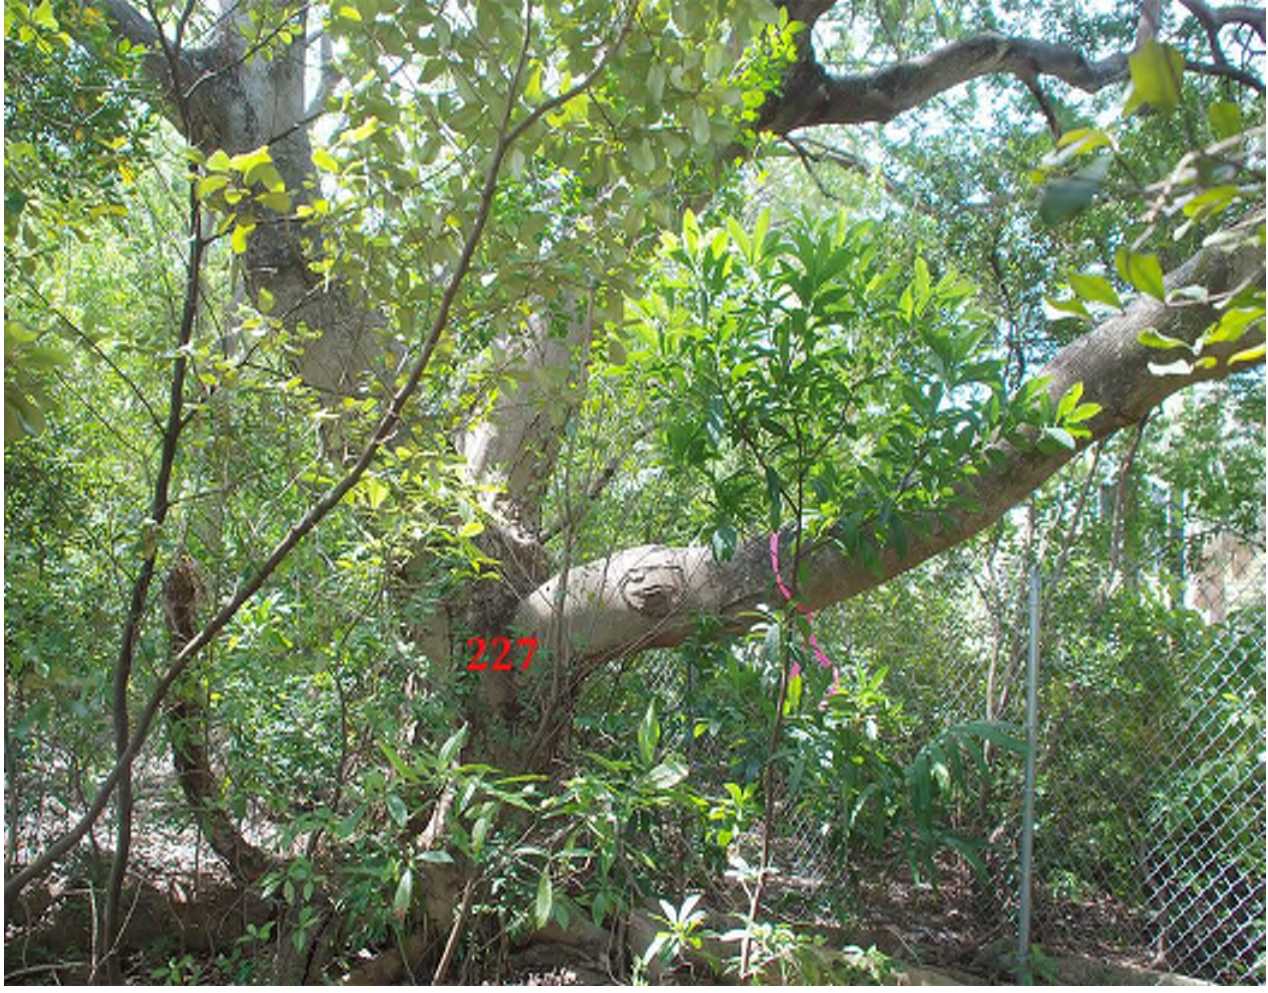
**Photo 123 above is tree 227 viewed from the west. I noted no signs of active decay or cavities on the trunk or root collar of this tree.**

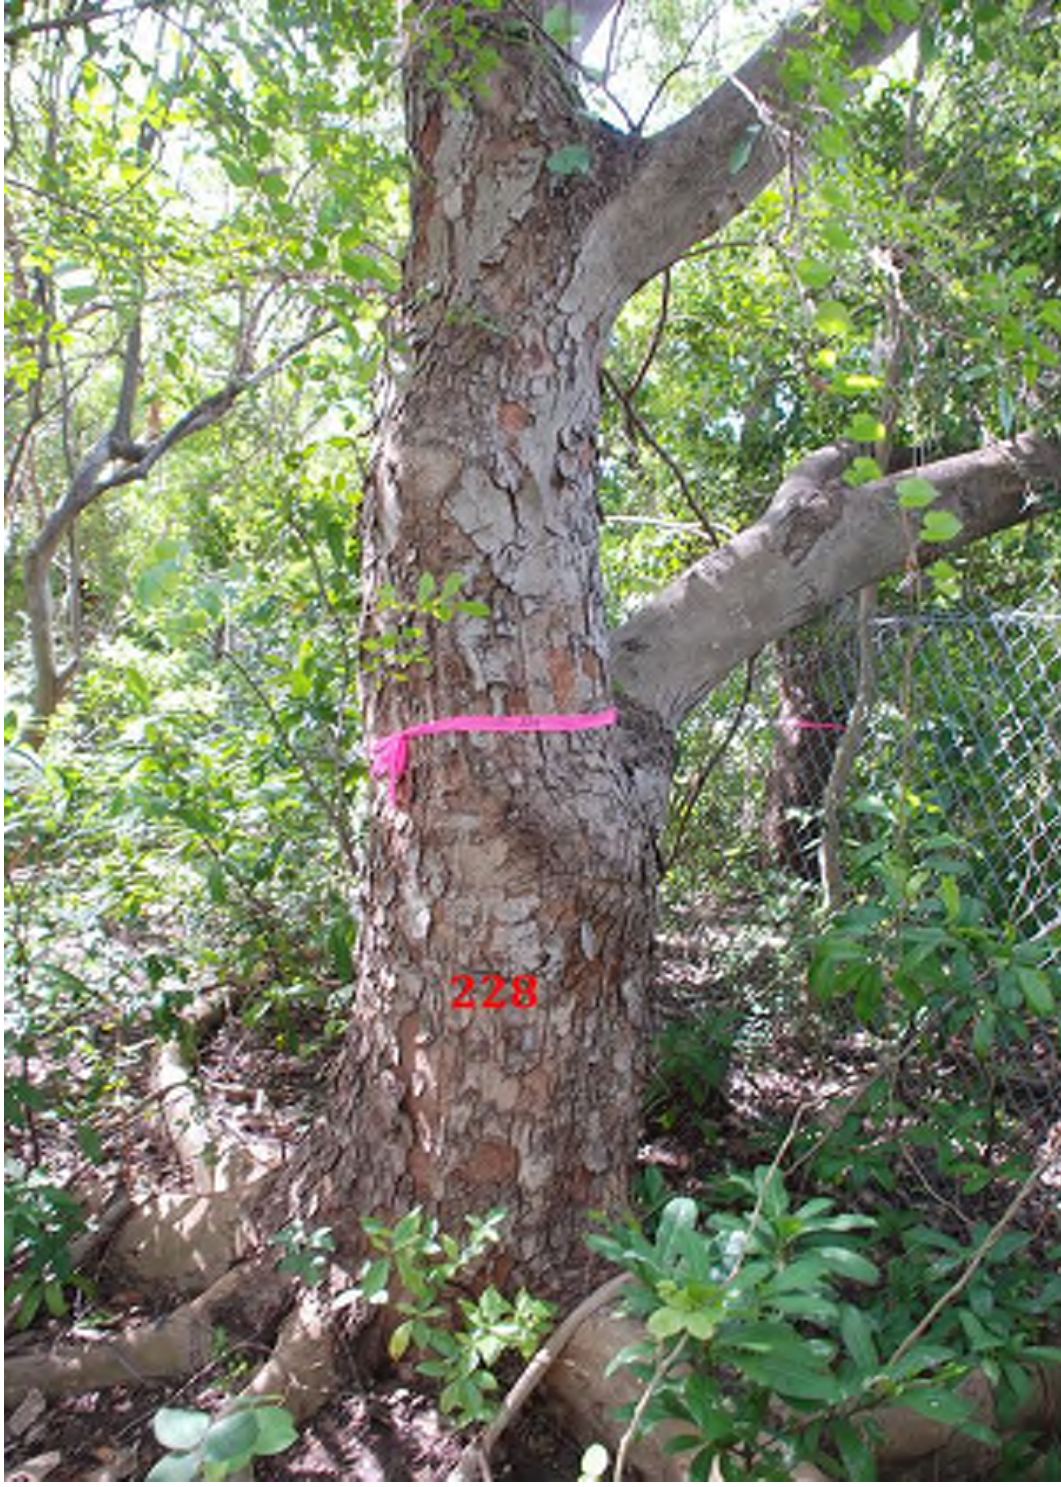
**Photo 125 above is tree 228 viewed from the west. I noted no signs of active decay or cavities on the trunk or root collar of this tree.**

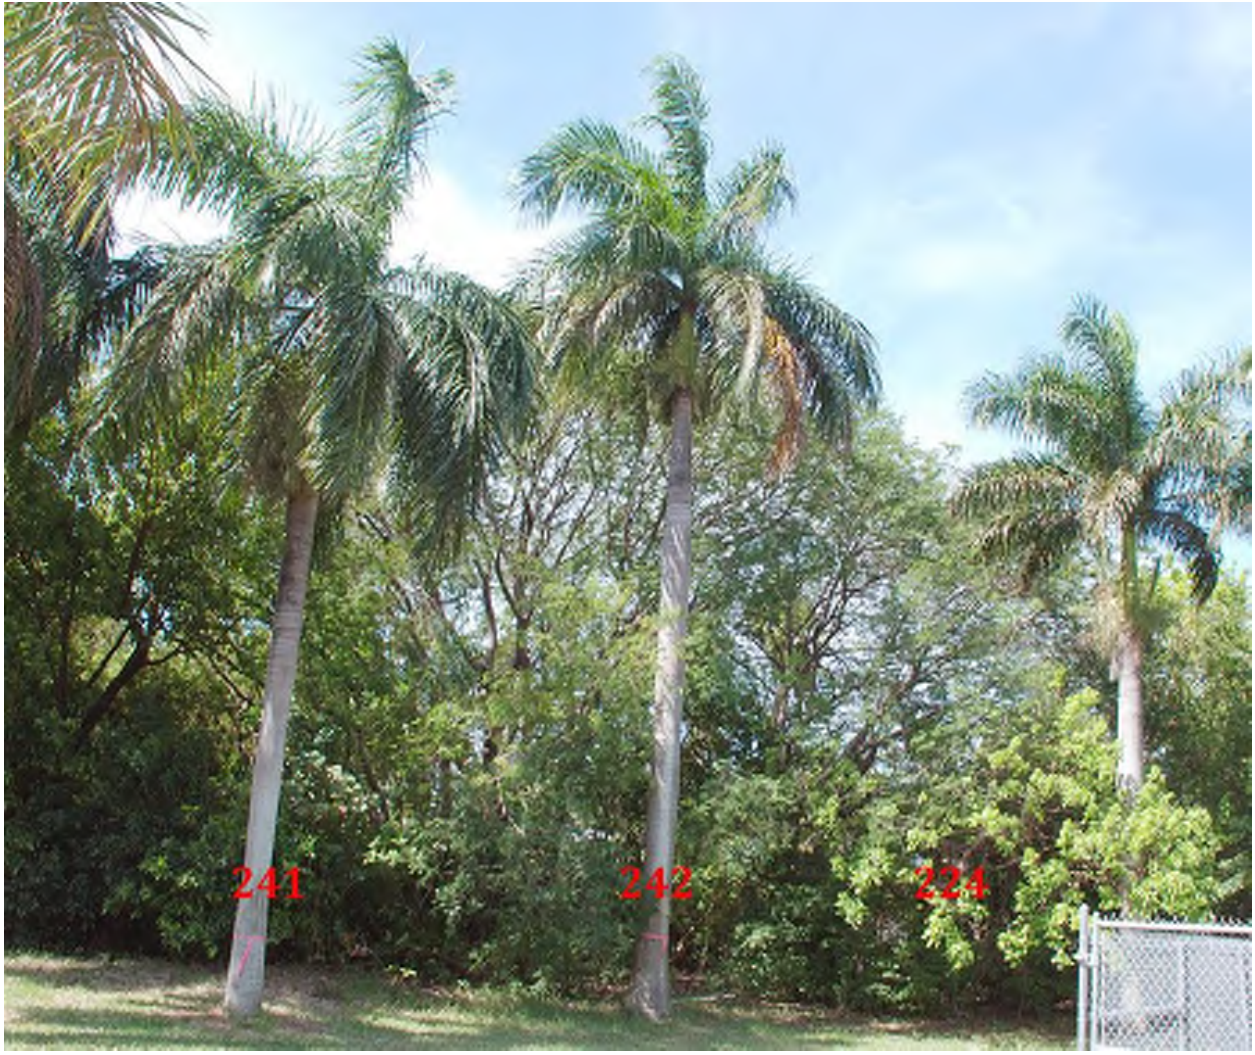
**Photo 135 above is palms 241 & 242 and tree 224.**

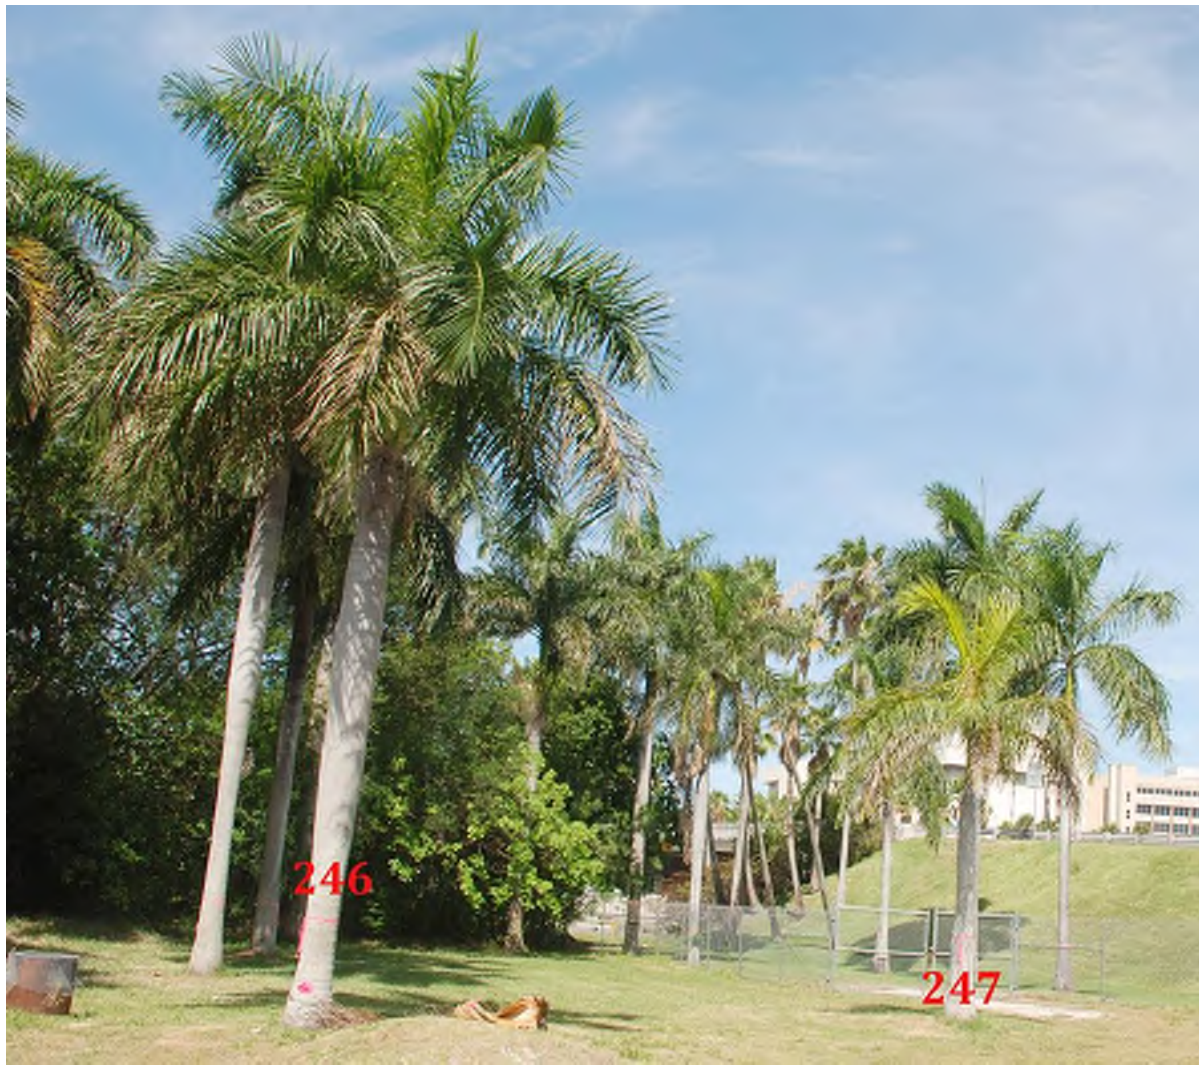
**Photo 136 above is palms 246 & 247.**

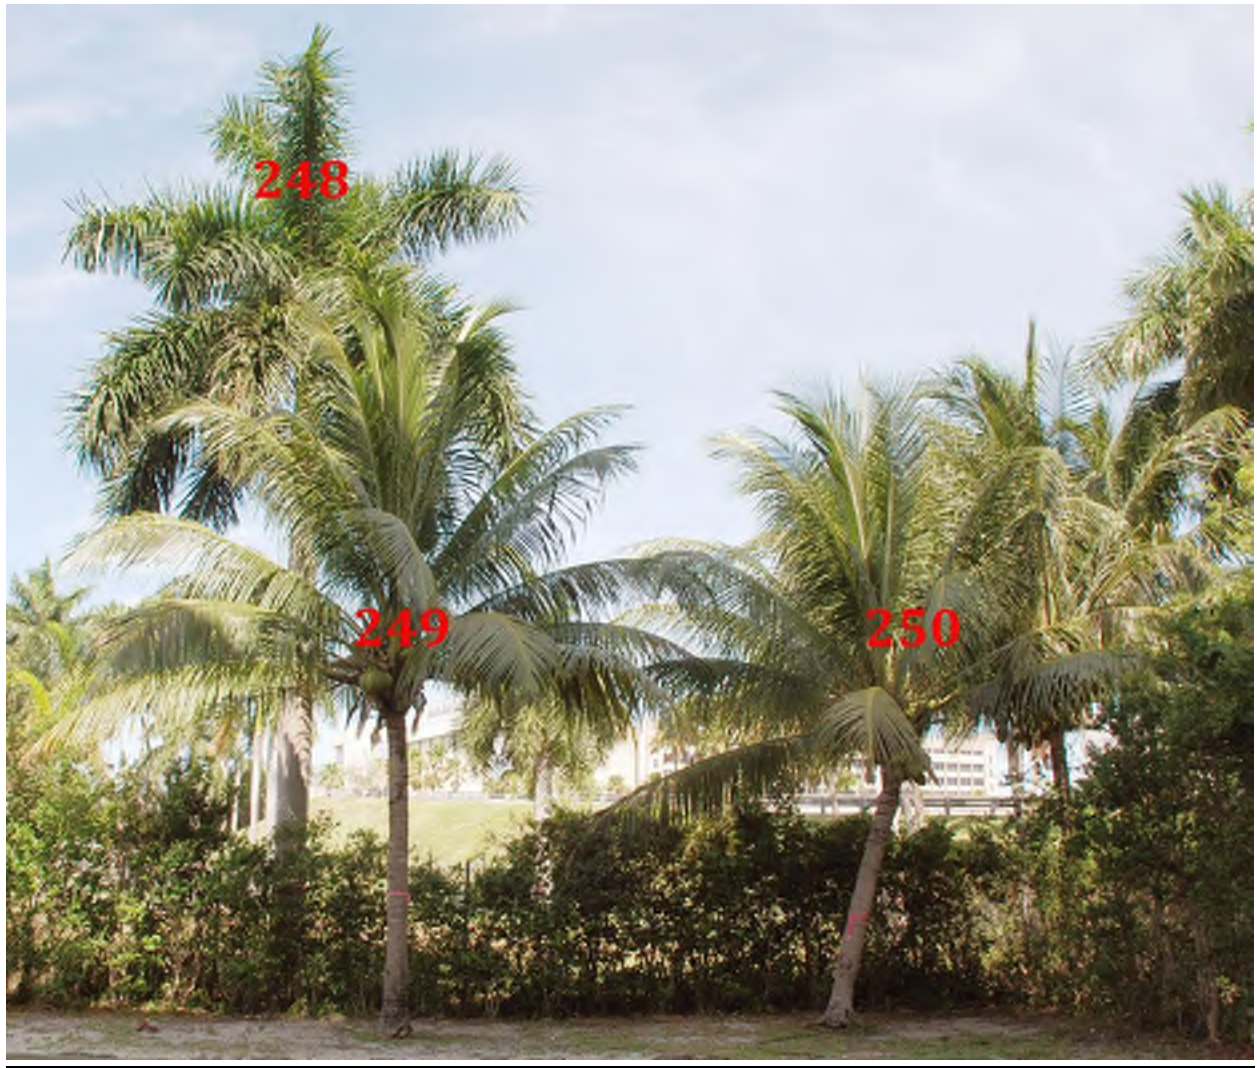
**Photo 138 above is palms 248, 249 & 250.**

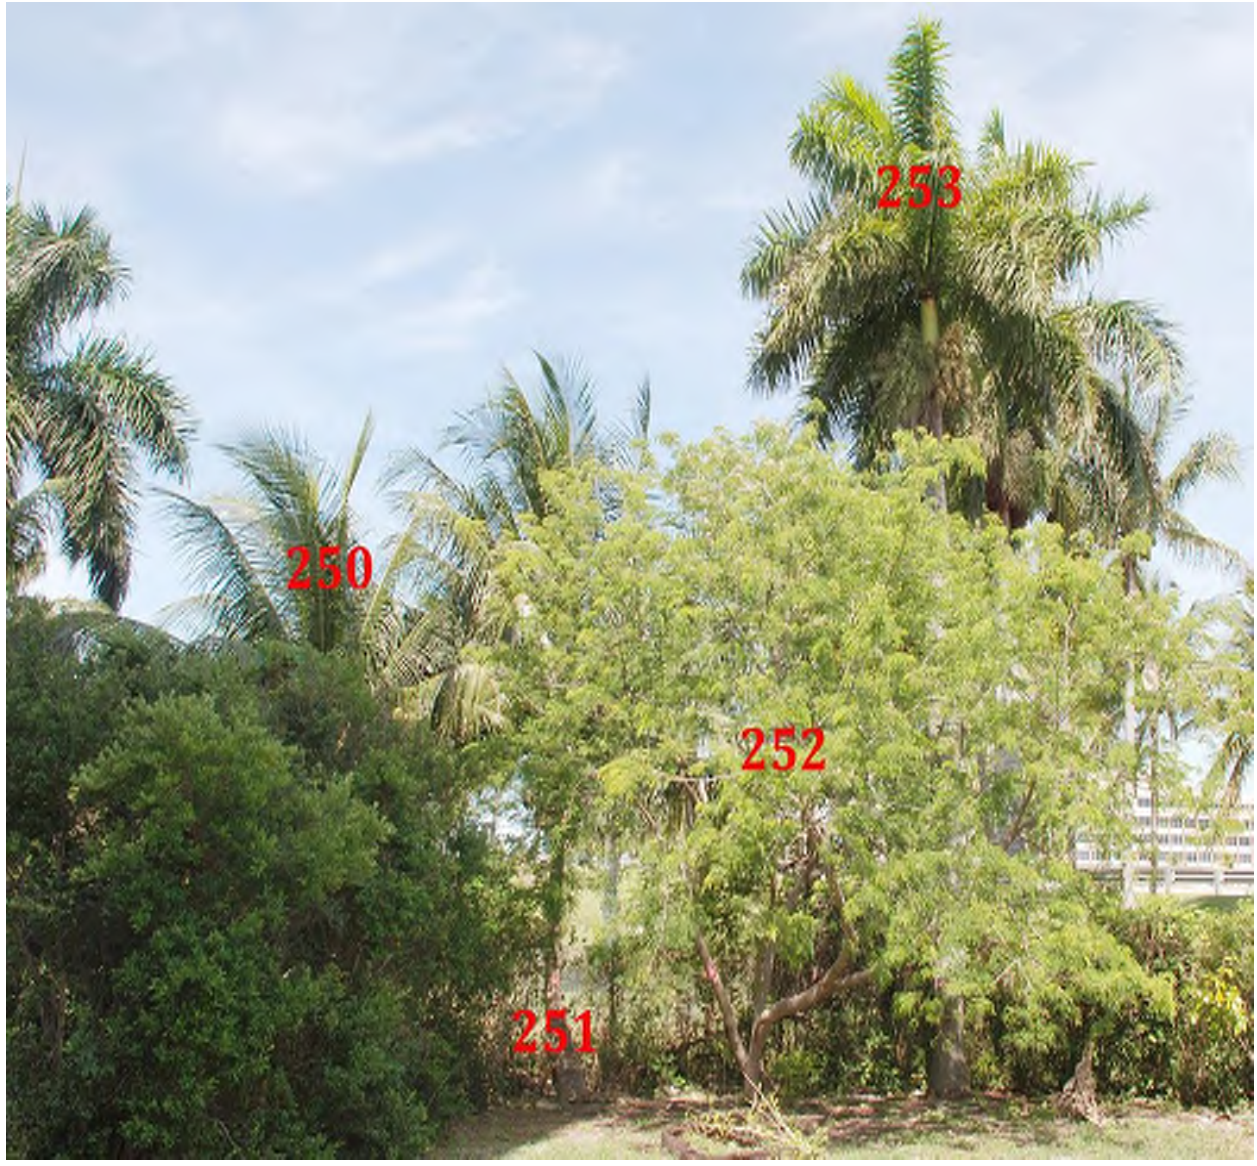
**Photo 139 above is palms 250, 251 & 253 and tree 252.**

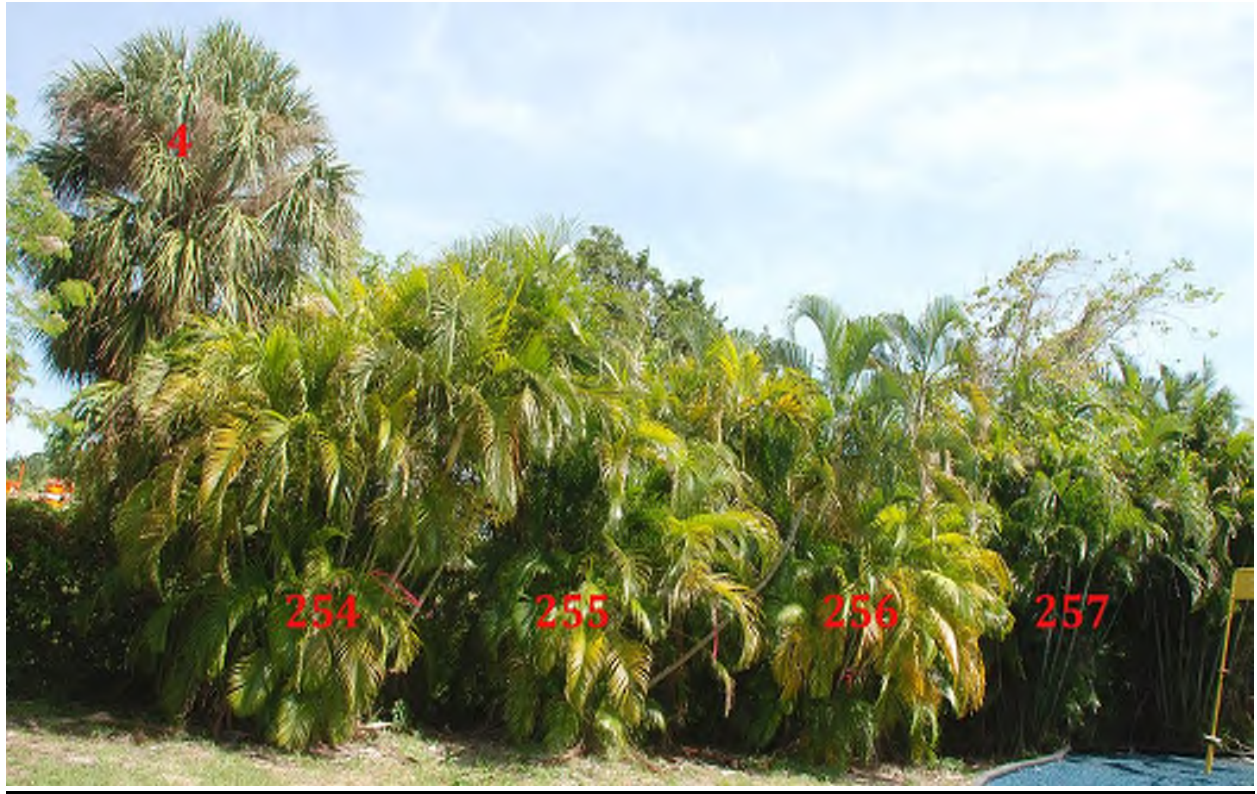
**Photo 140 above is palms 254 through 257.**
