FEASIBILITY REPORT FOR PRINCE MICHAEL HOTEL 2618 COLLINS AVENUE MIAMI BEACH, FLORIDA

STRUCTURAL FEASIBILITY REPORT FOR

**PRINCE MICHAEL HOTEL
2618 COLLINS AVENUE
MIAMI BEACH, FLORIDA**

JANUARY 17, 2017

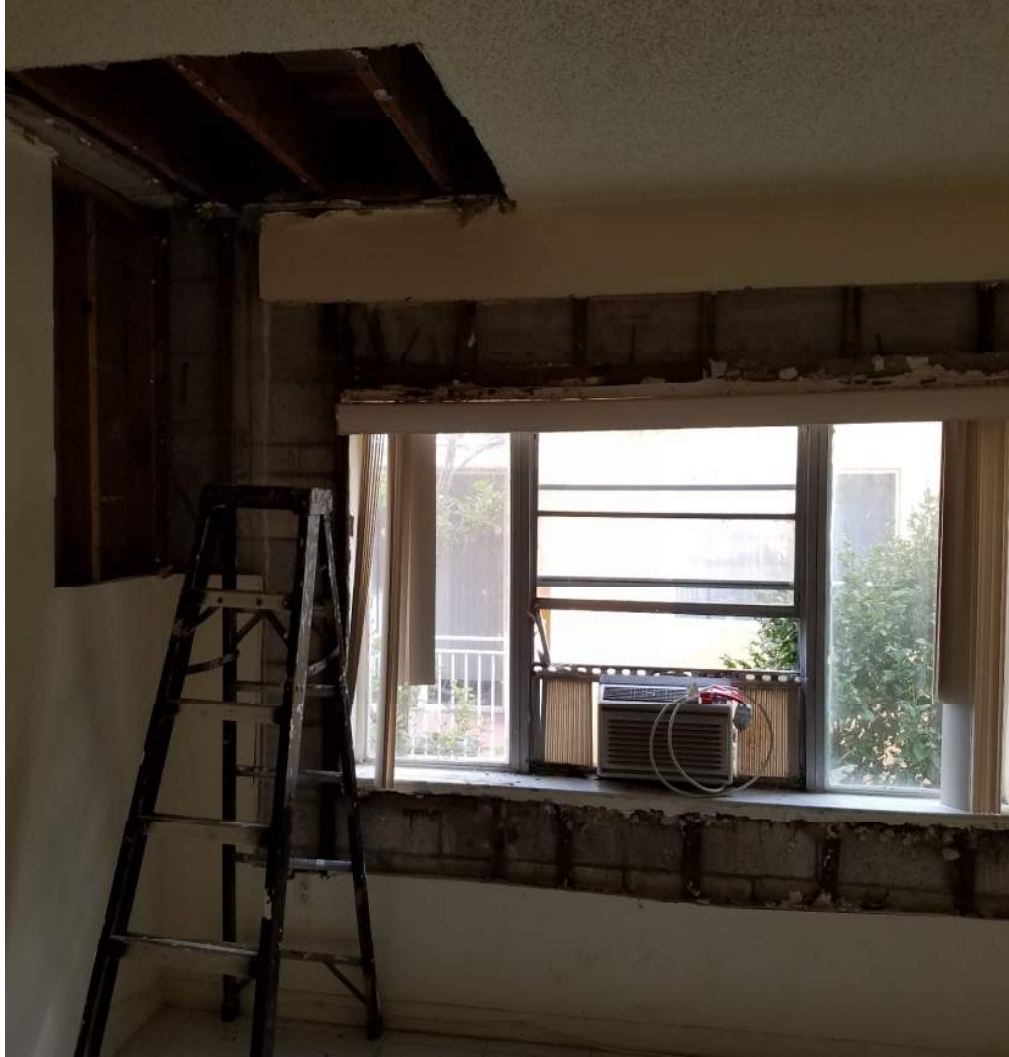
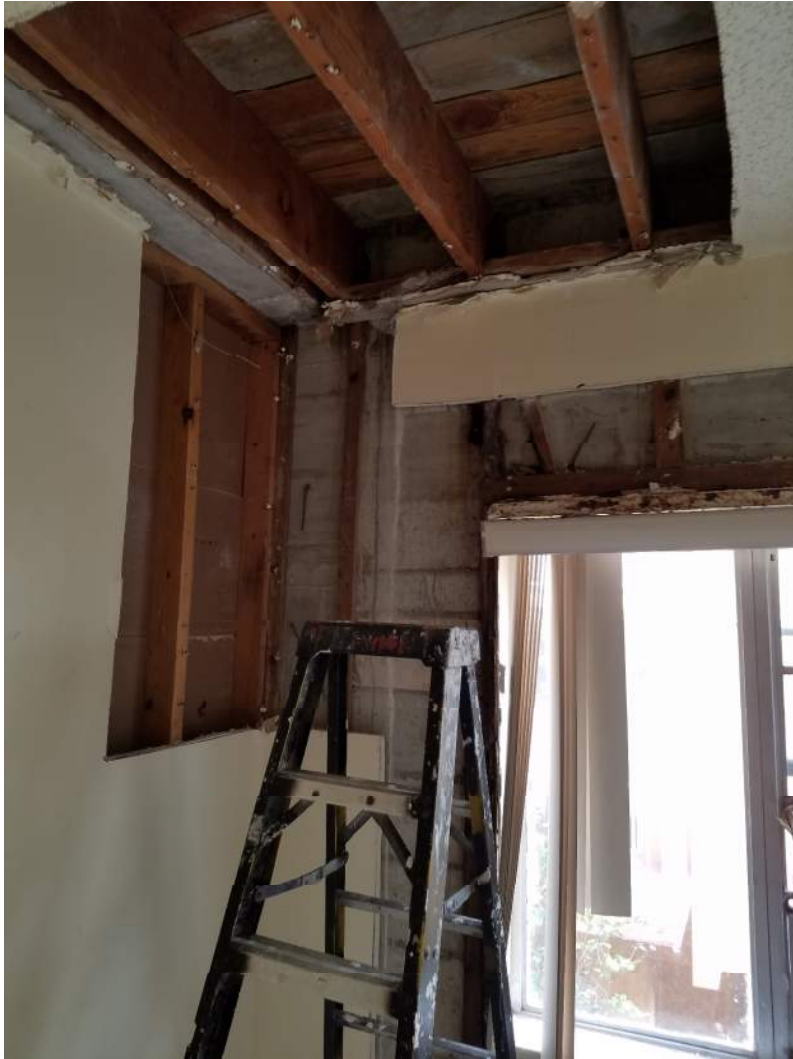
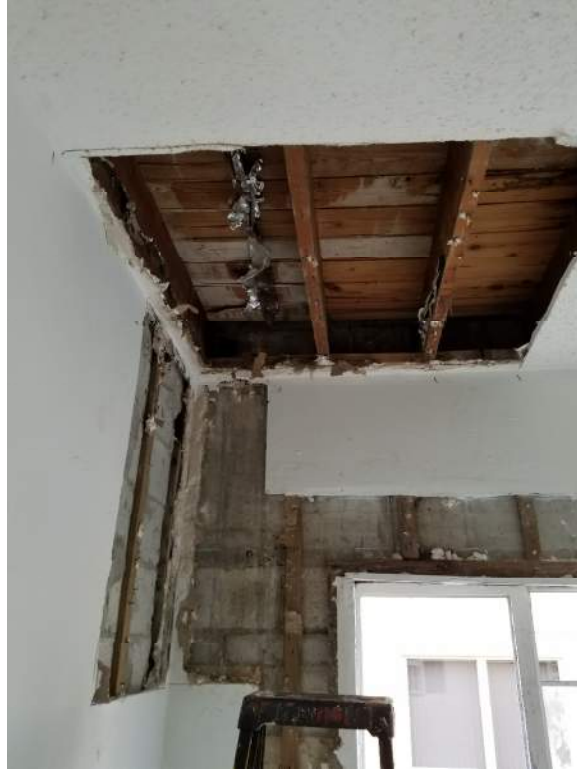
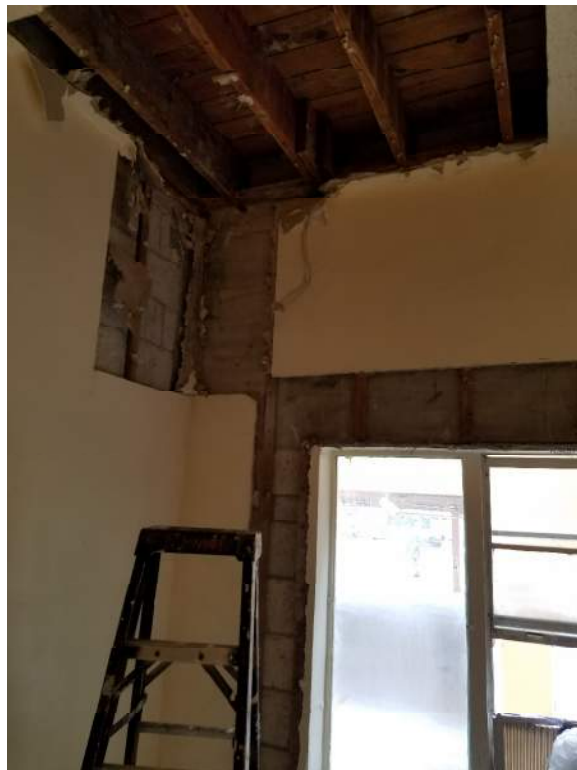
Around the perimeter of the building from the partial basement and second floor to the roof level and parapets the exterior walls consist of 8" bearing C.M.U. walls with concrete tie beams and concrete tie columns support the floor framing. In general, the tie columns on the perimeter walls were not completely exposed to measure the width. The concrete tie beams are 8"x46" at the second floor, 8"x22" at the third floor, and 8"x29" at the roof (Refer to Photographs No. 1 through No. 4).

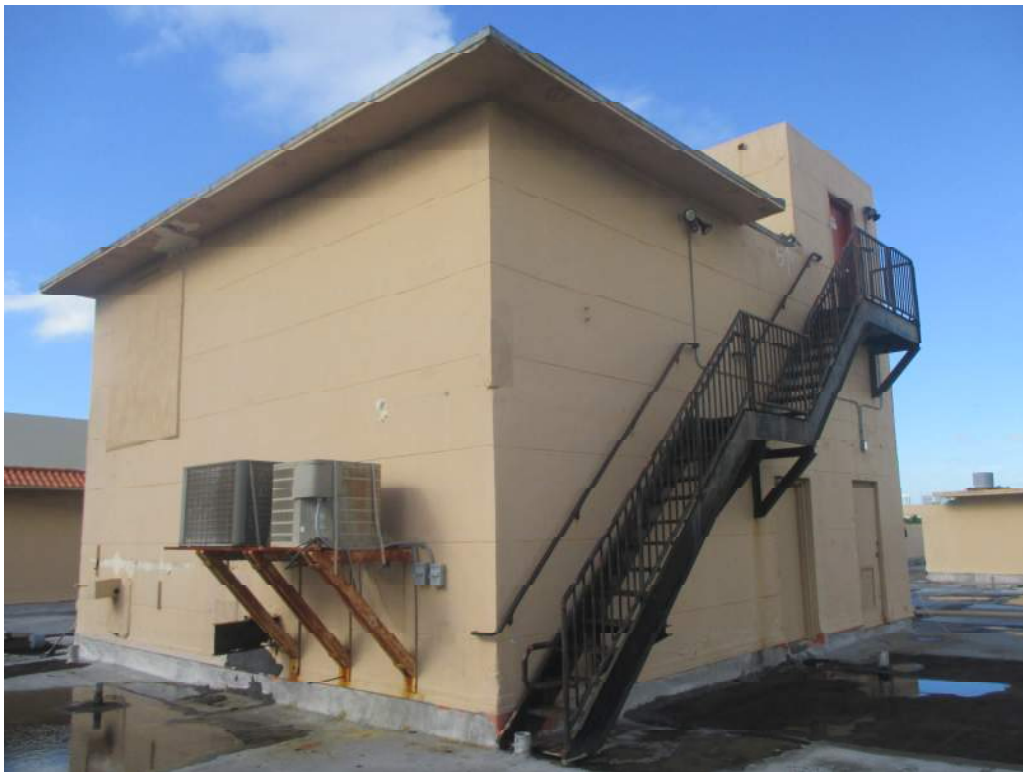
PHOTOGRAPH NO. 32

There is an elevator shaft located at the west side of the lobby. This shaft extends past the roof. There is an elevator machine room above the roof with a steel access ladder (Refer to Photograph No. 32).

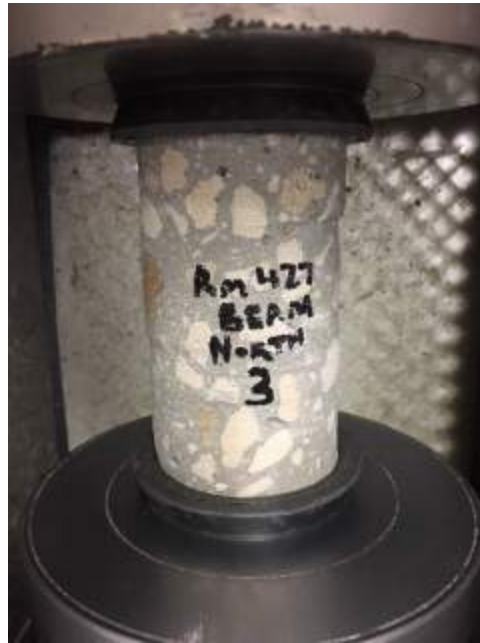
Figure 3: Core Sample – Compressive Strength Test

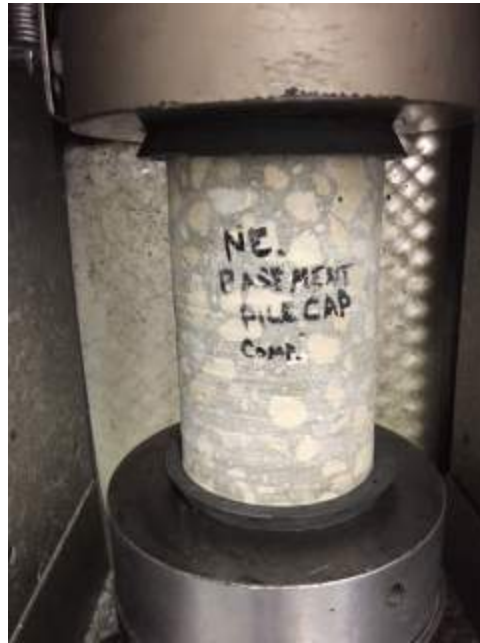
Figure 7: Core Sample – Compressive Strength Test
