HISTORIC RESOURCES REPORT

STRUCTURAL CONDITION ASSESSMENT
7925-7935 Crespi Blvd
Miami Beach, Florida 33141

STRUCTURAL CONDITION ASSESSMENT for
7925-7935 Crespi Blvd
Miami Beach, Florida

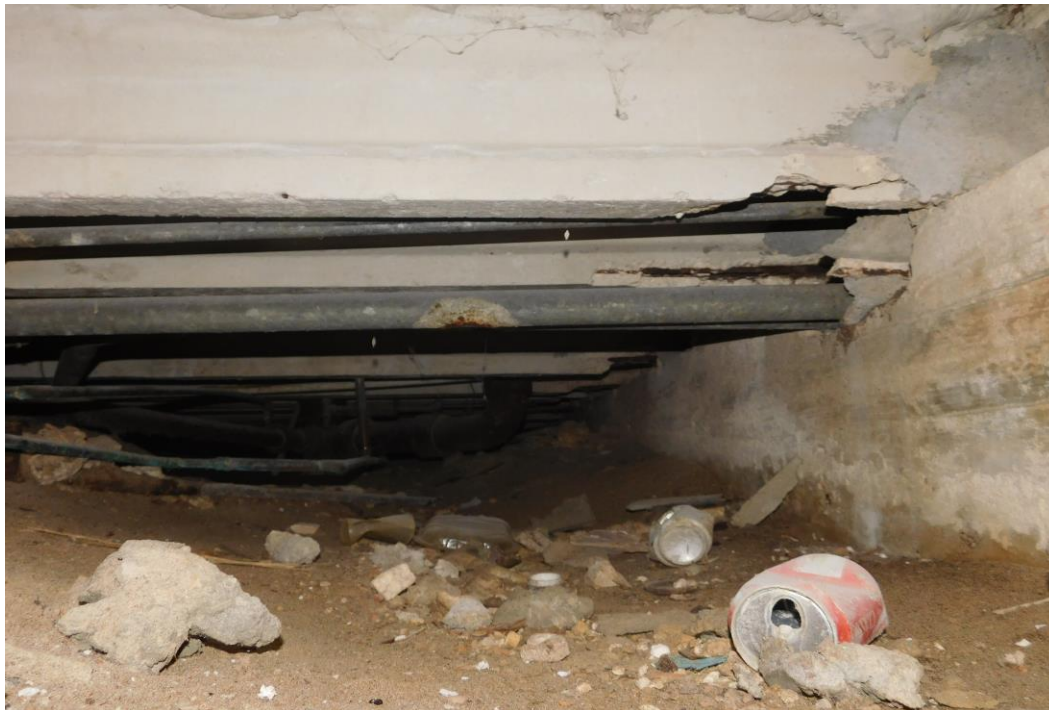
- The floor tiling system consists of typical ceramic tile installed over a wood framing attached to the precast planks mentioned above.
- We observed evidence of distress on the majority of the precast joists.

View of floor framing inside the crawlspace.

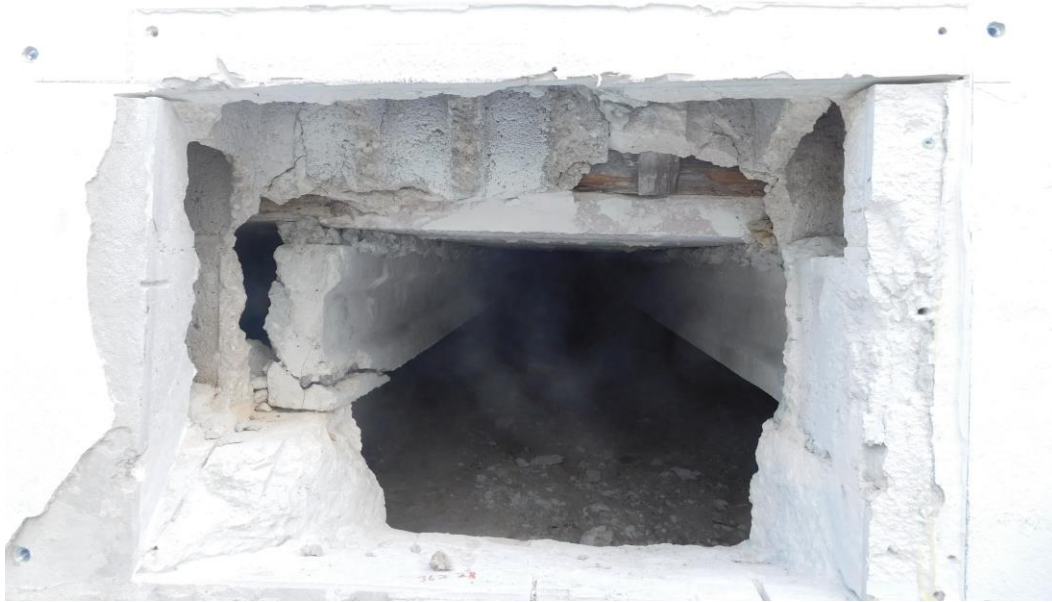
View of typical profile of floor framing.
