**Reference: 50-Year Recertification
Byron Carlyle Theater
500 71 St., Miami Beach, Florida
Folio 02-3211-002-1070**

MINIMUM INSPECTION PROCEDURAL GUIDELINES FOR BUILDING RECERTIFICATION - STRUCTURAL

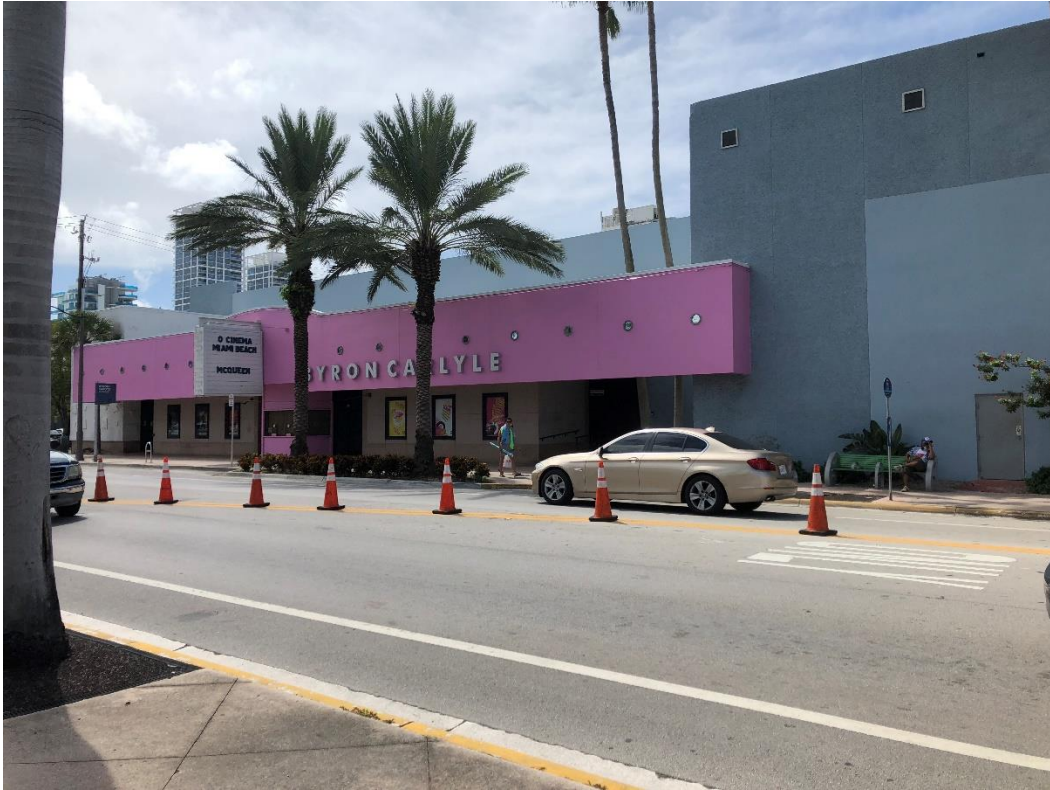
Photograph No. 1 - Overall Photograph of the Building

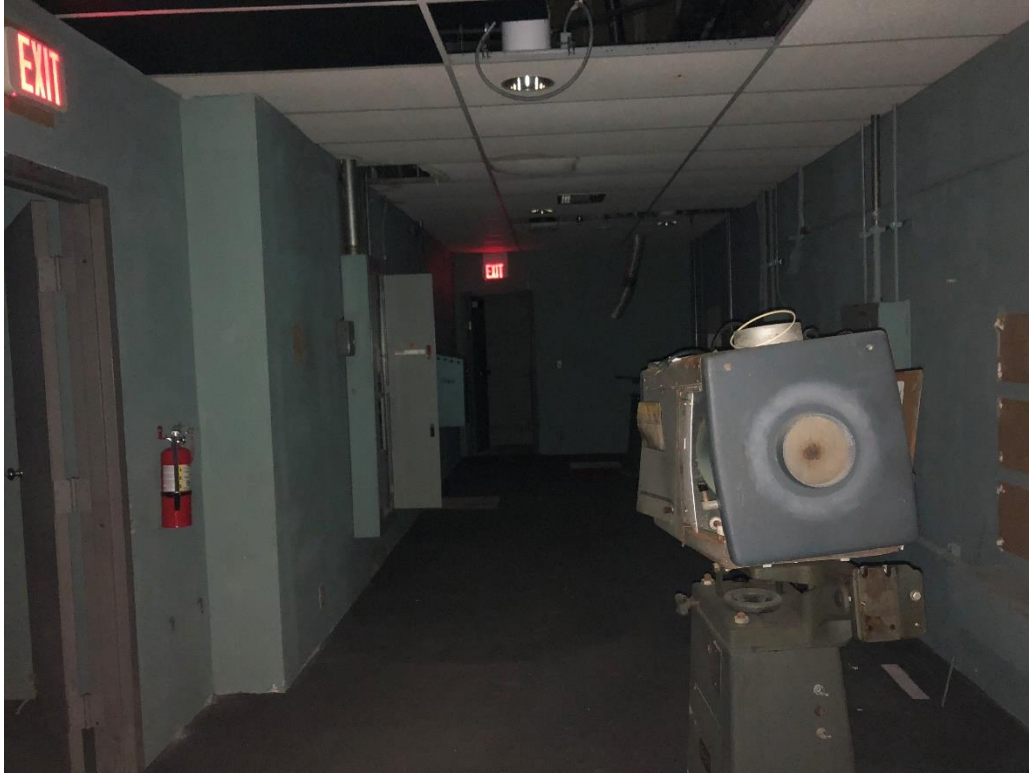
Photograph No. 3 - Projection Room for West Cinema Theaters

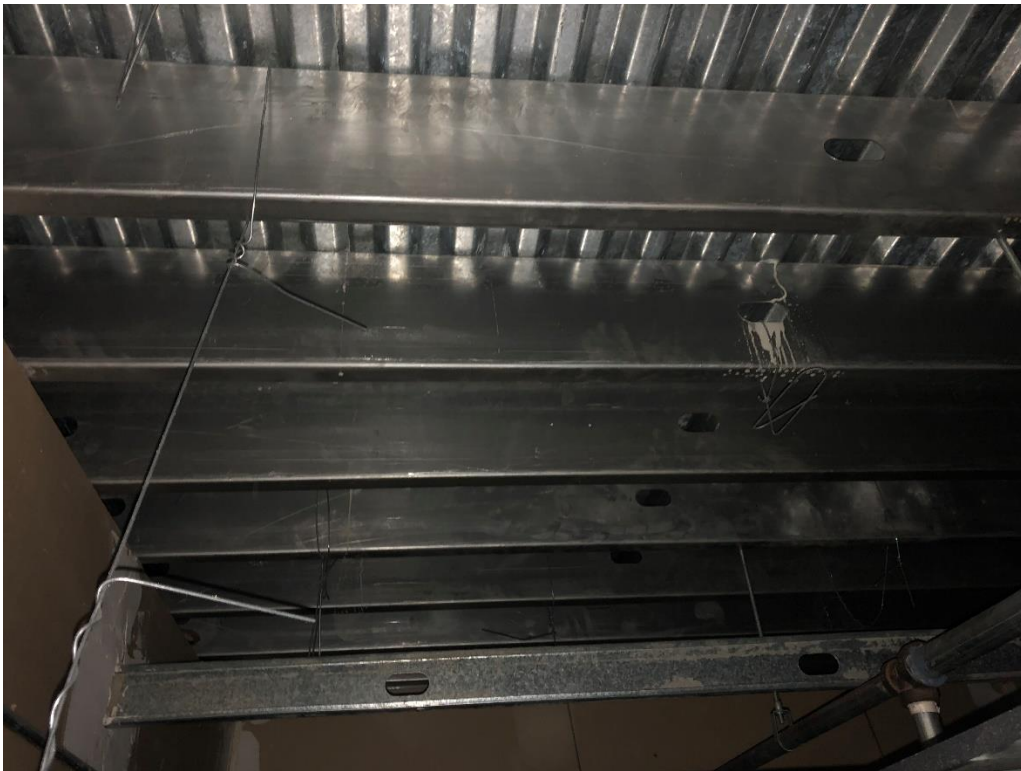
Photograph No. 4 – Floor framing of Projection Room for West Cinema Theaters

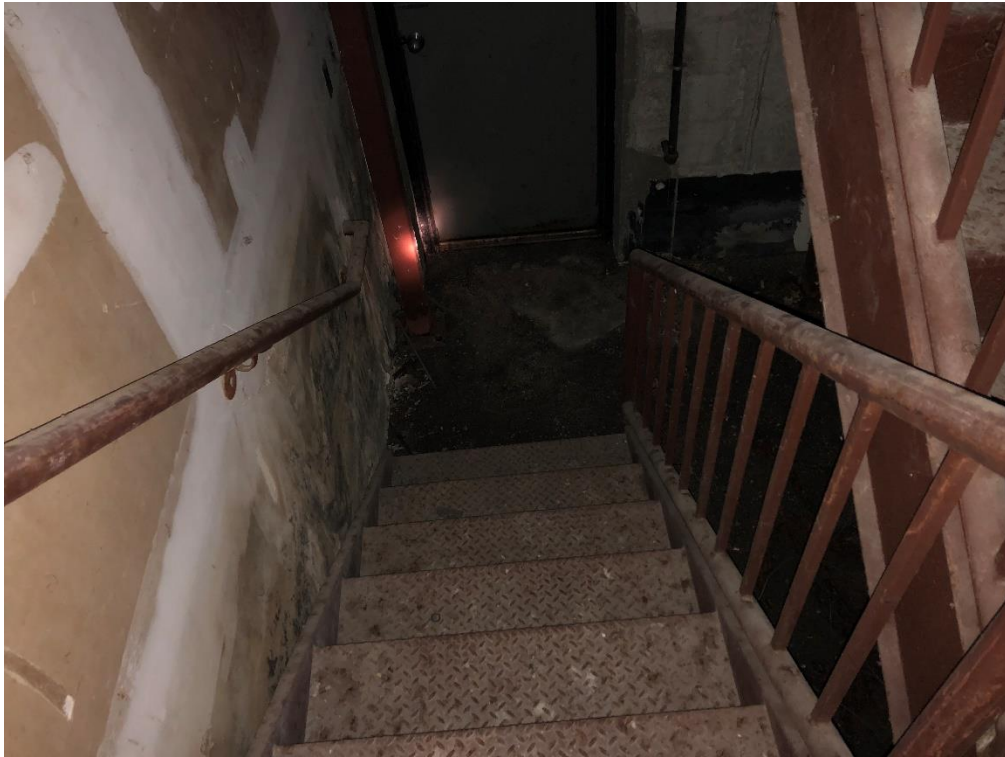
Photograph No. 5 – Steel-framed Exit Staircase for Projection Room of West Cinema Theaters

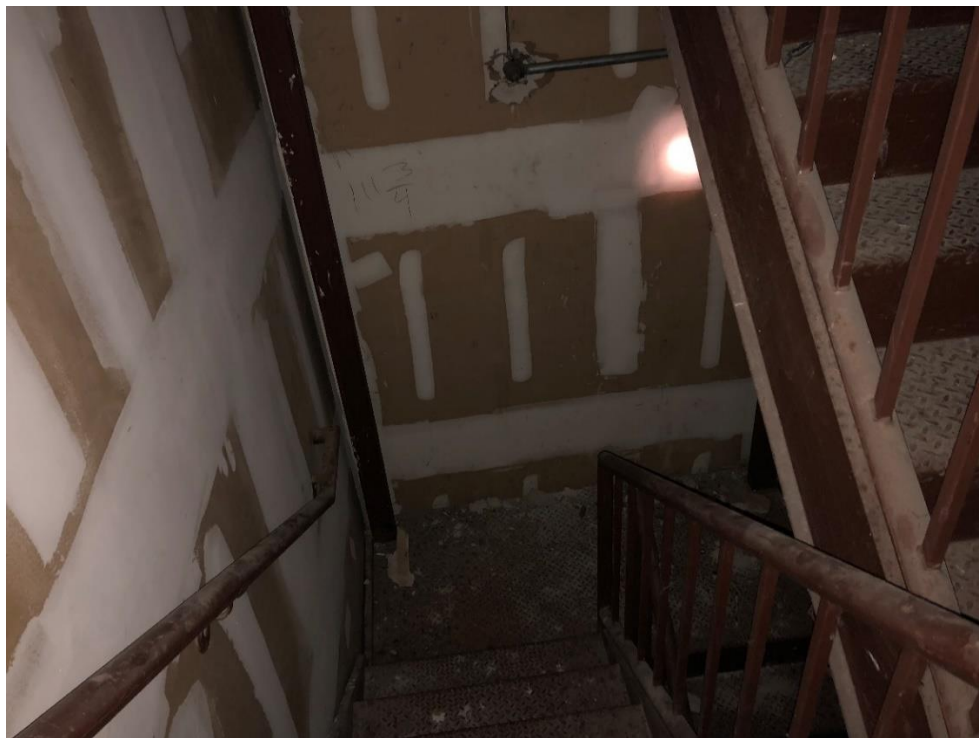
Photograph No. 6 – Steel-framed Exit Staircase for Projection Room of West Cinema Theaters

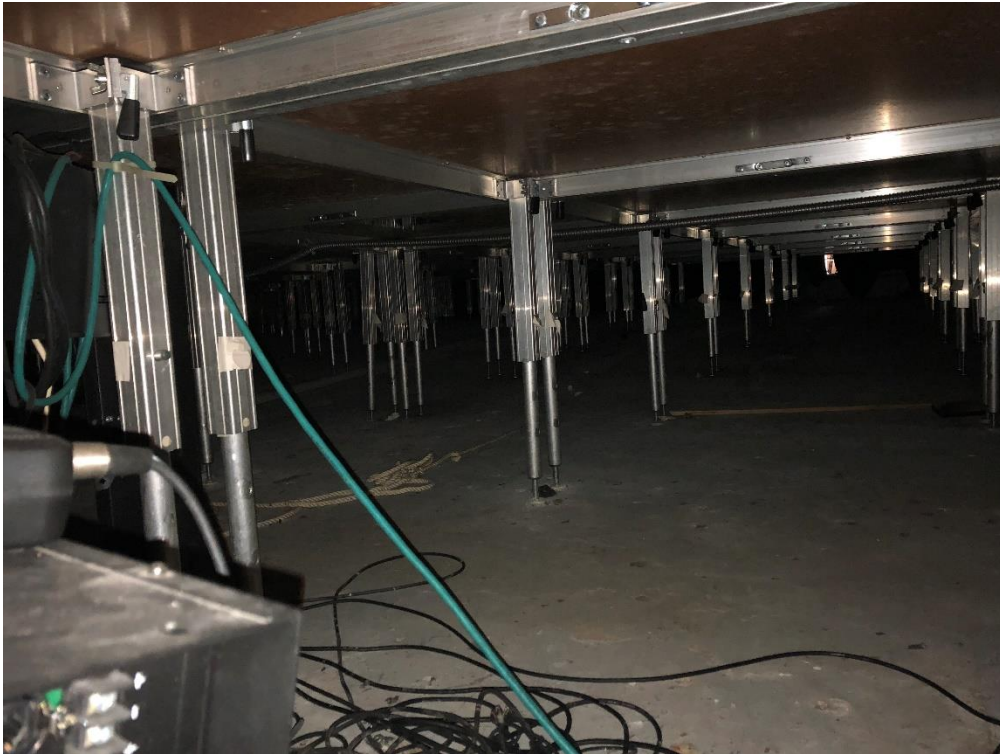
It is important to note that, as indicated before, the stage structure is a versatile (i.e. removable) prefabricated aluminum-framed platform (see Photographs 7 and 8). DWA could not find Building Department records for the construction/installation of this stage system. According to the manufacturer, Wegner, the load rating for a similar system is 125 PSF, which is a little below the 150 PSF required by the current Building Code. Additionally, the wood framing used to raise the platform does not appear to have been engineered nor permitted, nor does it appear to be an approved addition to the Wegner aluminum-framed stage system.

14) The main stage structure, a versatile (i.e. removable) prefabricated aluminum-framed platform (see Photographs 7 and 8), has some legs that are bent or crooked (see Photograph 78).

Photograph No. 7 - Aluminum-framed Stage Platform for East Cinema Theater

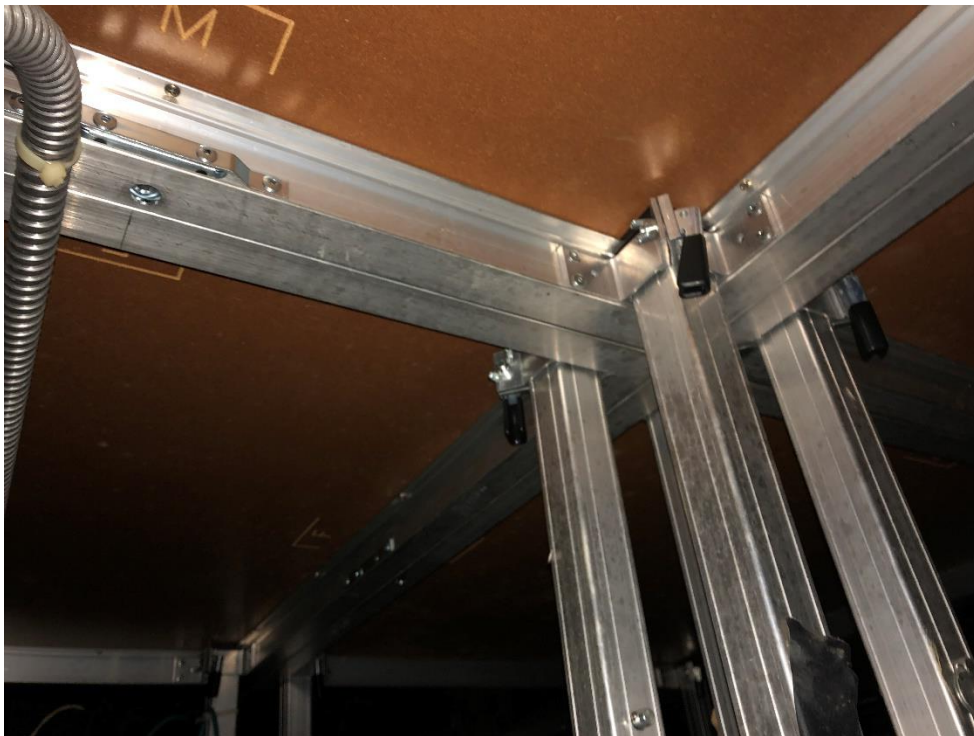
Photograph No. 8 - Aluminum-framed Stage Platform for East Cinema Theater

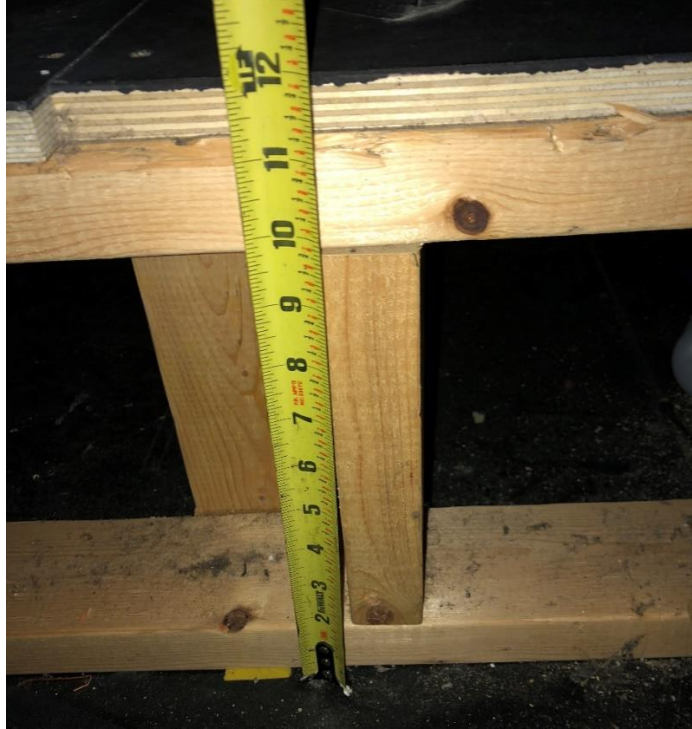
Photograph No. 9 – Built-up Wood Framing over Stage Platform for East Cinema Theater

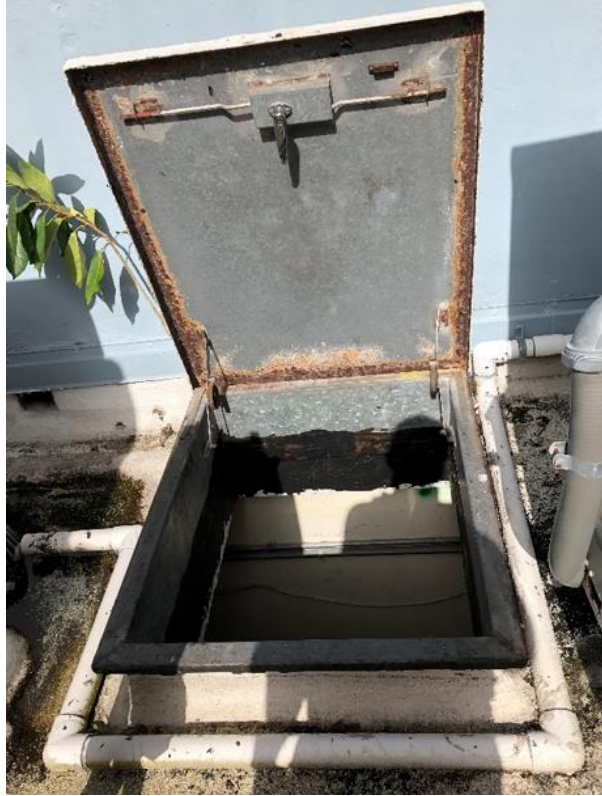
10) Access roof hatch located at the east low roof is mildly corroded (see Photograph 29).

Photograph No. 29 – Roof Access Hatch (Lower Roof at East Side)

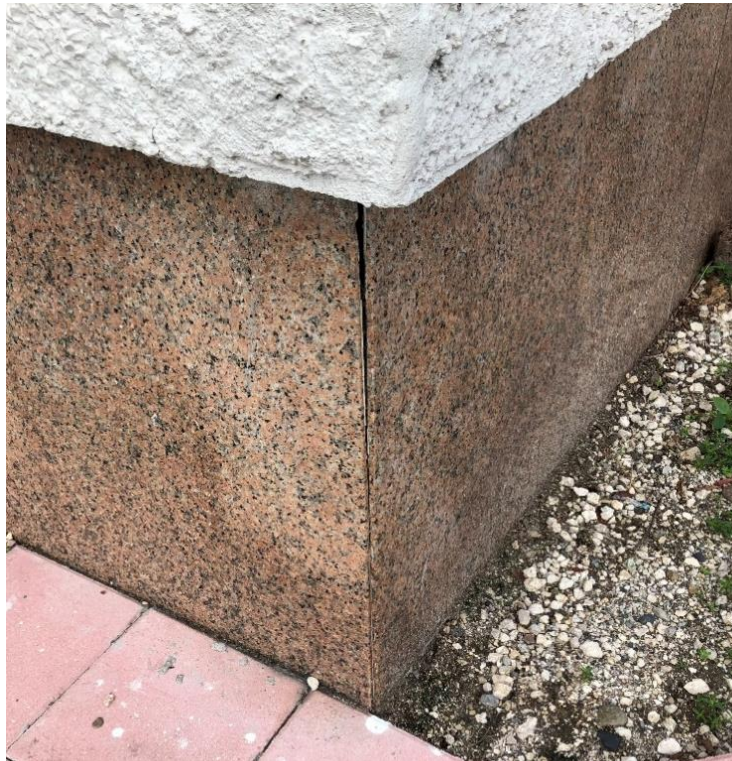
11) There is a small gap between the exterior adjoining stone tile at the northeast corner that might allow moisture ingress and therefore potential deterioration of structure behind (see Photograph 30).

Photograph No. 30 – Gap at Exterior Tile at Northeast Corner

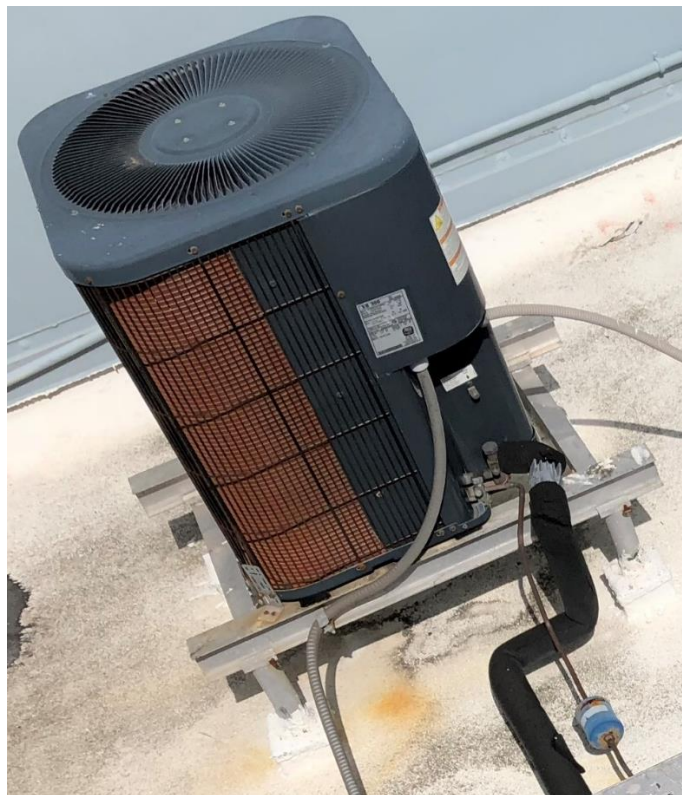
Photograph No. 32 – Stand-mounted AC unit at Lower Roof at East Side

- 19) Tighten cables that provide lateral stability to the north façade's theater sign (refer to Section 2.b.17).
 - 20) Stand-mounted condensing unit in lower roof at the east side is missing a clip connector (at a corner) to the aluminum-framed stand (see Photograph 32).

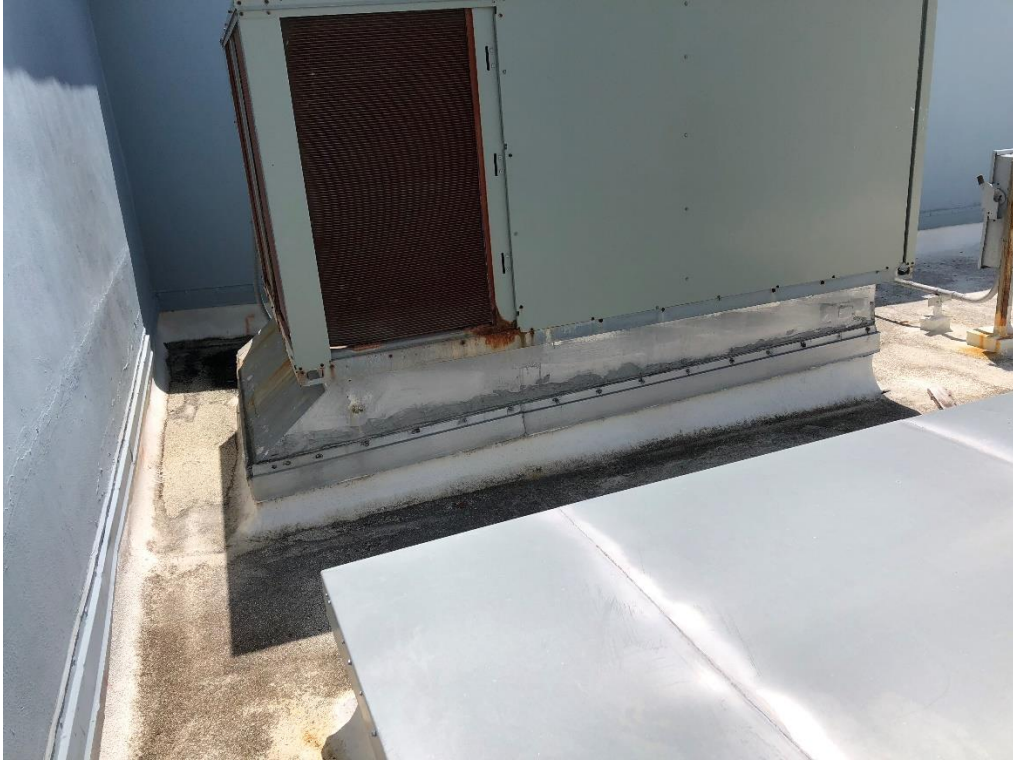
Photograph No. 33 – Rooftop Package Unit at Lower Roof between East and West Portions

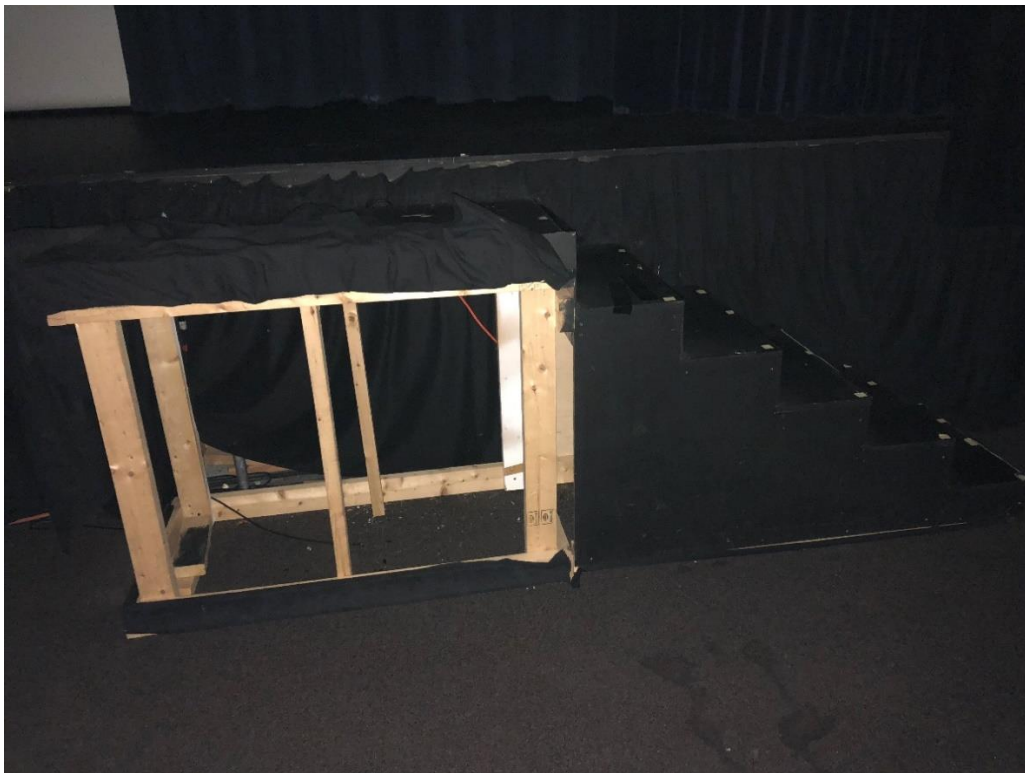
13) Steps to access stage of east cinema theater from the seating area are constructed of wood framing (see Photograph 34). The vertical members of this wooden staircase are constructed so that they transfer the load to the bottom wood plates that are bearing directly on the theater's carpet (see Photograph 35). Some of the vertical members, however, are not connected to the bottom plate (see Photograph 36). The framing of steps lacks bracing (they are not connected to the stage structure), and the assembly is not anchored to the floor.

Photograph No. 34 – Wood-framed staircase (East Cinema Theater)

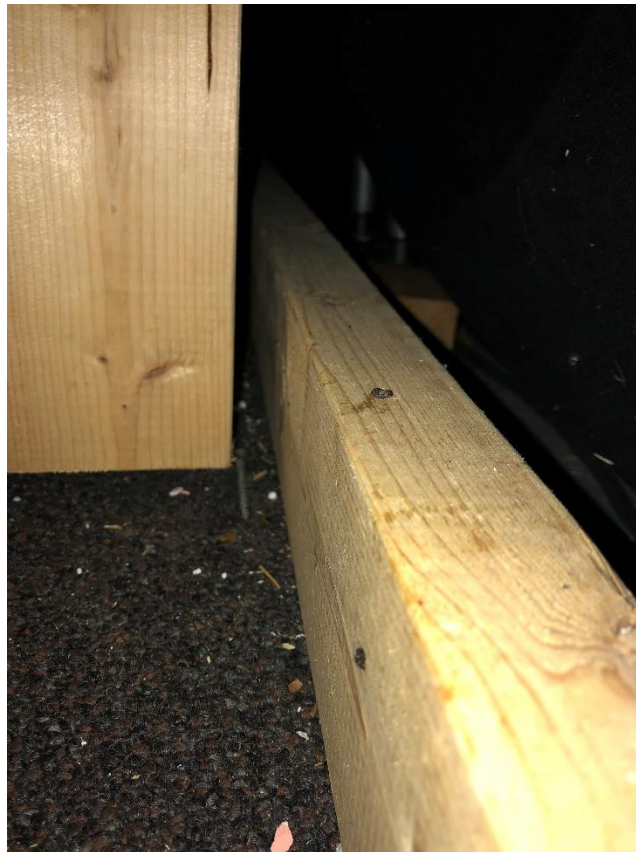
Photograph No. 36 – Gap between vertical member and bottom plate

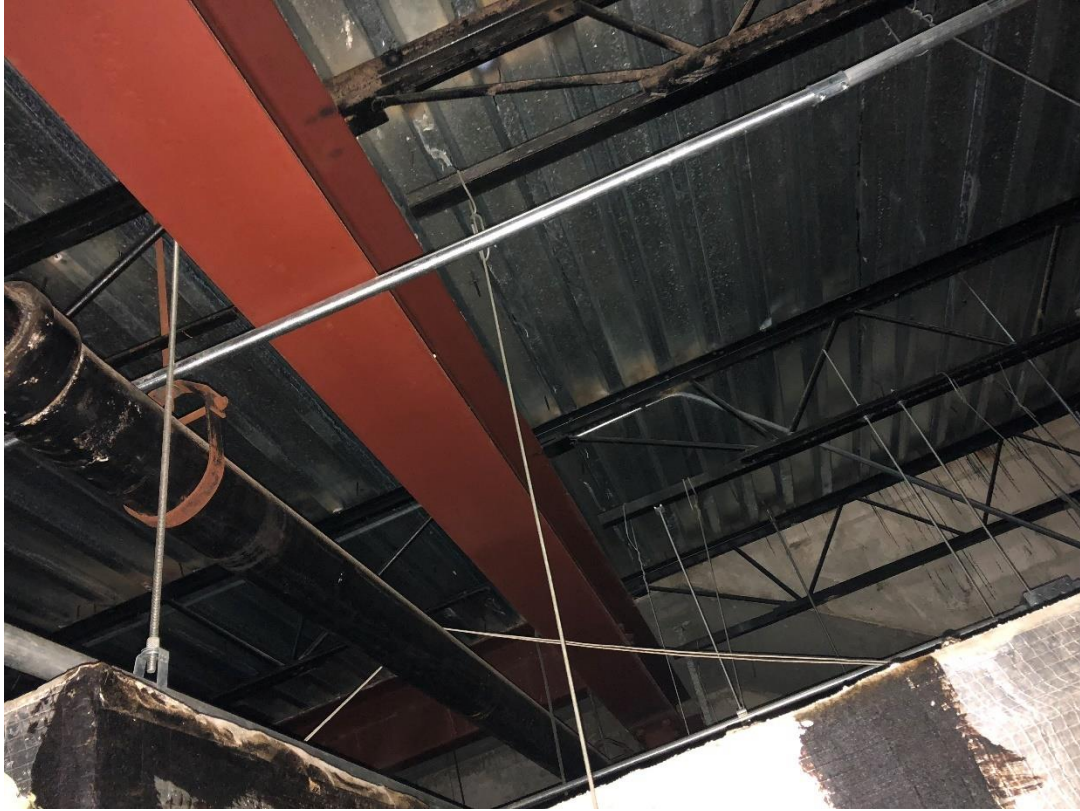
18) There were moisture stains in at least a couple of locations of the ceiling of the first-floor office area (towards the north façade) (see Photograph 40). This may be related to water intrusion from the low roof at the north façade. DWA, however, inspected the underside of the roof structure at this location and did not find signs of significant structural deterioration (see Photograph 41).

Photograph No. 41 – Underside of roof structure of Low Roof at North Façade

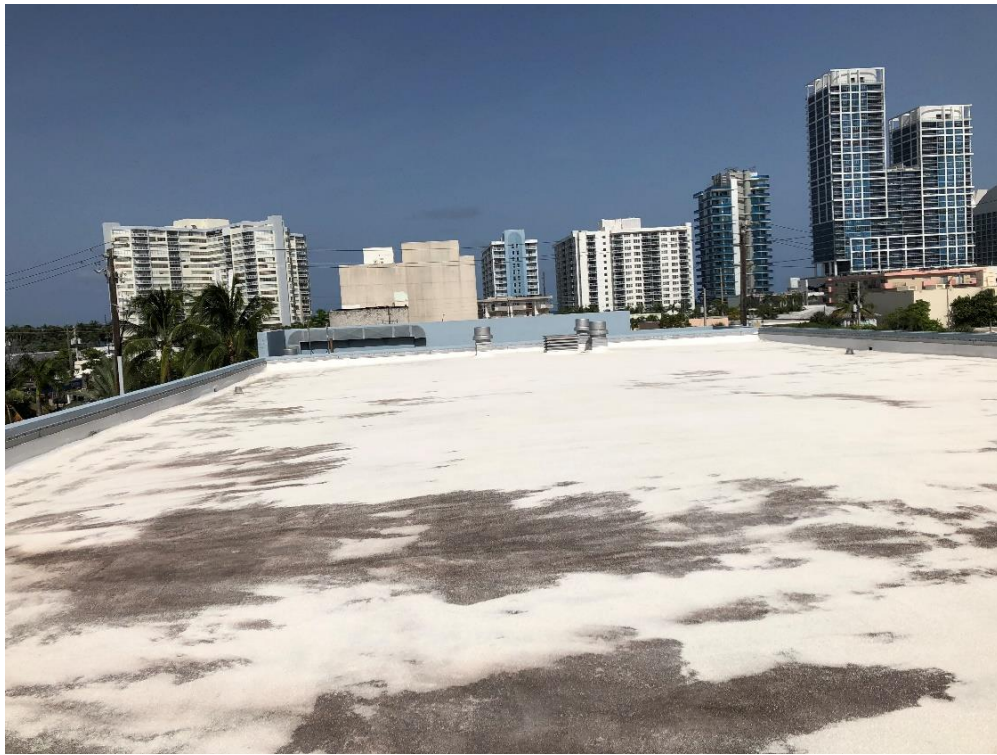
Photograph No. 42– Upper Roof of East Cinema Theater

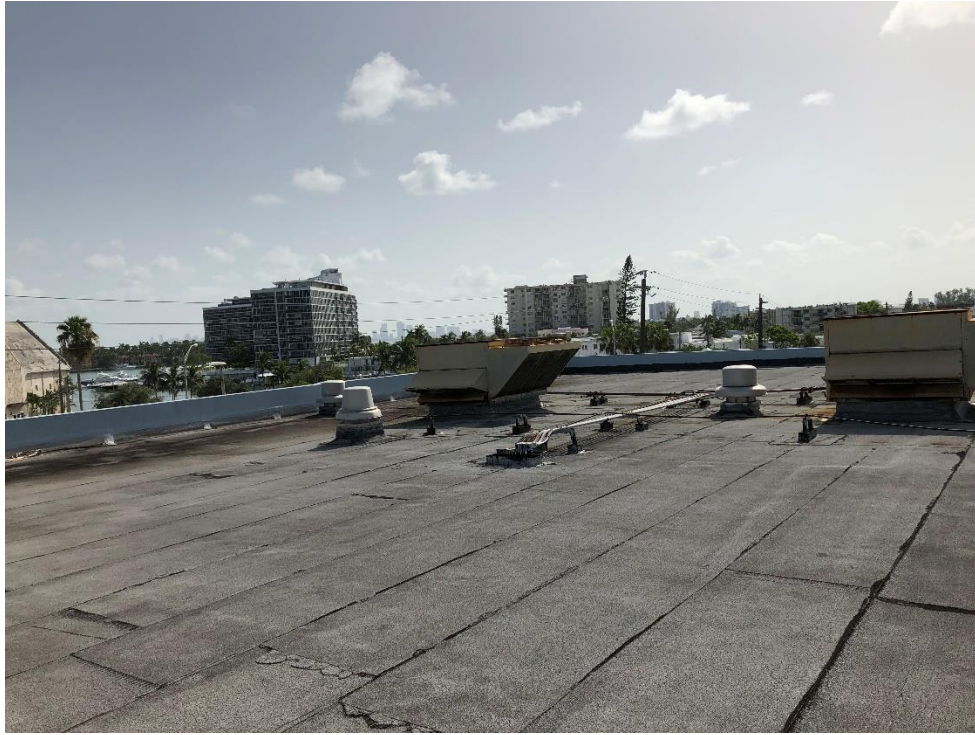
Photograph No. 43– Upper Roof of West Cinema Theater

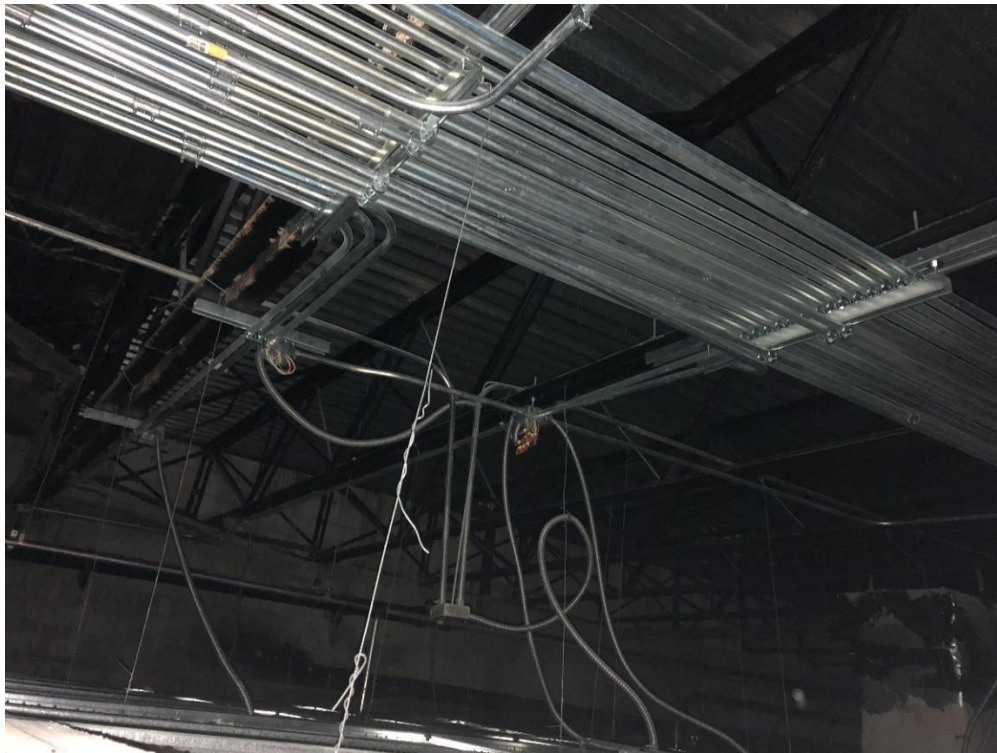
Photograph No. 44 – Underside of East Upper Roof Structure

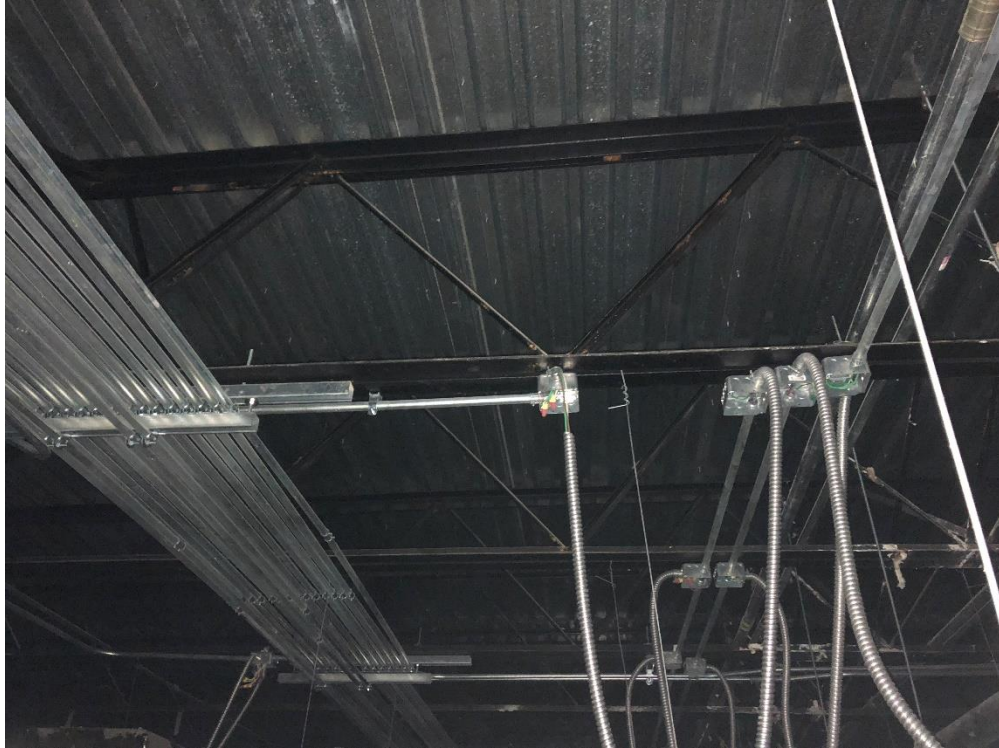
Photograph No. 45 – Underside of East Upper Roof Structure

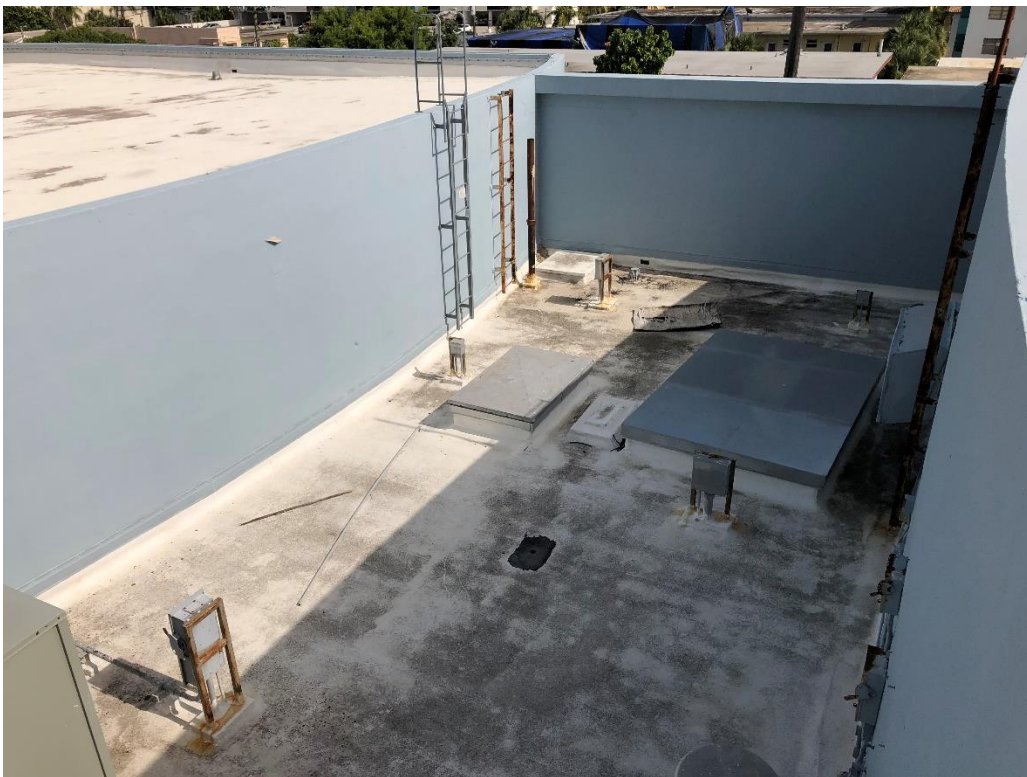
Photograph No. 46 – Lower roof between the East and West Portions of Building

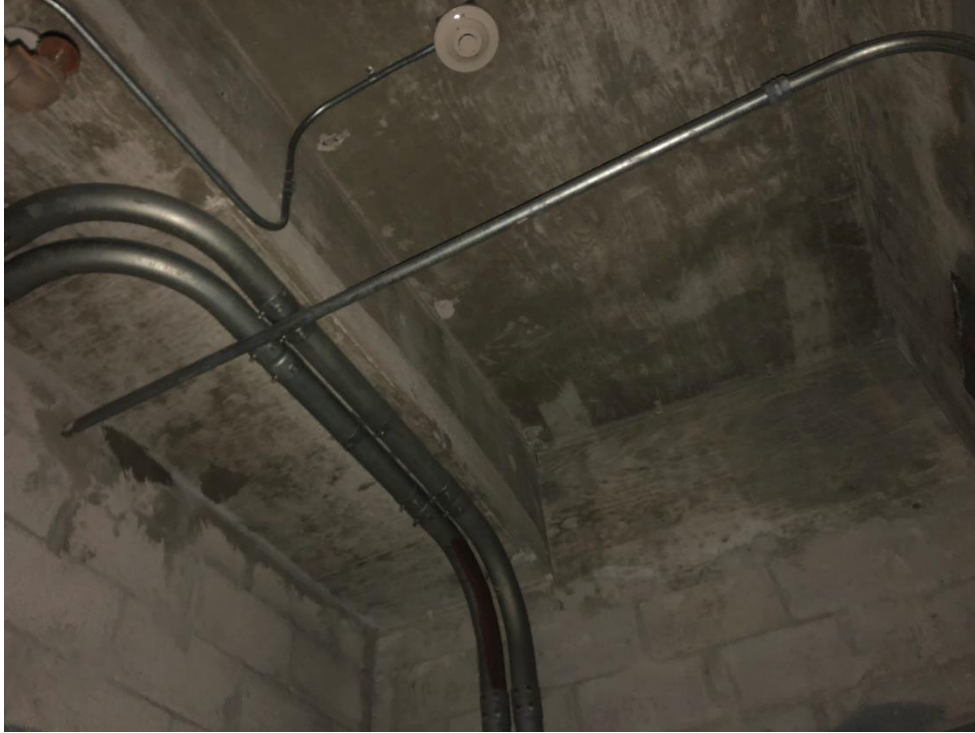
Photograph No. 47 – Underside of Lower roof between the East and West Portions

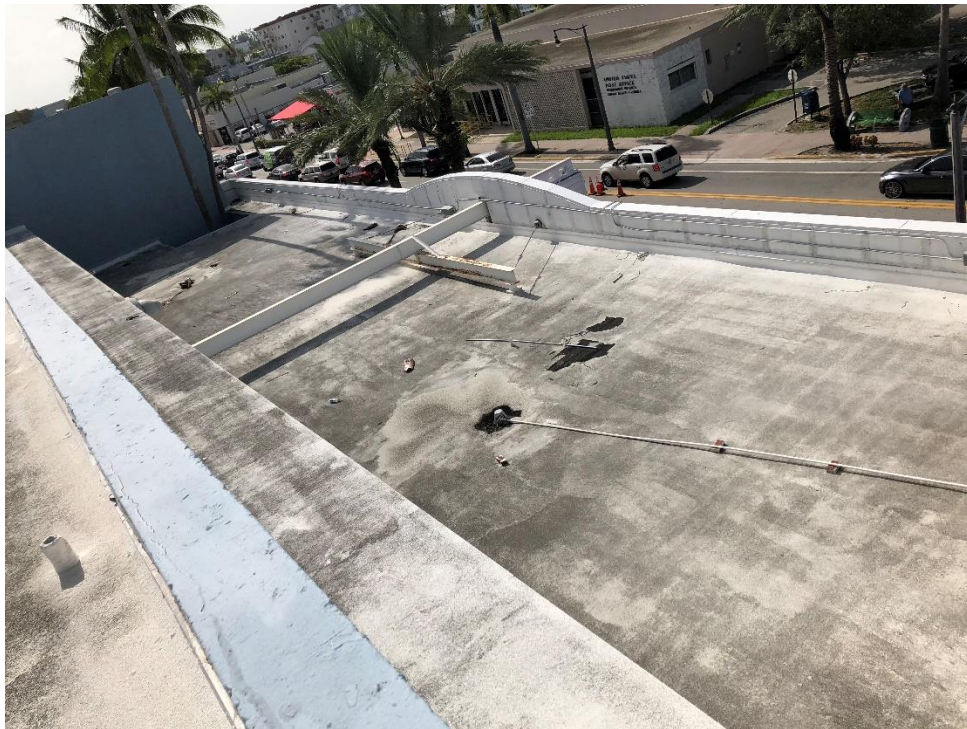
Photograph No. 48 – Low Roof at Second Level in North Portion of Building

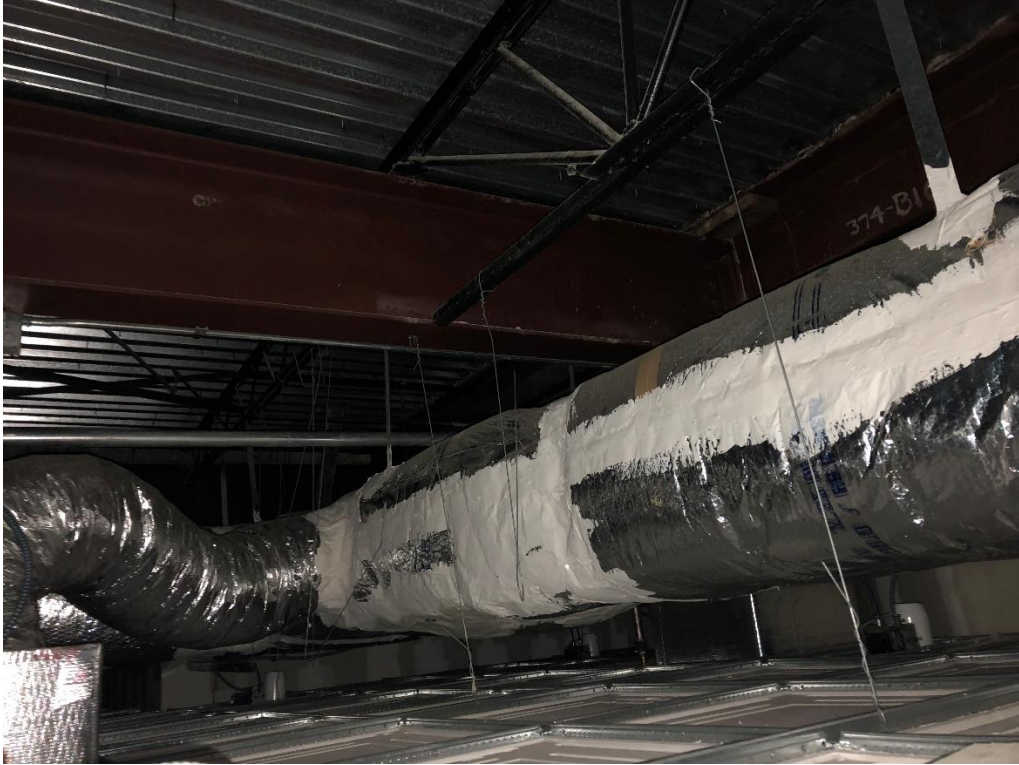
Photograph No. 49 – Underside of Low Roof at Second Level in North Portion of Building

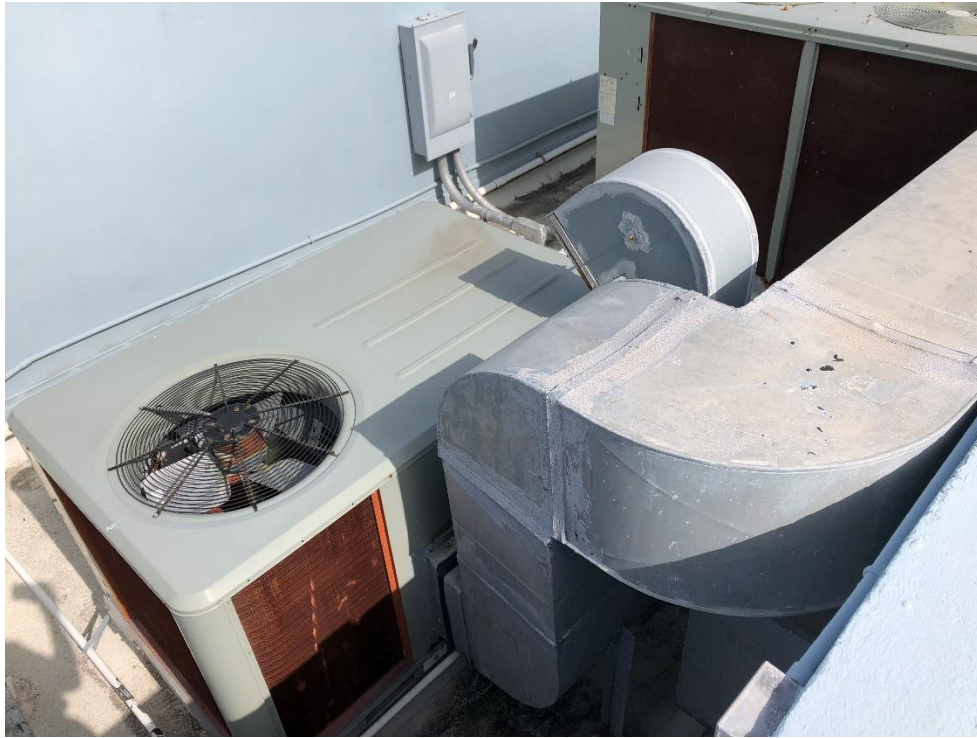
Photograph No. 53 – Low Roof at East Side of Building

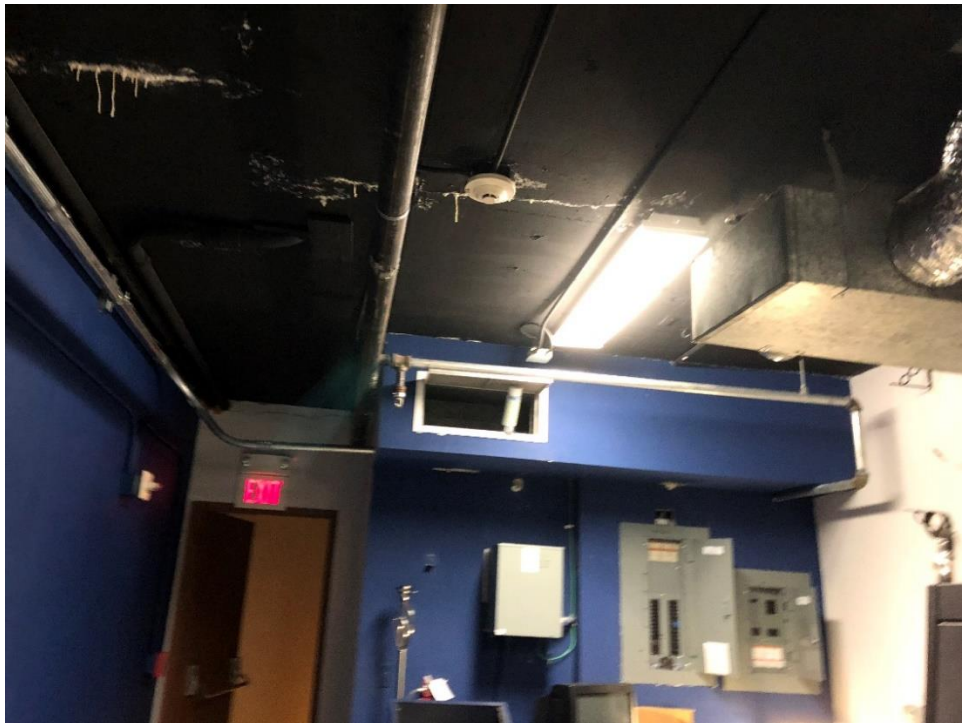
Photograph No. 54 – Underside of Low Roof at East Side of Building

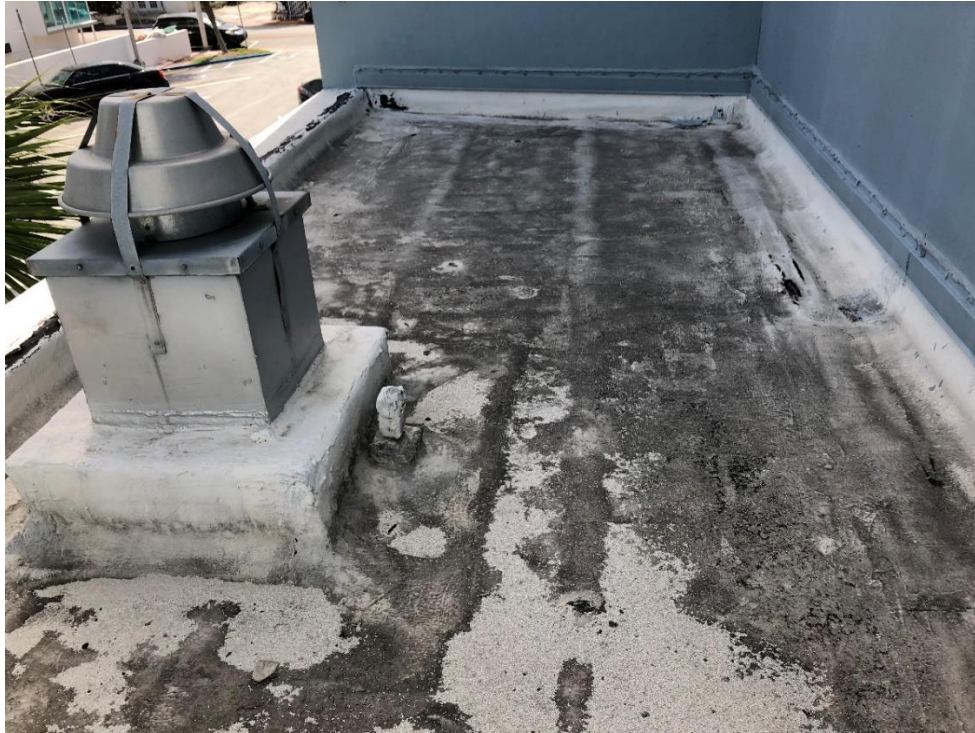
Photograph No. 55 – Low Roof at East Side of Building

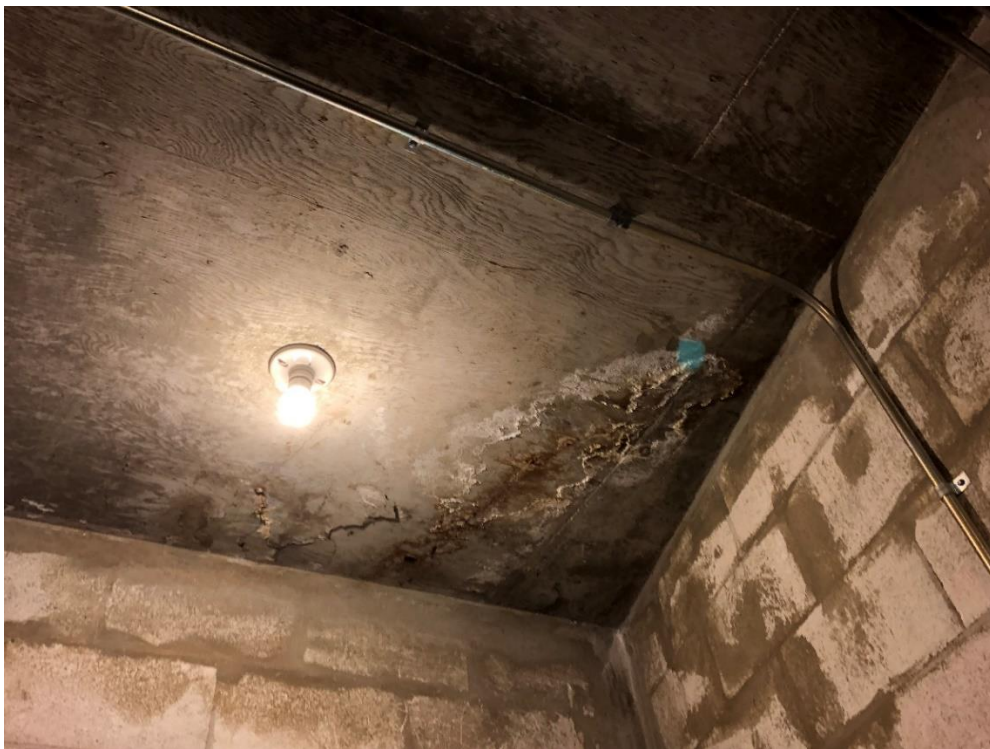
Photograph No. 56 – Underside of Low Roof at East Side of Building

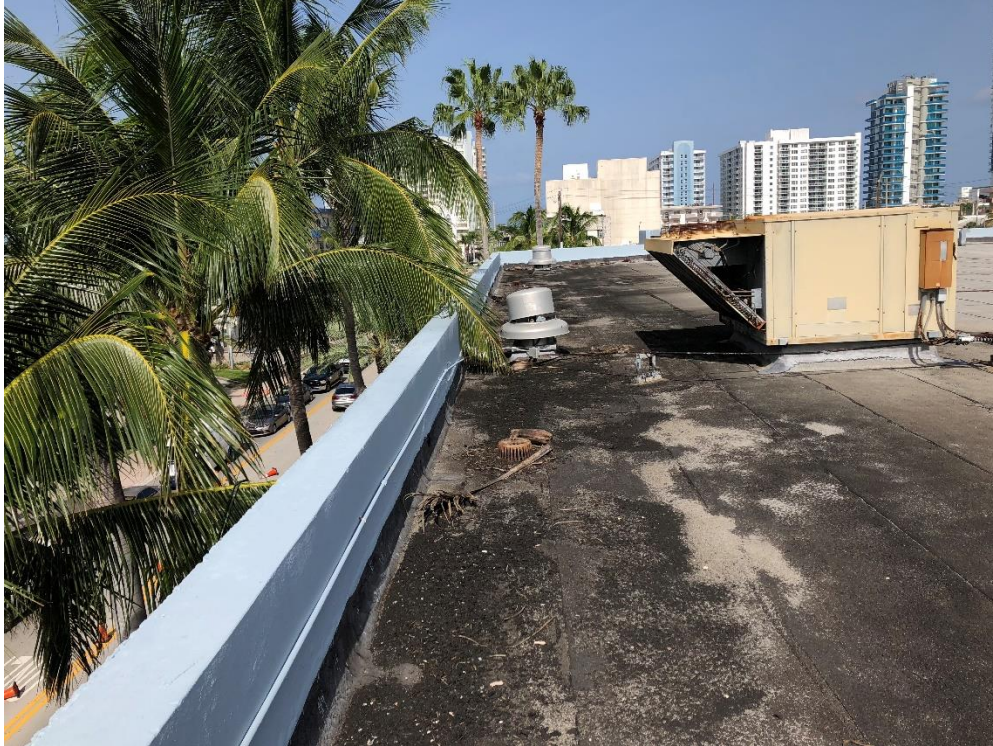
Photograph 56). The roofing over the two upper roofs and five lower roofs consists of built-up roofing systems. The roofing systems over all upper roofs and lower roofs are old and in need of maintenance (see photographs 23-27 and 57-59). No active water leaks were observed.

Photograph No. 57 - Upper roof at west side of the building

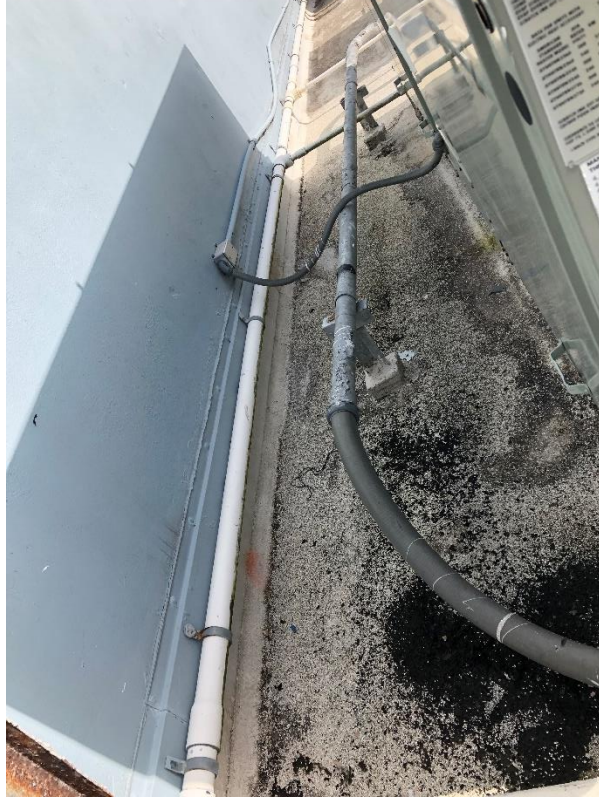
Photograph No. 59 – Lower roof at east side of the building

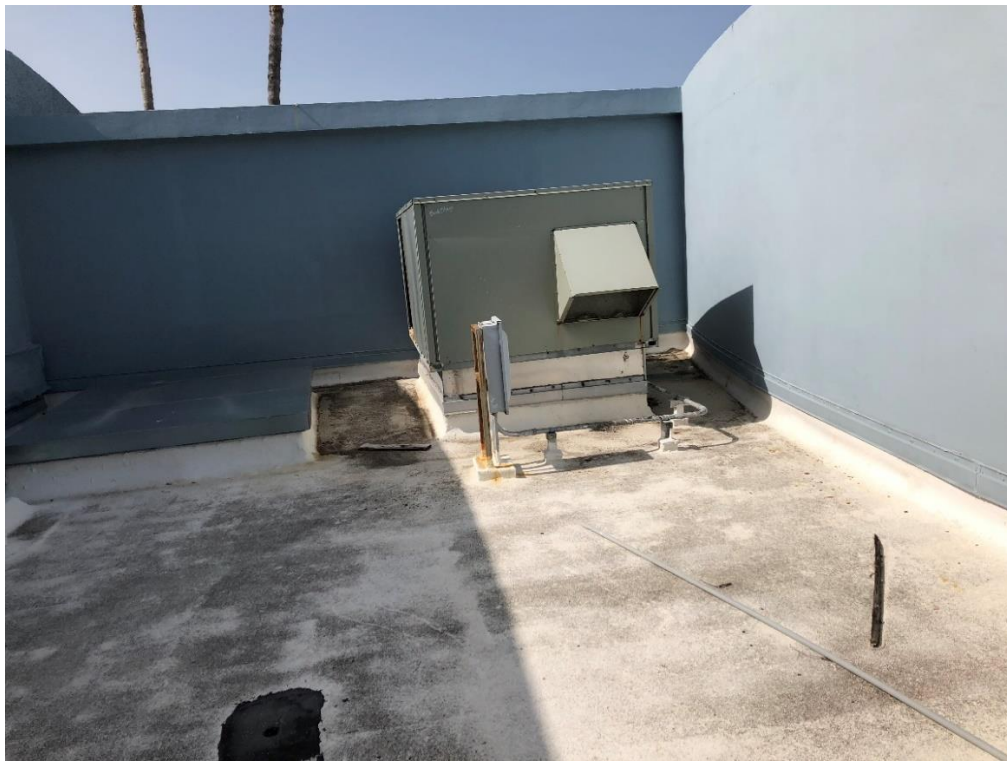
Photograph No. 60 – Covered Opening at Low Roof between East and West
