**Reference: 50-Year Recertification
Byron Carlyle Theater
500 71 St., Miami Beach, Florida
Folio 02-3211-002-1070**

MINIMUM INSPECTION PROCEDURAL GUIDELINES FOR BUILDING RECERTIFICATION - STRUCTURAL

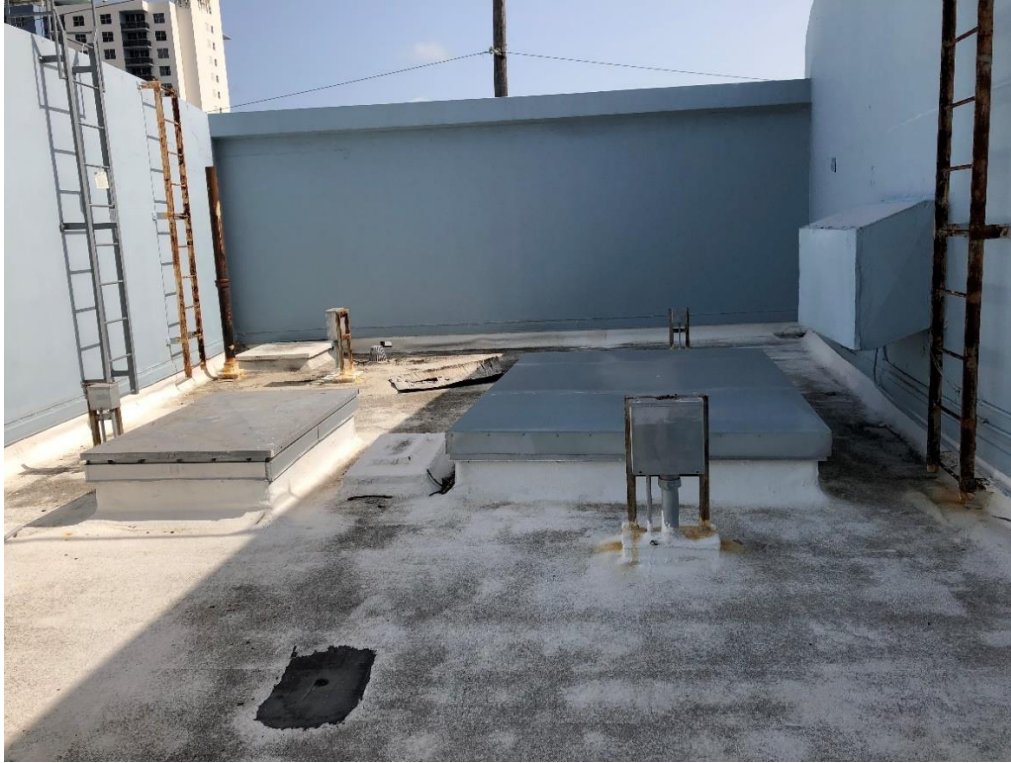
Photograph No. 61 – Covered Opening at Low Roof between East and West

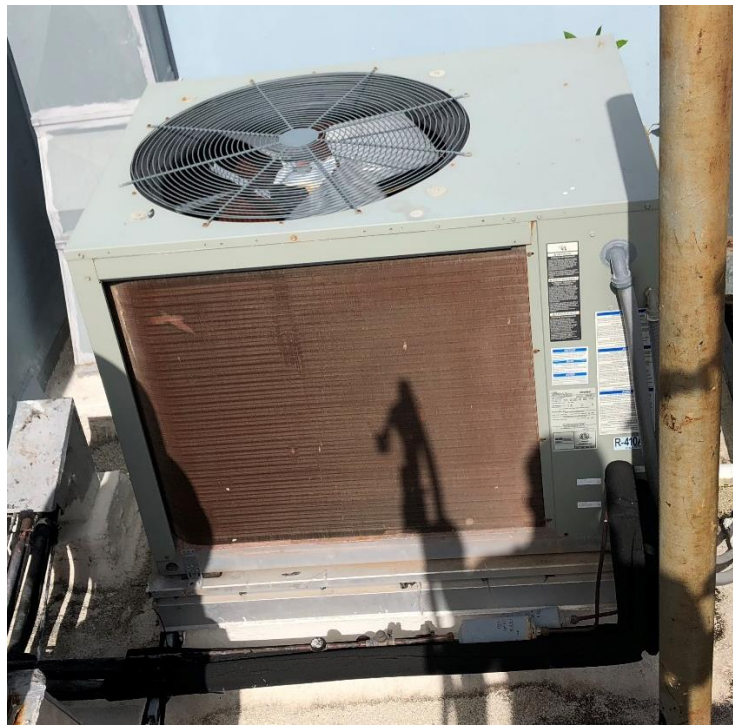
Photograph No. 62 – Condensing Unit Supported on Larger Roof Curb at Low Roof at East Side

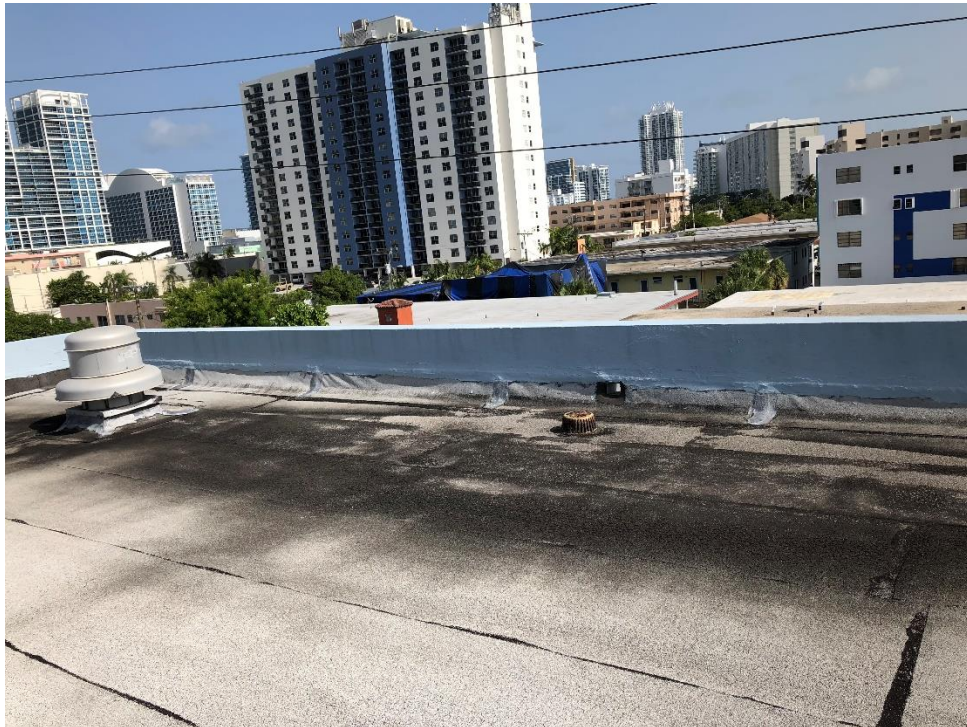
3. Note types of drains and scuppers and condition:
There are drains throughout the upper roofs with overflow scuppers around the perimeter curb (see Photographs 66 and 67). These drains are mostly located near the corners. Lower roofs also have drains with...CONTINUED ON ATTACHED SHEET

Photograph No. 66 – Westside upper roof

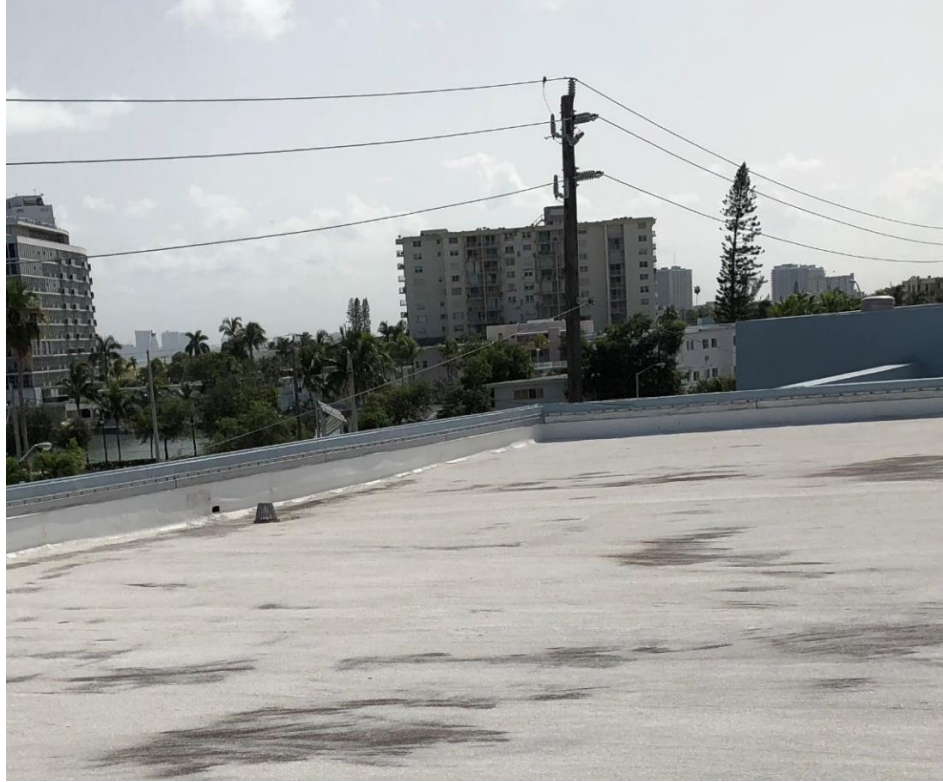
Photograph No. 67 – Eastside upper roof

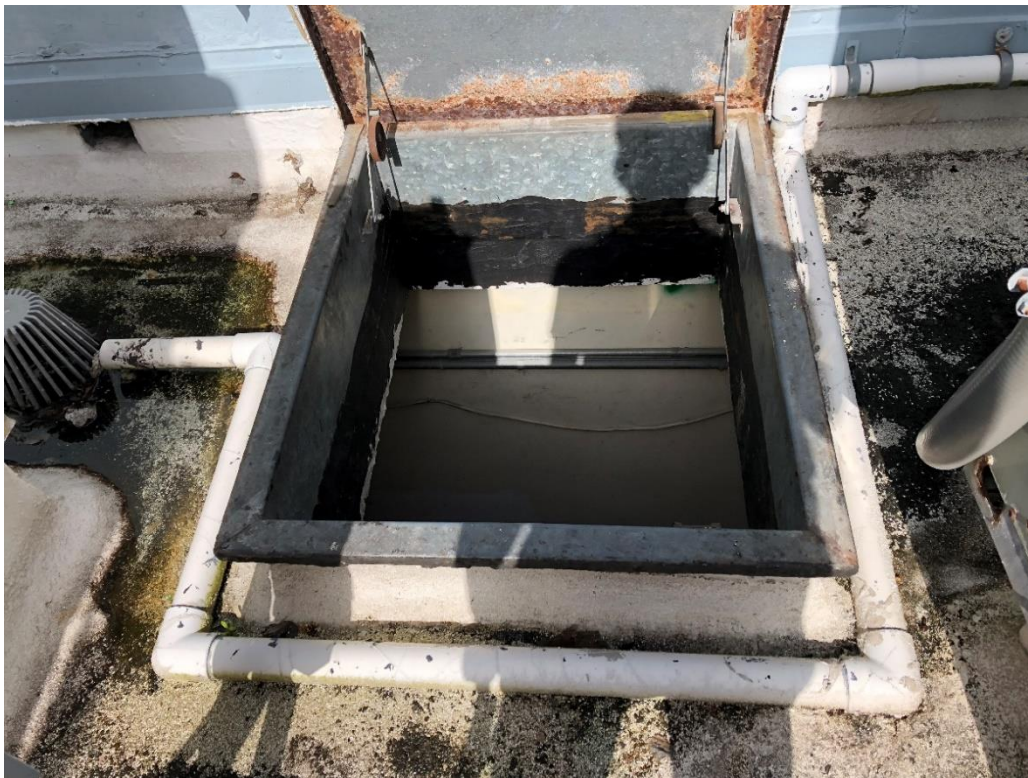
- 6.a.3 ... overflow scuppers (see photographs 68, 69, and 70), except the lower roof at the second level in the north portion of the building, where there are only drains but no overflow scuppers (see Photographs 71 and 72). It is important to note that this low roof has an exterior opening on the inside (see Photograph 73) which would facilitate overflow drainage.

Photograph No. 68 – Low roof at east side of building

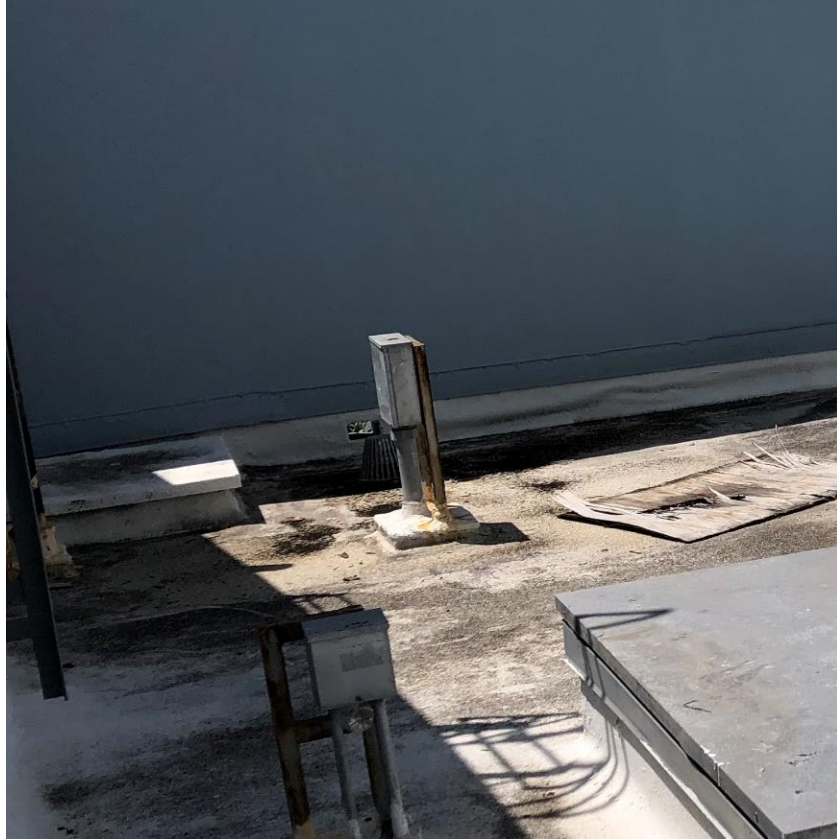
Photograph No. 69 – Low roof between east and west sides of the building

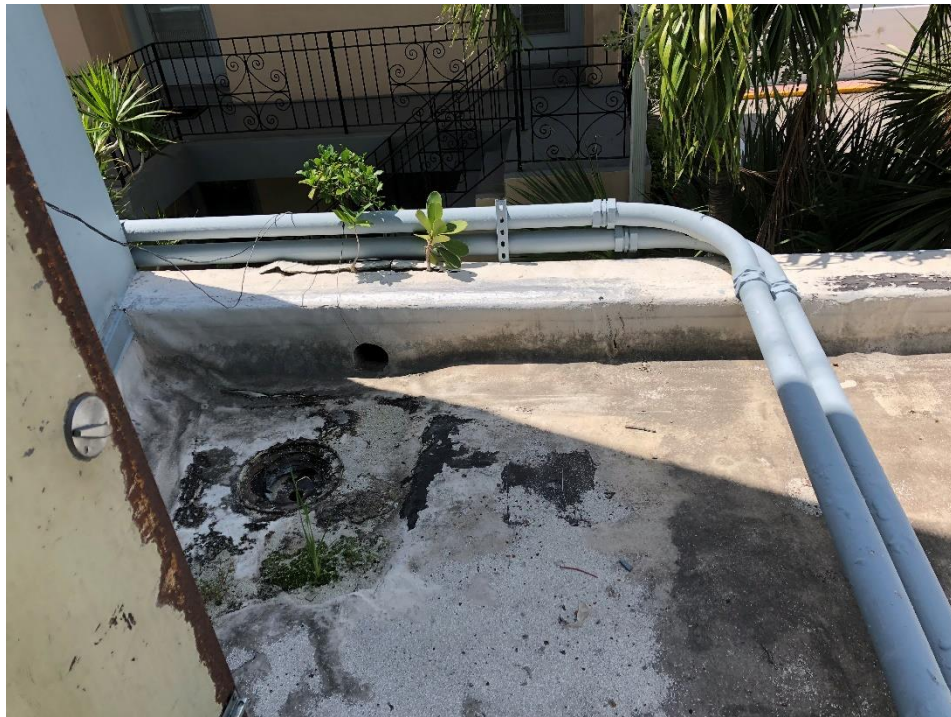
9) Drain of low roof at 2nd floor is missing protective cover. Debris could potentially clog the drain (see Photograph 70).

Photograph No. 70 – Low roof at the second floor

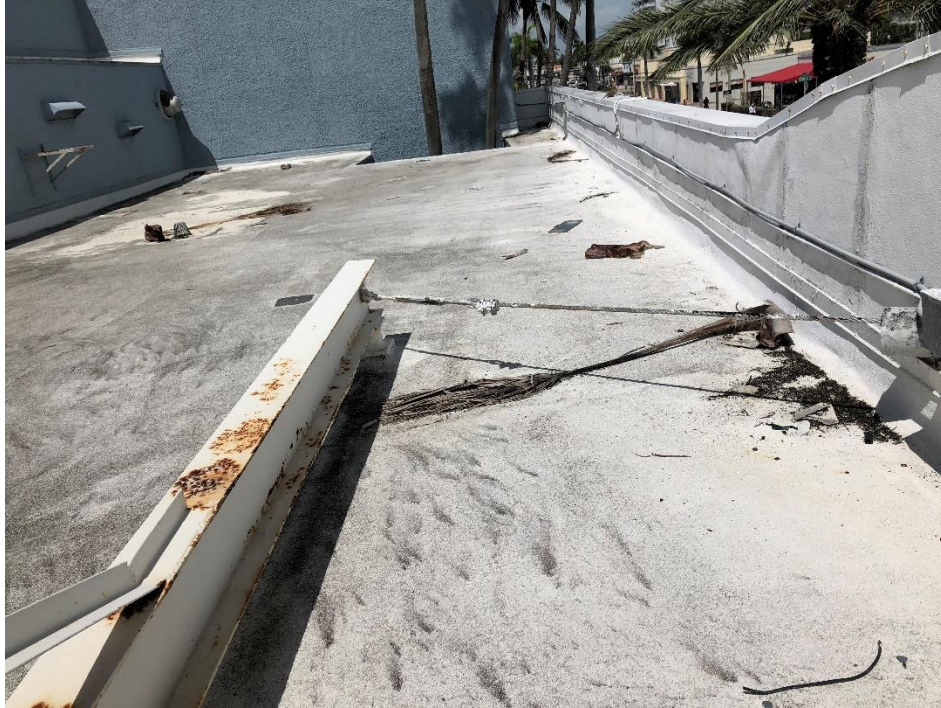
Photograph No. 71 – Low roof at the second floor (north)

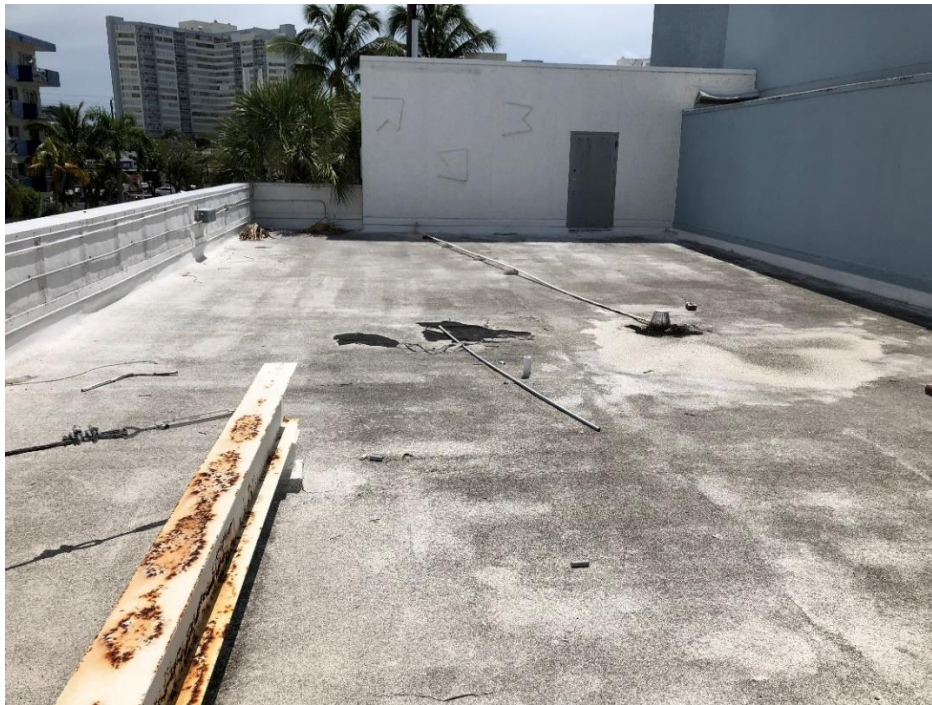
Photograph No. 72 – Low roof at the second floor (north)

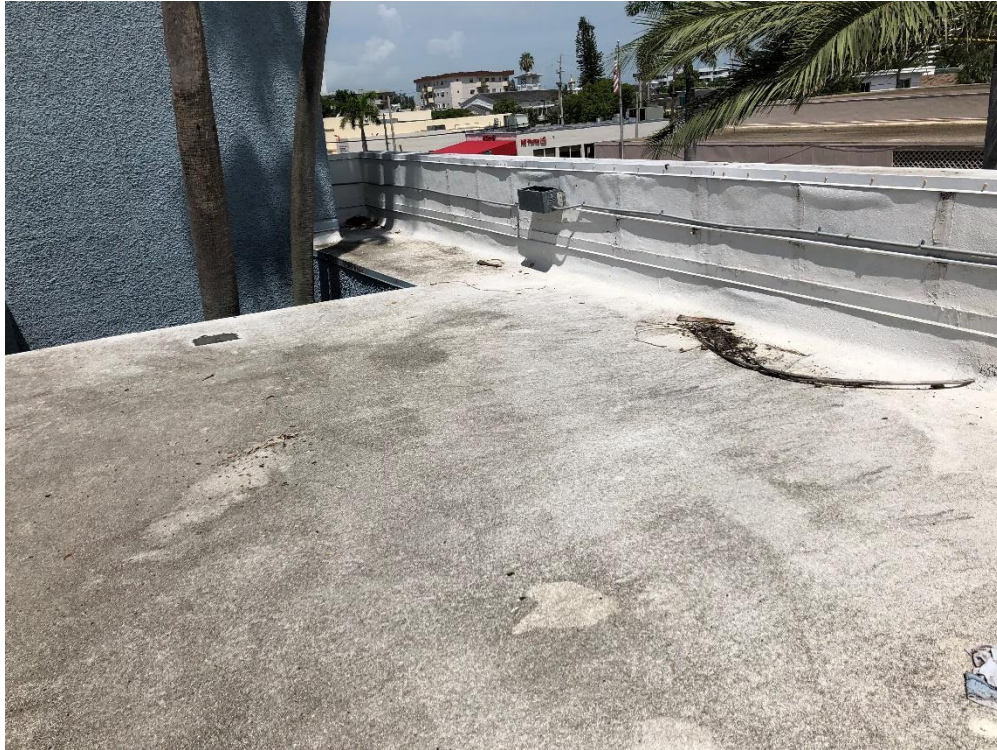
Photograph No. 73 – Low roof at the second floor (north)

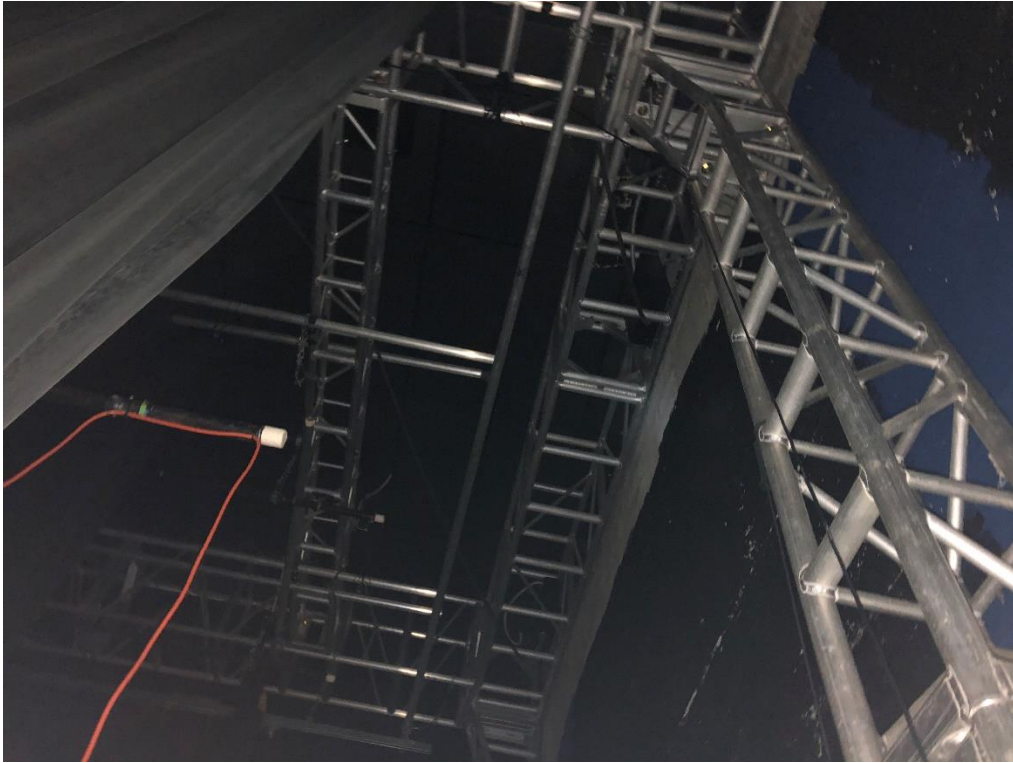
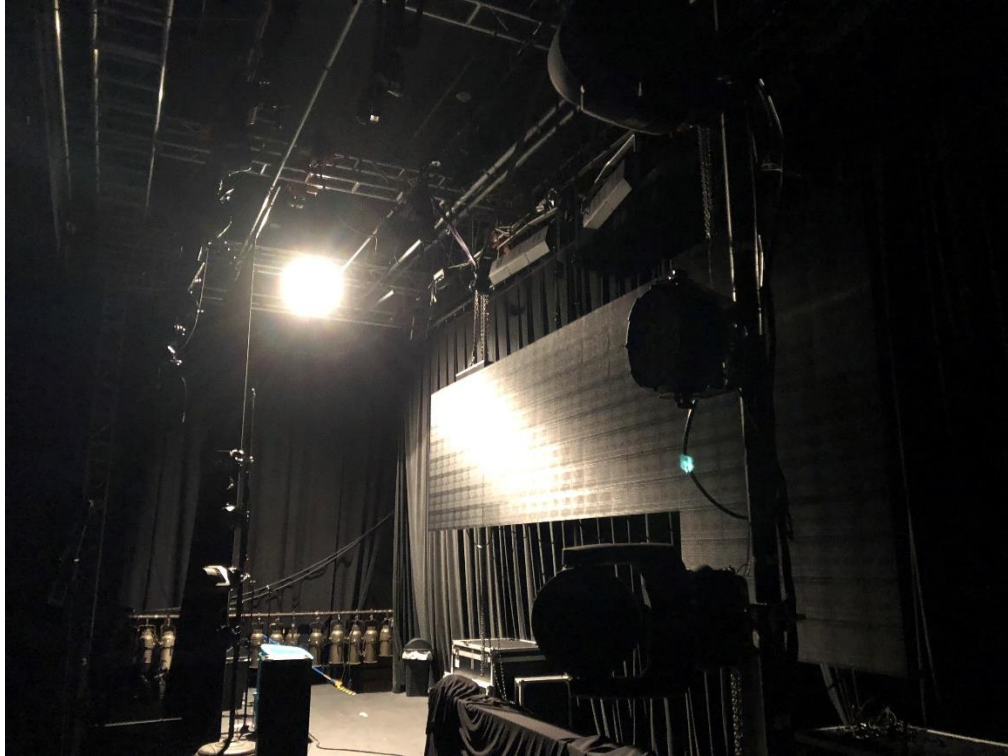
3) An independent (not connected to the structure laterally) aluminum truss frame was installed above the stage to support lighting and other theater equipment (see Photographs 79 to 82).

Aluminum Truss Frame: The truss frame that supports the lighting, and other theater equipment, over the stage also represents significant additional load to the original floor structure that was likely not designed to resist this loading (see Photographs 79 to 81). These additional loads are of importance as the vertical loads from the frame are transferred to the floor structure through a limited area (base plate of the vertical member, see Photograph No. 82), and hence they are considered point loads rather than distributed loads. These vertical loads may be bearing on grade beams not designed for these loads, or directly on the reinforced concrete slab, which was most likely not designed for these point loads.

Photograph No. 79 – Aluminum Truss Frame for Lighting Support

Photograph No. 80 – Aluminum Truss Frame for Lighting Support

Photograph No. 81 – Aluminum Truss Frame for Lighting Support

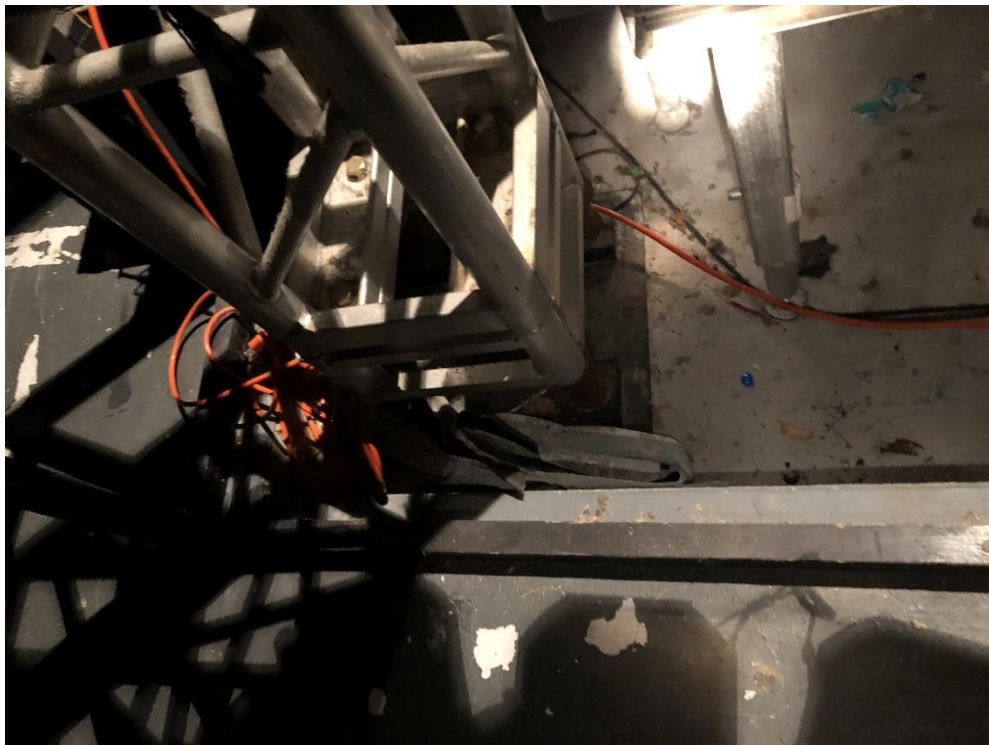
Photograph No. 82 – Aluminum Truss Frame Base Plate

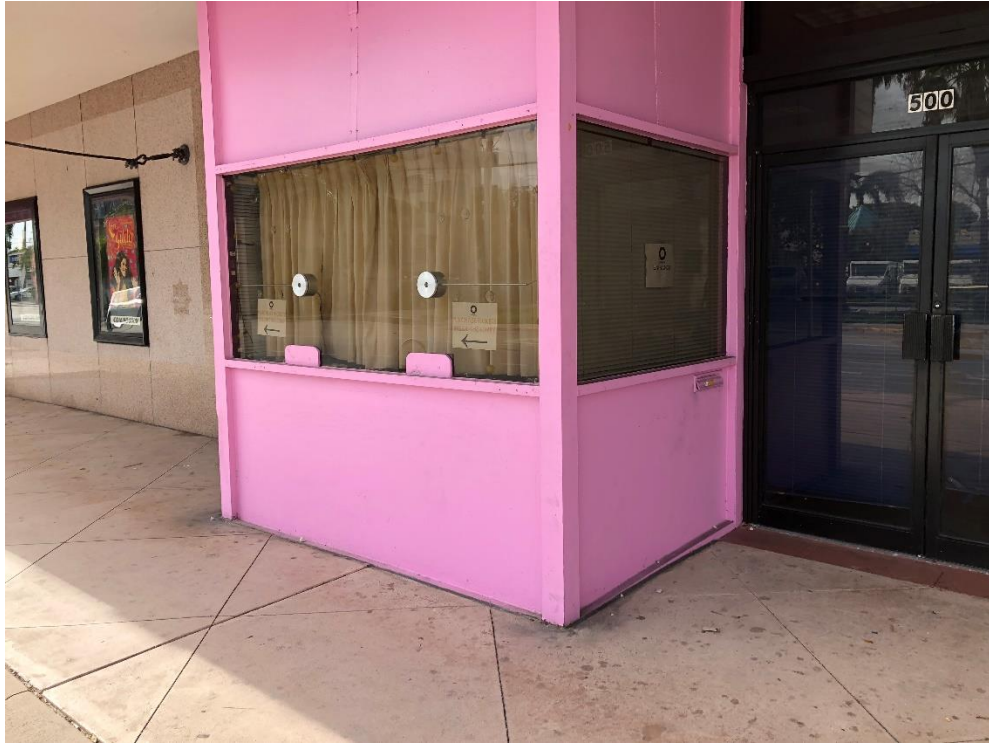
6) Ticket box office appears to be an addition to the original structure (see Photograph 85). It is aluminum-framed with fixed glass windows and walls made out of a composite material.

Photograph No. 85 – Ticket Box Office at North Façade
