***Tree Resource Evaluation for
The South Seas, Richmond, and Raleigh Hotels,
Miami Beach***

April 4, 2020

Summary

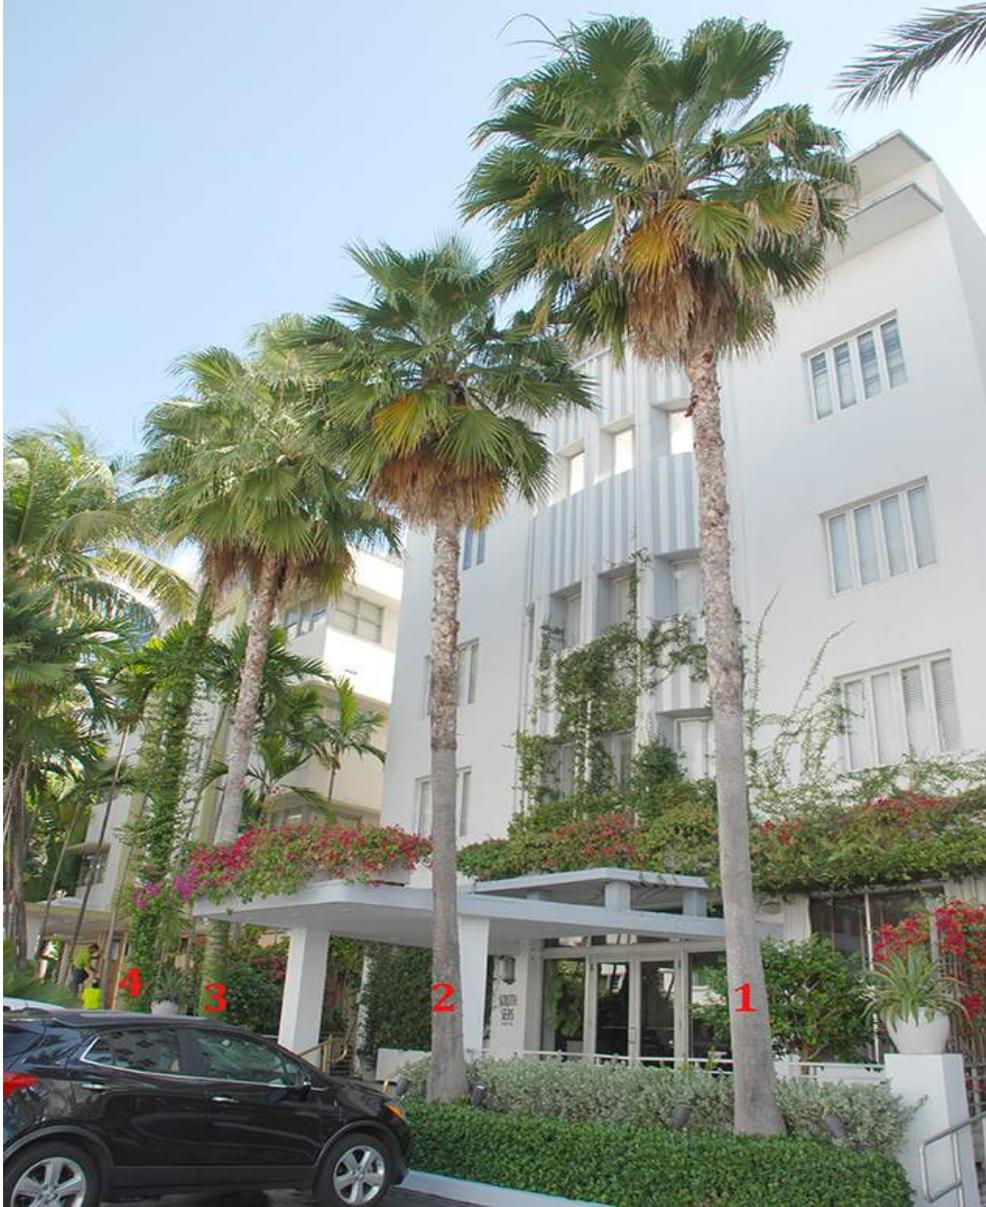
Photo 1 above is palms 1, 2, 3 & 4.

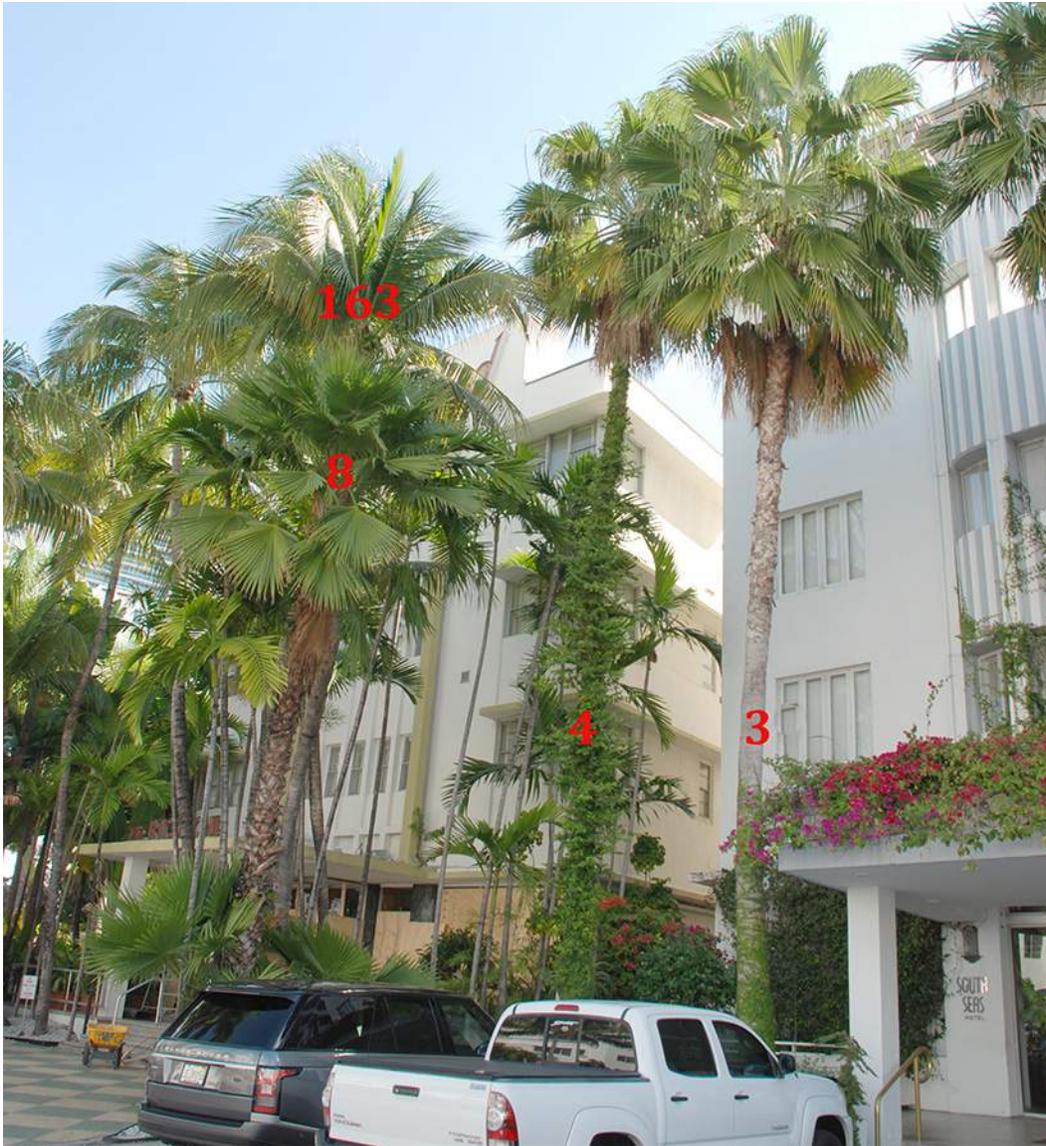
Photo 2 above is palms 3, 4, 8 & 163.

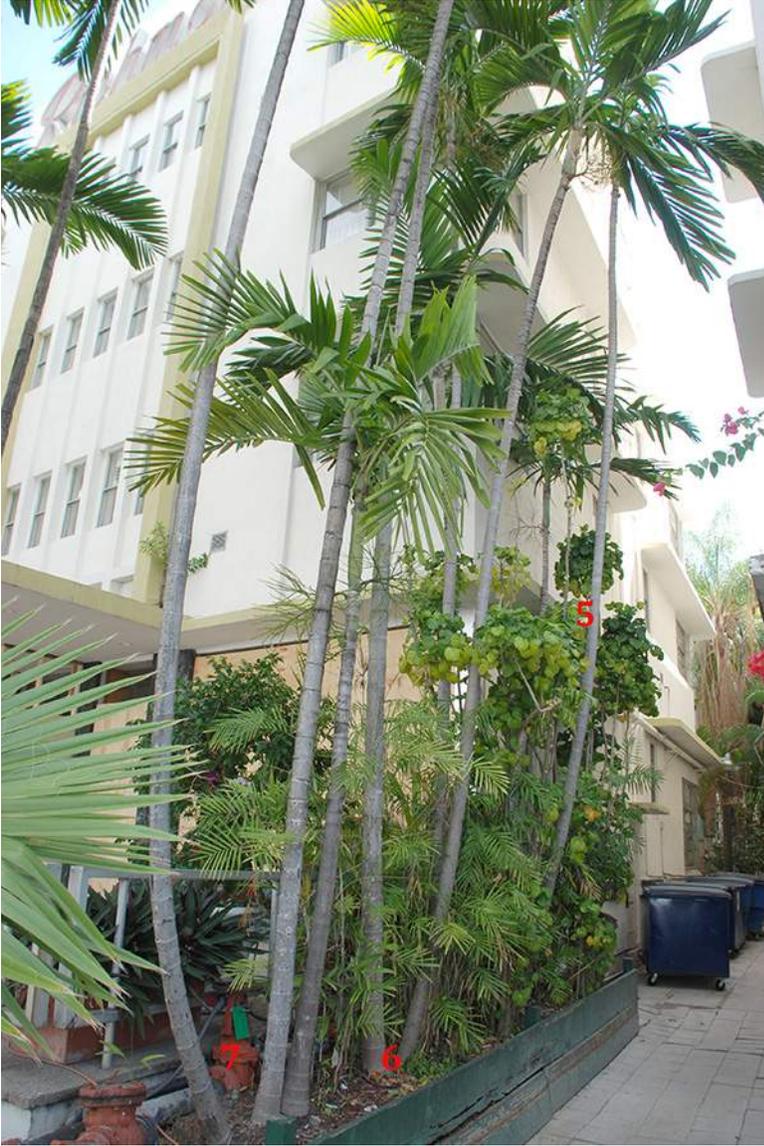
Photo 3 above is palms 5, 6 & 7.

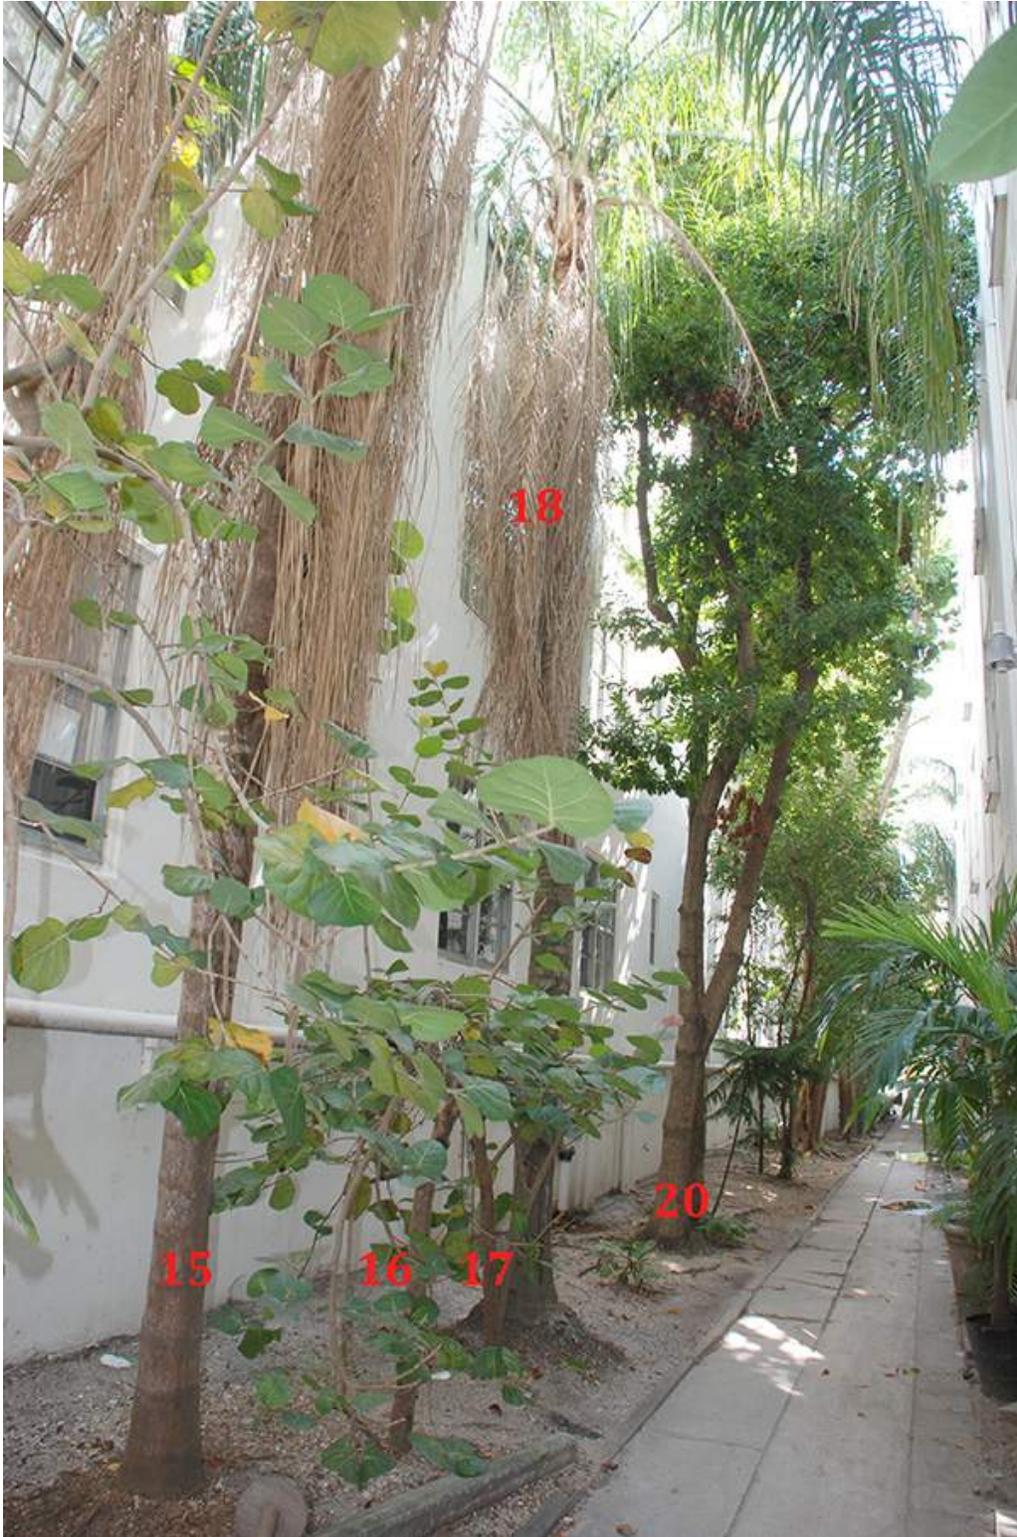
Photo 5 above is palms 15 & 18 and trees 16 & 17.

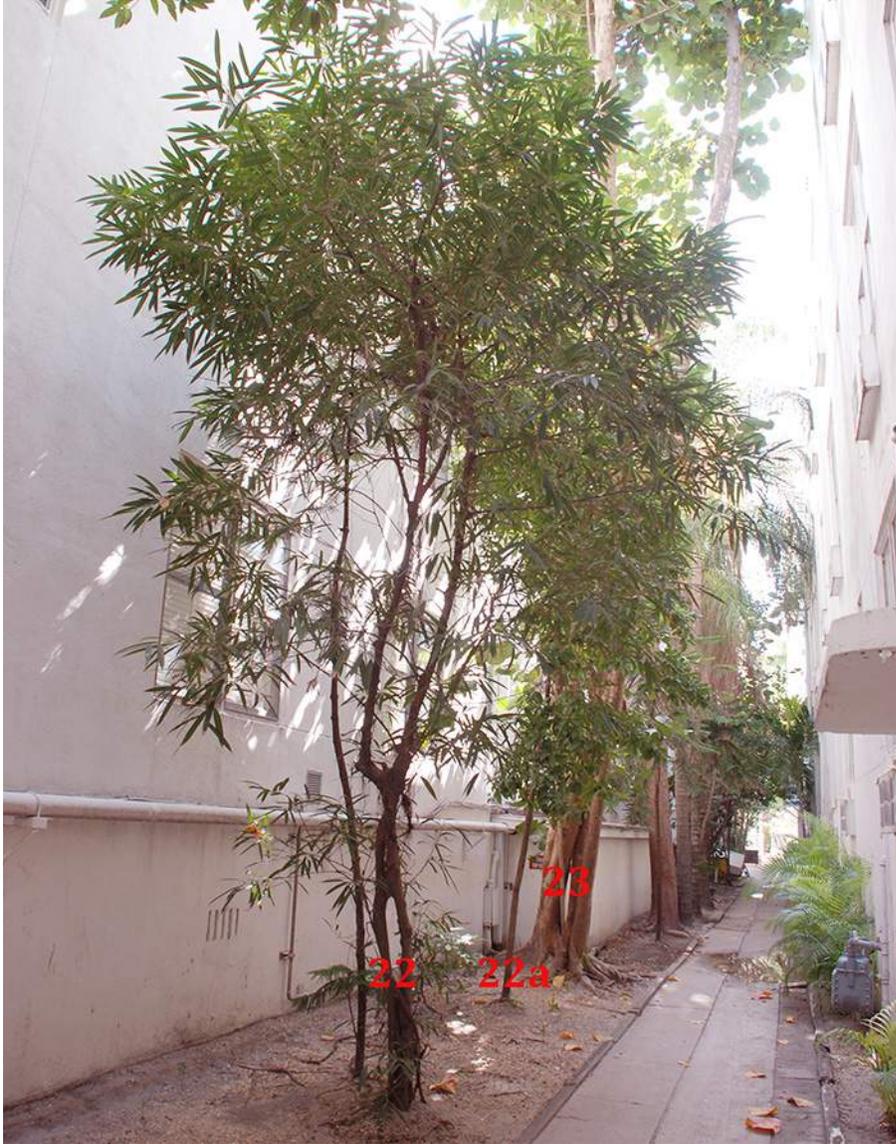
Photo 8 above is trees 22, 22a & 23.

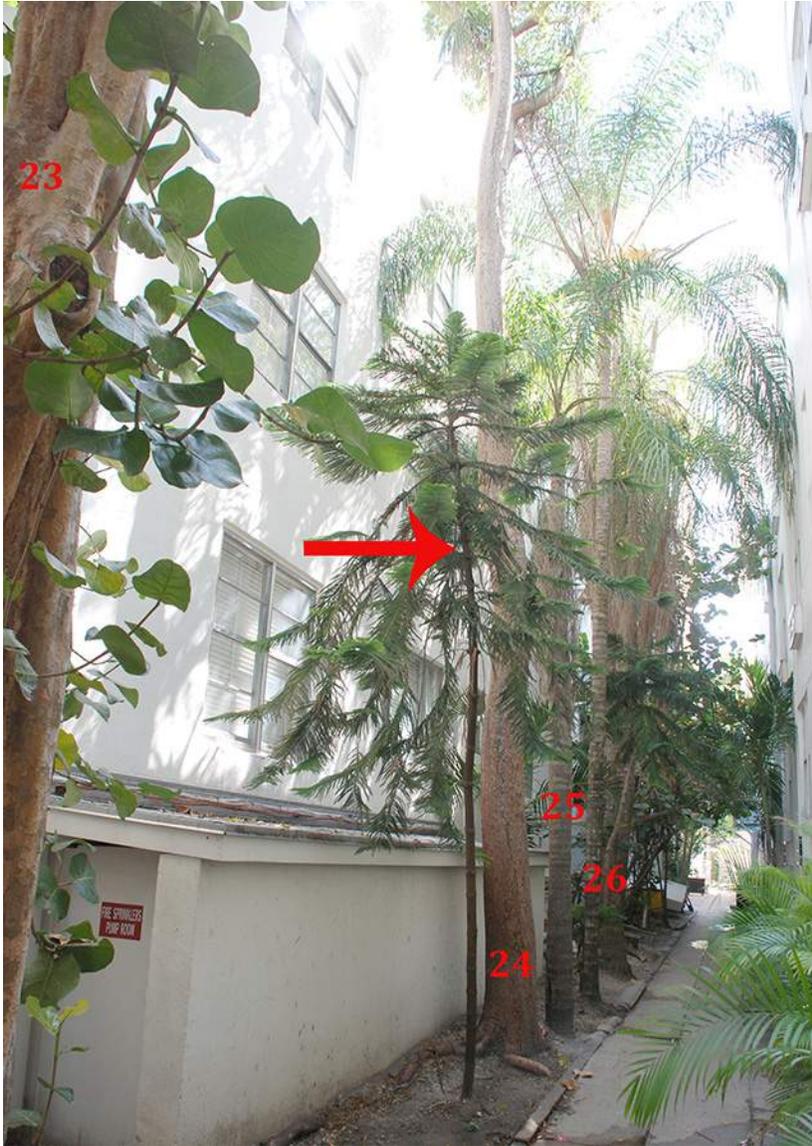
Photo 10 above is tree 24 and palms 25 & 26. The Norfolk Island Pine indicated with the arrow is too small to document. The DBH is less than 2 inches.

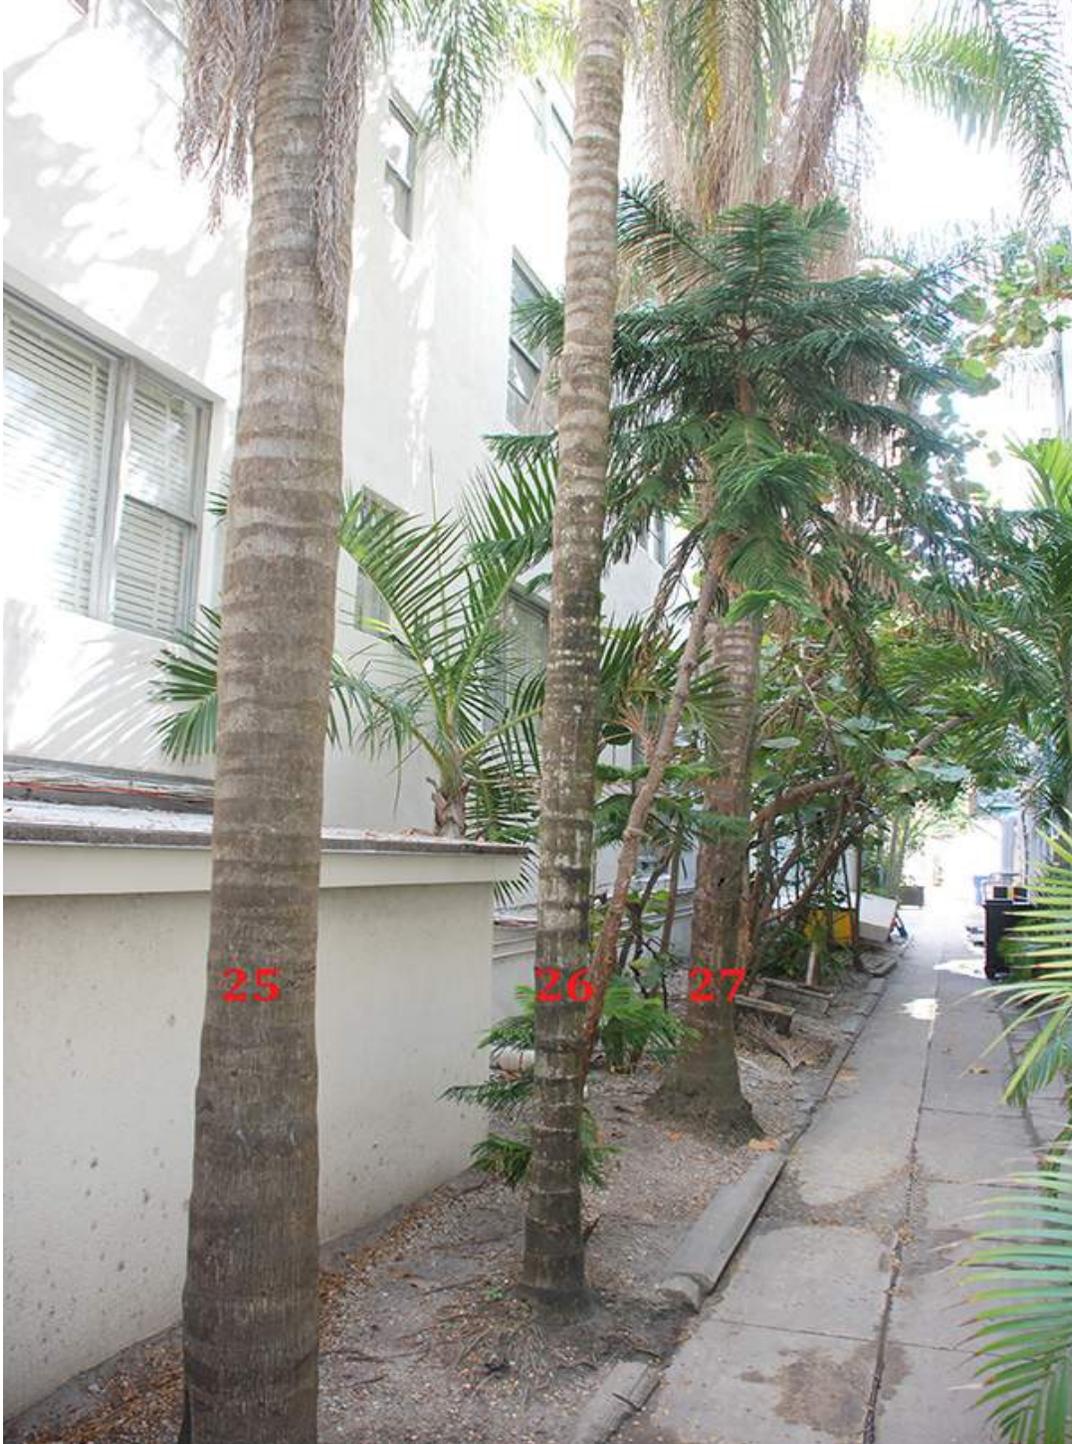
Photo 12 above is palms 25, 26 & 27.

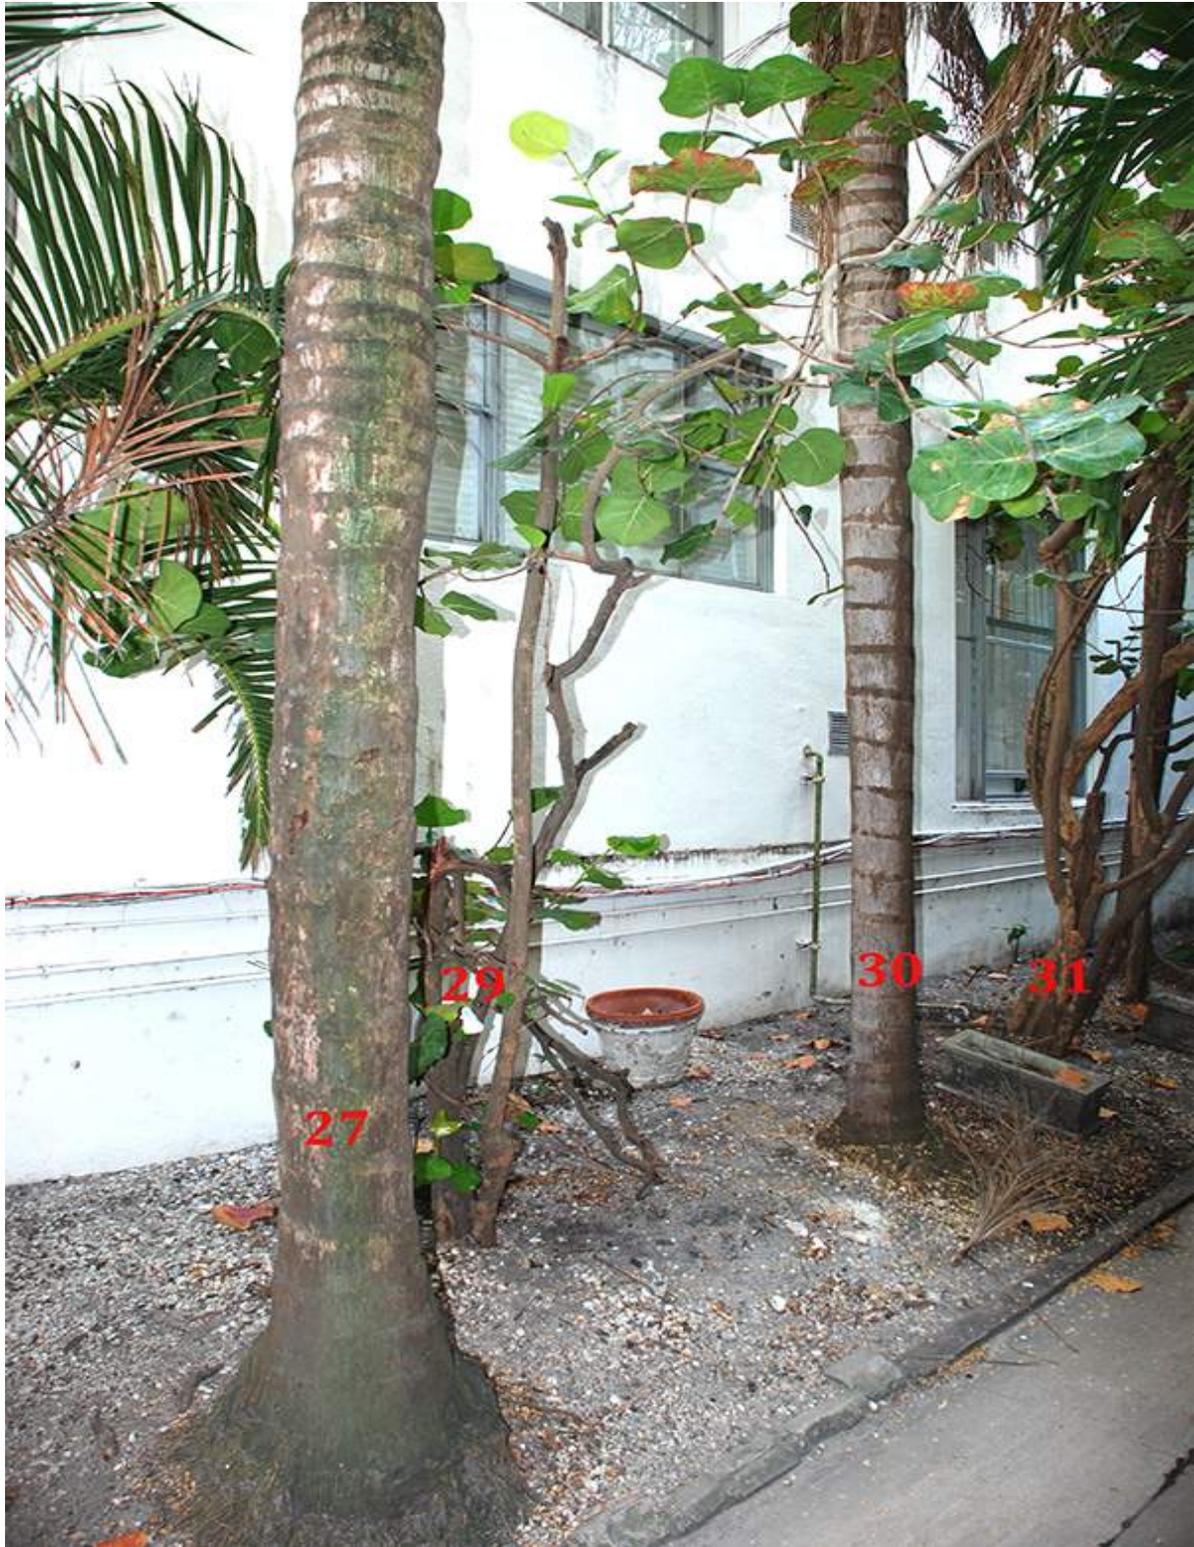
Photo 13 above is palms 27 & 30 and trees 29 & 31.

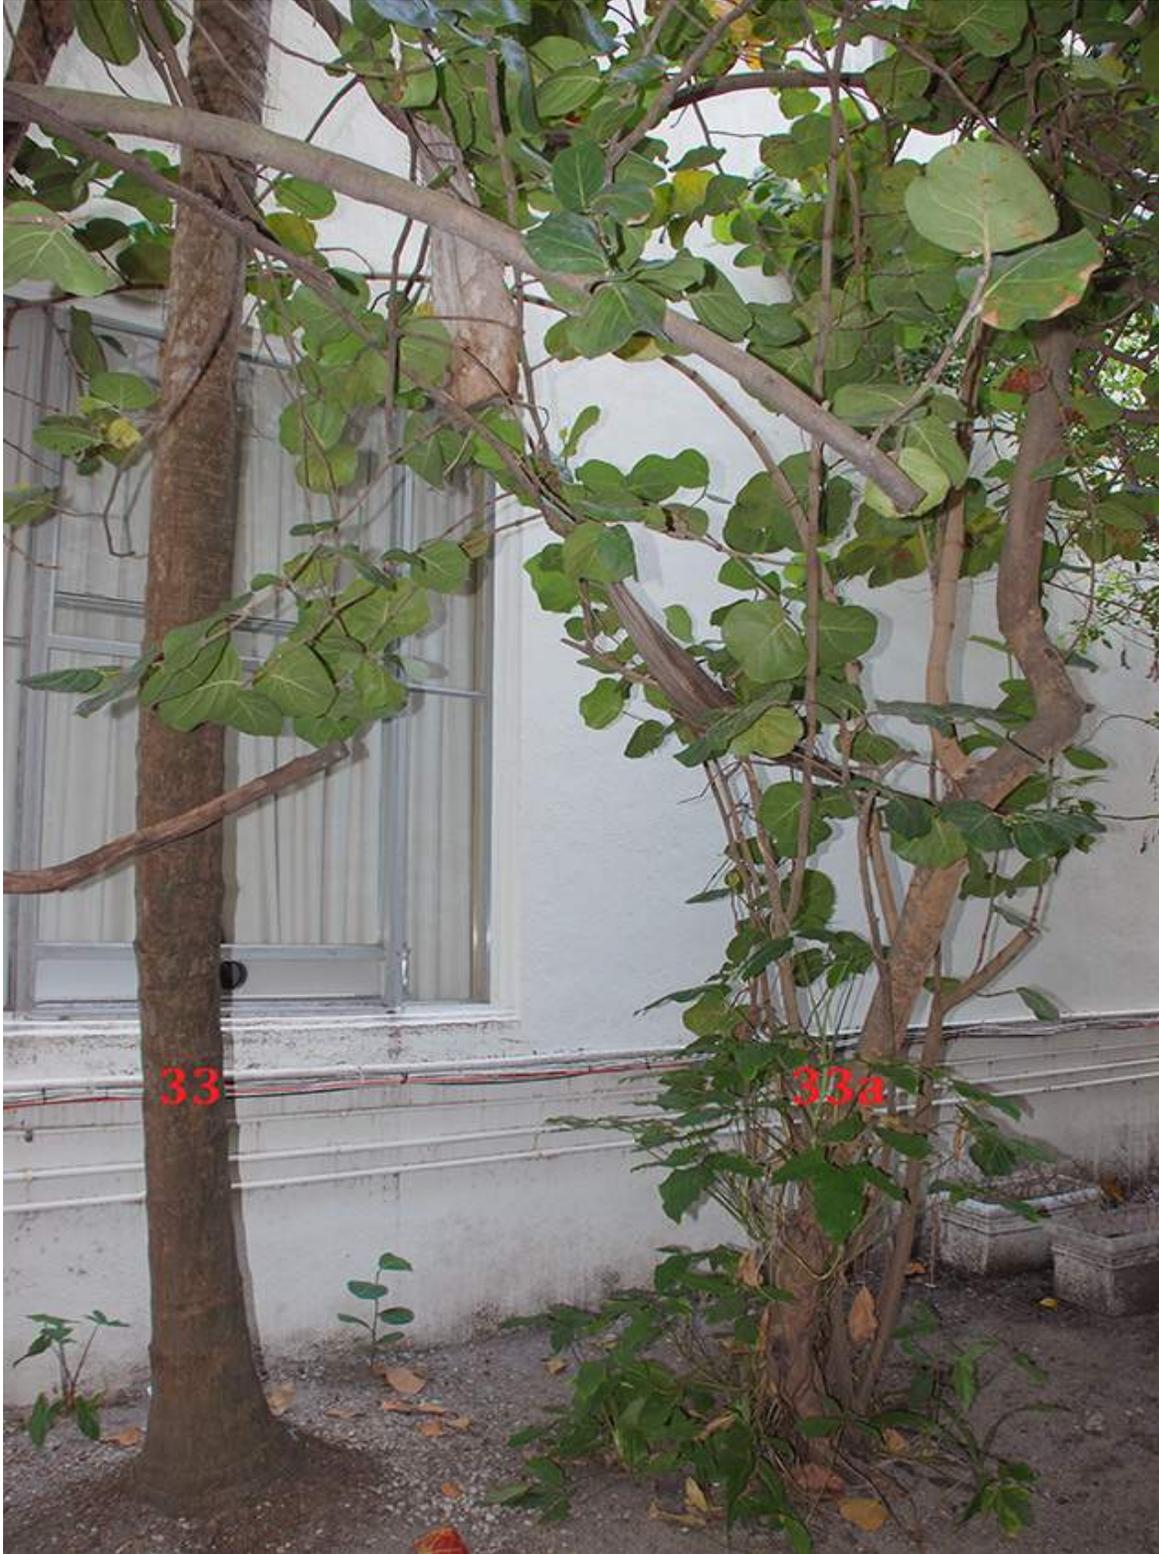
Photo 15 above is palm 33 and tree 33a.

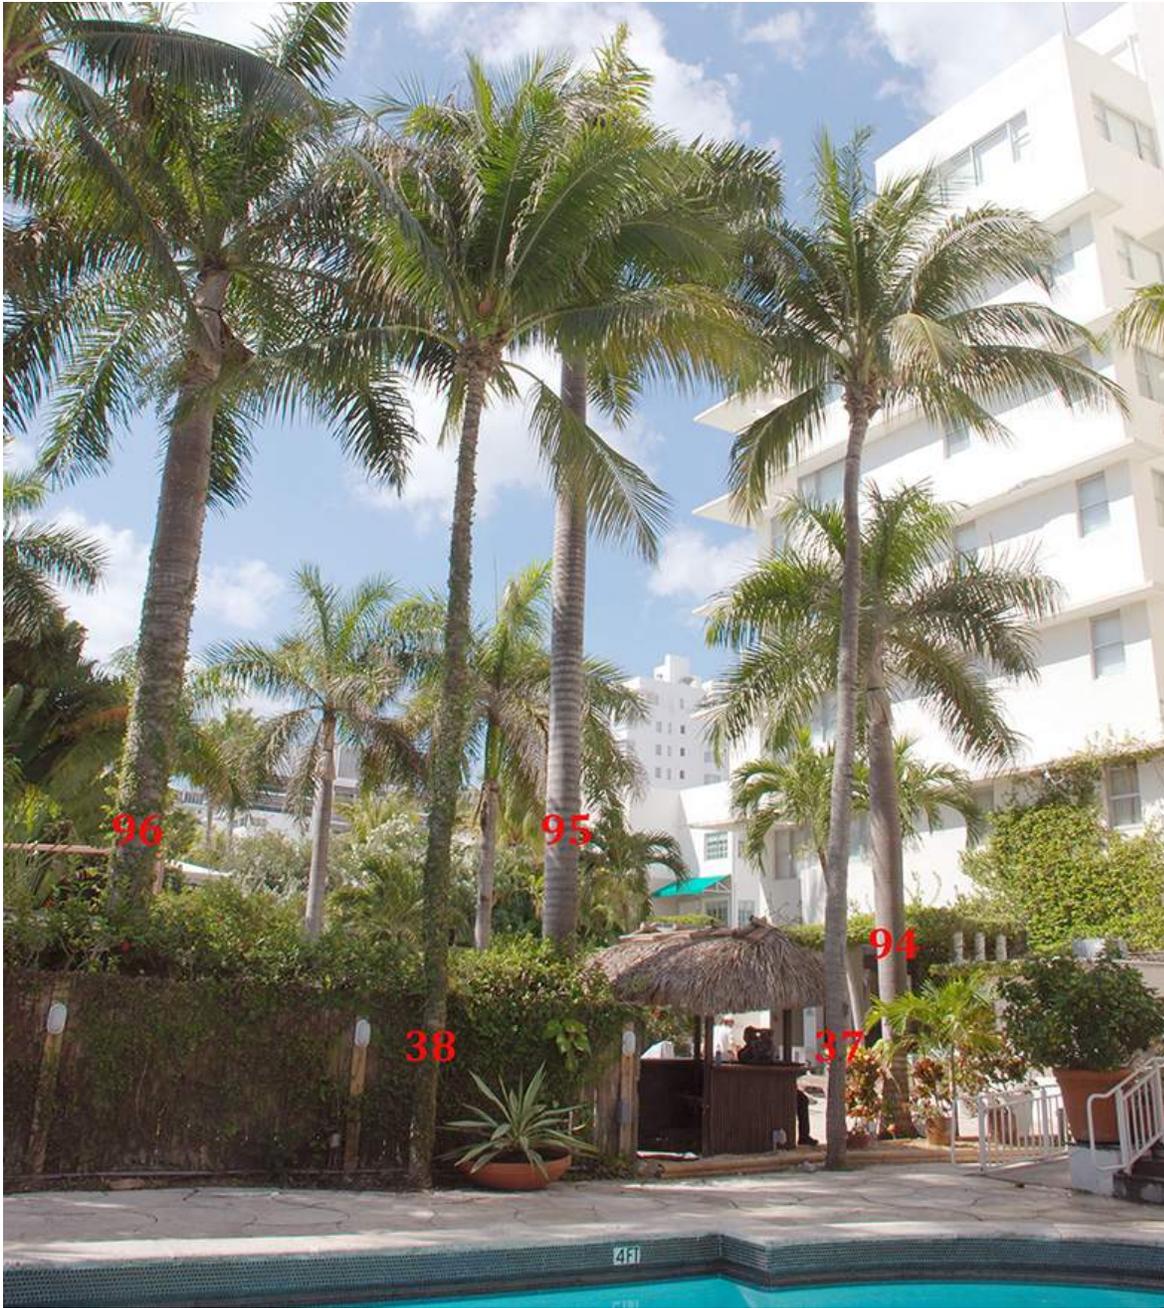
Photo 17 above is palms 37, 38, 94, 95 & 96.

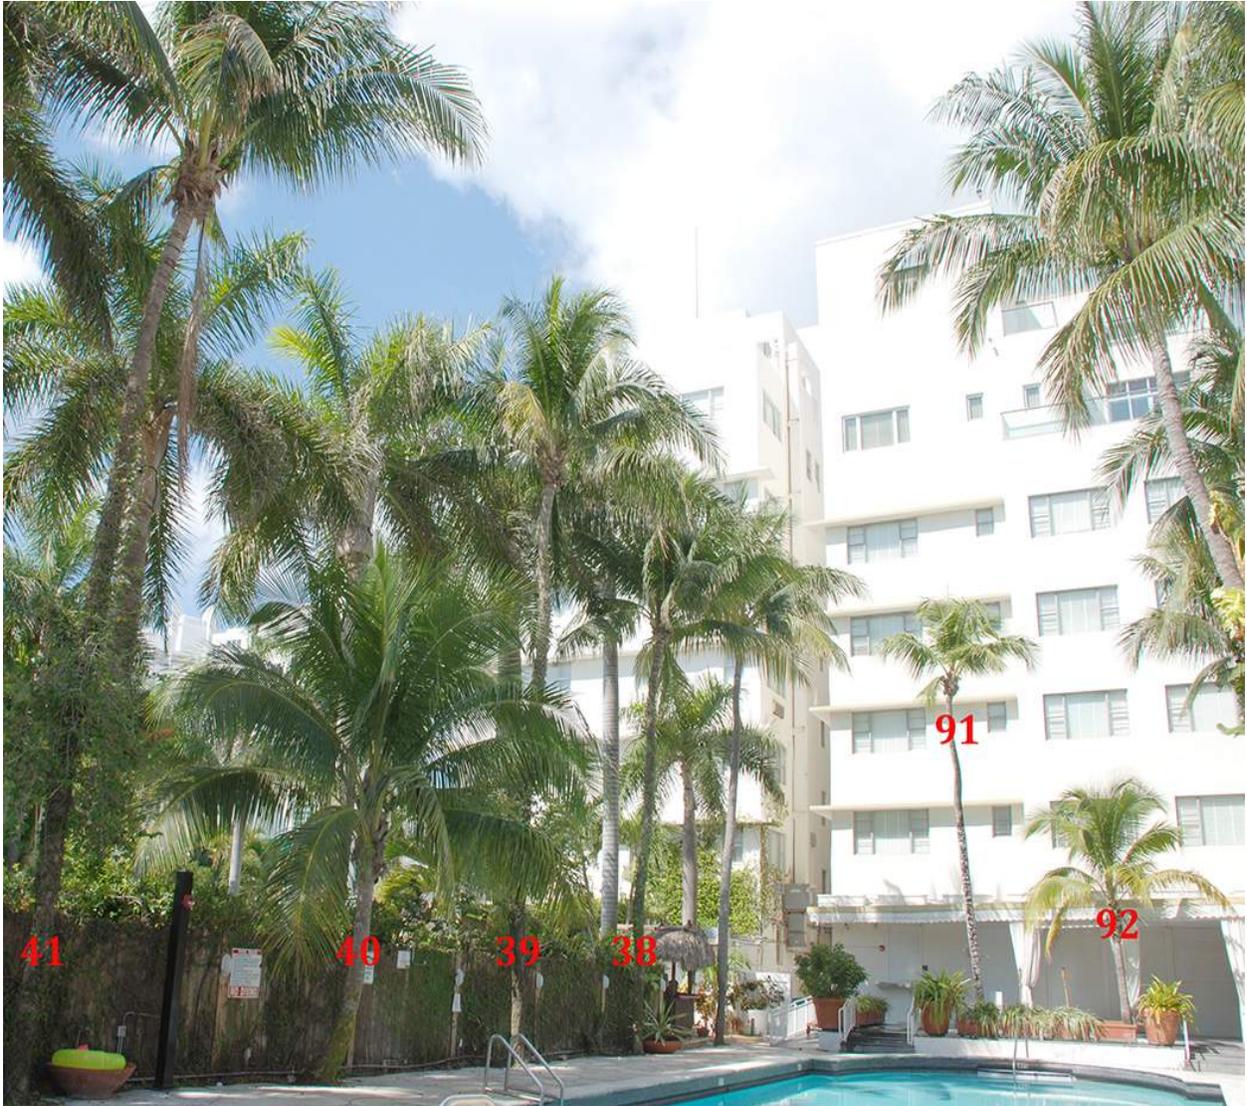
Photo 18 above is palms 38, 39, 40, 41, 91 & 92.

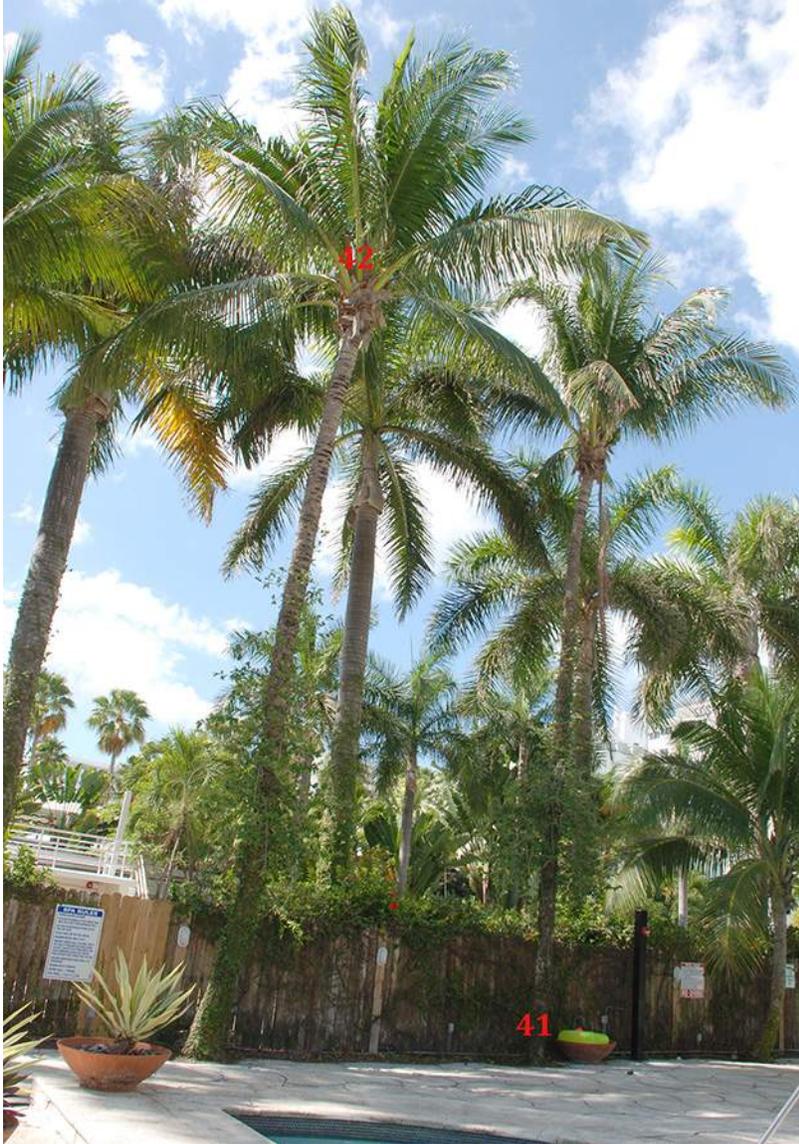
Photo 19 above is palms 41 & 42.

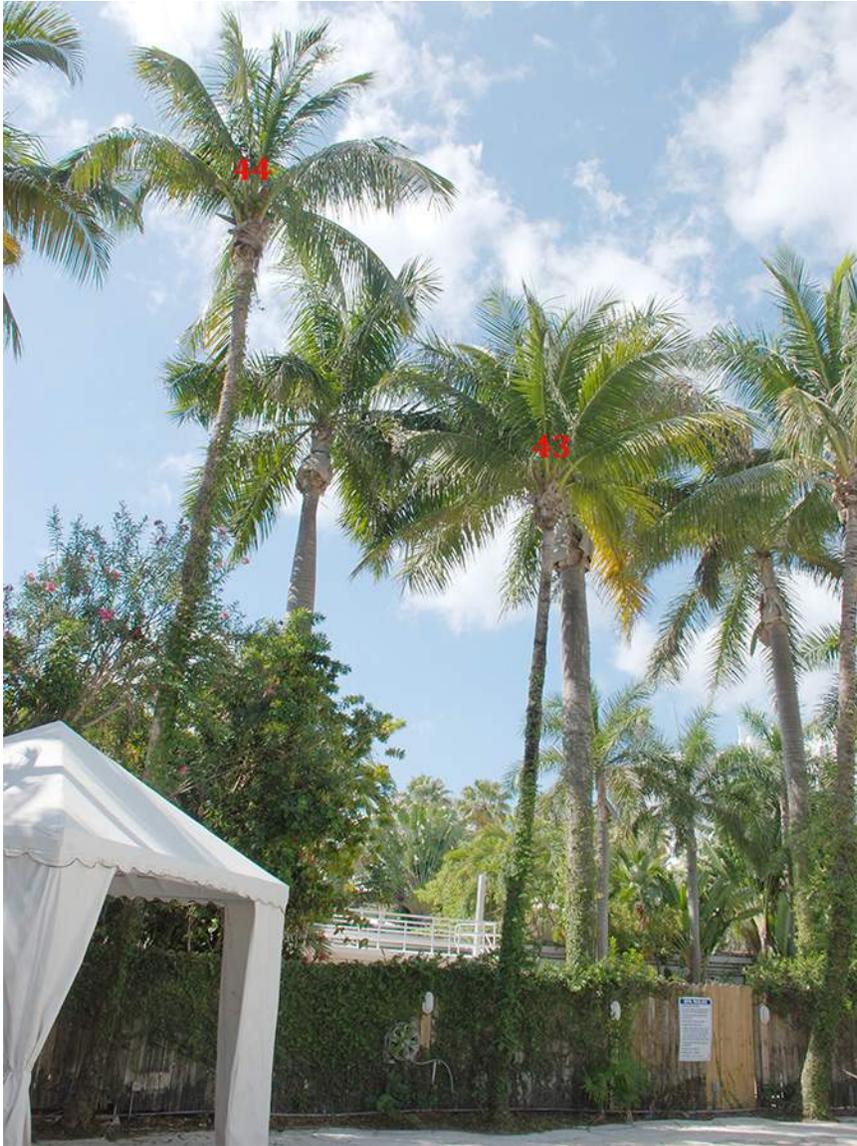
Photo 20 above is palms 43 & 44.

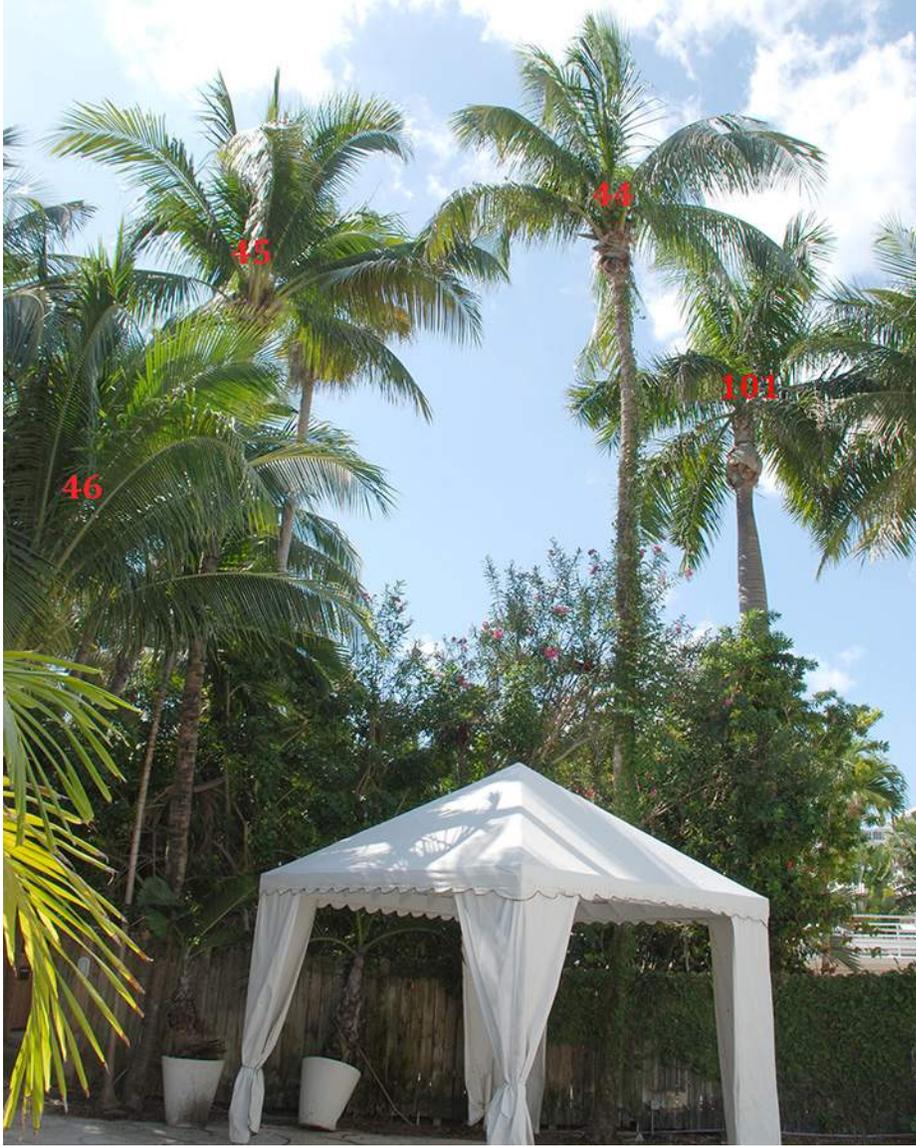
Photo 21 above is palms 44, 45, 46 & 101.

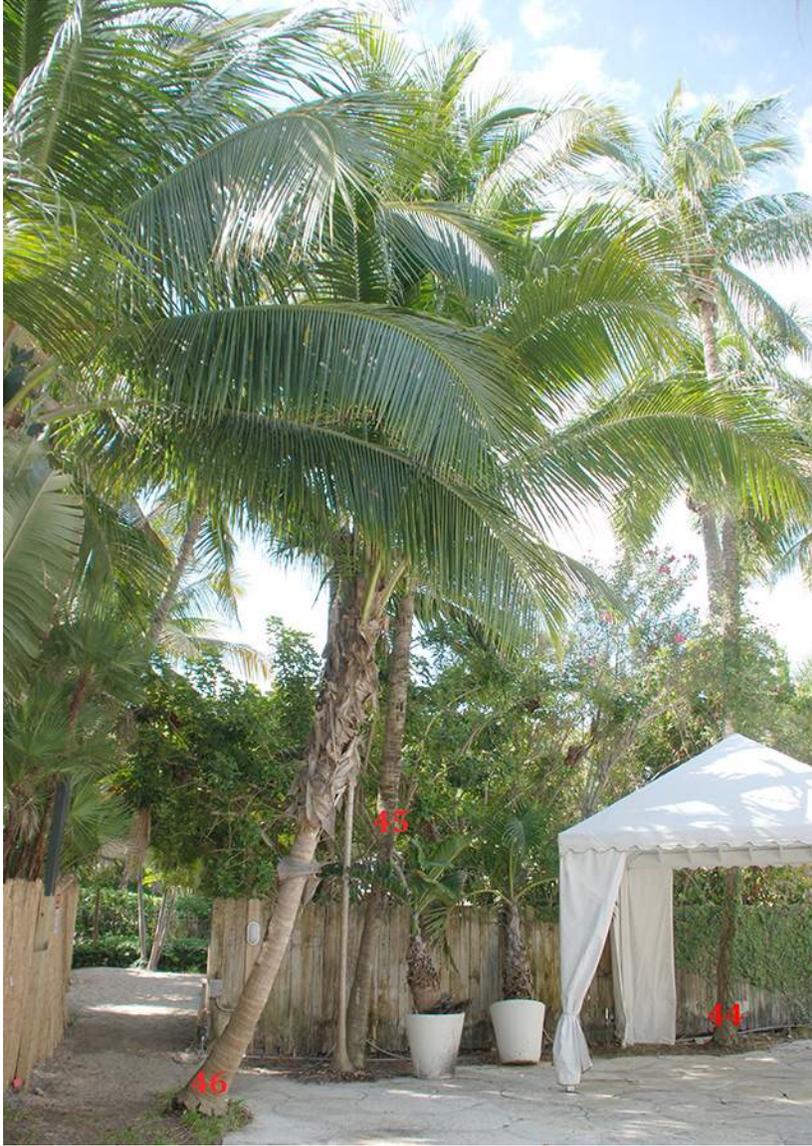
Photo 22 above is palms 45 & 46.

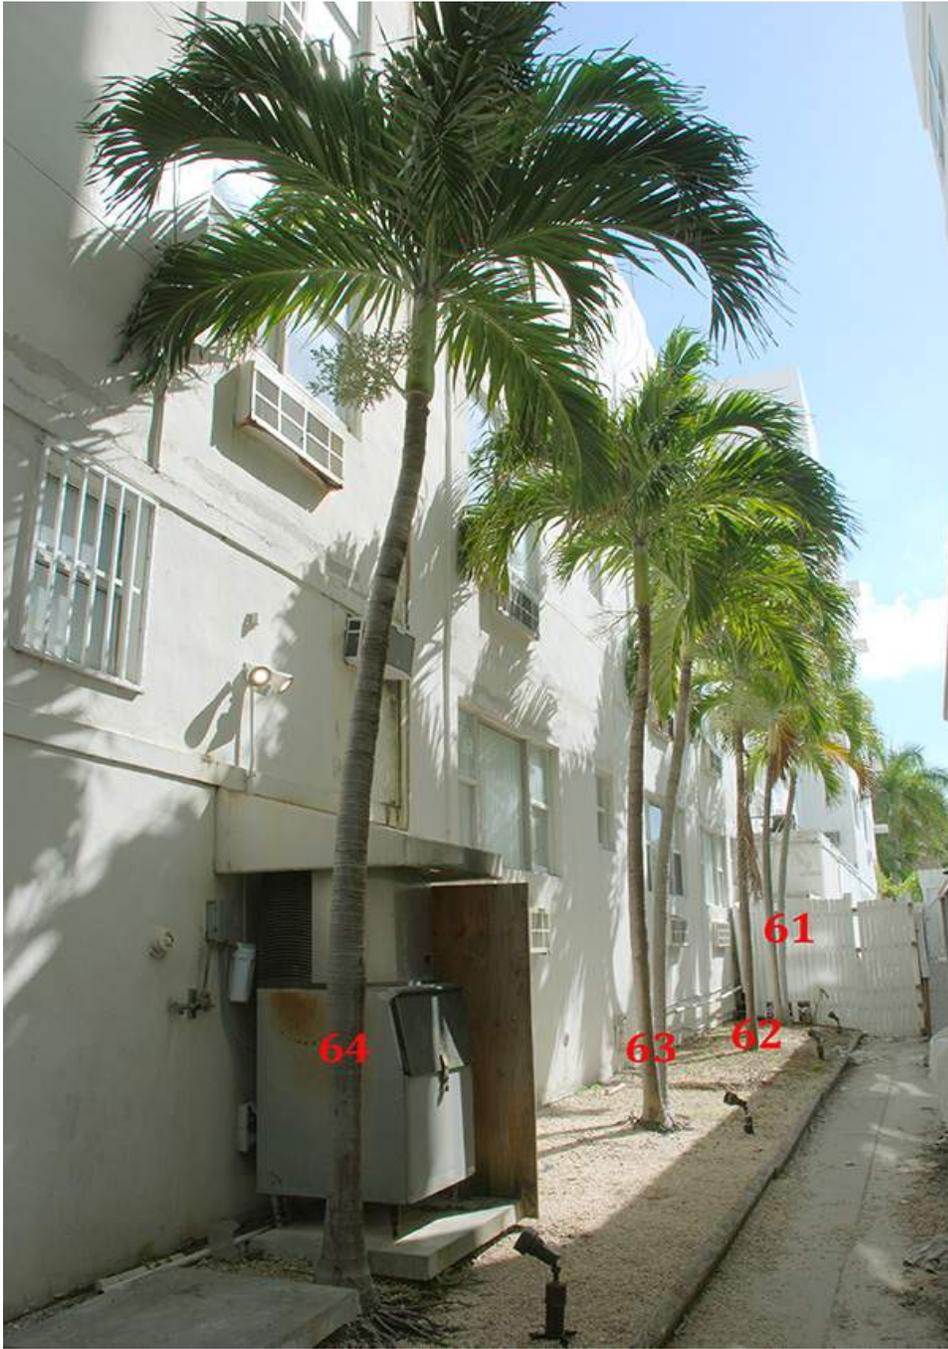
Photo 24 above is palms 61, 62, 63 & 64.

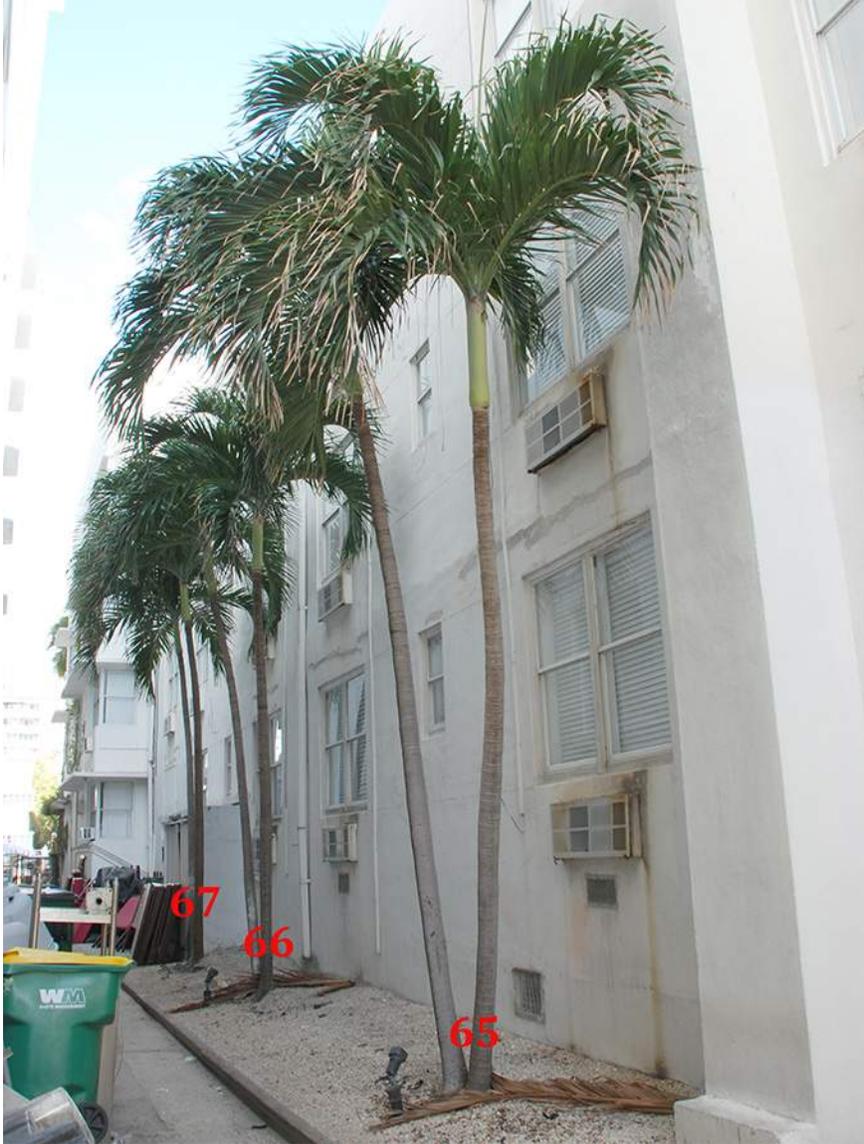
Photo 25 above is palms 65, 66 & 67.

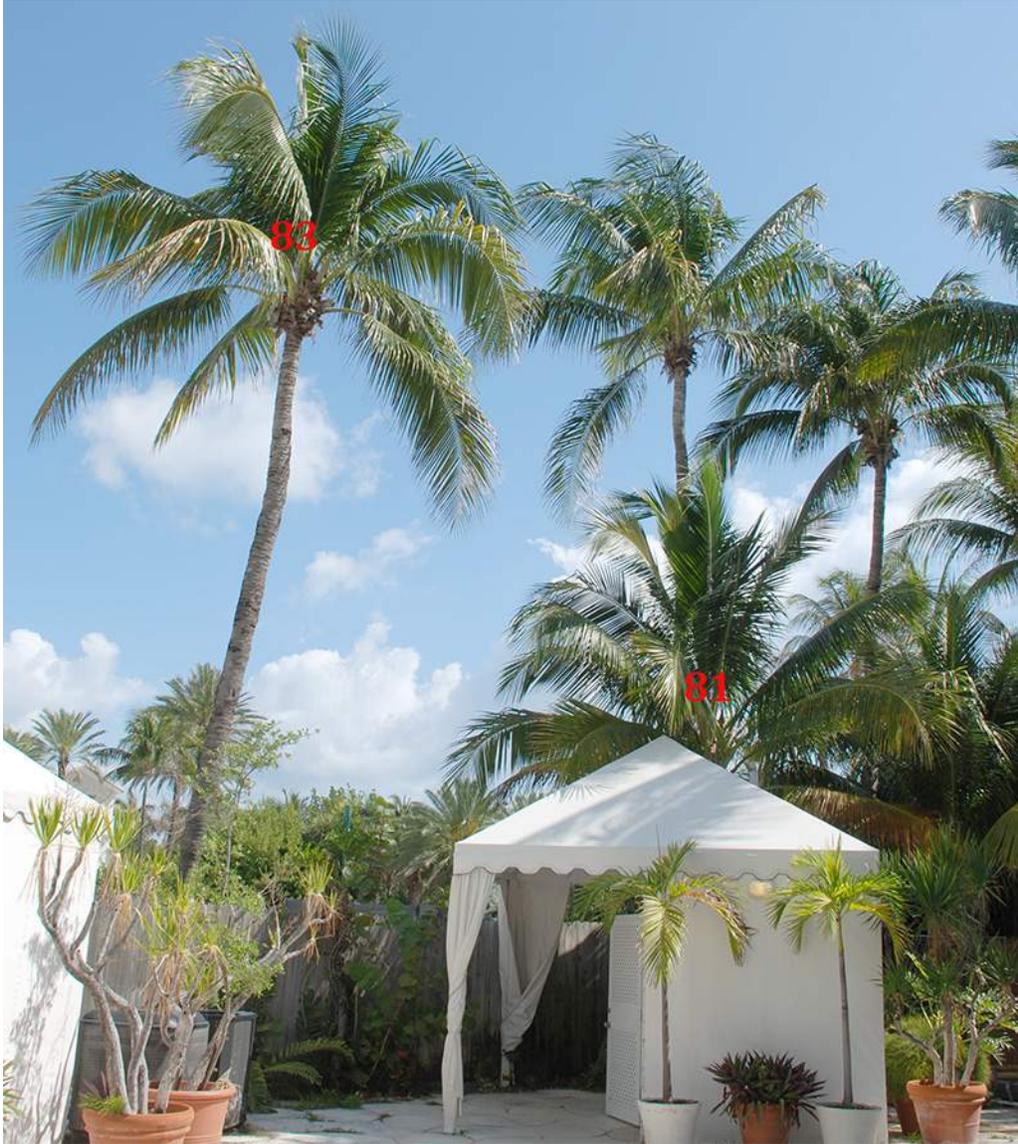
Photo 27 above is palms 81 & 83.
