***Tree Resource Evaluation for
The South Seas, Richmond, and Raleigh Hotels,
Miami Beach***

April 4, 2020

Summary

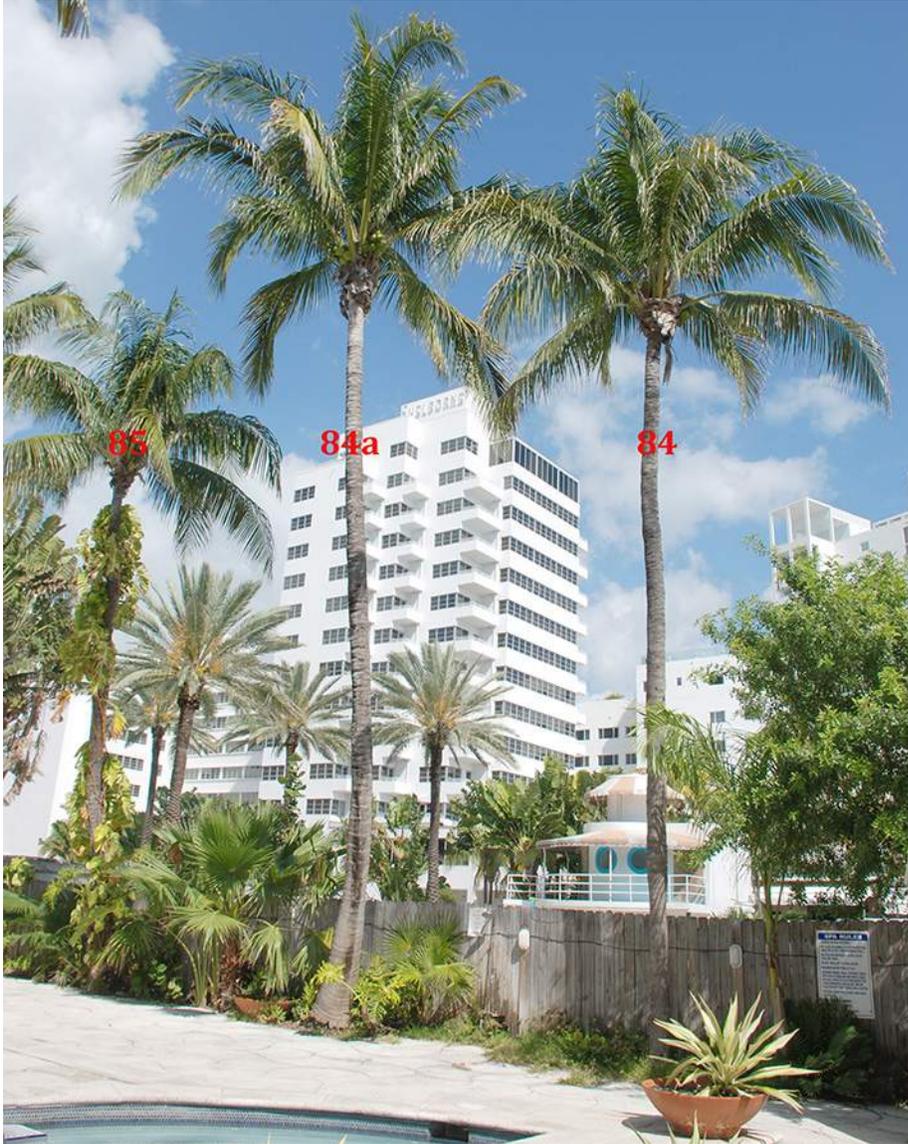
Photo 28 above is palms 84, 84a & 85.

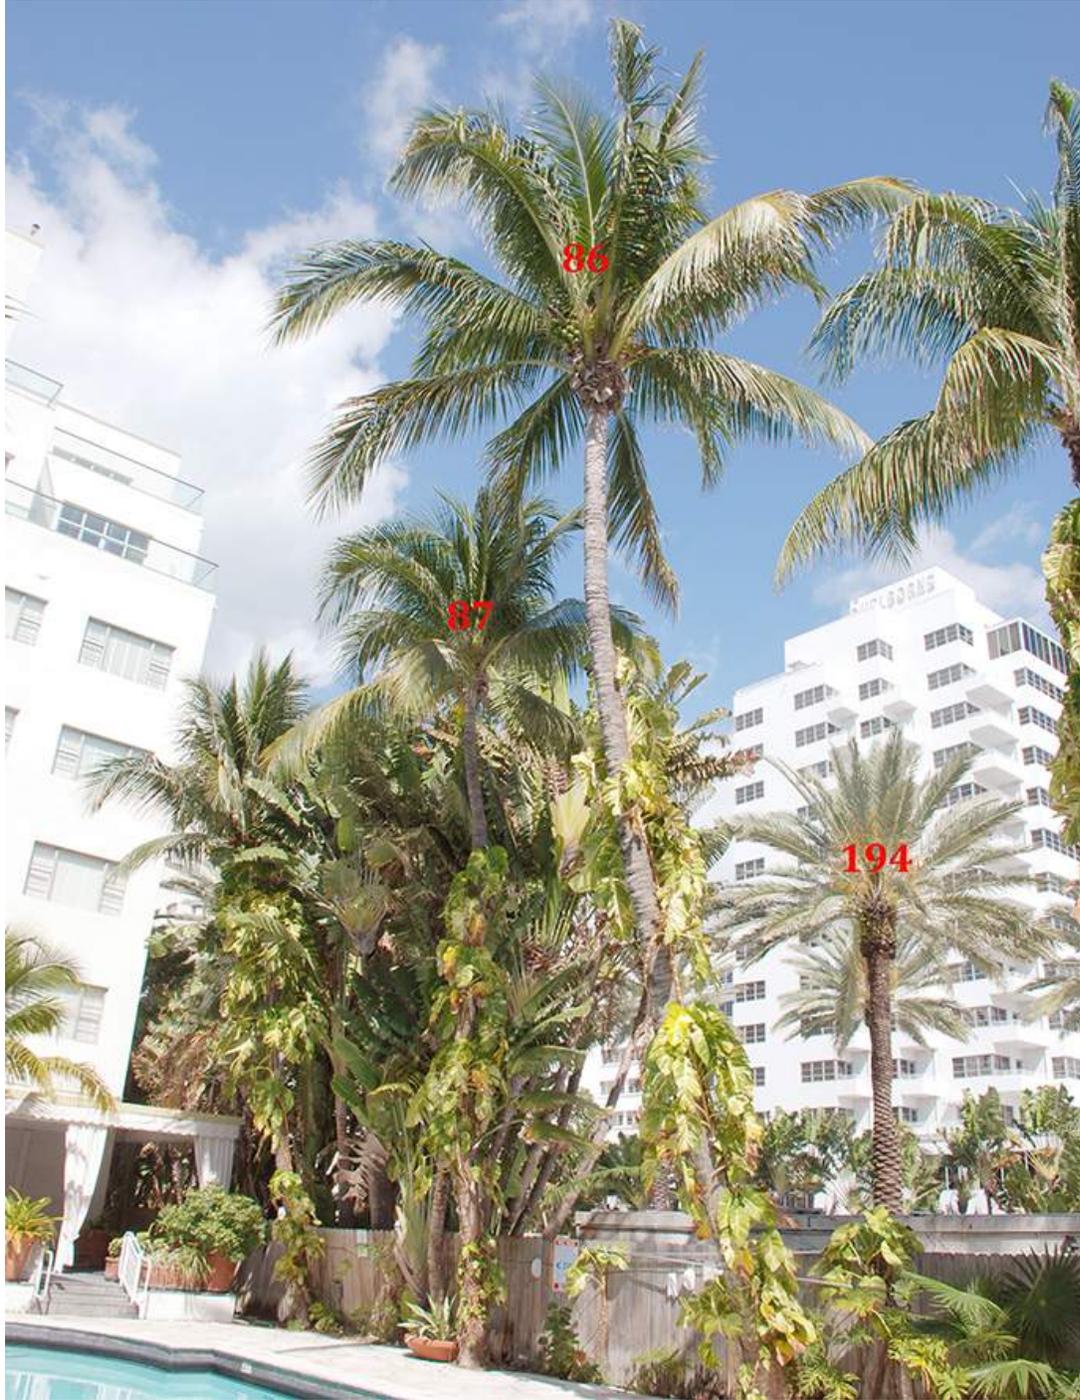
Photo 29 above is palms86 & 87.

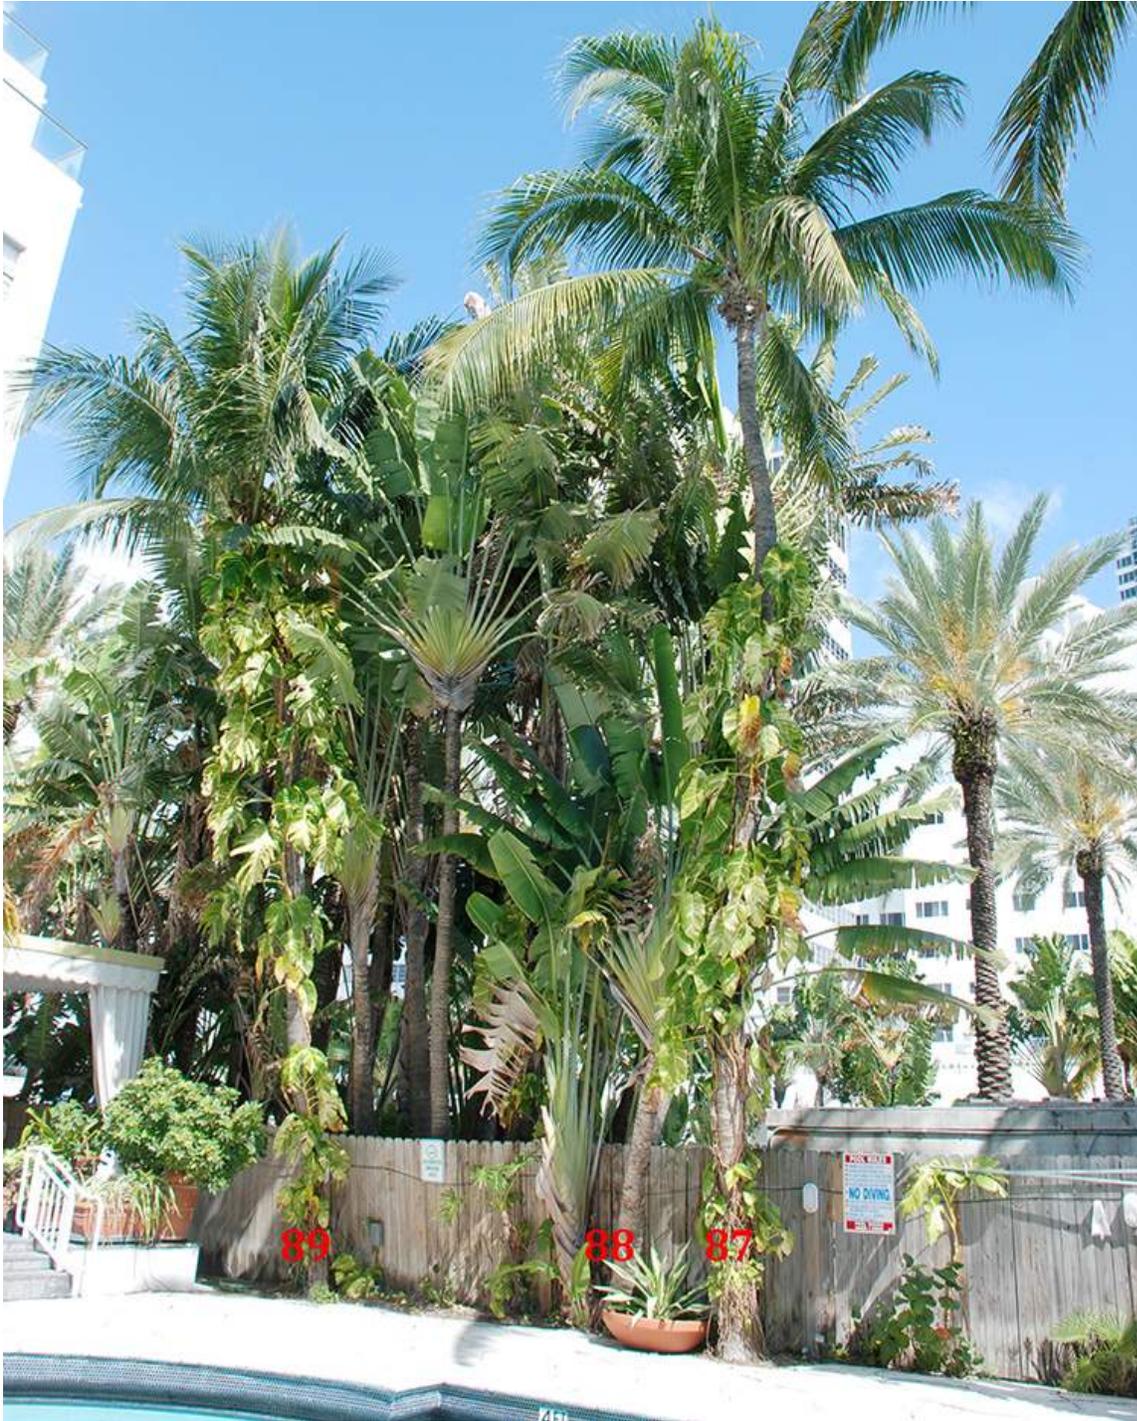
Photo 30 above is palms 87, 88 & 89.

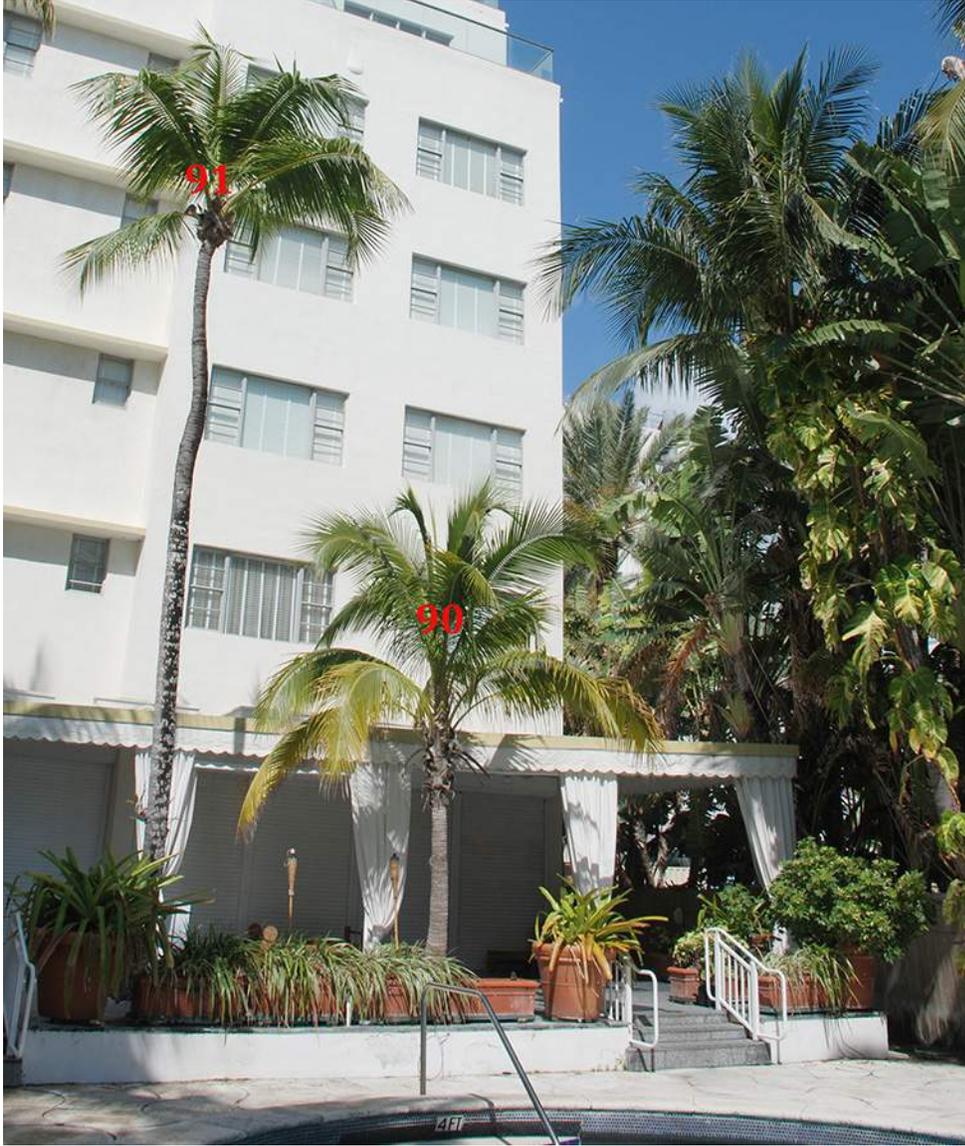
Photo 31 above is palms 90 & 91.

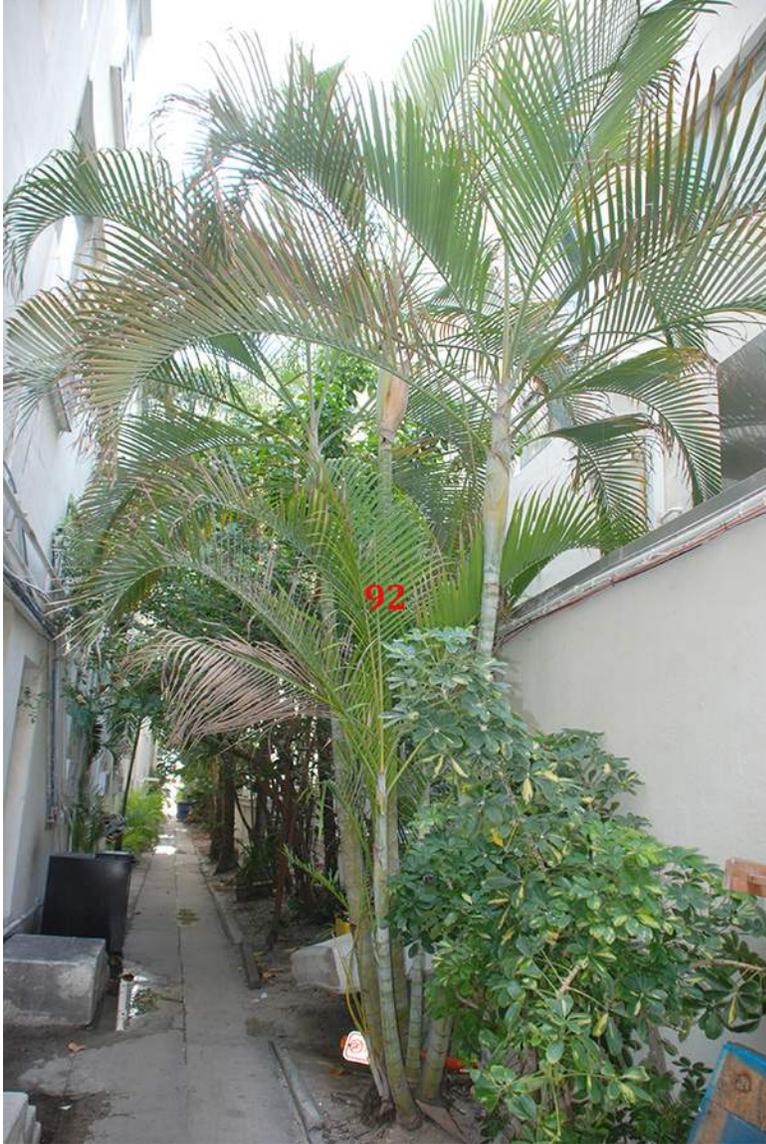
Photo 32 above is palm 92.

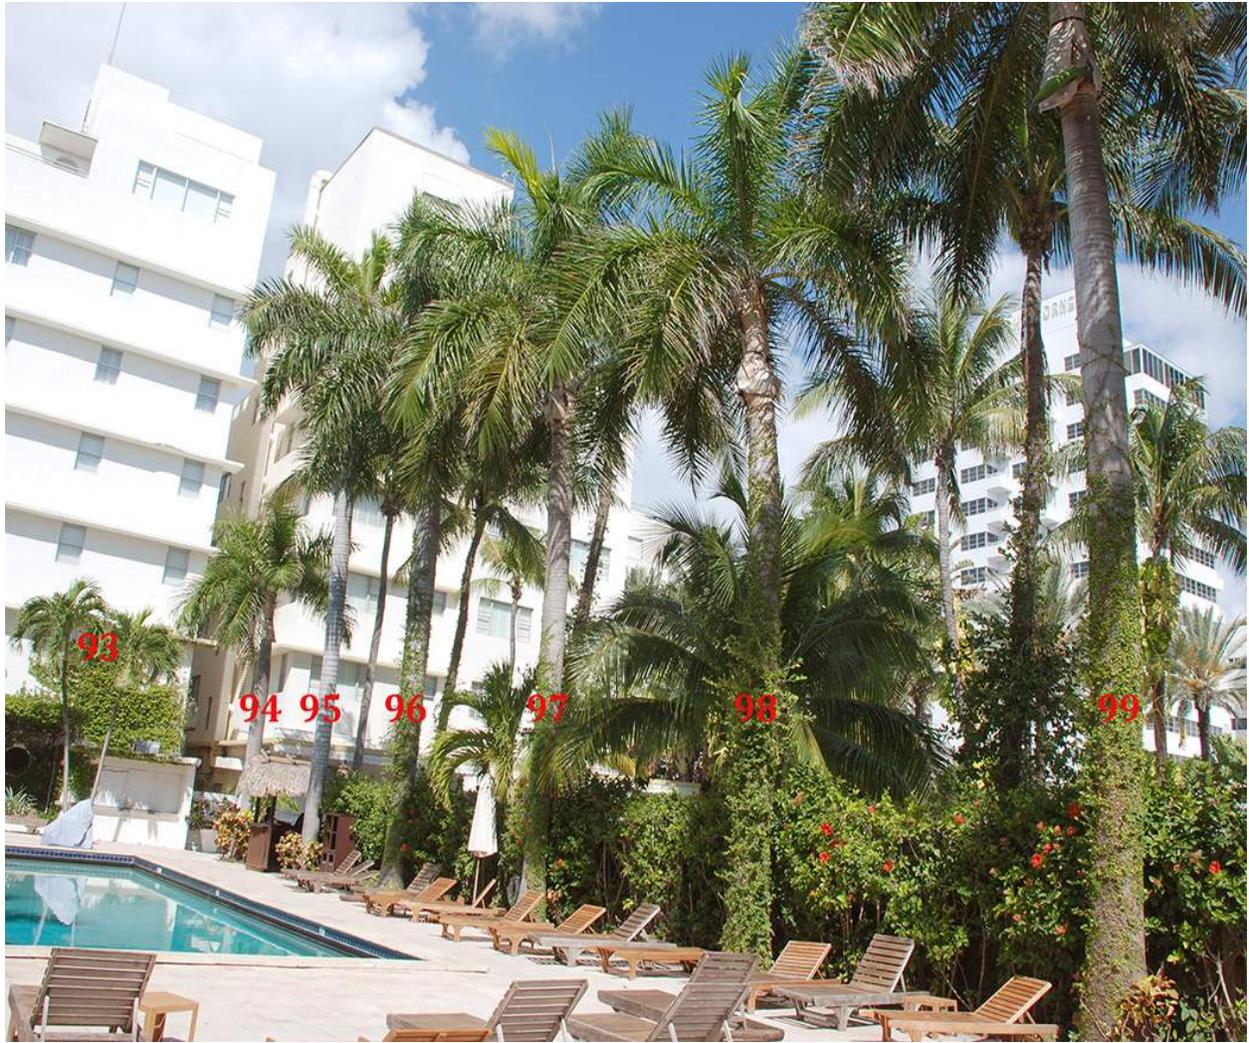
Photo 33 above is palms 93 through 99.

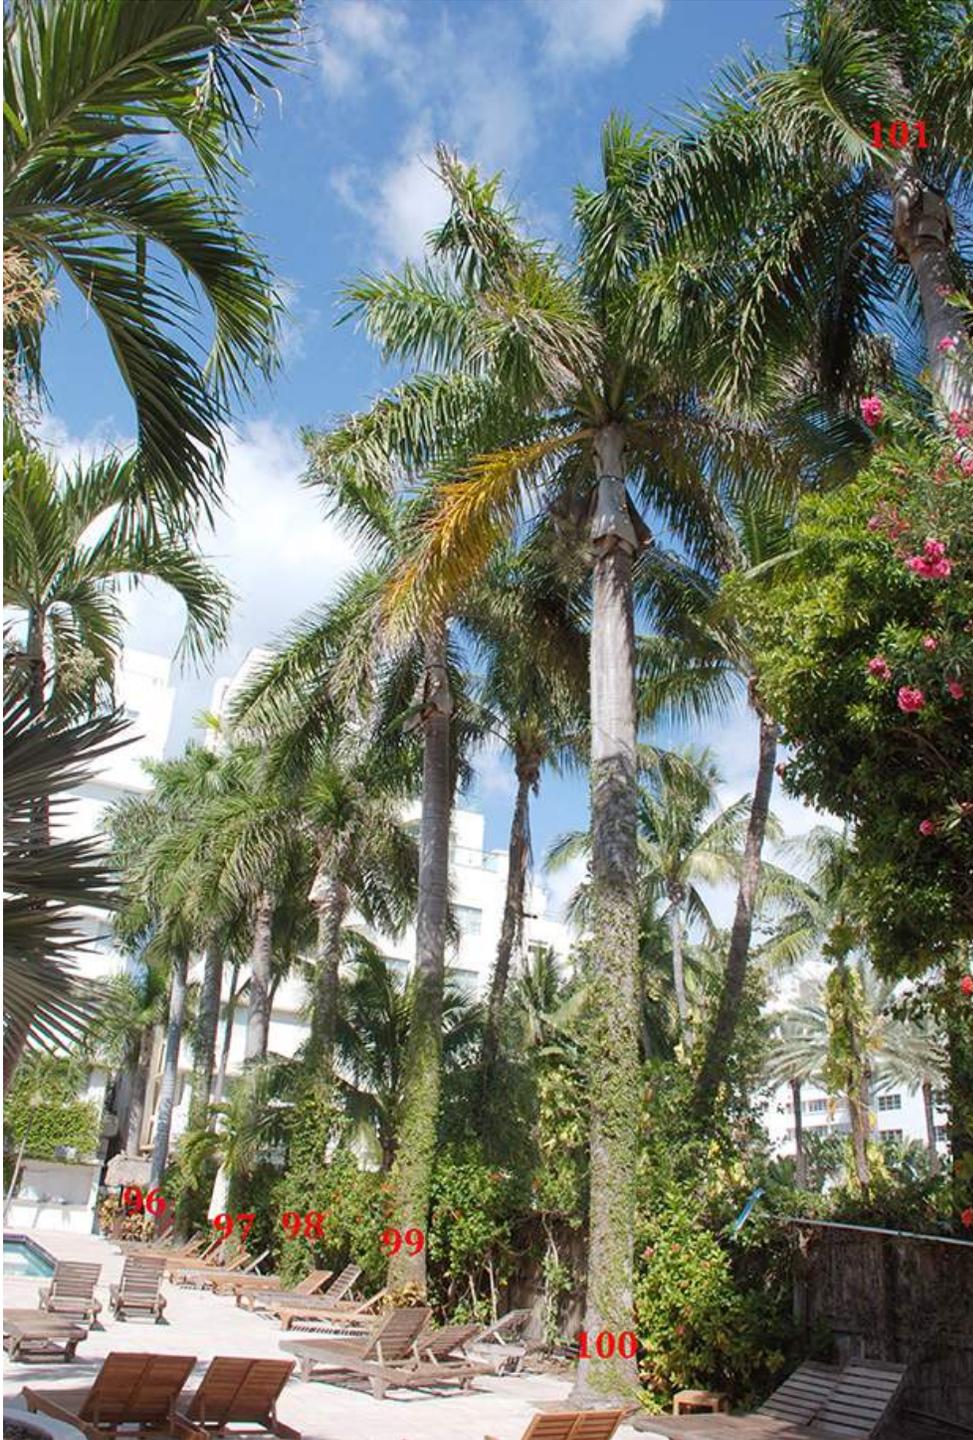
Photo 34 above is palms 96 through 100.

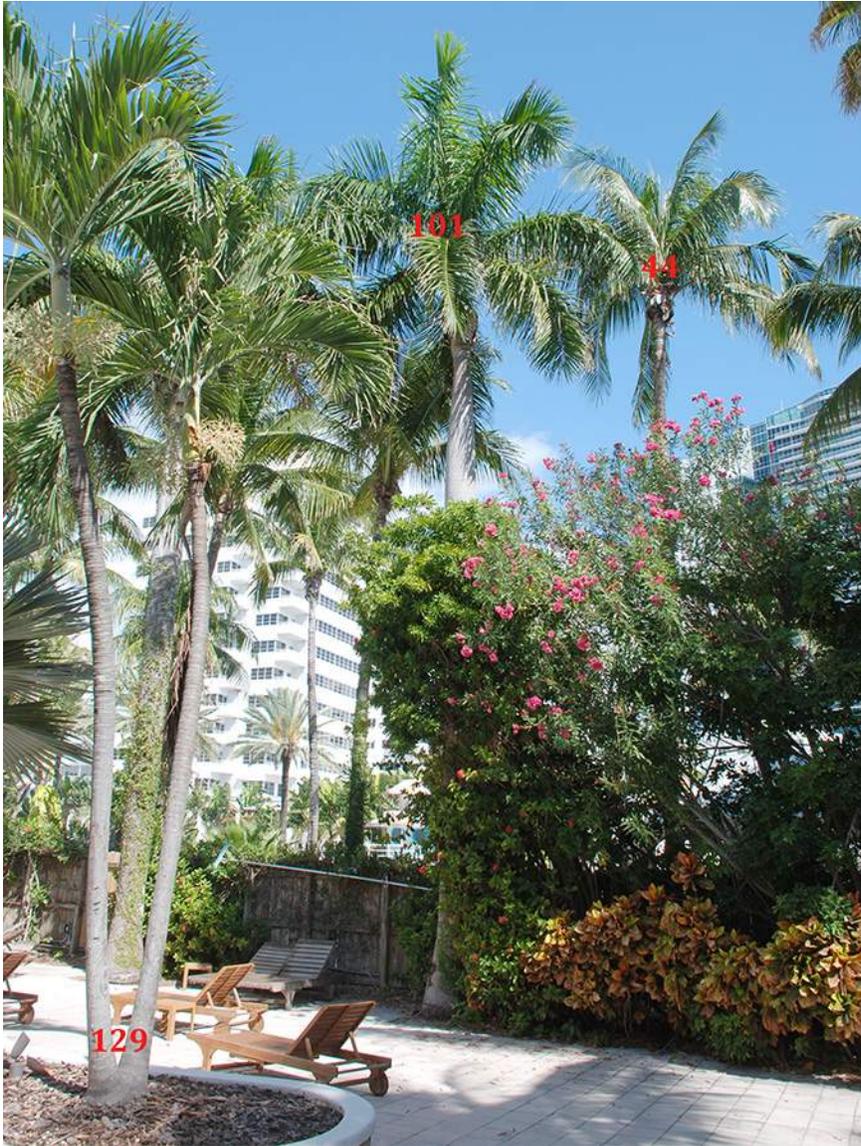
Photo 35 above is palms 44, 101 & 129.

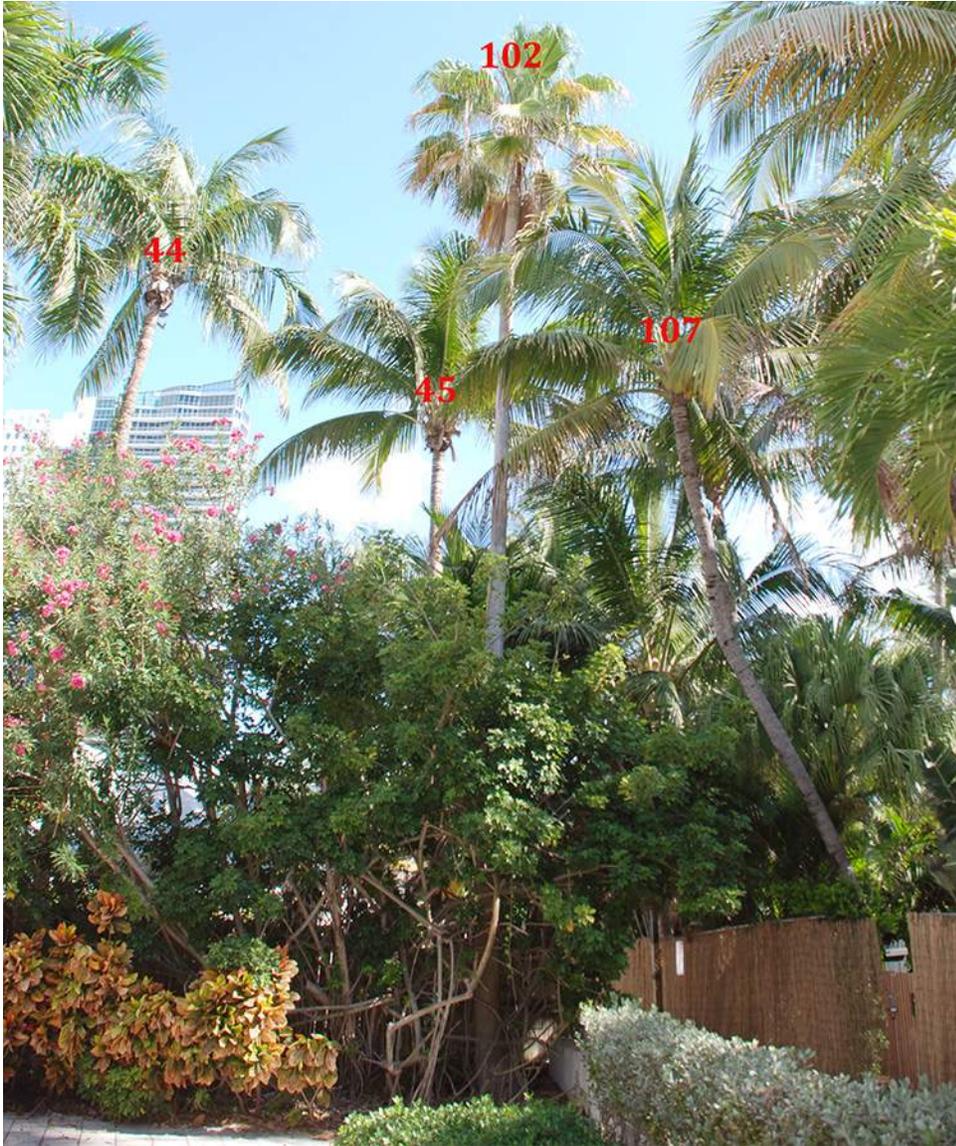
Photo 36 above is palms 44, 45, 402 & 107.

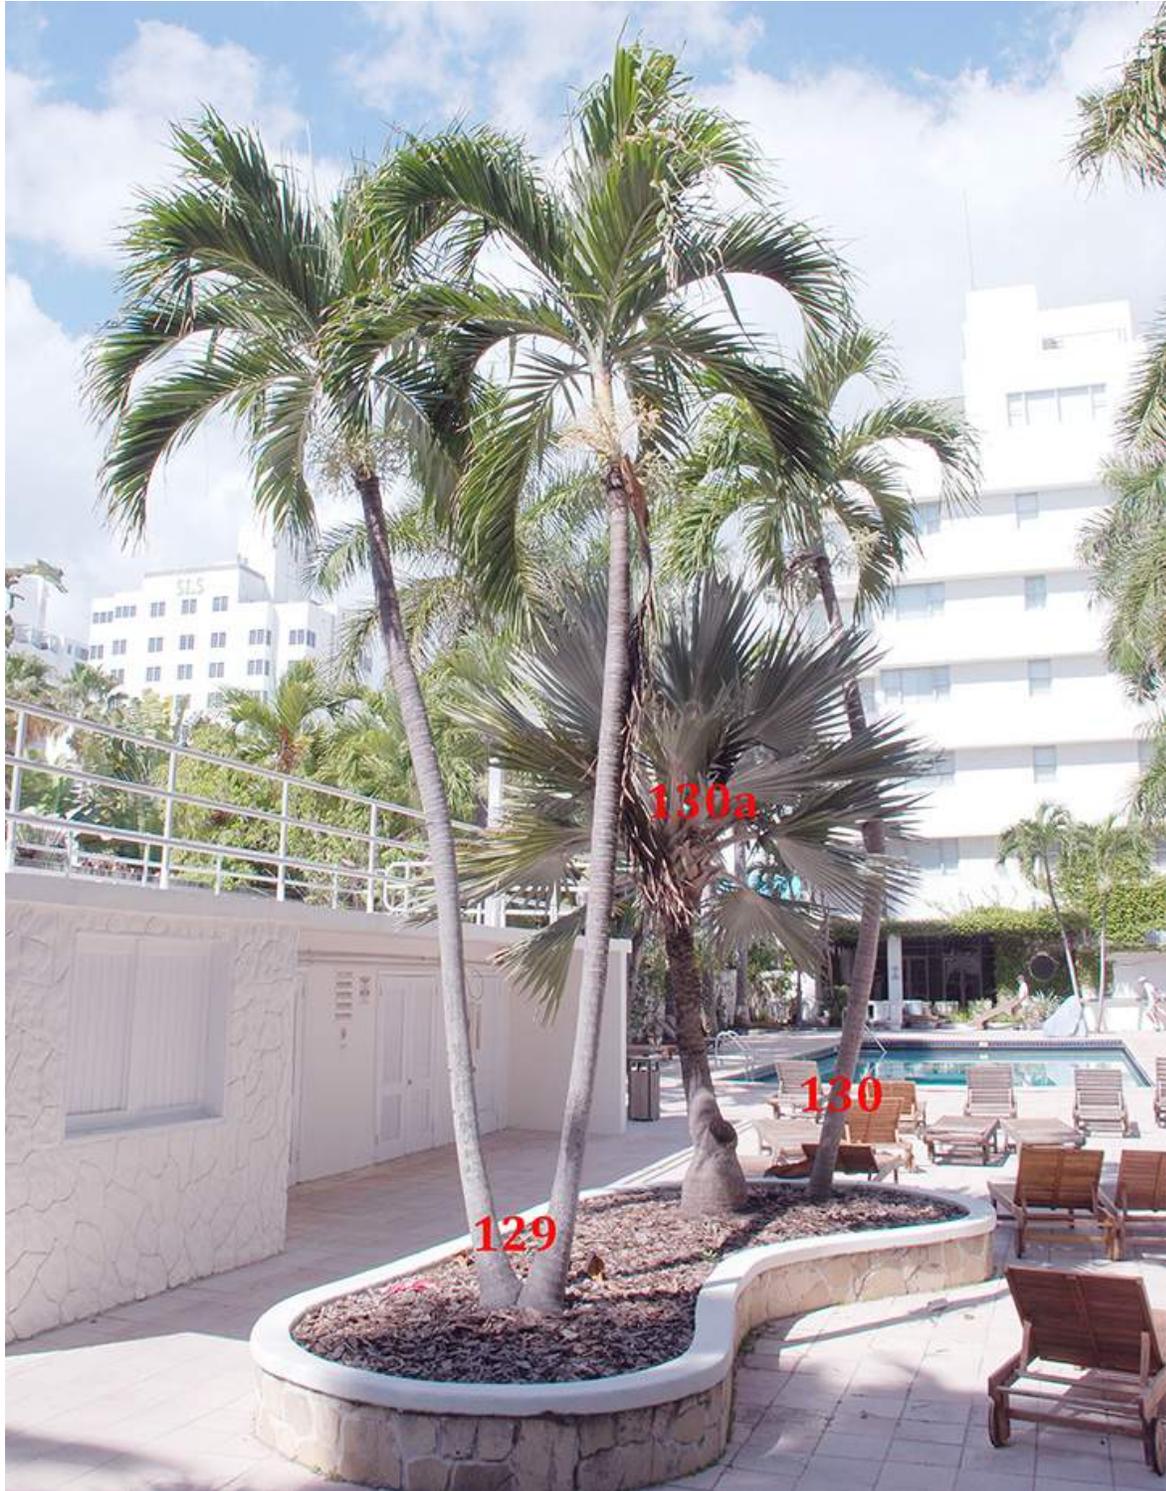
Photo 37 above is palms 129, 130 & 130a.

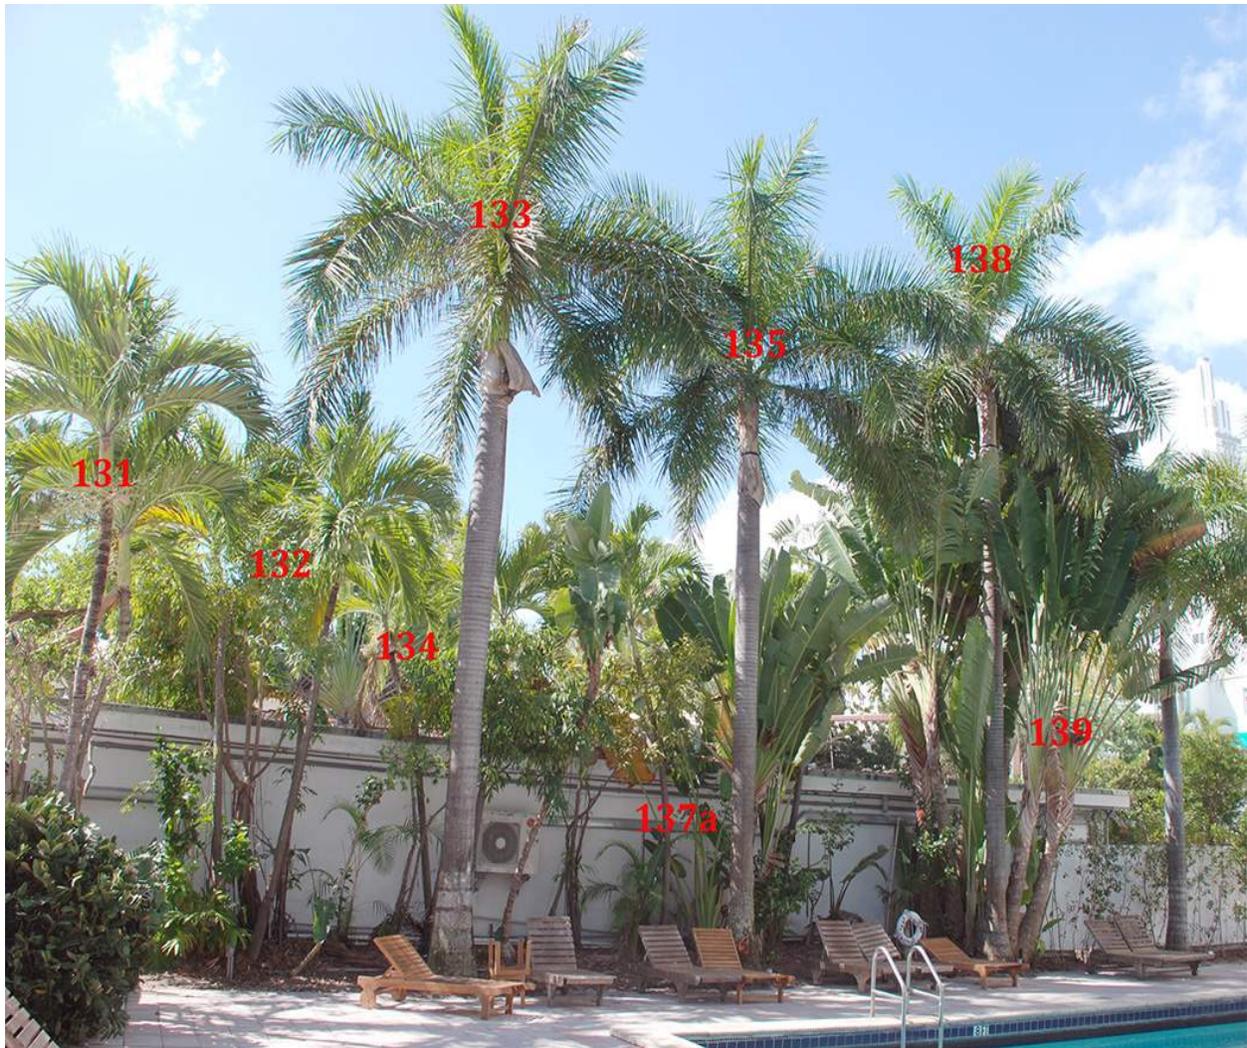
Photo 38 above is palms 131 through 138.

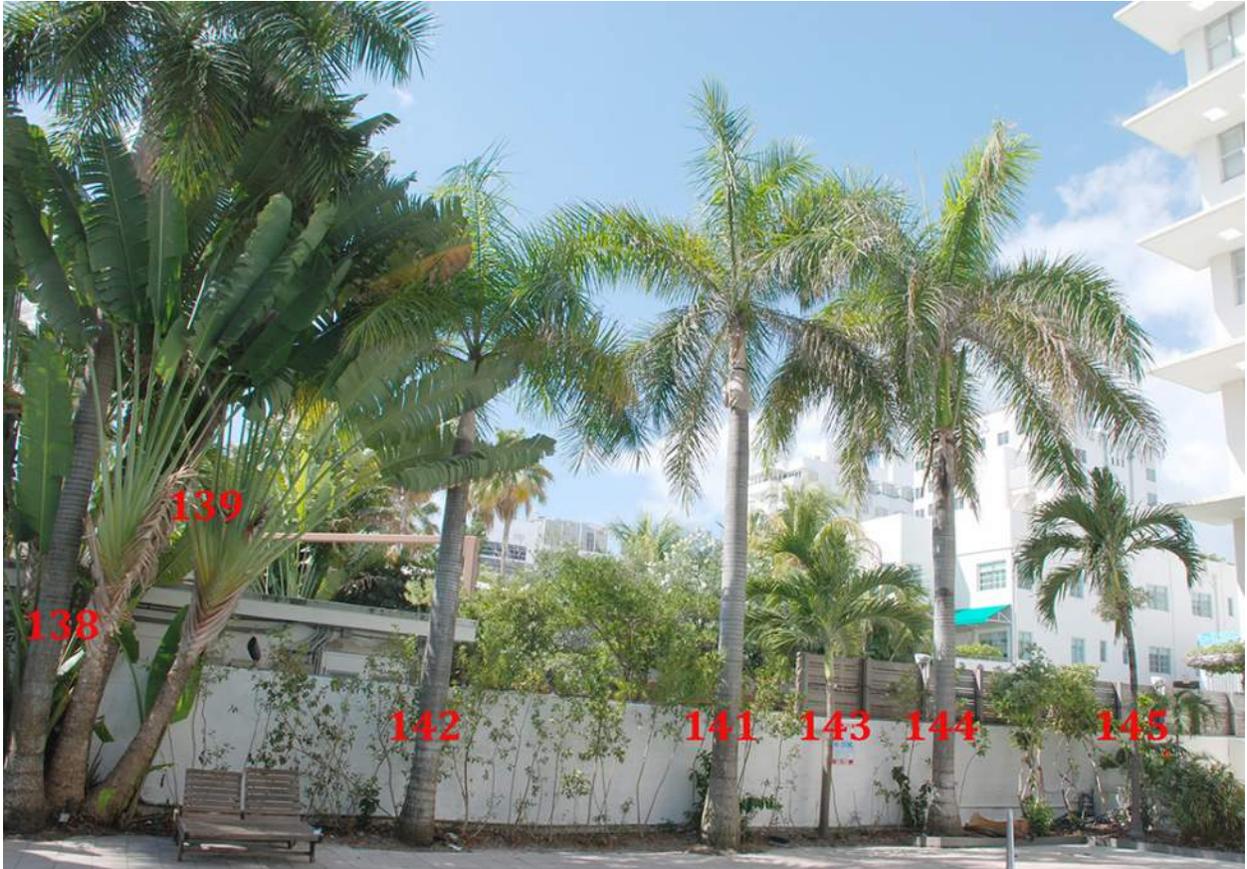
Photo 39 above is palms 142 through 145.

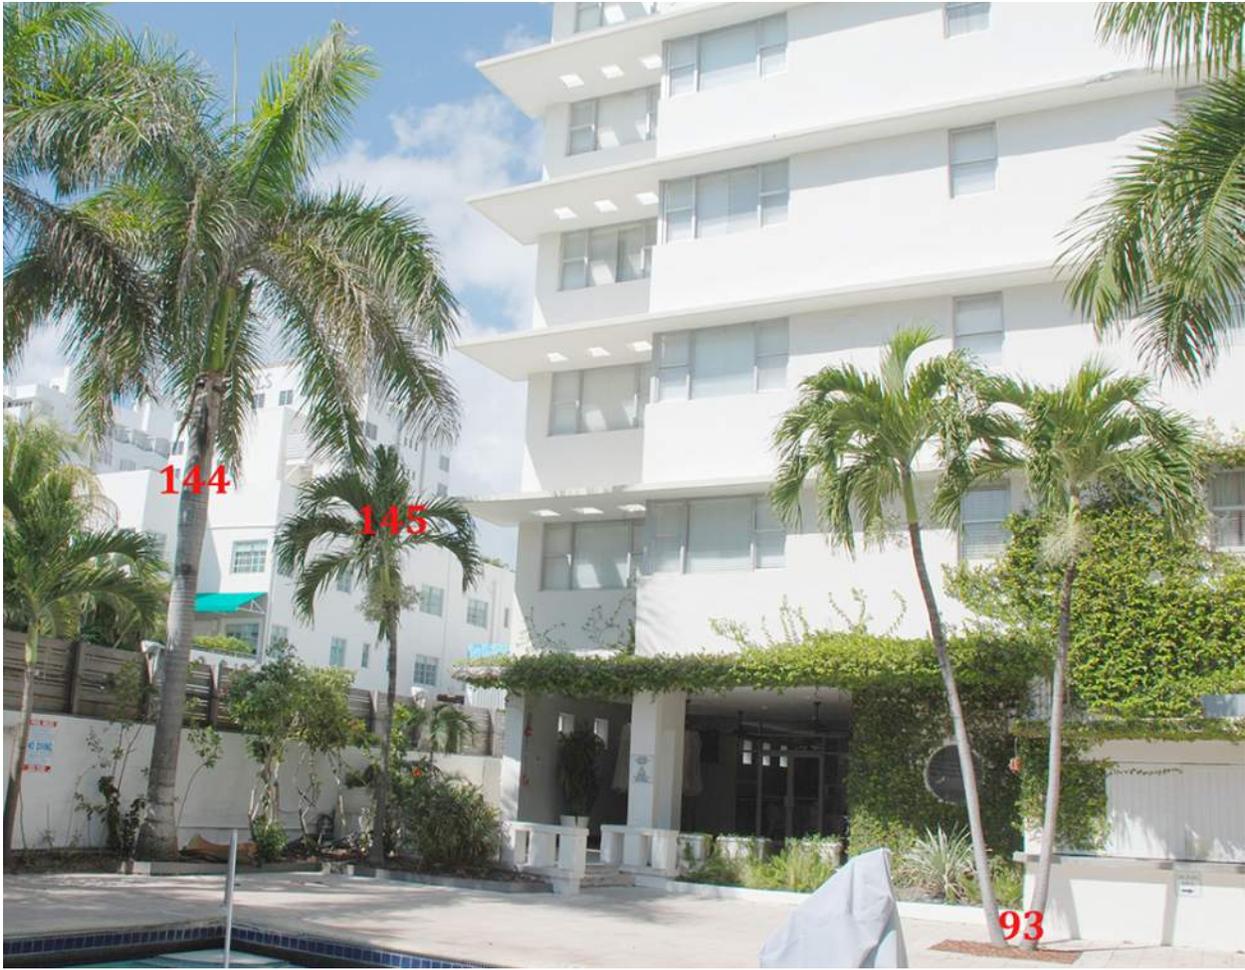
Photo 40 above is palms 93, 144 & 145.

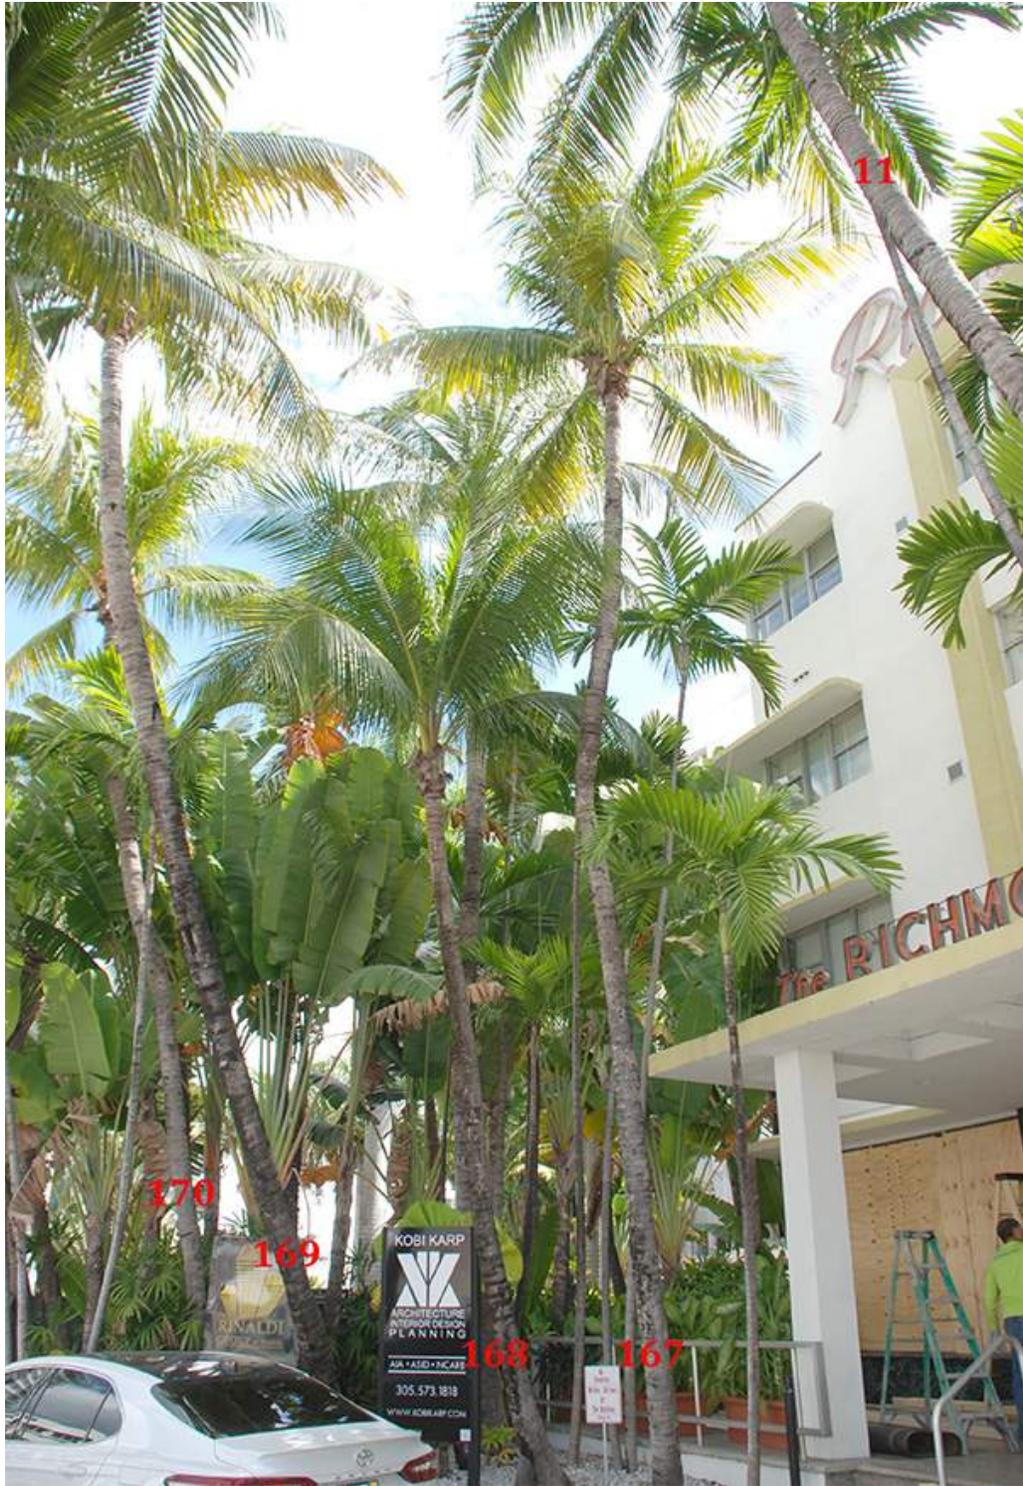
Photo 41 above is palms 167 through 170.

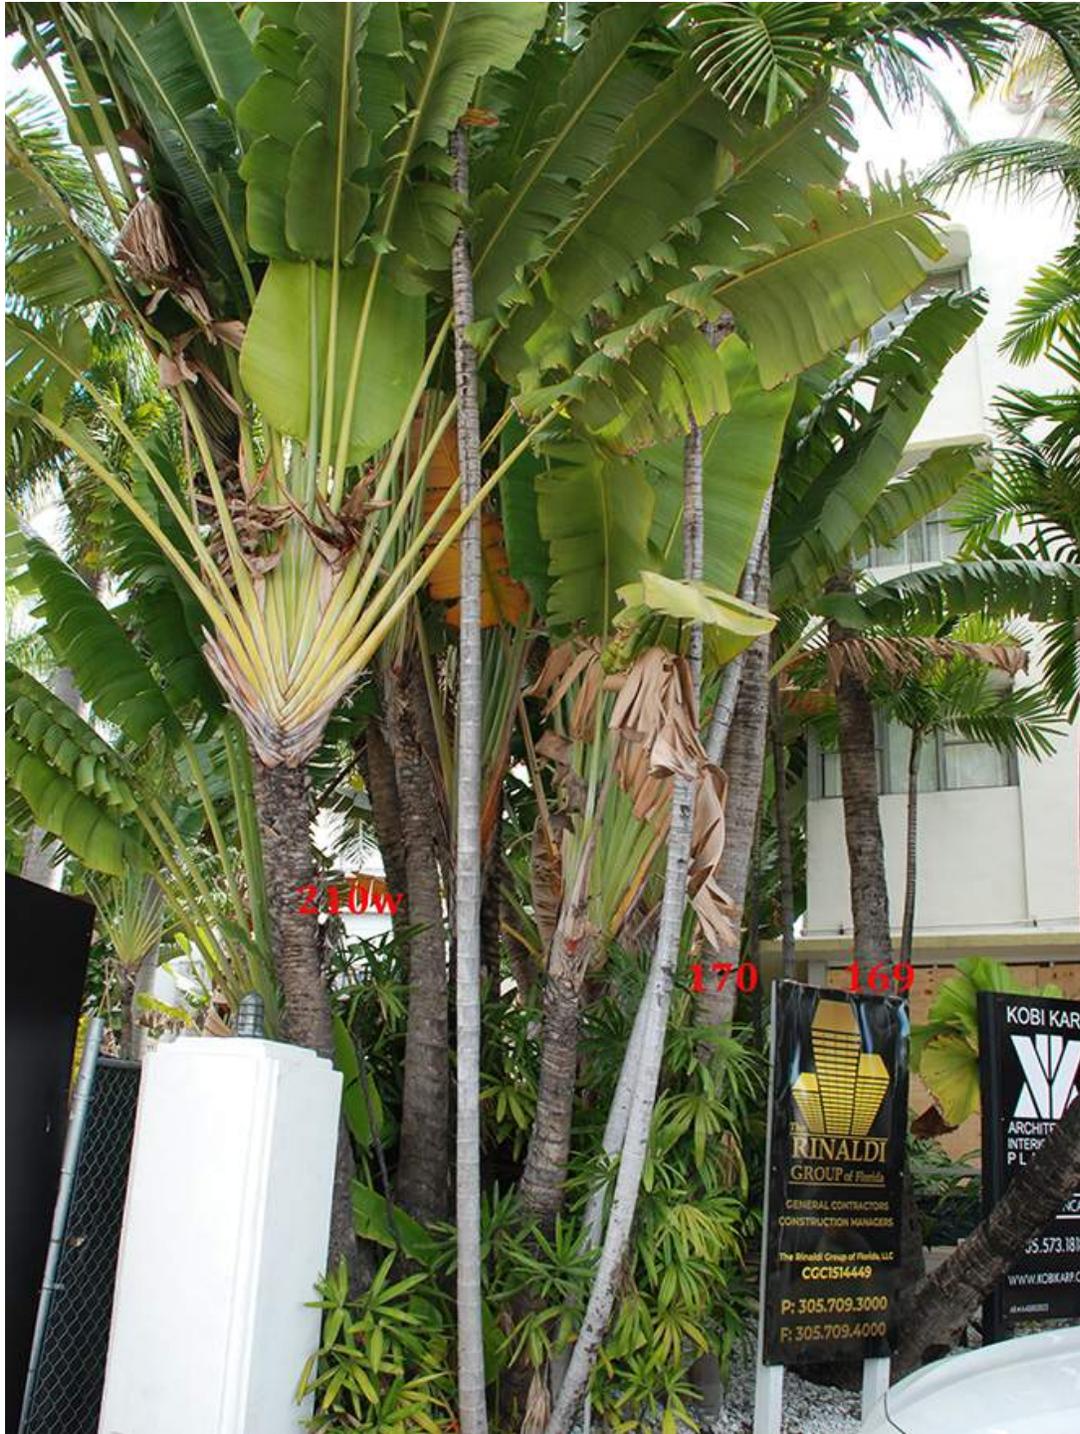
Photo 42 above is traveller's tree 210 w. The traveller's trees onsite are very densely grown in together and being a multi-trunked plant, very often it is very difficult to distinguish between individual plants

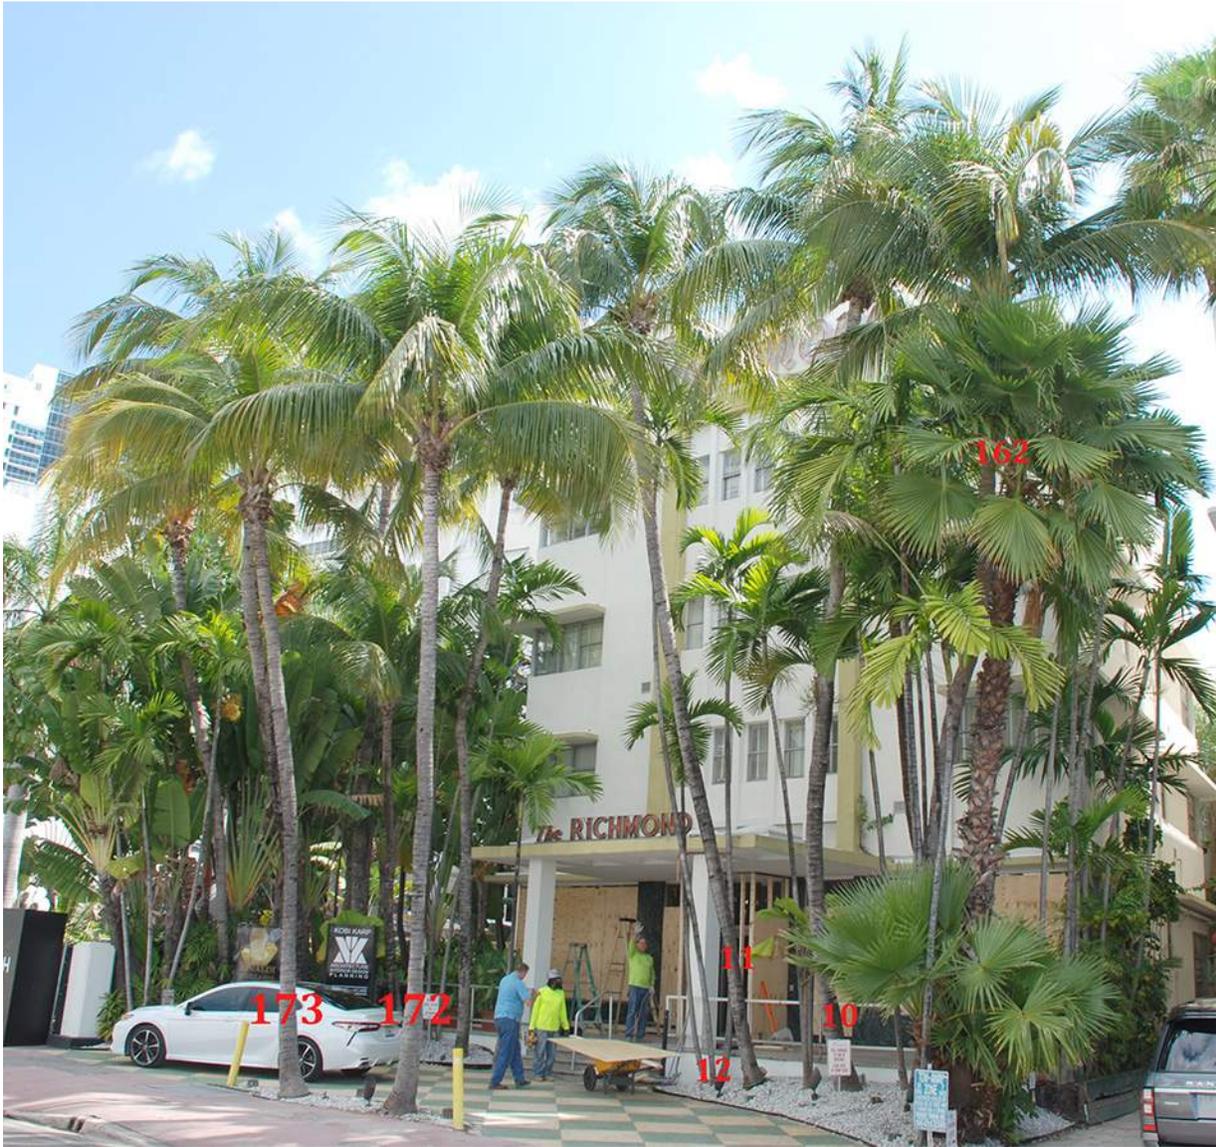
Photo 43 above is palms 10, 11, 12, 172 & 173.

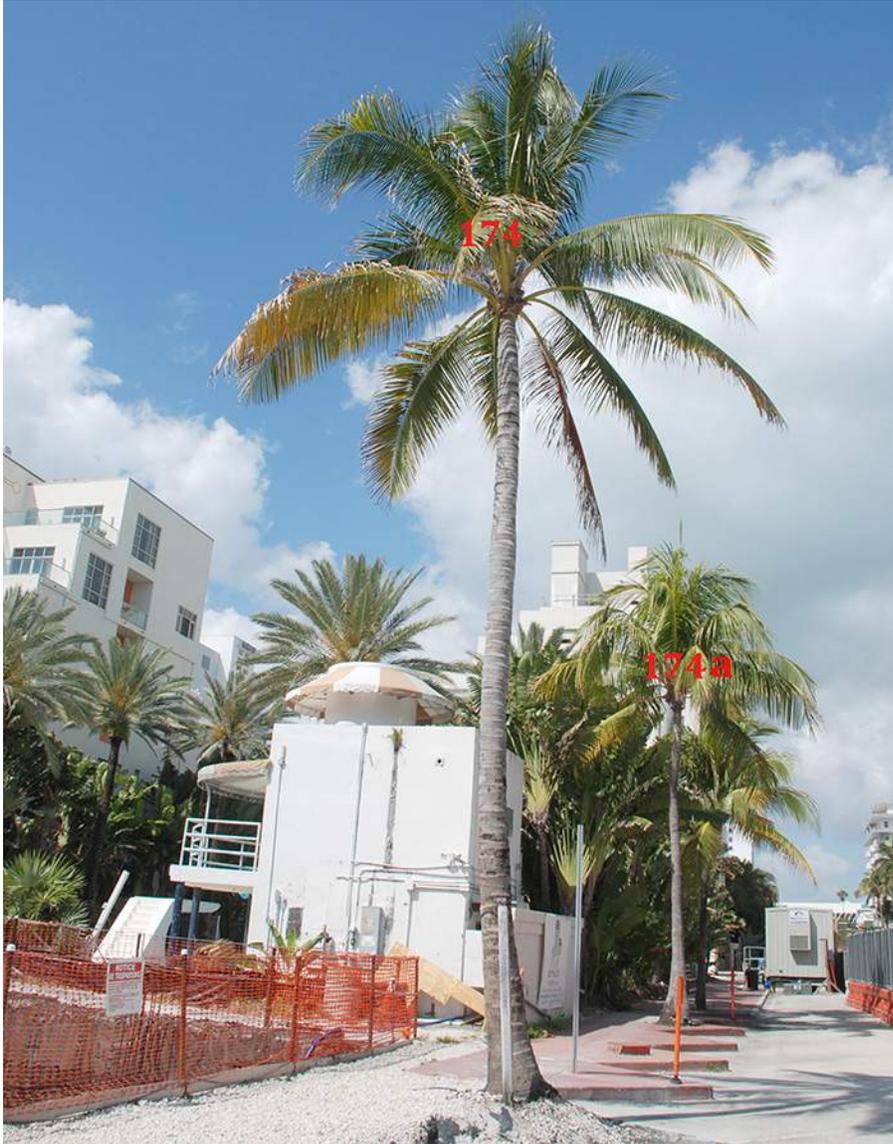
Photo 44 above is palms 174 & 174a.

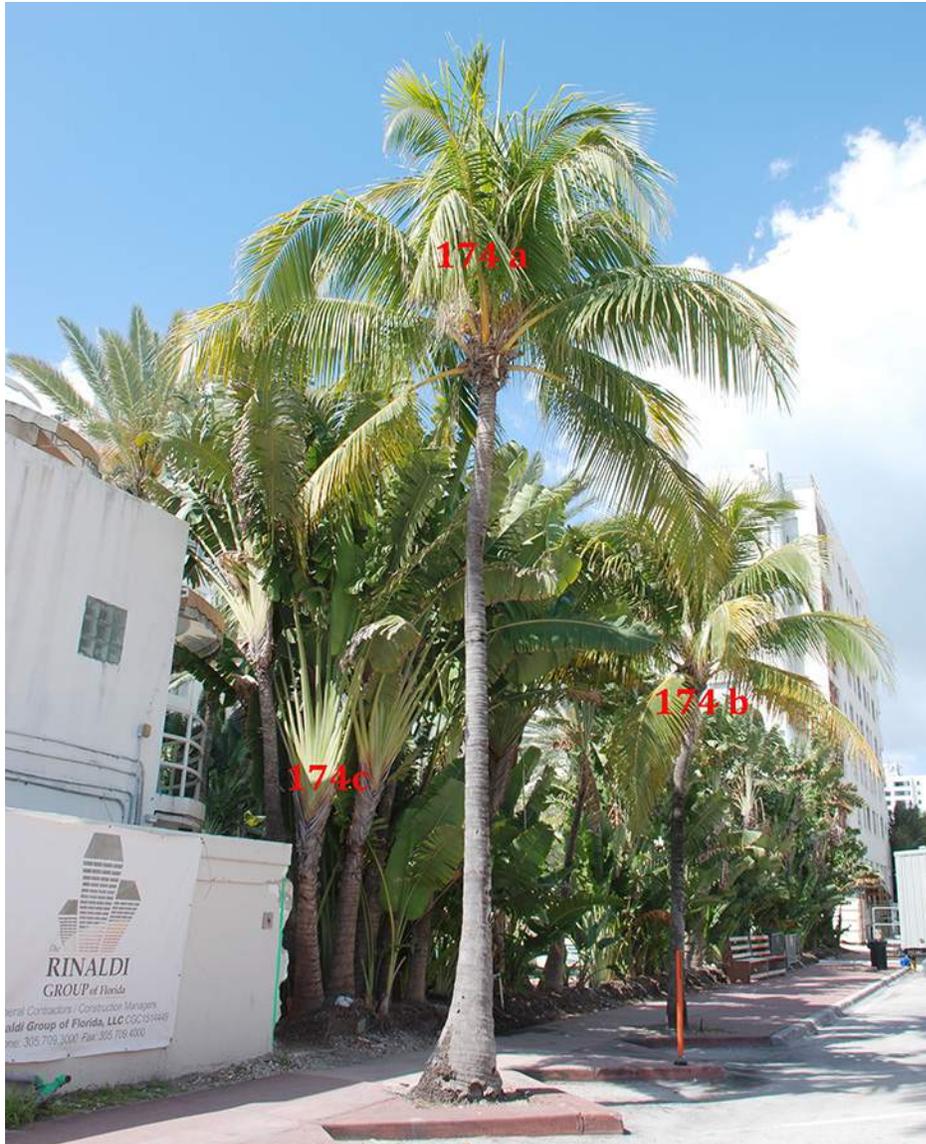
Photo 45 above is palm 174a & 174b.
