***Tree Resource Evaluation for
The South Seas, Richmond, and Raleigh Hotels,
Miami Beach***

April 4, 2020

Summary

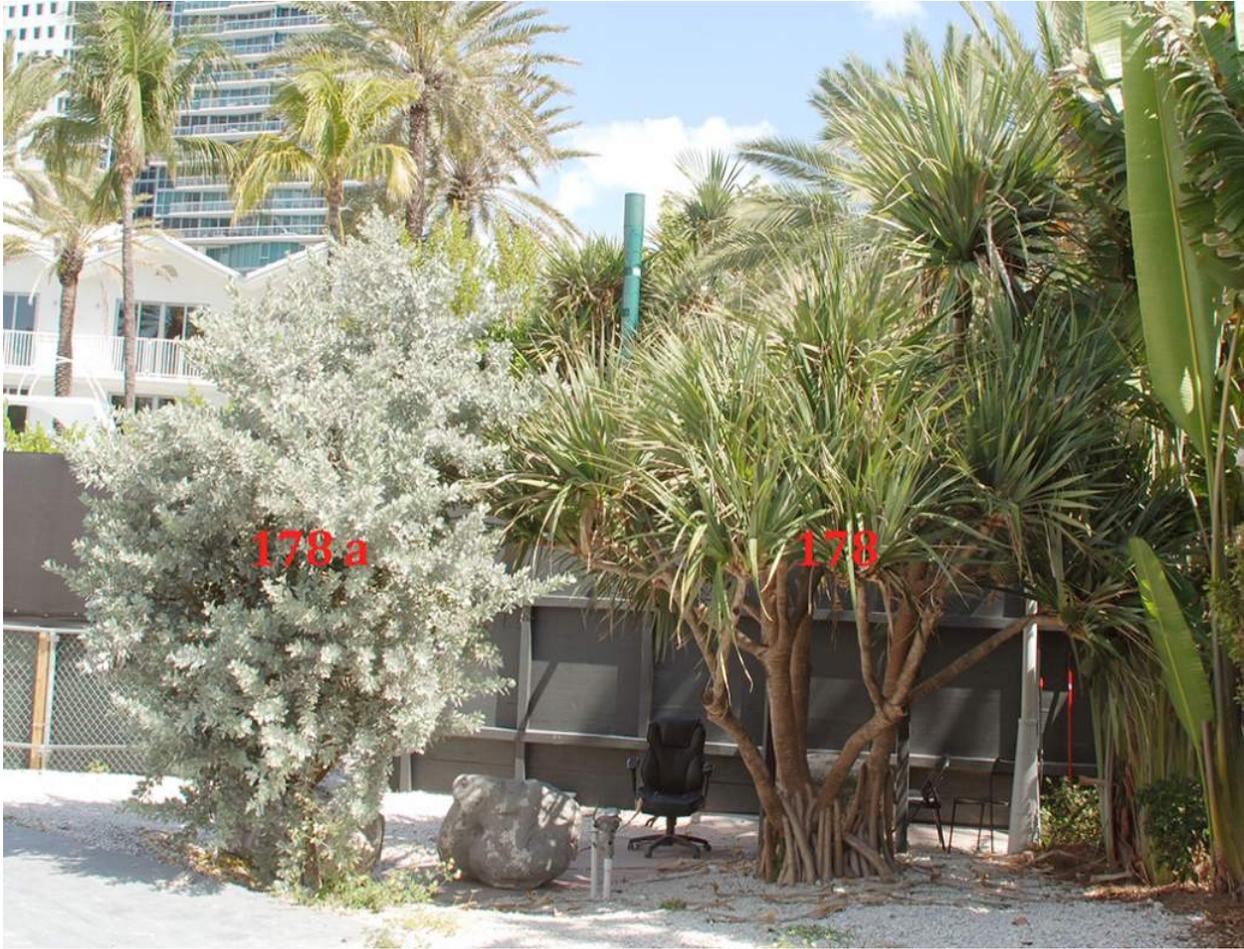
Photo 46 above is trees 178 & 178a.

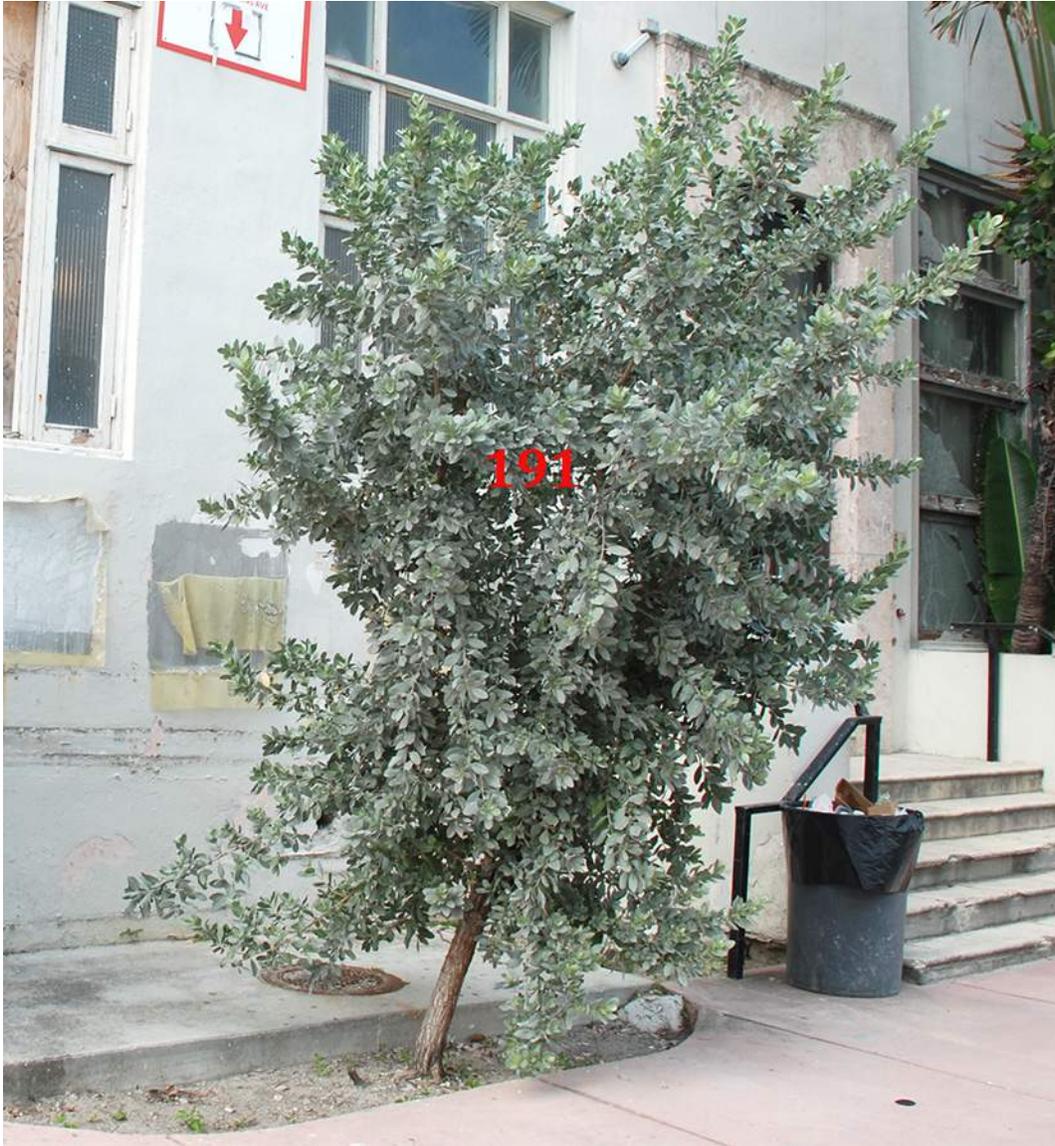
Photo 48 above is tree 191.

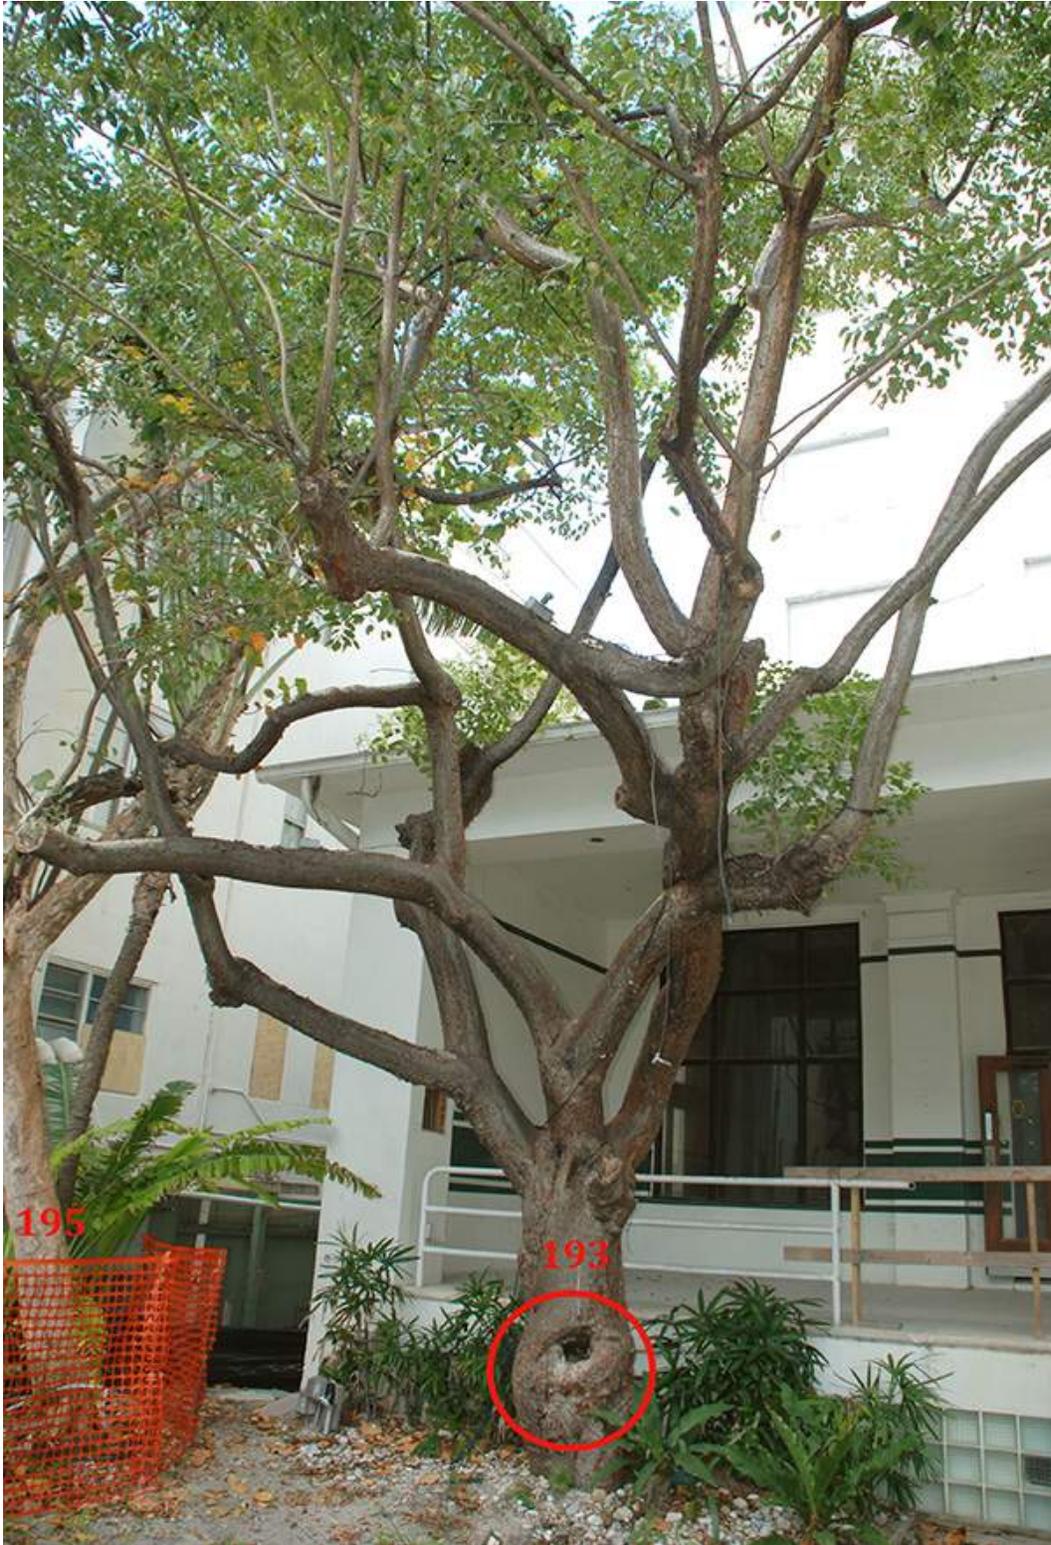
Photo 49 above is tree 193. See following photo.

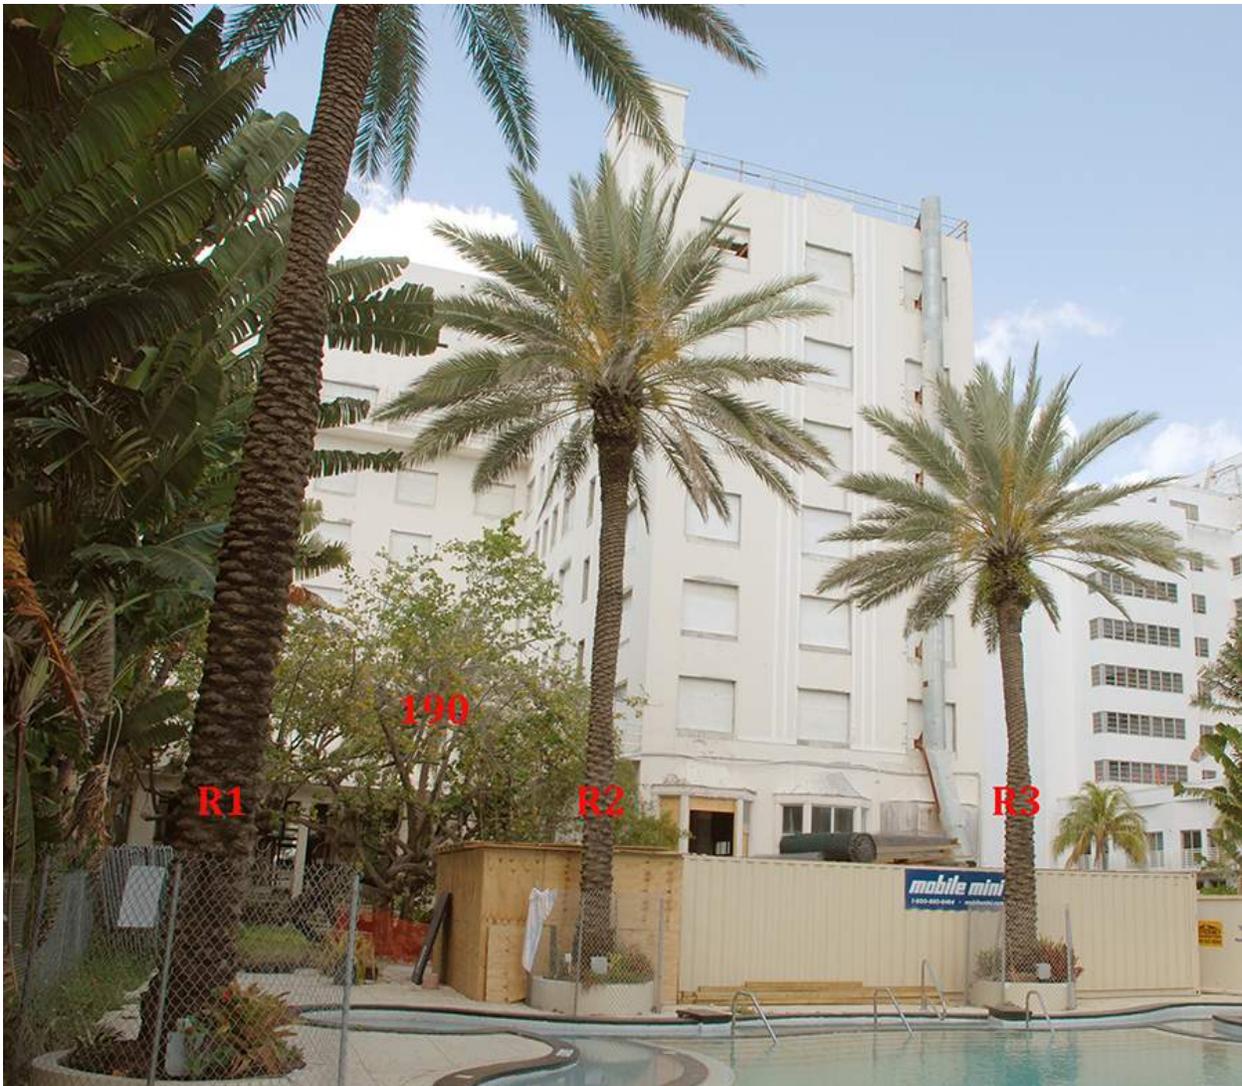
Photo 71 above is palms R1, R2 & R3. Note the canopy of tree 190 in the background.
