# HOME INSPECTION REPORT

Client Name: **Jacqueline Sankowski**  
Property Address: **828 4th Street**  
Address Line 2:  
City (State): **Miami Beach (FL)**  
ZIP: **33139**  
Phone:

Inspection #: **060320-828**  
Inspection Date: **06/03/2020**  
Inspector: **Jorge Garcia**  
License: **HI 9540**  
Time: **10:00 AM**  
Weather/Temp: **Rainy**

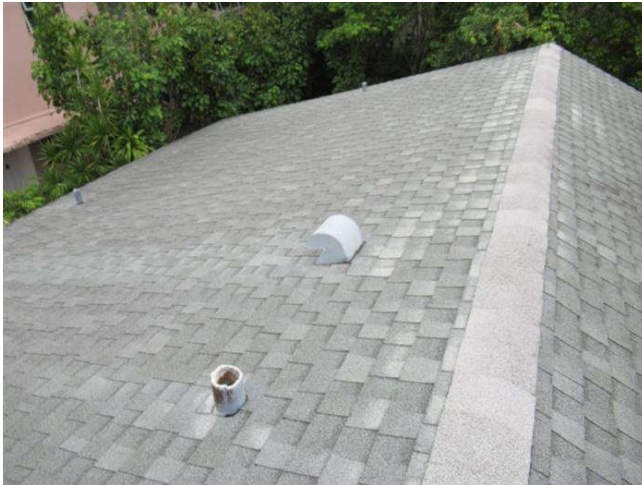
ROOF COVERING

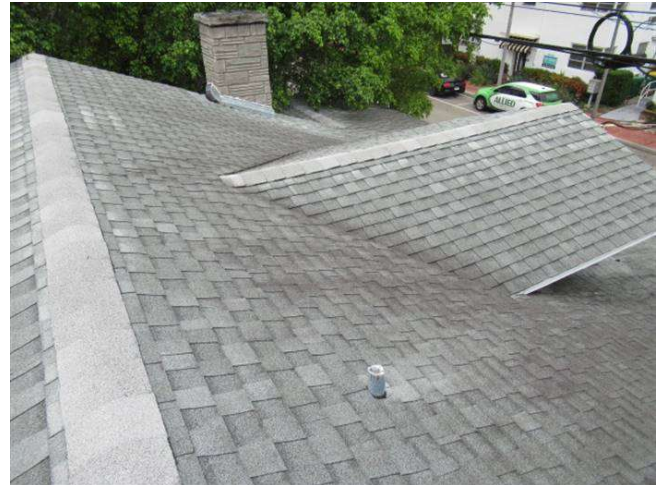
ROOF COVERING

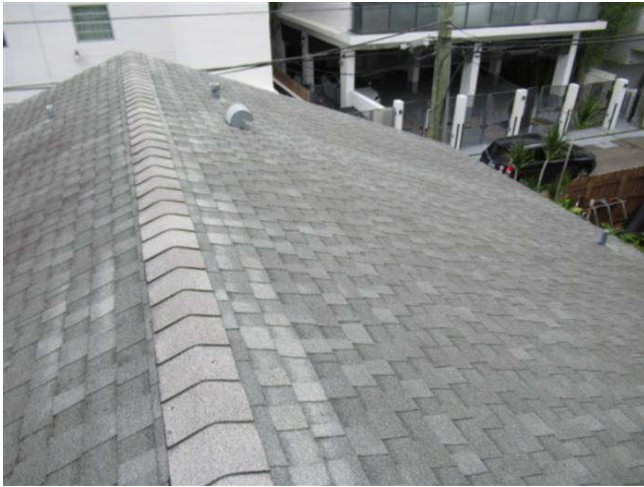
ROOF COVERING

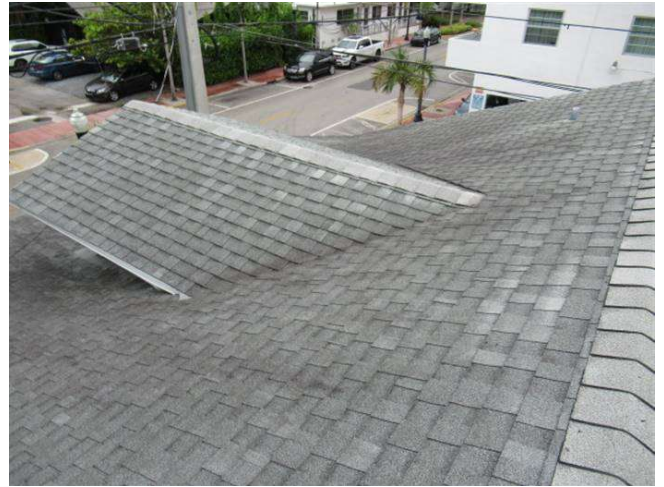
ROOF COVERING

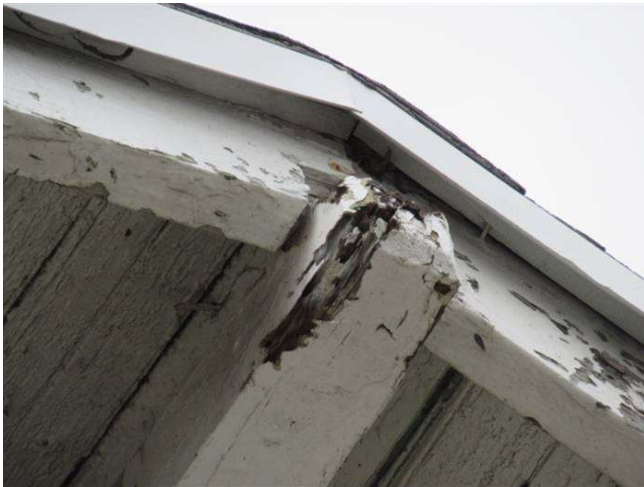
WOOD ROT

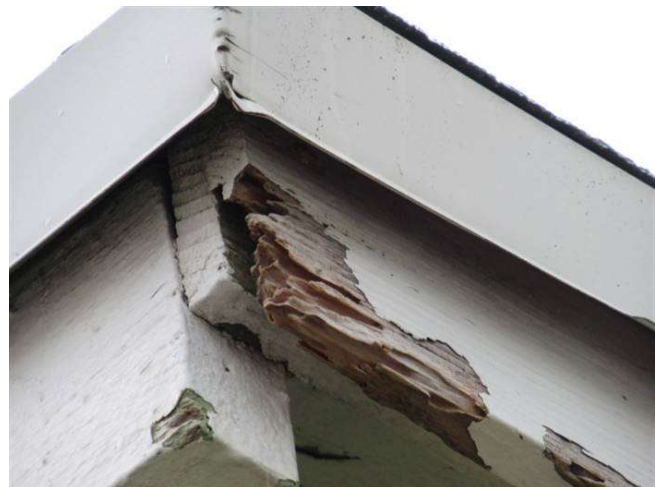
TERMITE DAMAGE

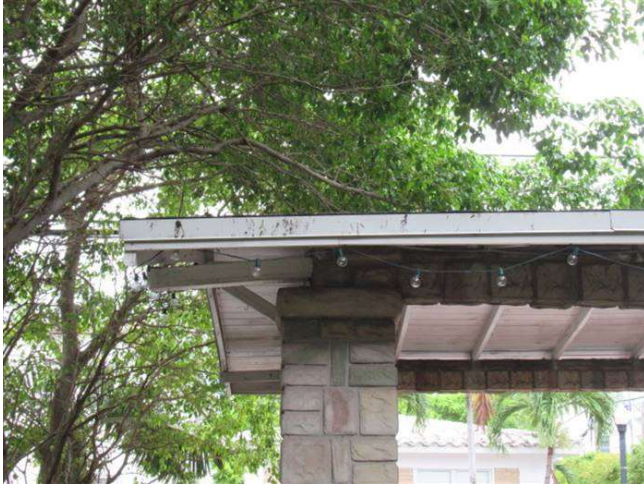
SAGGING ROOF

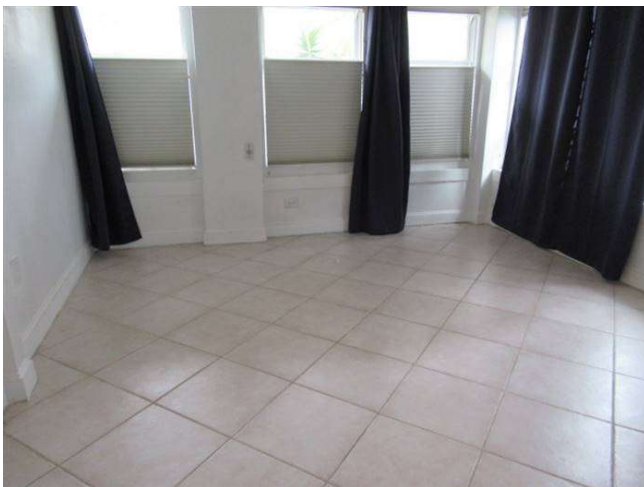
SAGGING FLOORS

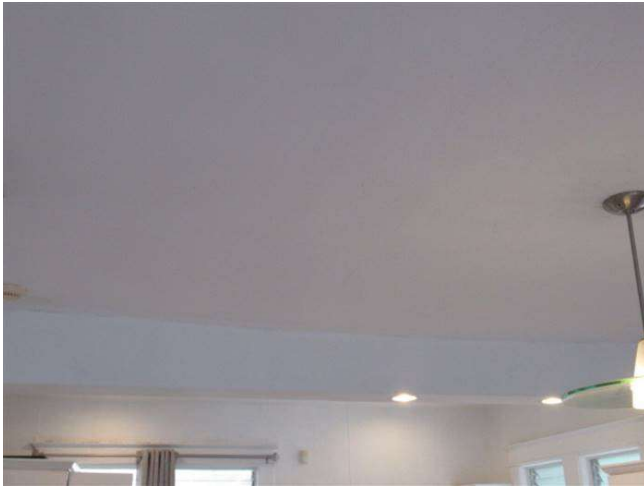
SAGGING CEILINGS

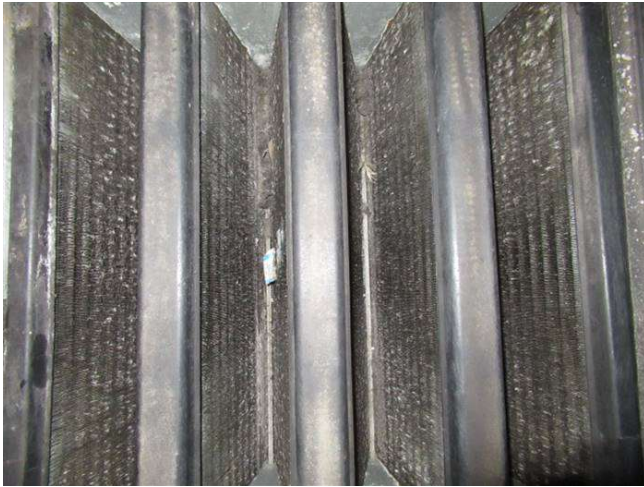
DIRTY COILS

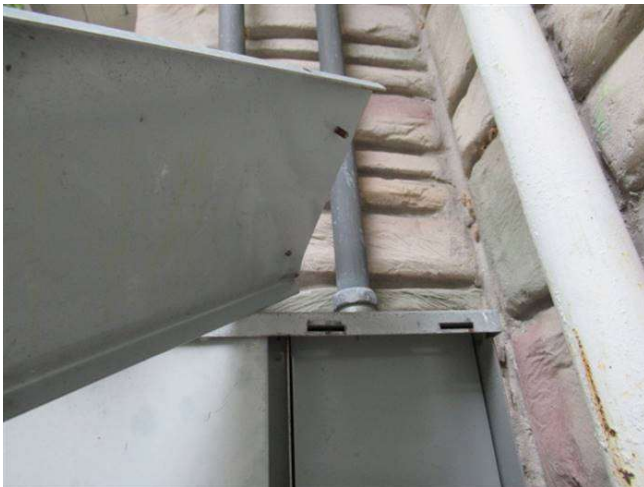
DAMAGED PANELS

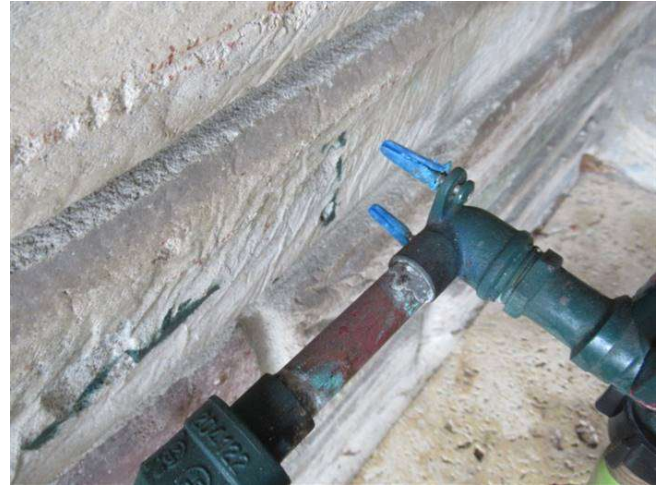
LOOSE PLUMBING

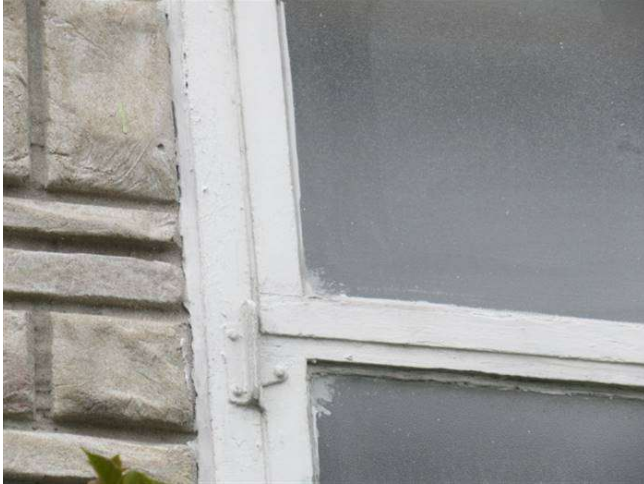
1. Several of the windows were noted sealed.
2. Recommend to properly seal the window framing.
3. A cracked jalousie pane in the kitchen and northeast bedroom was noted.
4. Wood rot was noted at the kitchen exterior door and frame.
5. Several windows were missing the crank handles.
6. The northeast bedroom door is not closing properly.
7. Several of the closet doors are damaged and/or loose.

SEALED WINDOWS

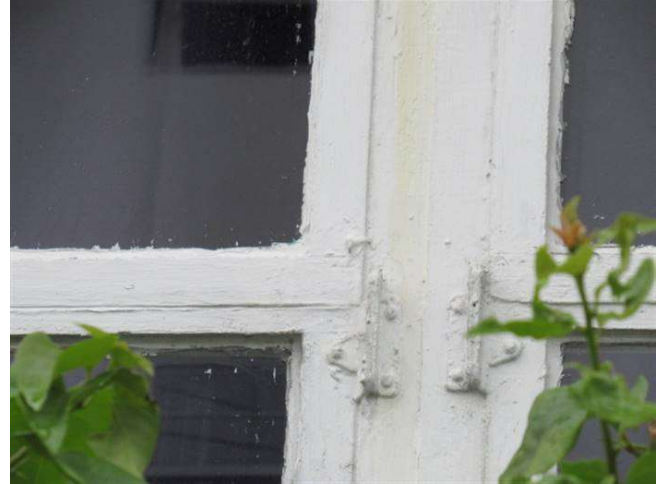
SEALED WINDOWS

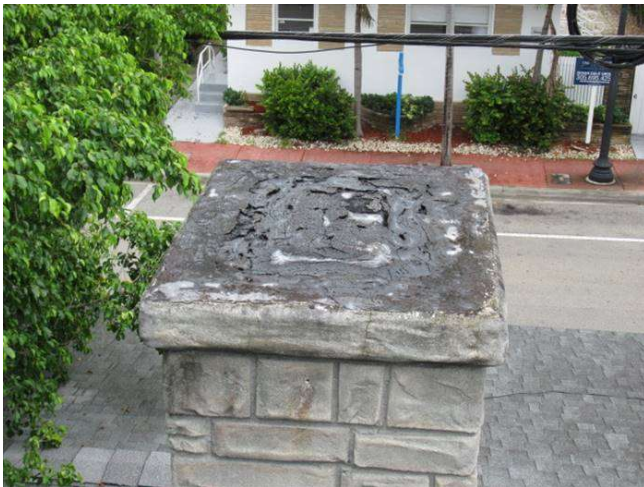
Fireplace Type **Unknown**  
Damper Condition **Not Visible**  
Chimney Cap Condition **Missing Cap**

SEALED CHIMNEY
